# **INDOOR AIR QUALITY ASSESSMENT**

**E. Ethel Little School  
7 Barberry Road  
North Reading, Massachusetts**

Prepared by:  
Massachusetts Department of Public Health  
Bureau of Environmental Health  
Indoor Air Quality Program  
January 2015

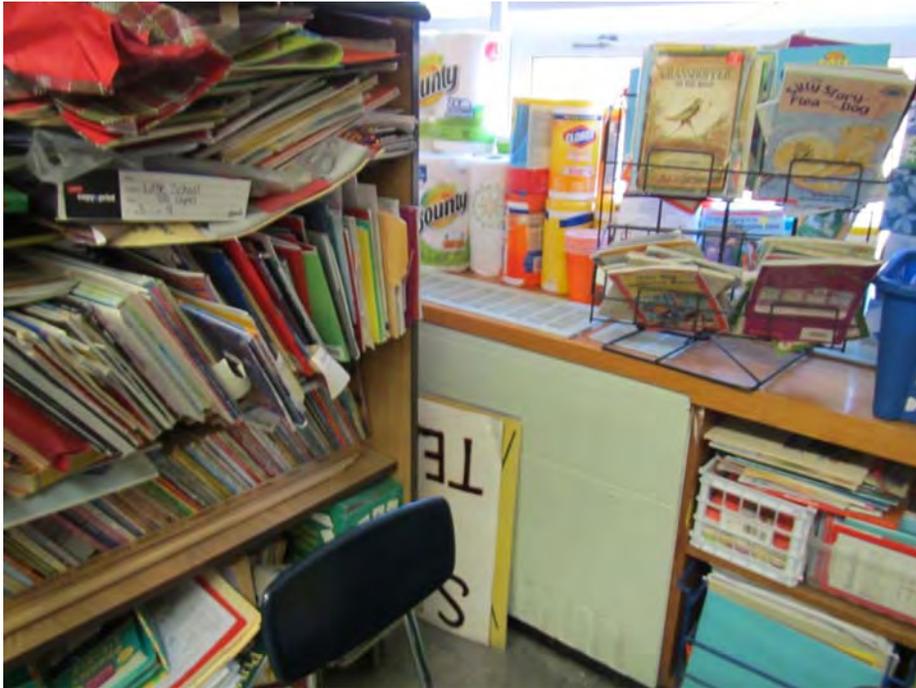
**Picture 1**

**Classroom univent, note obstructions with furniture, placement of items**

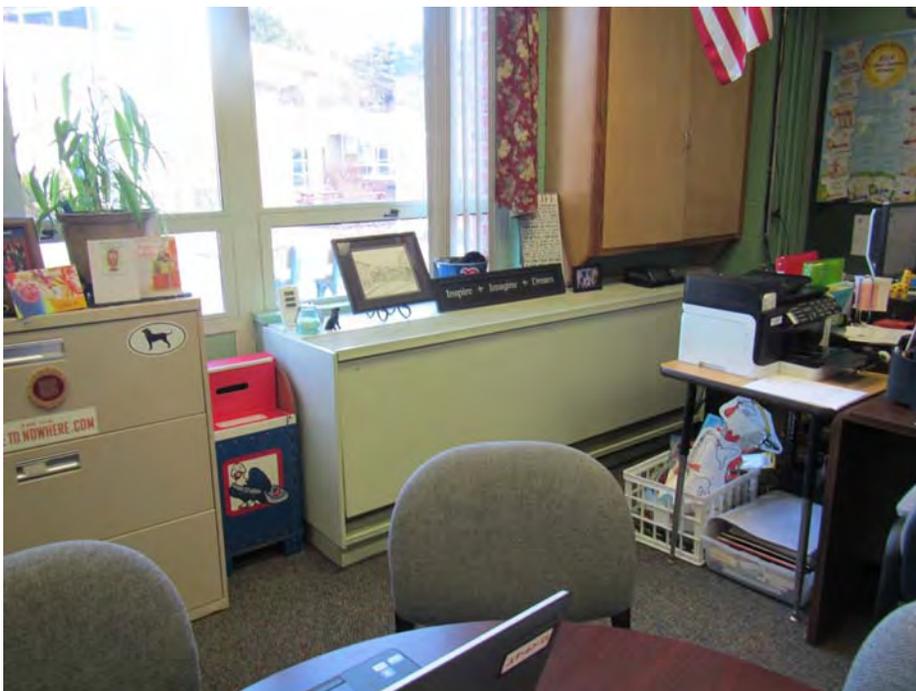
**Picture 2**

**Univent in office**

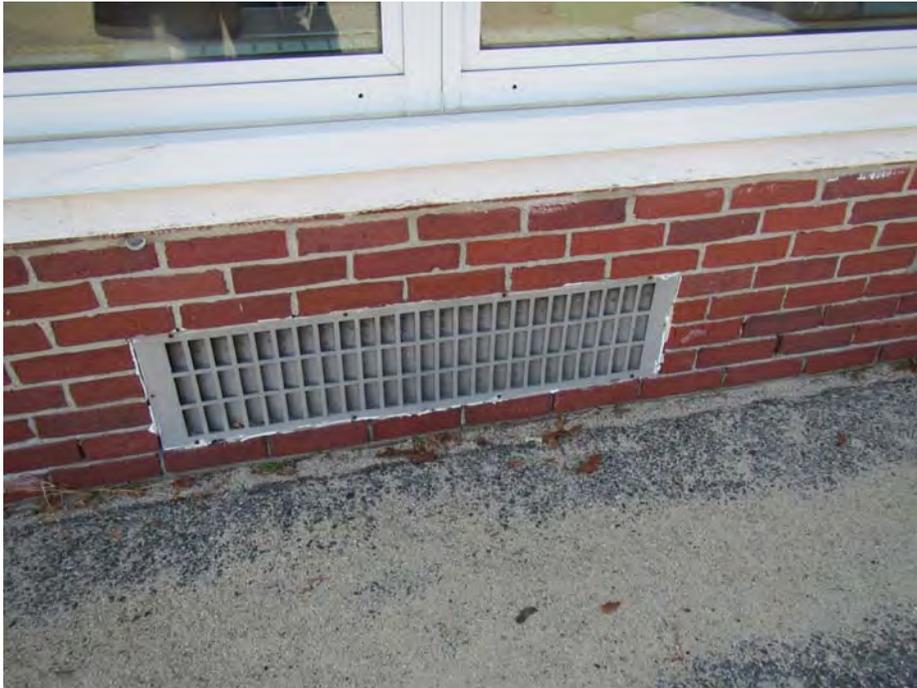
**Picture 3**

**Air intake for univent**

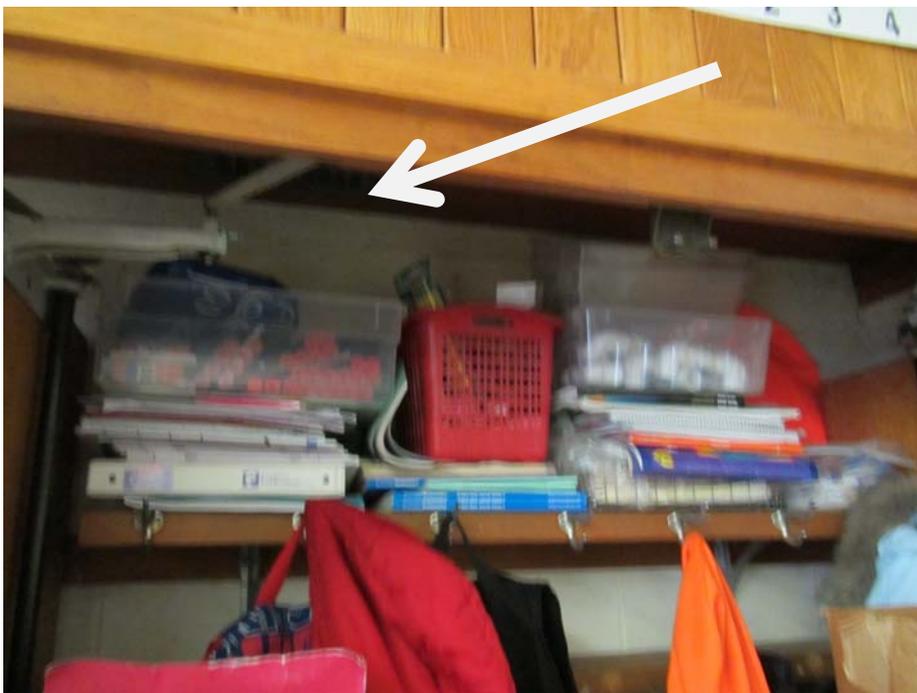
**Picture 4**

Exhaust ventilation in classrooms in the 1955 area is provided by exhaust vents located in coat closets (Pictures 4 and 5) ducted to fans on the roof. These vents were observed to be off or drawing weakly in some areas (Table 1). Some exhaust vents were also blocked by items inside the closet (Picture 4). Exhaust ventilation in the 1968 area is provided by unit exhausts, which look like univents, but do not have fresh air diffusers with only a return along the bottom. These units draw air out of the classroom and exhaust it directly outside through a vent in the outside wall. Many of the unit exhausts were obstructed and none were found to be on at the time of the visit.

**Coat closet containing classroom exhaust (arrow); note items partially obstructing vent**

2. Restore exhaust ventilation throughout the building. Inspect motors in rooftop units and unit exhausts and belts for proper function, and perform repairs and adjustments as necessary.

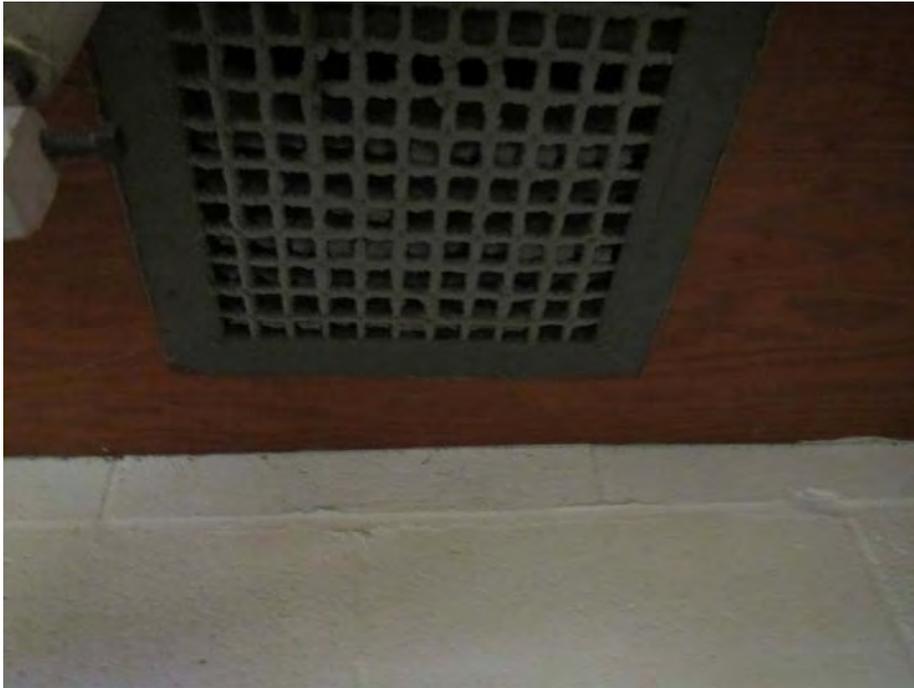
**Picture 5**

A number of exhaust vents and personal fans were found to have accumulated dust/debris (Pictures 5 and 17; Table 1). If exhaust vents are not functioning, backdrafting can occur, which

**Close-up of coat closet exhaust, note dust**

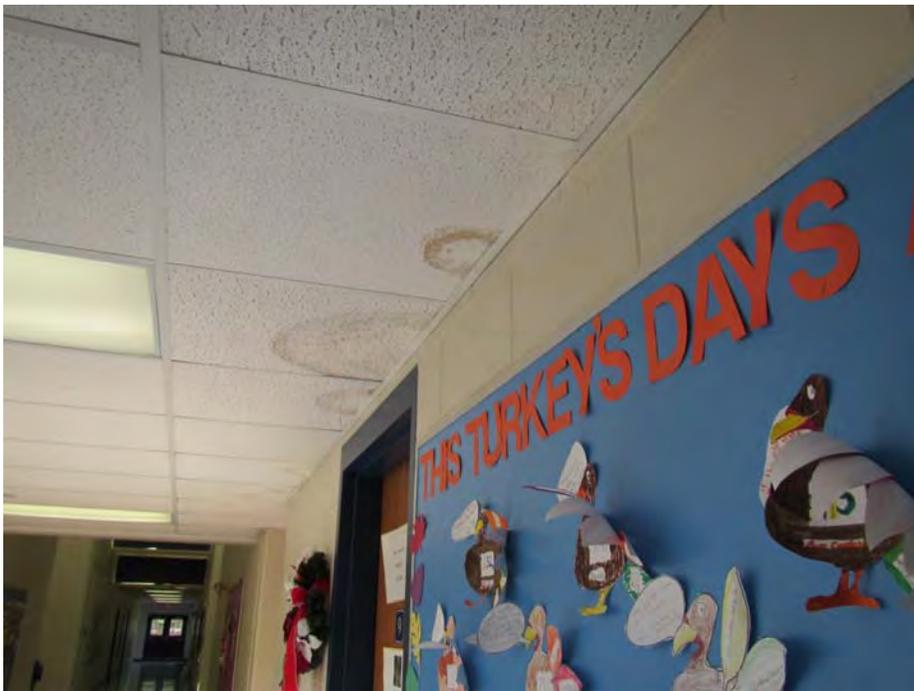
**Picture 6**

Water-damaged ceiling tiles were observed in a few areas throughout the building (Picture 6; Table 1); these can indicate active/historic leaks from either the roof/building envelope or plumbing system. Most of the water-damaged ceiling tiles observed during the assessment appeared to be near areas where different portions of the building joined. Joining structures constructed at different times out of different materials can lead to leaks along the shared wall/roof joints because of differential settling/movement of the materials over time. Flashing or sealant on roofs/walls in these locations should be examined regularly and repaired to prevent leaks. If repeatedly moistened, ceiling tiles can be a medium on which mold can grow. Water-damaged tiles should be replaced after a water leak is discovered and repaired.

**Water-damaged ceiling tiles**

10. Replace water-damaged ceiling tiles, and examine the area above ceiling tiles for mold growth. Disinfect areas of water leaks with an appropriate antimicrobial, as needed. Periodically examine areas where sections of the building join for missing/damaged flashing or other gaps where materials may have settled differently and repair as needed.

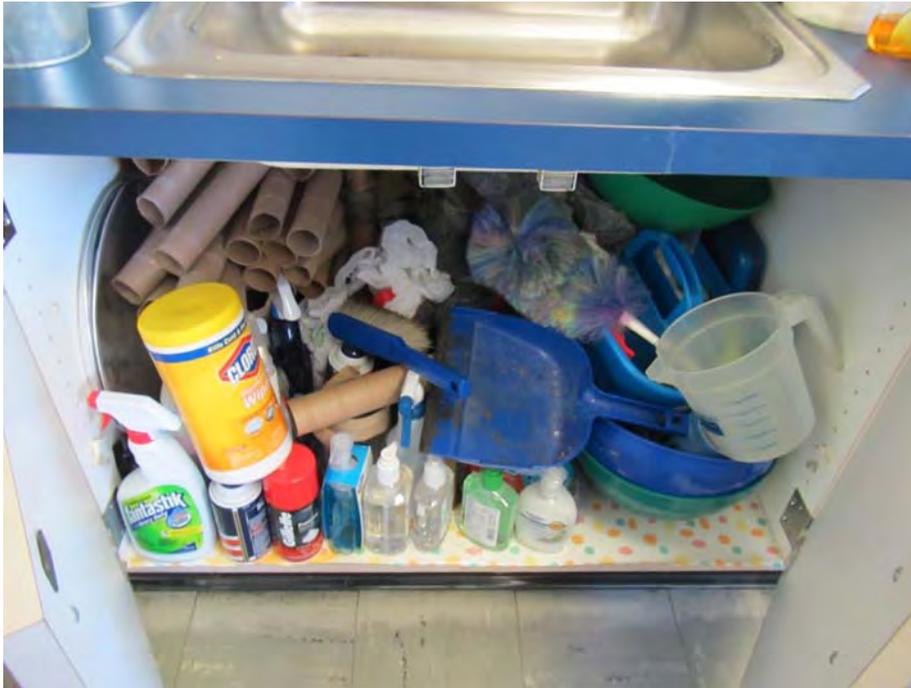
**Picture 7**

In a few areas, odors were noted coming from sinks (Table 1). The odors were reduced when water was poured down the drain. Odors from drains may be related to dry drain traps which can allow sewer gases and odors into occupied areas. In these cases it was reported that sinks are regularly used so it is more likely that drains are in need of cleaning/flushing to remove any substances that may be causing odors. Large quantities of porous items were also stored under these and other sinks (Table 1; Picture 7). The area under sinks is a moist environment that can lead to water damage and microbial growth on porous items. The large amount of items

**Large amounts of items, including porous items and cleaning products, under classroom sink**

13. Remove items from under sinks and inspect items and sink cabinets for water damage. Store fewer items and only non-porous items under sinks to prevent water damage.

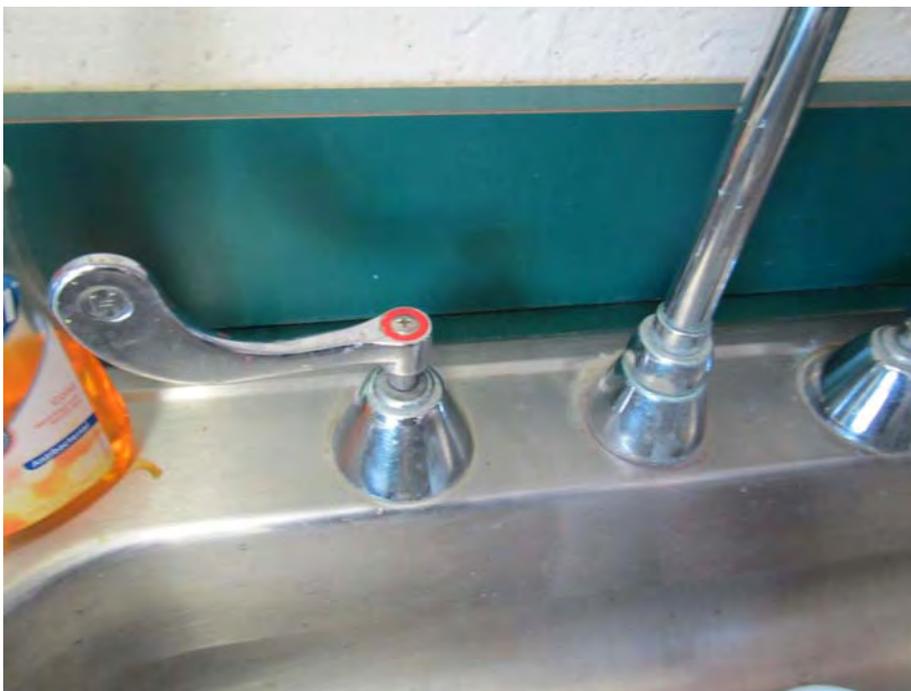
**Picture 8**

also makes any leaks difficult to detect. Items should be removed from under sinks and inspected for water damage. In addition, in many areas the backsplashes of sinks had open seams (Picture 8). If seams are not watertight, water can penetrate the seam, causing water damage. Water penetration and chronic exposure of porous and wood-based materials can cause them to swell, show signs of water damage and lead to potential mold growth.

**Open backsplash behind sink**

14. Repair backsplashes on sinks using waterproof sealant. Consider replacing sink countertops with single-piece molded countertops which have no seam.

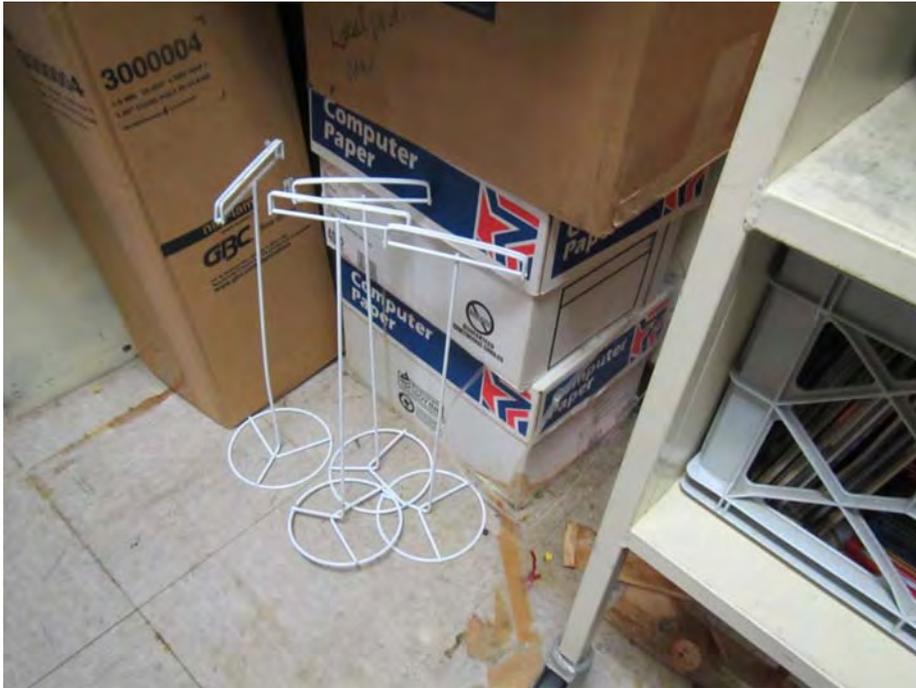
**Picture 9**

In a storeroom off the library, there was evidence of water damage on the floor and on boxes stored on the floor (Picture 9). It was reported that this room is rarely used. It is likely that condensation occurred during the summer when hot, humid air came into contact with the floor, which would be colder due to being slab on grade. The water-damaged materials should be removed and discarded and the floor cleaned. Porous items in this and other storerooms should be kept off the floor through use of shelving or pallets, as evidenced in other areas of the school.

**Evidence of water damage on floor and water-damaged boxes in storeroom**

15. Remove water-damaged items from the library storeroom shown in Picture 9 and discard. Thoroughly clean and disinfect the floor. Do not store porous items directly on floors to prevent moistening due to condensation; use pallets or shelving.

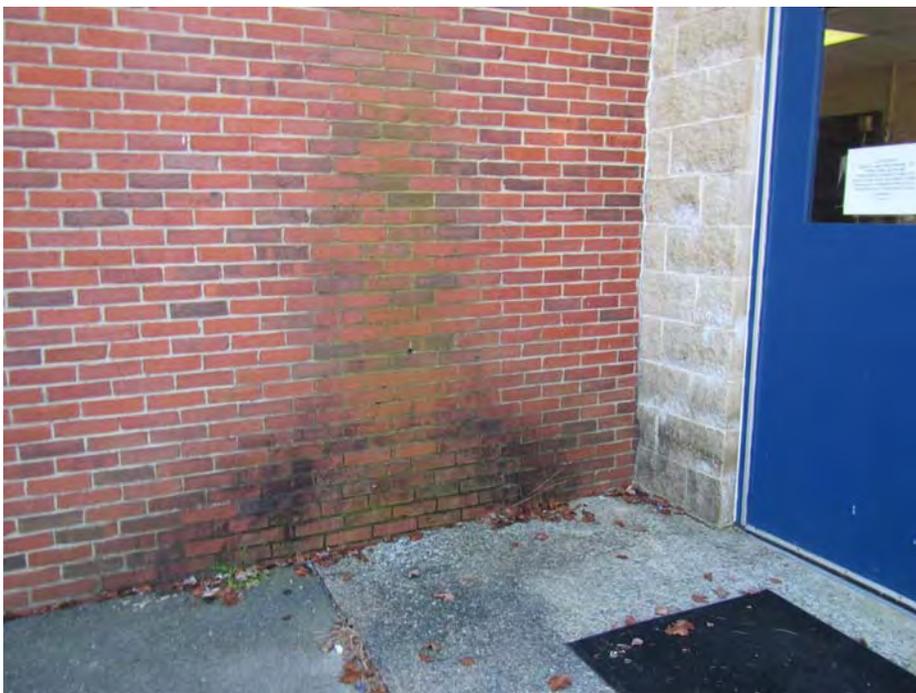
**Picture 10**

The exterior of the building was examined for conditions that might lead to indoor air quality concerns. Moss/plant growth was observed growing on exterior walls (Pictures 10 and 11), due to chronic moisture/lack of sunlight. Many areas of the school do not have gutter systems, and as a result water flows down over walls and splashes directly next to the building. In other areas, gutter downspouts terminate directly at the foot of the building, which may lead to infiltration back into the building. Existing gutters and downspouts should be maintained in good repair, and extended away from the building. Areas with "splash zones" directly at the base of the building should be evaluated to see if more effective drainage/gutters can be installed to direct water away from the side of the building.

**Water staining/moss growth on exterior wall**

18. Clean moss/water staining off the exterior of the building (e.g., as shown in Pictures 10 and 11). Evaluate the building drainage/gutter system to see if additional drainage can be added to remove water away from “splash zones” and be directed away from the building.

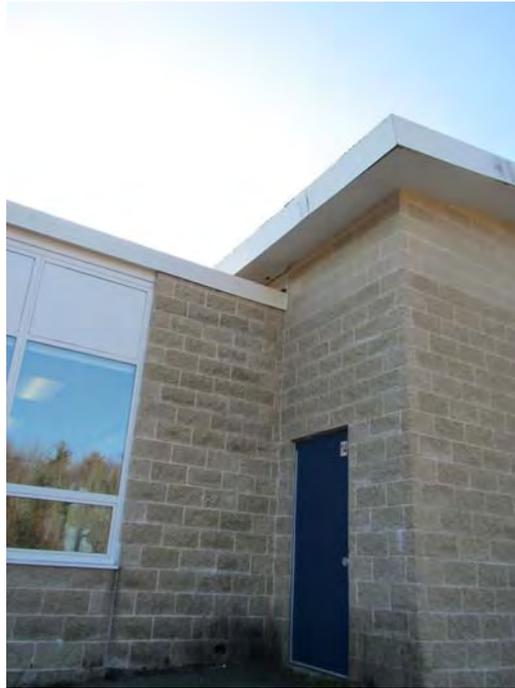
**Picture 11**

**“Splash zone” at corner of building in the 1997 wing showing evidence of chronic dampness**

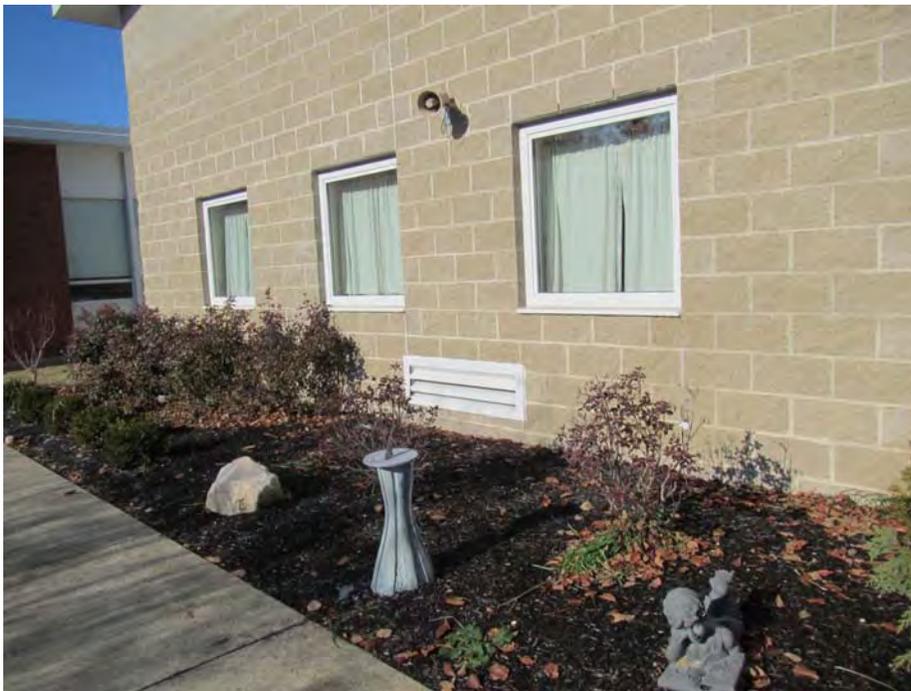
**Picture 12**

Plants and mulch were seen up against the building in a few areas (Picture 12). Plants and mulch can hold moisture against the building exterior and prevent drying. The growth of roots against exterior walls can bring moisture in contact with the foundation. Plant roots can eventually penetrate the wall, leading to cracks and/or fissures in the sublevel foundation. Over time, these conditions can undermine the integrity of the building envelope and provide a means of water entry into the building via capillary action through exterior walls, foundation concrete, and masonry (Lstiburek & Brennan, 2001). The freezing and thawing action of water during the winter months can create cracks and fissures in the foundation that can result in additional penetration points for both water and pests. Trees and shrubs can also be a source of pollen,

debris, and mold into univents and windows. Consideration should be given to removing landscaping in close proximity to the building so as to maintain a space of 5 feet between shrubbery and the building.

**Plants next to building and air intake**

19. Remove plants and mulch to five feet away from the building.
20. Ensure that doors to the outside close/fit tightly to prevent the ingress of unconditioned air, moisture and pests. Replace weather stripping and monitor for light and drafts.

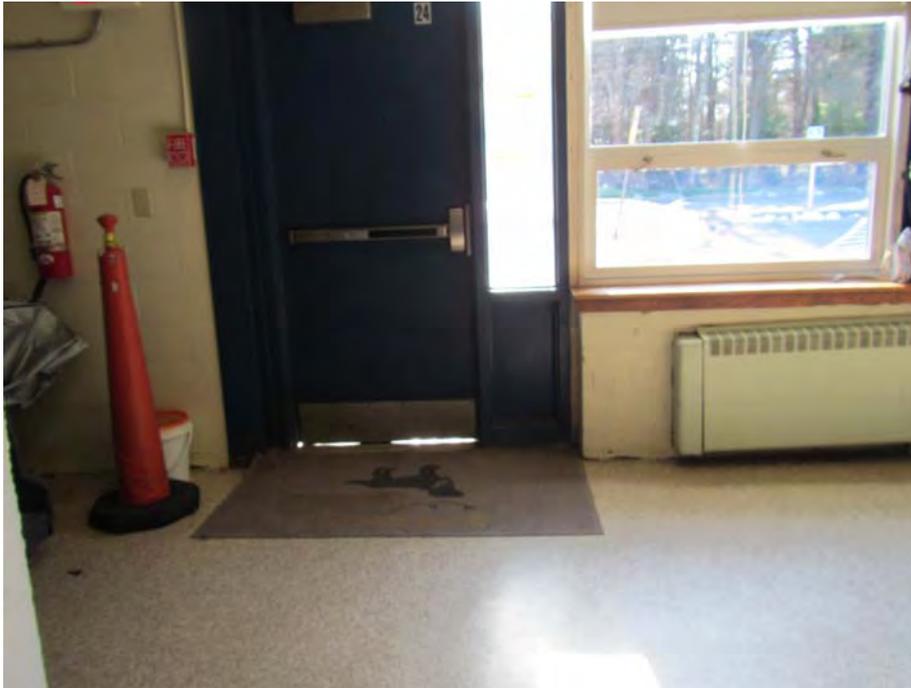
**Picture 13**

Doors to the exterior were seen to be missing weather stripping (Picture 13), which can allow unconditioned air, moisture and pests into the building.

**Light visible beneath door showing lack of weatherstripping**

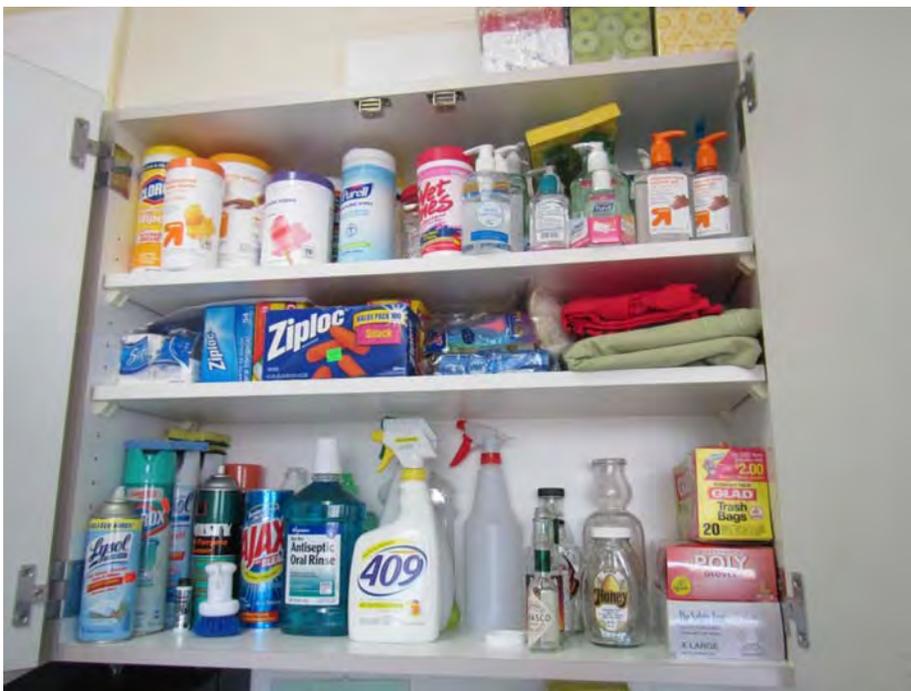
**Picture 14**

Cleaning and sanitizing products were observed on/under sinks, in cabinets and elsewhere in classrooms, sometimes in large quantities (Pictures 1, 7 and 14; Table 1). These products contain chemicals that can be irritating to the eyes, nose and throat of sensitive individuals. Mr. Hardacker reported that the school issues cleaning products that are the same as or compatible with the cleaners used by janitors for classroom cleaning. However, many of the products observed did not appear to be school issued. Cleaning products should be properly labeled and stored in an area inaccessible to children. In addition, a Material Safety Data Sheet (MSDS) should be available at a central location for each product in the event of an emergency.

**Cleaning products and hand sanitizers in a cabinet in a classroom**

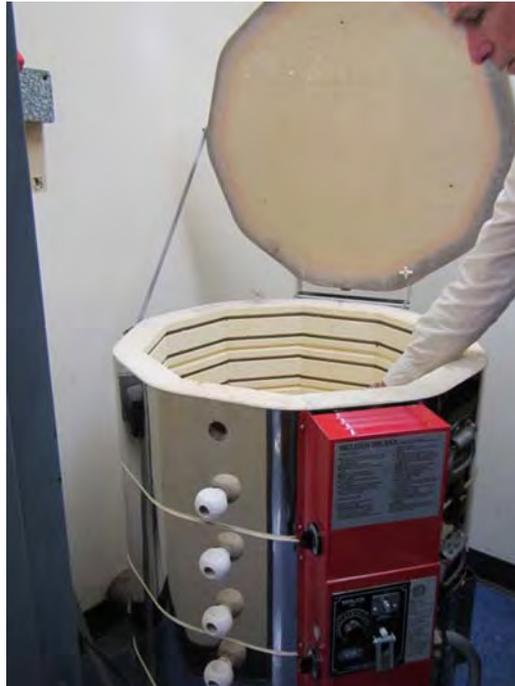
**Picture 15**

An electric kiln was located in a room off the art room (Picture 15). The exhaust vent from this unit was located below the unit and appeared to be functional. The room also has general exhaust which reportedly connects directly outside the building. It is important that

exhaust ventilation be turned on and operating prior to the operation of any kilns and it should remain operating until the kiln cycle has completed and the kilns have cooled down.

**Kiln in closet off art room**

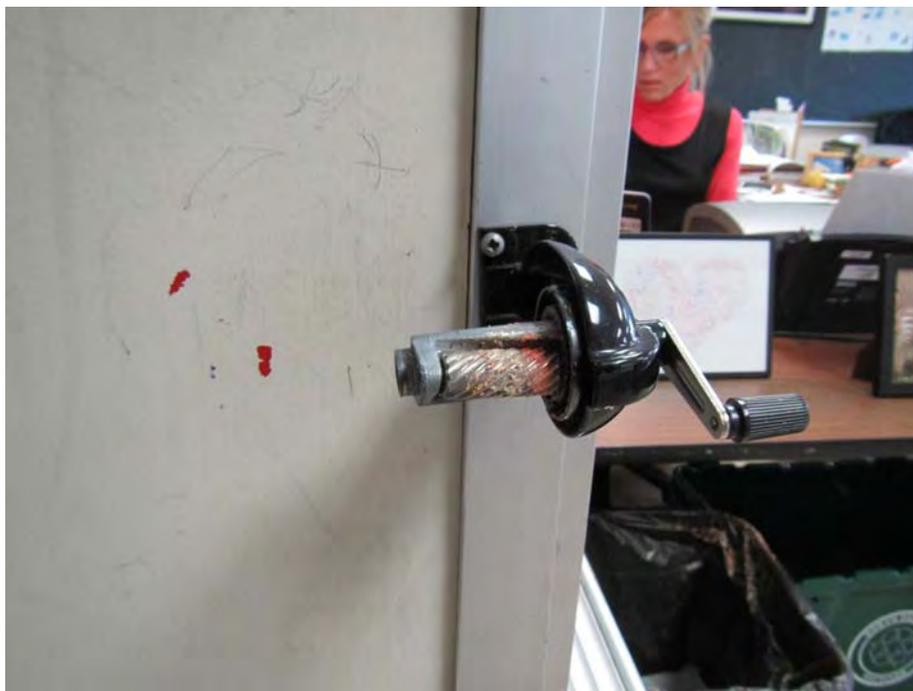
**Picture 16**

Accumulated chalk dust was noted in a few classrooms. Chalk dust is a fine particulate, which can become easily aerosolized and serve as a source of eye and respiratory irritation. Pencil shavings and uncovered pencil sharpeners were observed in classrooms (Picture 16; Table 1). This material can also be irritating when aerosolized. Pencil sharpeners should be contained and located away from air sources and shavings cleaned regularly.

**Pencil sharpener with no cover**

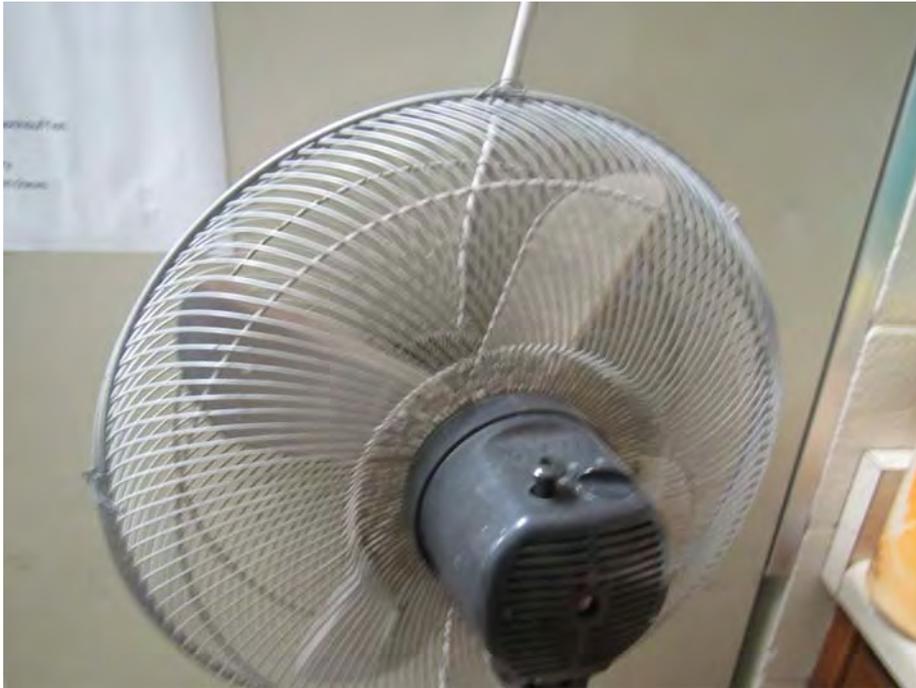
**Picture 17**

can re-aerosolize accumulated dust particles. Re-activated supply, exhaust/return vents and fans can also aerosolize dust accumulated on vents/fan blades.

**Dusty personal fan**

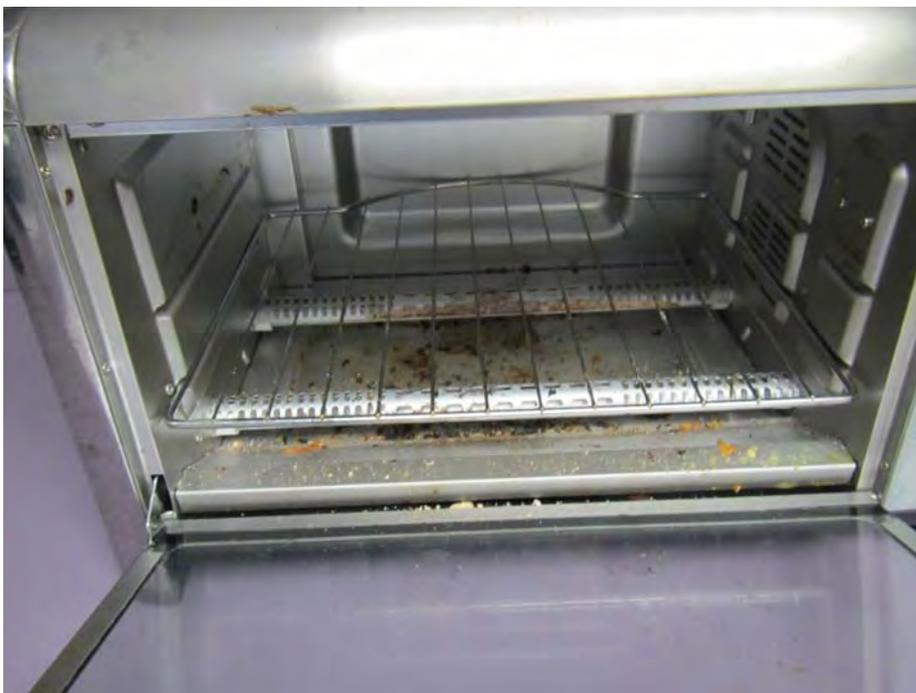
**Picture 18**

A toaster oven and other appliances in the staff lounge were found to have crumbs/food debris (Picture 18). This material can burn and cause odors as well as attracting pests.

**Toaster oven with crumbs**

30. Refrain from hanging items from the ceiling tile system.
31. Clean cooking appliances of crumbs regularly.
32. Store new and used fluorescent bulbs in a manner that will prevent them getting broken. Dispose of spent bulbs properly as they may contain mercury.

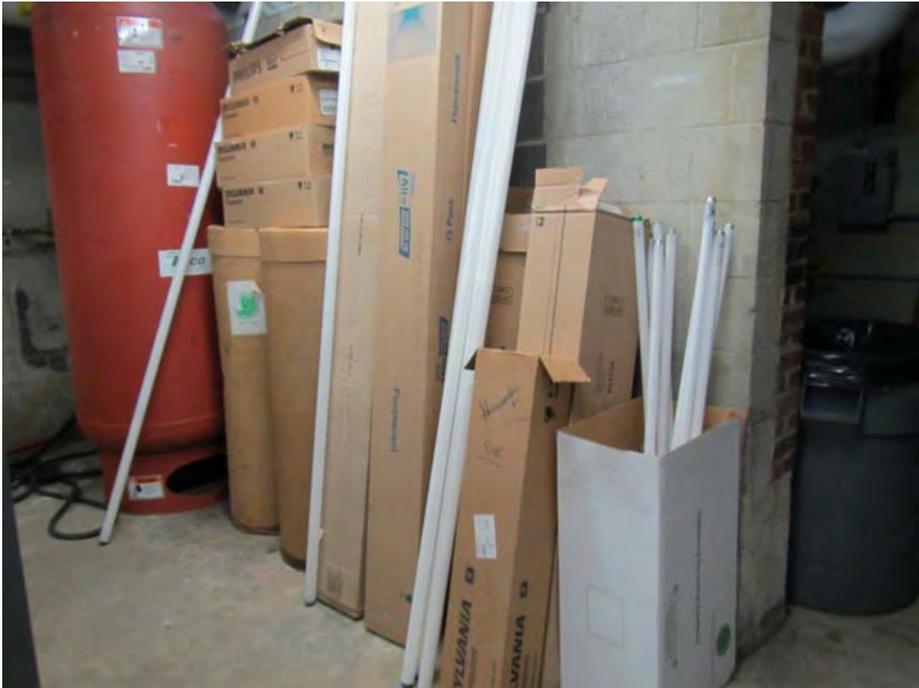
**Picture 19**

Fluorescent light bulbs were observed to be stored in a non-secure manner in the mechanical room (Picture 19). These bulbs contain mercury, and must be properly handled and stored in order to prevent breaks and releases of mercury.

**Improperly stored fluorescent bulbs**
