# **INDOOR AIR QUALITY ASSESSMENT**

**Executive Office of Health and Human Services Center  
Shetland Park Office Complex  
45 Congress Street  
Salem, MA**

Prepared by:  
Massachusetts Department of Public Health  
Bureau of Environmental Health  
Indoor Air Quality Program  
June 2015

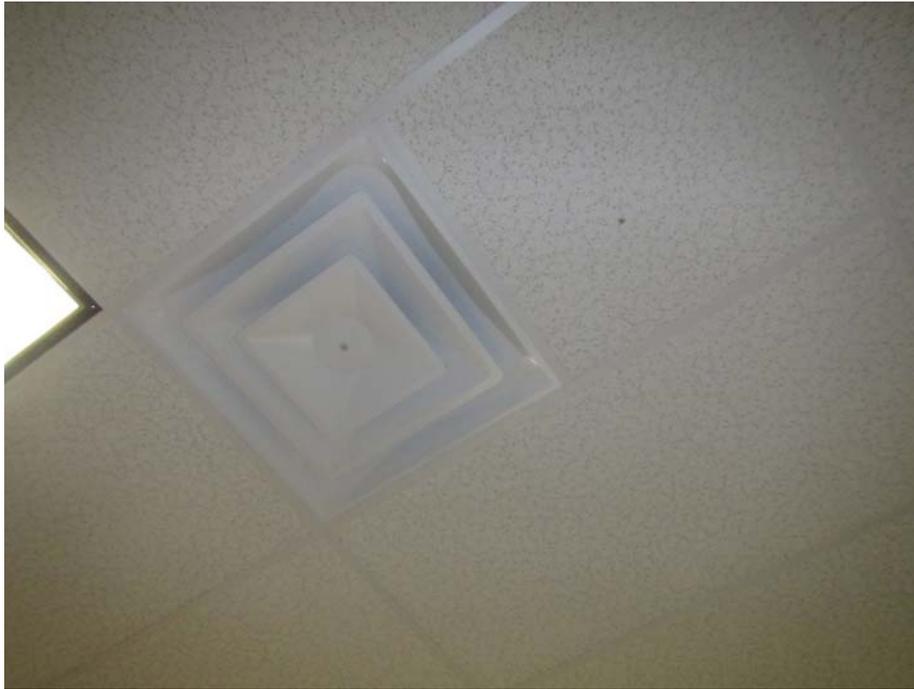
**Picture 1**

Air-handling units (AHUs) are mounted above the ceiling tiles and provide fresh air to the office space via air intakes ducted to the roof. AHUs are connected to ceiling-mounted supply air diffusers (Picture 1) and return/exhaust (Picture 2) vents via ductwork.

**Ceiling-mounted supply air diffuser**

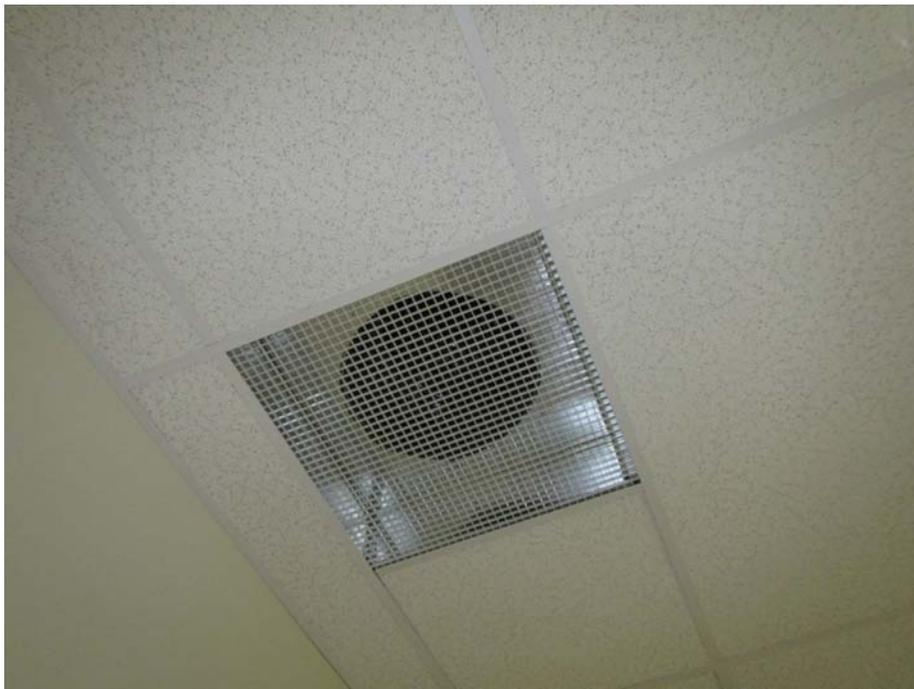
**Picture 2**

**Return/exhaust vent**

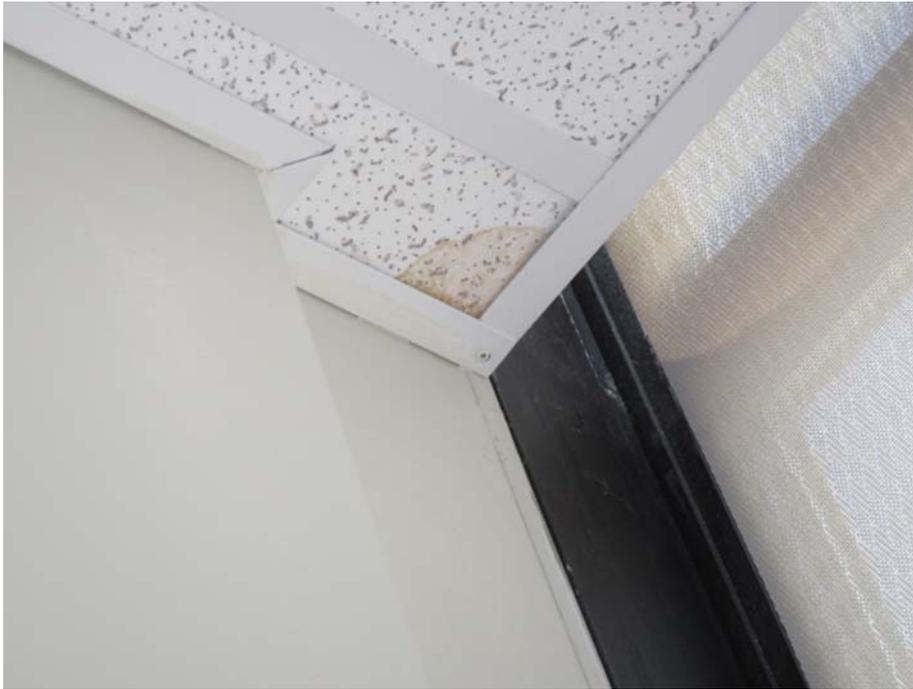
**Picture 3**

Water-damaged ceiling tiles were observed in a few areas (Pictures 3 and 4). Water-damaged ceiling tiles can indicate water penetration or leaks from HVAC components. They can provide a source of mold and should be replaced after a water leak is discovered and repaired.

**Water-damaged ceiling tile**

6. Investigate the source of the water leaks moistening ceiling tiles and repair. Continue to monitor the file room for active water leaks. Verify that the leaks have been repaired and replace water-damaged ceiling tiles.

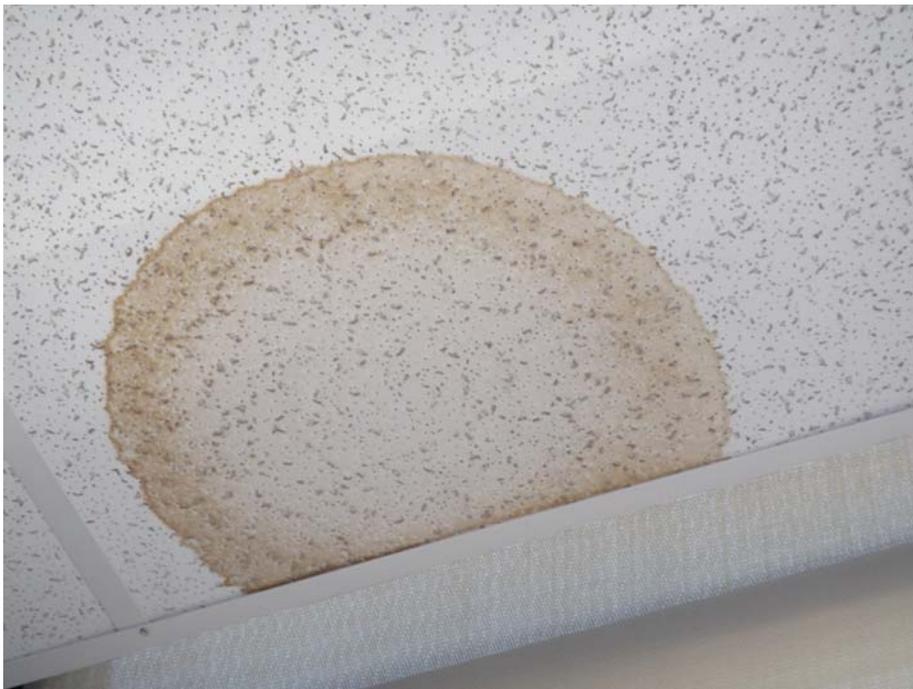
**Picture 4**

**Water-damaged ceiling tile**

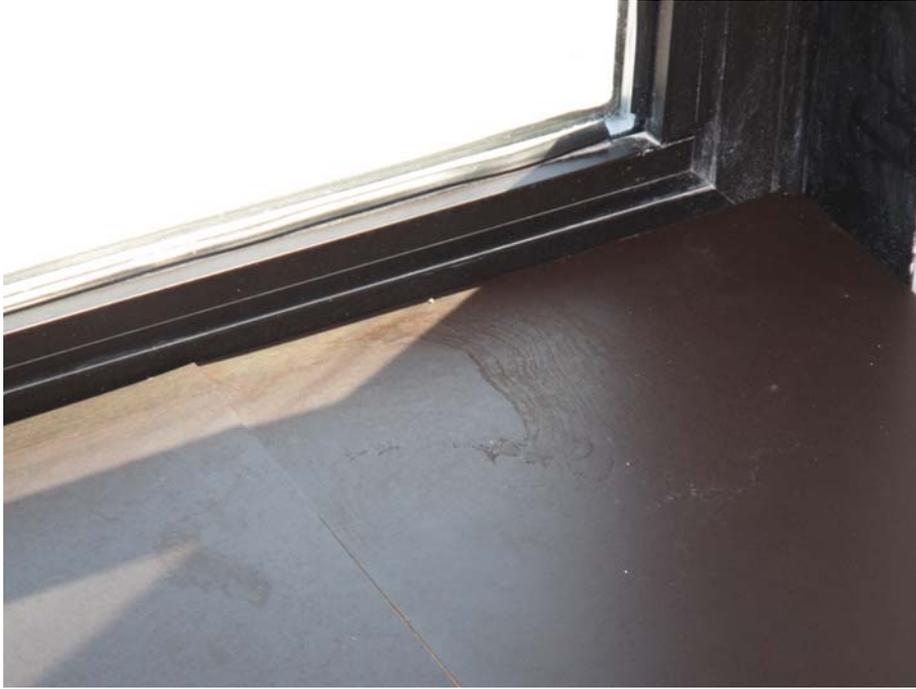
**Picture 5**

Several windows along the front of the building appear to be leaking. Missing sections of window seals as well as signs of water staining on the laminate window sill were observed (Pictures 5 and 6, Table 1). Chronic water infiltration has the potential to moisten porous building materials leading to water damage, mold and associated odors.

**Missing window seal (corner) and water staining on sill**

7. Determine the cause of the leaking windows (missing/damaged gaskets or seals, flashing, etc.) Make repairs to prevent chronic water damage to porous building materials.

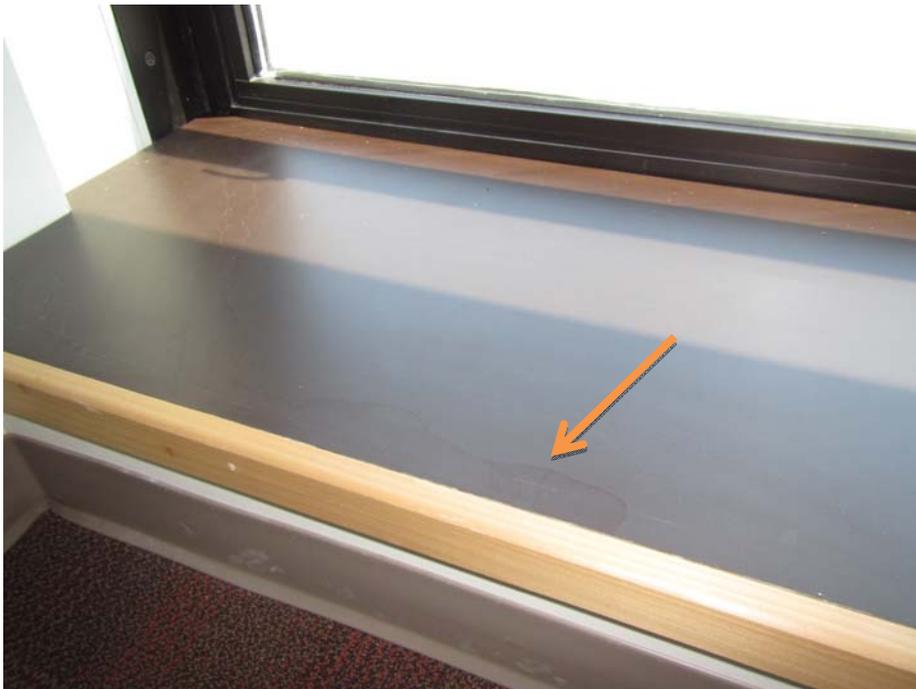
**Picture 6**

**Water staining on window sill (arrow)**

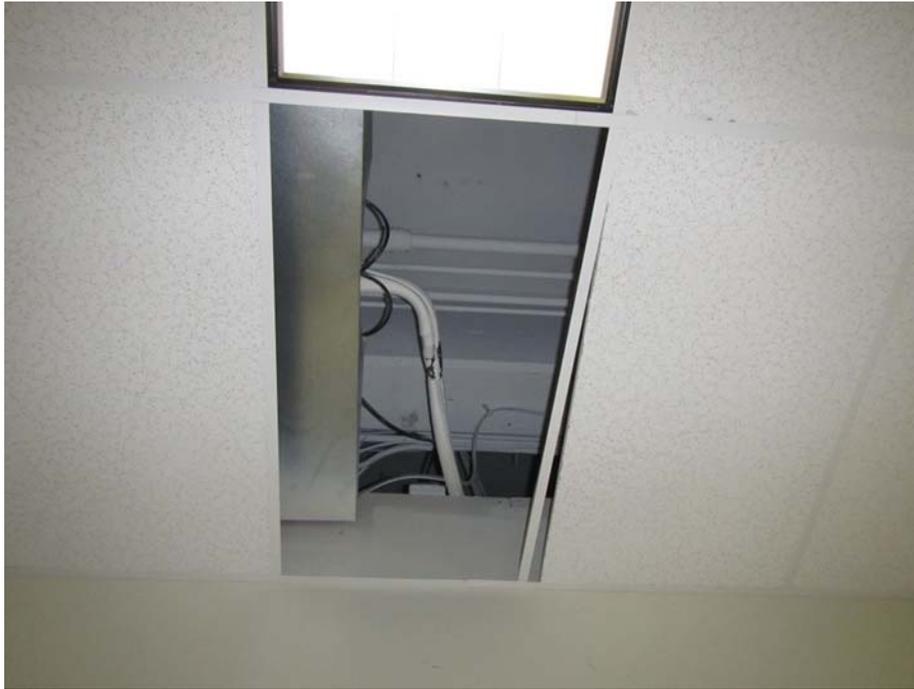
**Picture 7**

A water leak from the HVAC system in the file room reportedly occurred one week prior to this assessment. A missing ceiling tile directly beneath an AHU with a condensate drip pan was observed (Picture 7). EOHHS staff reported that maintenance personnel have addressed the issue. No porous building materials or files appeared to be water-damaged. The area should continue to be monitored for leaks and the ceiling tile should be replaced.

**Missing tile where leak occurred in file room (note AHU drip pan above)**

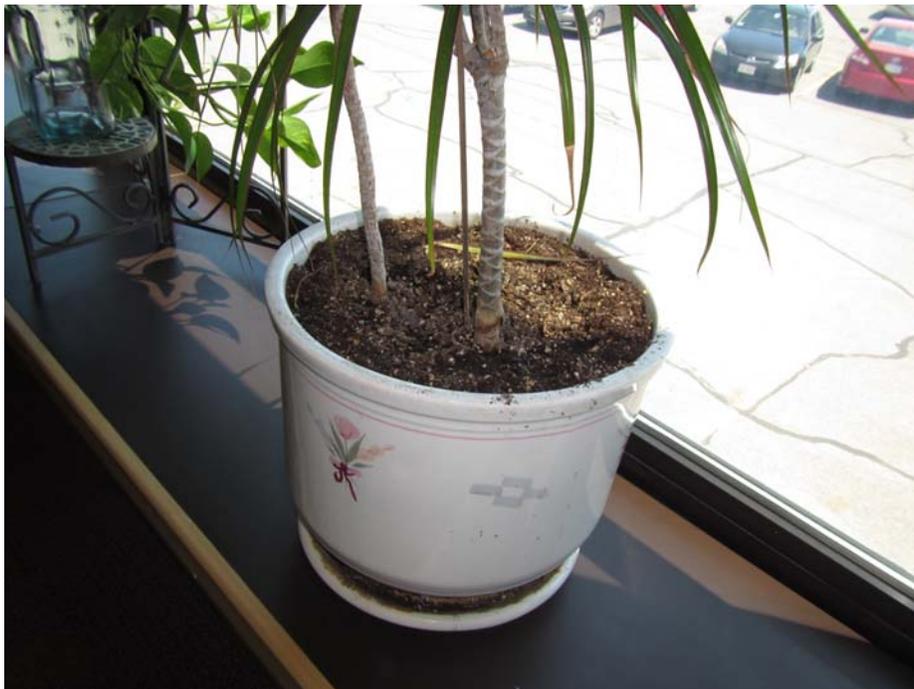
**Picture 8**

Plants were observed in some areas and in some cases were poorly-maintained, leading to microbial growth (Picture 8). Plants can be a source of pollen and mold, which can be

respiratory irritants. Plants should be properly maintained and equipped with drip pans to prevent water damage to porous building materials. If drip pans become colonized with mold, they should be cleaned with an antimicrobial solution or replaced. Plants should also be located away from ventilation sources to prevent the aerosolization of dirt, pollen or mold.

**Plant with microbial growth in drip tray**

8. Place waterproof mats under all water coolers that are located directly on carpeting or relocate these appliances to non-carpeted areas.
9. Plants should be properly maintained and equipped with drip pans to prevent water damage to porous building materials and be located away from ventilation sources to prevent the aerosolization of dirt, pollen or mold. Clean or replace any mold-colonized drop pans.

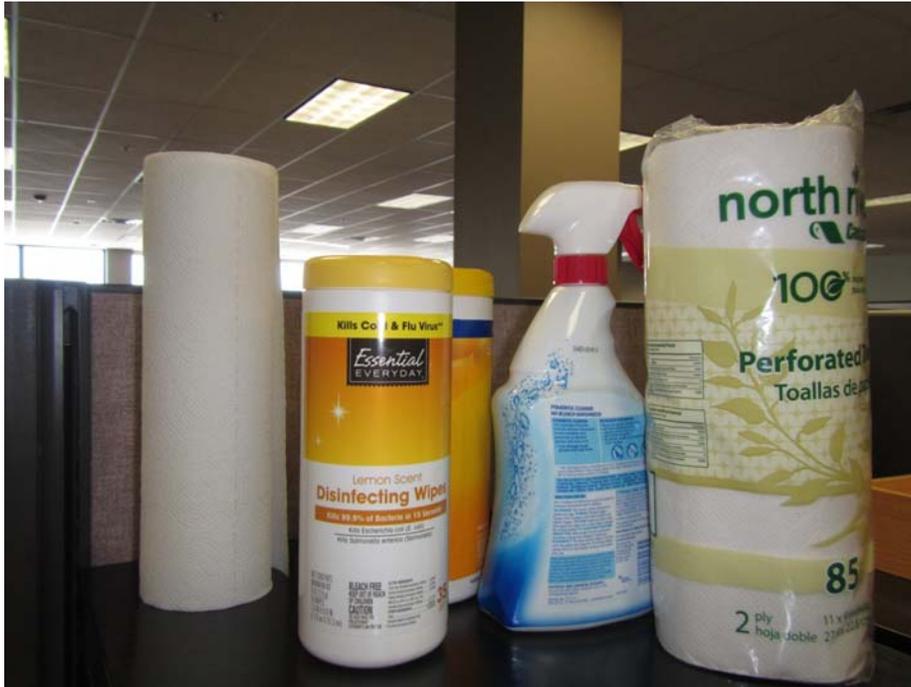
**Picture 9**

Cleaning products, air freshening sprays and scented products were also observed (Pictures 9 and 10, Table 1). Air fresheners and other air deodorizers contain chemicals that can be irritating to the eyes, nose and throat of sensitive individuals. Many air fresheners contain 1,4-dichlorobenzene, a VOC which may cause reductions in lung function (NIH, 2006). Furthermore, deodorizing agents do not remove materials causing odors, but rather mask odors

that may be present in the area. Many cleaning products also contain chemicals that can be irritating to the eyes, nose and throat of sensitive individuals.

**Cleaning products**

11. Consider locating photocopiers and other office equipment to areas with good ventilation or localized exhaust.
12. Consider discontinuing use of air fresheners/deodorizers to prevent exposure to VOCs.

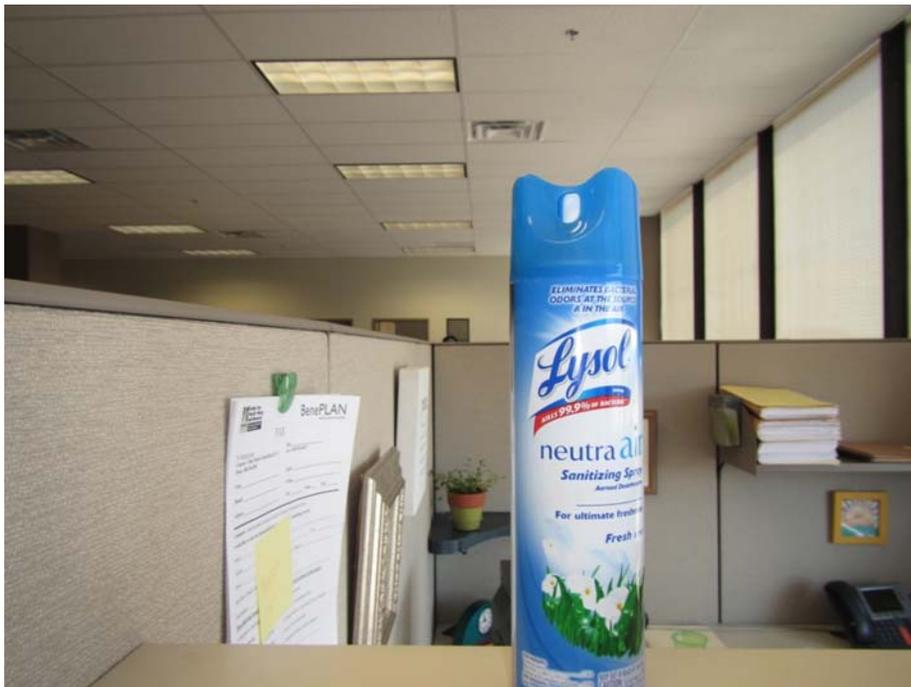
**Picture 10**

**Disinfecting/deodorizing spray**
