INDOOR AIR QUALITY ASSESSMENT

Commonwealth of Massachusetts
Department of Children and Families
140 High Street
Springfield, Massachusetts

Prepared by:
Massachusetts Department of Public Health
Bureau of Environmental Health
Indoor Air Quality Program
April 2015

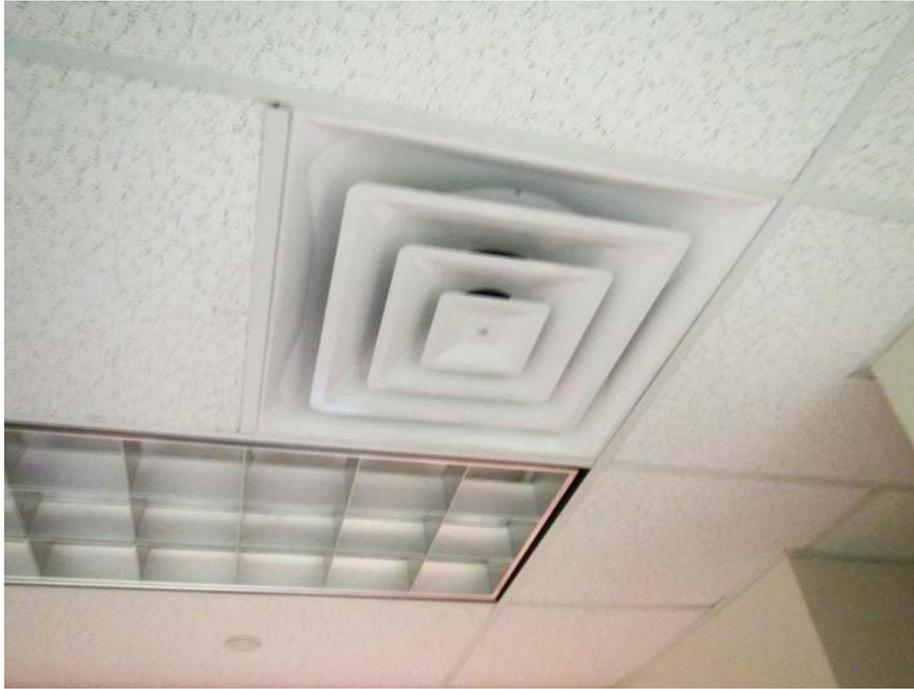
Picture 1

Fresh air is provided by air handling units (AHUs) ducted to ceiling-mounted supply diffusers (Pictures 1 and 2). Return air is drawn back into ceiling vents (Picture 3) and returned to AHUs. Note that in a few areas, supply vents were diverted or blocked off (e.g., Picture 4), which reduces the ability of the system to supply fresh air to that space.

Full-sized supply vent

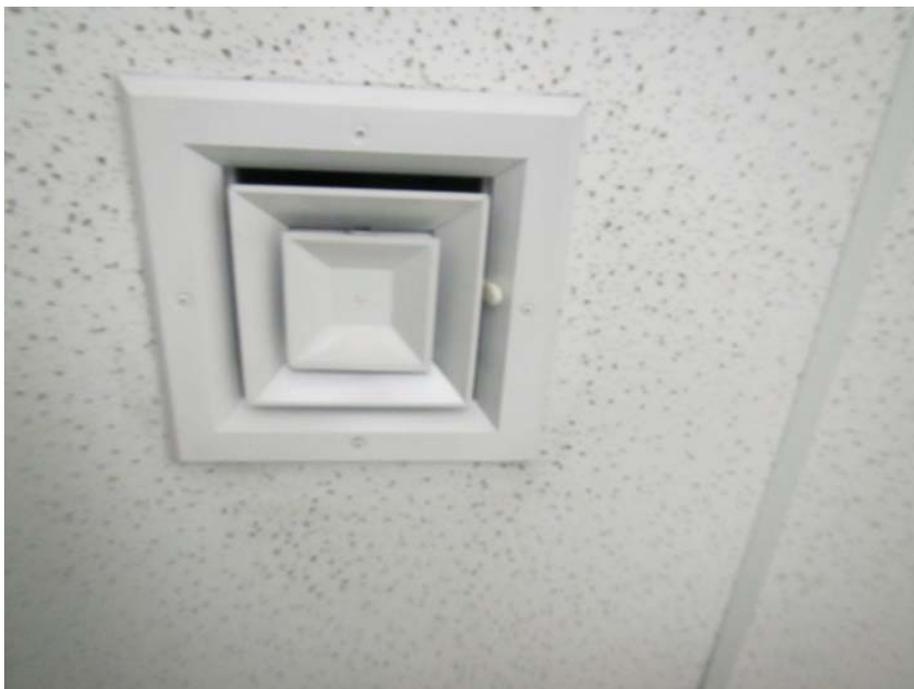
Picture 2

Smaller-sized supply vent

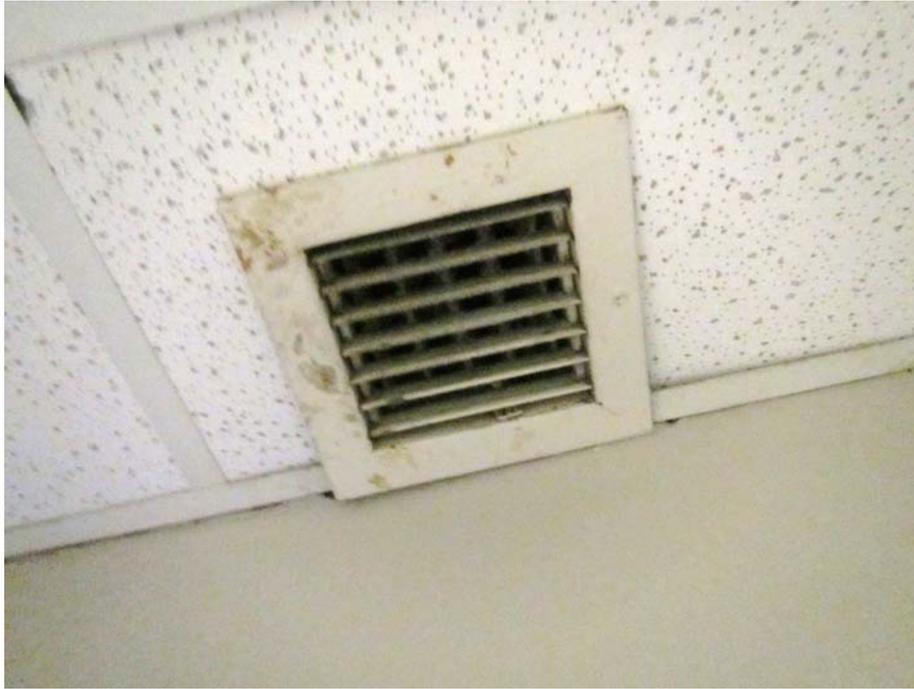
Picture 3

Personal fans, supply and exhaust vents were found to be dusty in some areas (Picture 3, Table 1). Regular cleaning of supply diffusers, exhaust vents and personal fans will reduce aerosolization of any accumulated particulate matter on these surfaces. In some areas, items were observed to be hanging from the ceiling (Picture 13). These items can be a source for dusts to accumulate as well as disturbing the ceiling tile system, which can allow dust and debris from the ceiling tile system/plenum to enter occupied space.

Typical exhaust vent, note dust/debris

20. Consider reducing the amount of items stored in offices and other areas, particularly paper/boxes.
21. Regularly clean supply diffusers, exhaust vents and personal fans to avoid re-aerosolizing any accumulated debris.

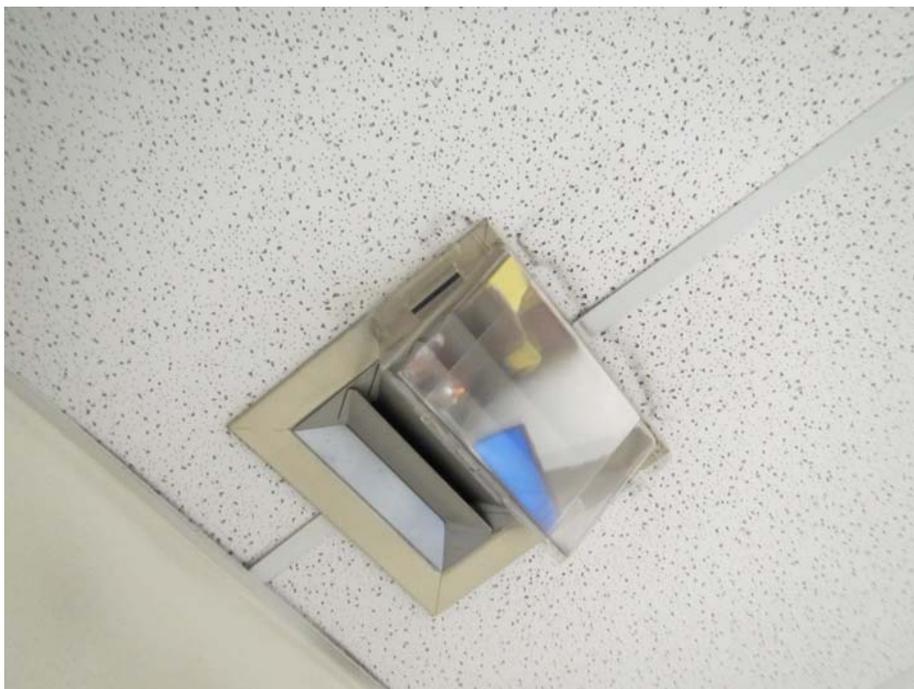
Picture 4

Diverted/blocked supply vent

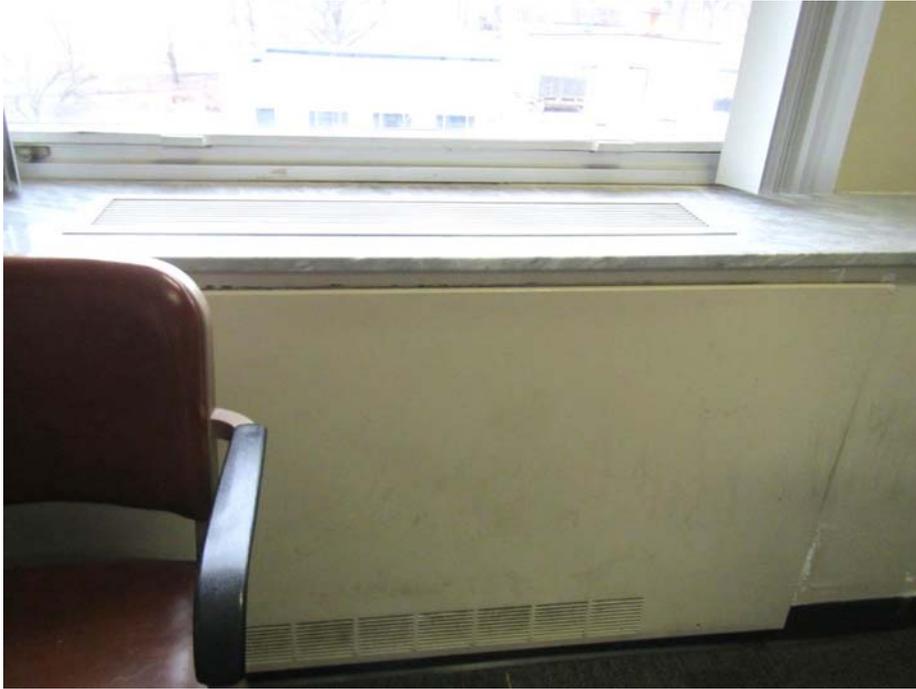
Picture 5

Fan coil units (FCUs) are located along the base of walls under windows (Picture 5) and provide supplemental heating or cooling to perimeter areas. FCUs do not introduce outside air; these units are limited to recirculating air. In some areas, FCUs were blocked/obstructed by furniture (Picture 6). Others had books, papers, plants and other items on top, which blocks airflow and may also distribute dust, pollen and other irritants into the space. In order for FCUs to facilitate airflow as designed, they must remain free of obstructions. FCUs appear to be original to the building, which would make them approximately 50 years old. According to the American Society of Heating, Refrigeration and Air-Conditioning Engineering (ASHRAE), the service life¹ for a unit heater, hot water or steam is 20 years, assuming routine maintenance of the equipment (ASHRAE, 1991). Despite attempts to maintain the equipment, the optimal operational lifespan of this equipment has been exceeded.

Fan coil unit

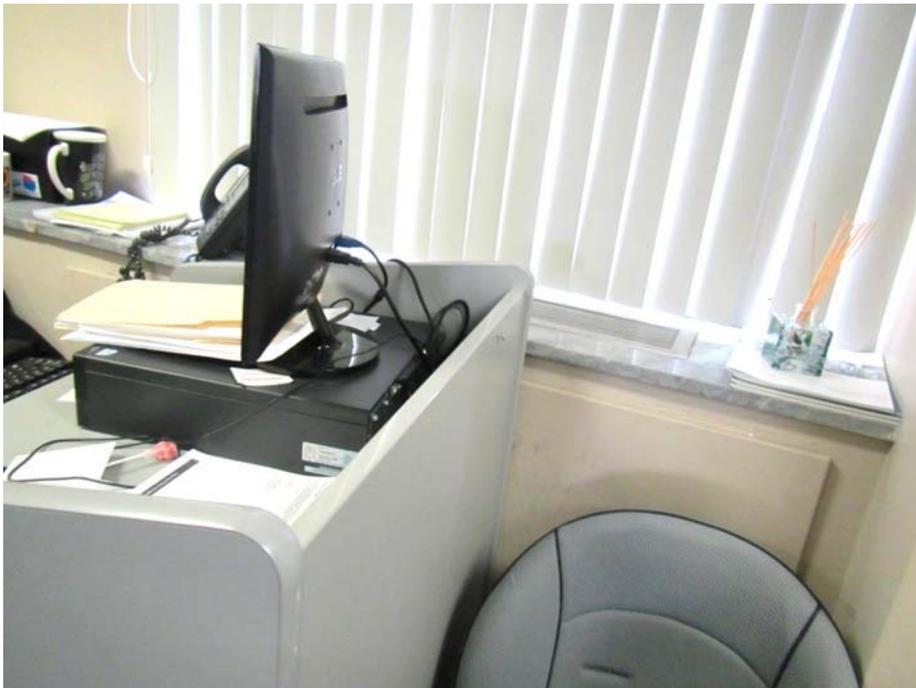
Picture 6

Obstructed fan coil unit

4. Remove obstructions from in front of FCUs and avoid placing items on top of them which obstruct/impact airflow.
5. Avoid placing heaters on or near items which may off-gas and ensure all heaters are turned off at the end of the day.

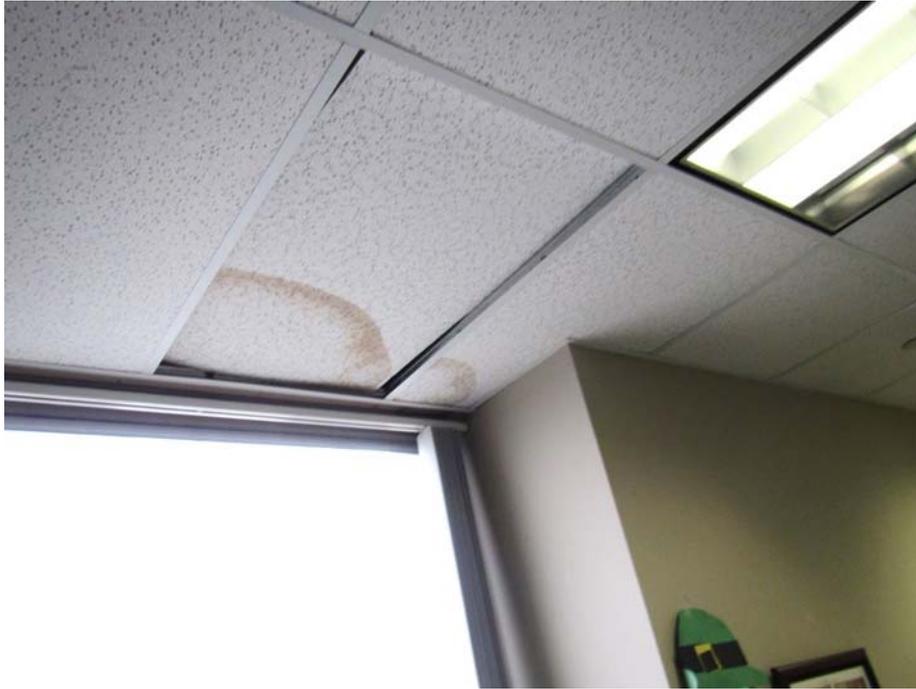
Picture 7

A few water-damaged ceiling tiles were observed (Picture 7, Table 1). These appeared to be from historic or periodic roof leaks. Water-damaged ceiling tiles can provide a source of mold and should be replaced after a water leak is discovered and repaired. The location of the stained tiles near windows/exterior walls suggest leakage may be associated with heavy rains and wind in a specific direction. The roof, flashing or masonry in this area may need repairs.

Water-damaged ceiling tiles

8. Examine areas of leakage and ensure any water-damaged ceiling tiles are repaired and/or replaced. Examine the area above ceiling tiles for mold growth. Disinfect areas of water leaks with an appropriate antimicrobial, as needed.

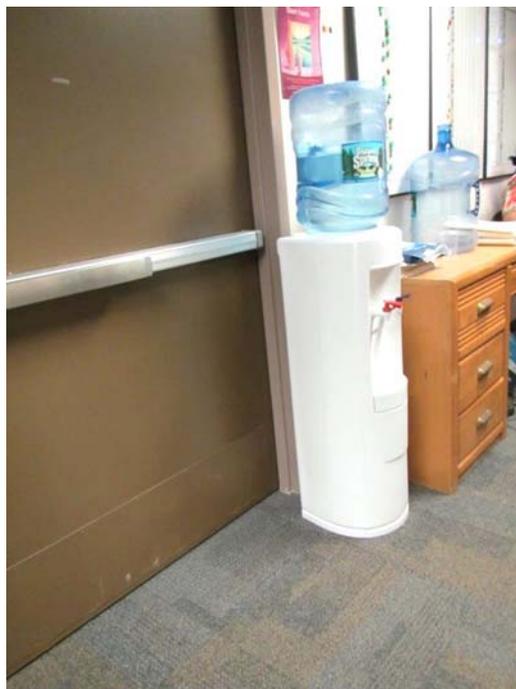
Picture 8

Water coolers and refrigerators were observed on carpet (Picture 8). Spills or leaks from these appliances can moisten carpeting. They should be located in a non-carpeted area or on waterproof mats. Several water fountains not in current use were observed in the office (Picture 9). The drains in these units may become dry if they are not used or maintained, and may allow sewer gases to penetrate occupied space. In addition, broken plumbing fixtures can be a source of leaks. These fountains should either be repaired and brought back into service, or removed with plumbing properly cut/capped.

Water dispenser on carpet

10. Place water coolers/dispensers in areas without carpeting or place on a waterproof mat.
11. Repair or properly abandon/cut/cap unused water fountains.

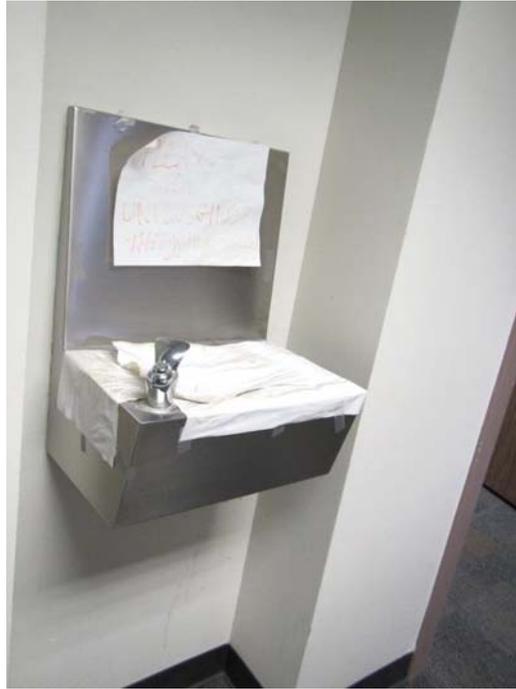
Picture 9

Blocked off water fountain

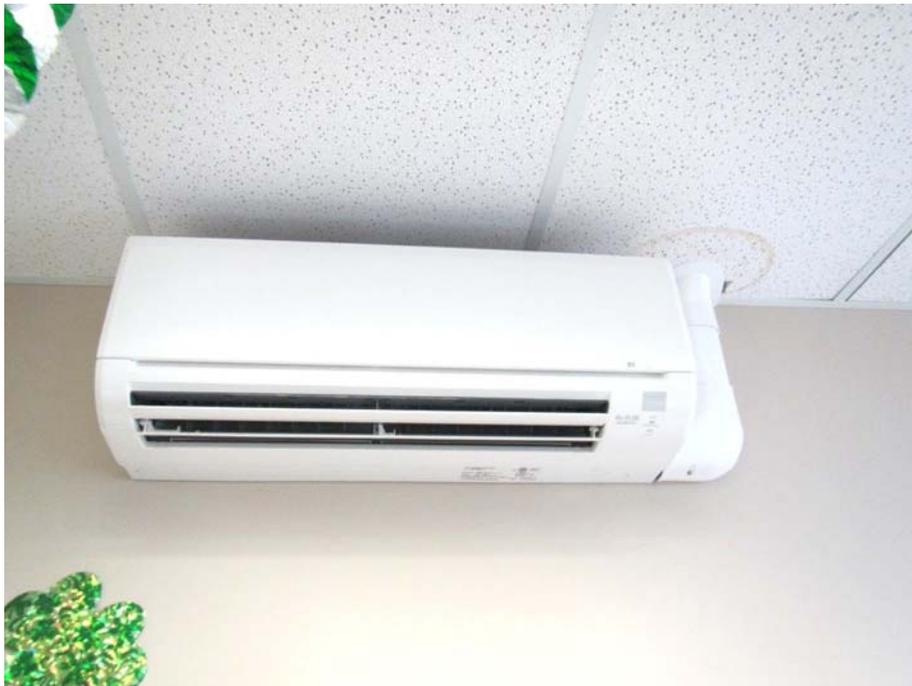
Many rooms on the fourth floor were equipped with ductless air conditioning (AC) units to maintain temperature control during the cooling season (Picture 10). These units have condensation drains that are typically pumped to the outside of the building. The ACs should be regularly inspected to ensure that condensation drains and pumps are working properly and are not clogged or leaking. The water-damaged ceiling tile shown in Picture 10 may indicate a leak from the condensation drain system or another source of water that should be repaired.

Ductless air conditioning unit, note water-damaged ceiling tile next to drain pipe

14. Regularly inspect ductless air conditioning units for proper condensation drainage.
15. Consider installing local exhaust vents near photocopiers or relocating them to areas with local exhaust ventilation and away from occupants.

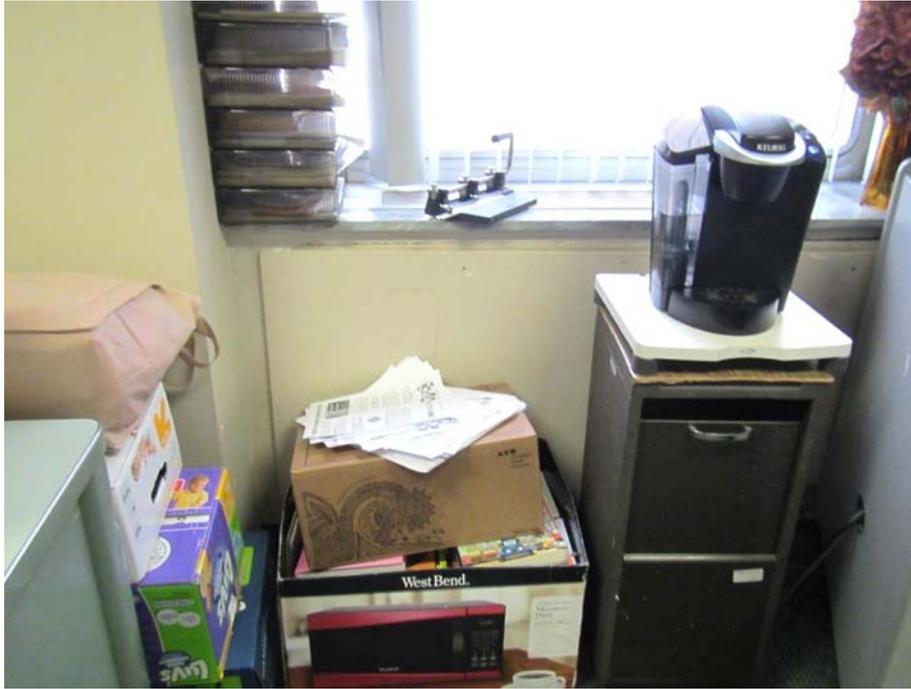
Picture 11

Other conditions that can affect IAQ were observed during the assessment. In some areas, accumulations of items were seen on floors, windowsills, tabletops, counters, bookcases and desks, which provide a source for dusts to accumulate (Picture 11). These items (e.g., papers, folders, boxes) make it difficult for custodial staff to clean. Items should be relocated and/or be cleaned periodically to avoid excessive dust build up.

Items in an office, including food preparation equipment and boxes on the floor

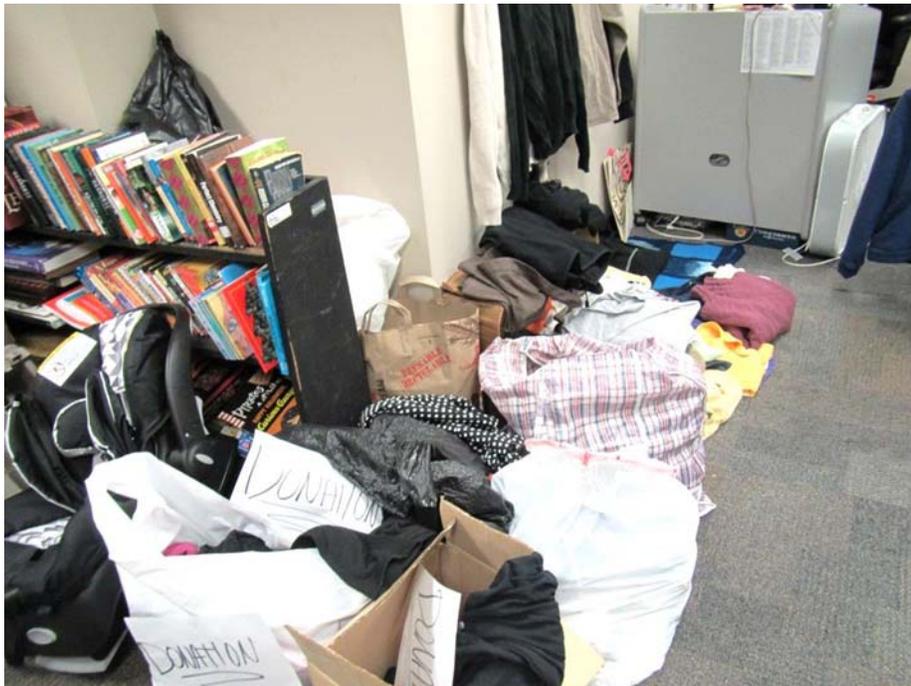
Picture 12

The DCF also has a large number of items stored for clients, including clothing and luggage (Picture 12). Some of these items were observed to be in open bins or on floors in storage rooms, where they can become dusty, dirty or damaged or can serve as harborage for pests.

Stored items on the floor

18. Avoid the use of air freshener sprays, solids and diffuser reeds to avoid exposure to VOCs and fragrance compounds.
19. Ensure that stored items are enclosed to protect from dust and are in plastic containers or on shelves off the floor to prevent condensation.

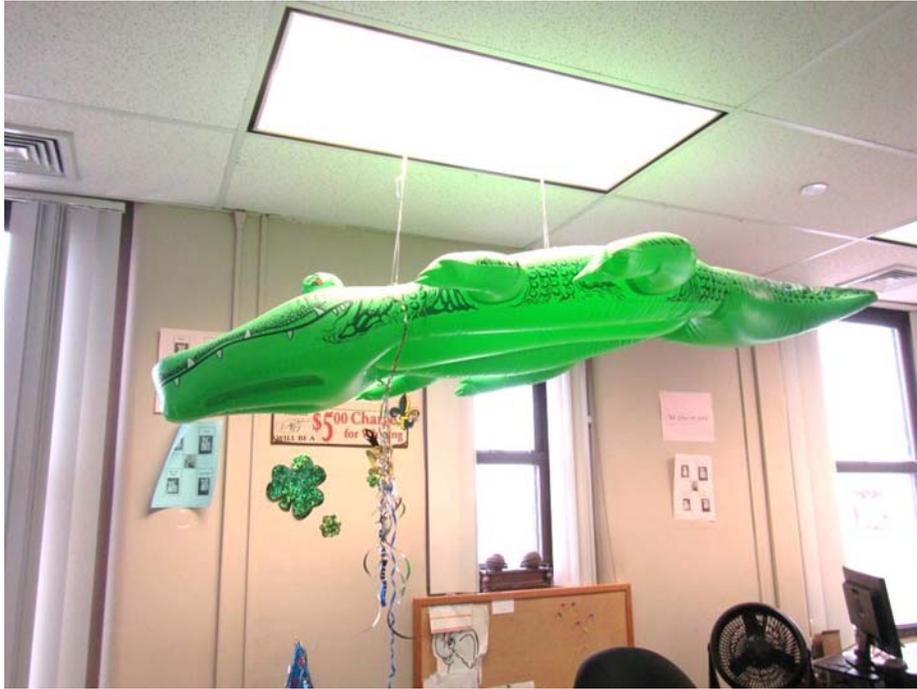
Picture 13

Items hanging from the ceiling tile system

22. Avoid hanging items from the ceiling tile system.
23. Vacuum carpet with a high efficiency particulate arrestance (HEPA) filtered vacuum in combination with an annual cleaning to help to reduce accumulation and potential aerosolization of materials from the carpeting.

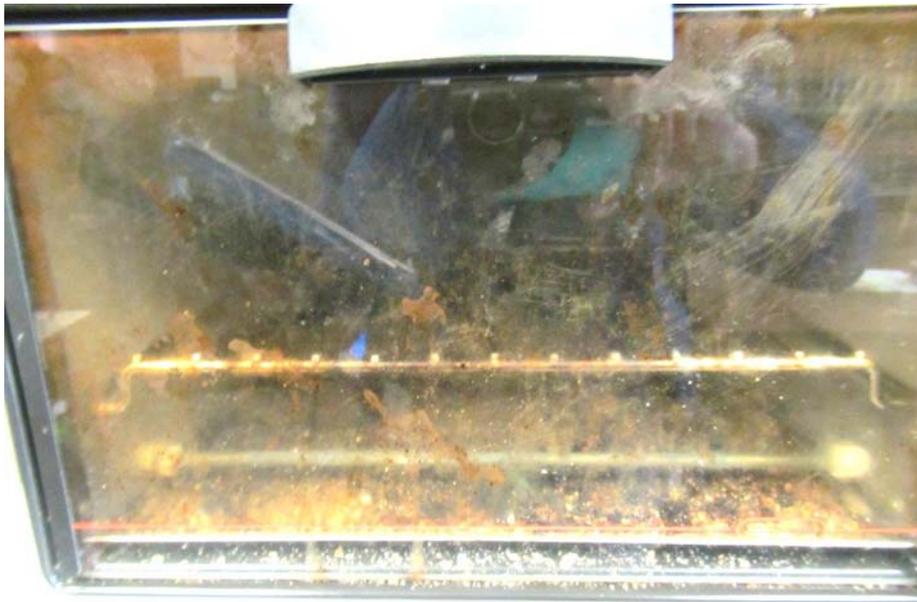
Picture 14

Food and food preparation equipment was seen in some areas, and crumbs/food debris was observed in appliances (Picture 14). Food should be kept in tightly-sealed bags/containers to prevent attracting pests. Food preparation equipment should also be kept clean and free of debris.

Toaster oven with crumbs
