# **INDOOR AIR QUALITY REASSESSMENT**

**Commonwealth of Massachusetts  
Massachusetts Rehabilitation Commission  
Worcester Branch  
340 Main Street  
Worcester, Massachusetts**

Prepared by:  
Massachusetts Department of Public Health  
Bureau of Environmental Health  
Indoor Air Quality Program  
May 2015

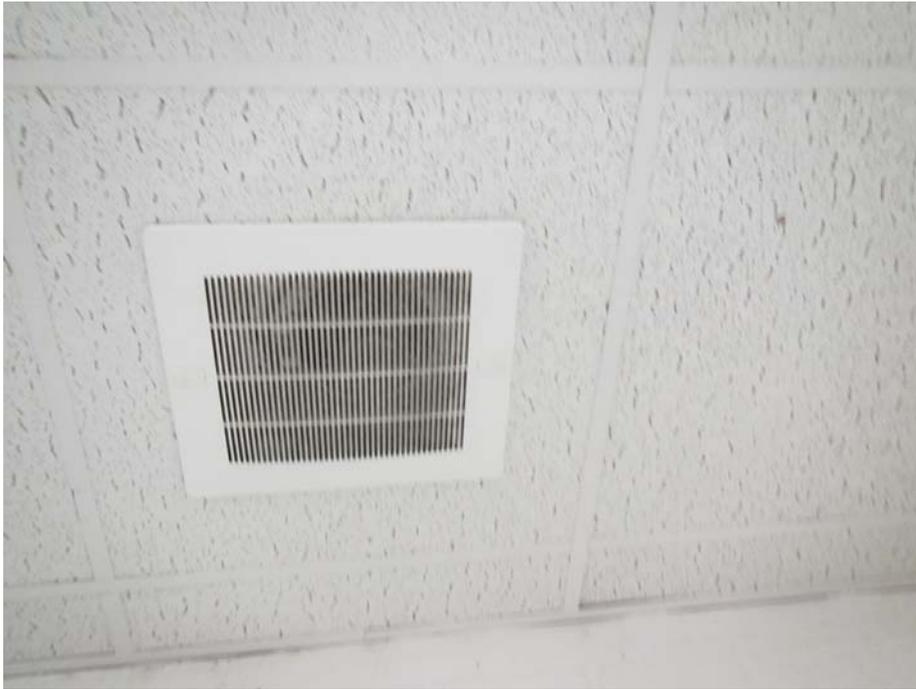
**Picture 1**

Mechanical ventilation is provided by a series of heating, ventilation and air conditioning (HVAC) air handling units (AHUs) located in closets throughout the floor. Fresh air is drawn through vents located above select window frames. Ductwork connects the AHUs to ceiling-mounted air supply diffusers. By design, air diffusers are equipped with fixed louvers that direct air along the ceiling to flow down the walls and create airflow. Air returns to the AHUs through the fixed louvers in the doors of the AHU closets. A few areas, such as the lounge/kitchen, training rooms and restroom, also have directly-vented exhaust to remove the pollutants generated in these areas (Picture 1).

A number of supply diffusers, return grates, exhaust vents and personal fans were observed to have accumulated dust/debris (Picture 1). If exhaust vents are not functioning,

backdrafting can occur, which can re-aerosolize accumulated dust particles. Re-activated supply vents can also aerosolize dust accumulated on vents.

**Direct vented exhaust, note dust/debris on vent**

8. Clean air diffusers, exhaust and return vents periodically of accumulated dust/debris.
9. Avoid hanging items from the ceiling tile system.
10. Relocate or consider reducing the amount of materials stored on flat surfaces to allow for more thorough cleaning. Clean items regularly with a wet cloth or sponge to prevent excessive dust build-up.

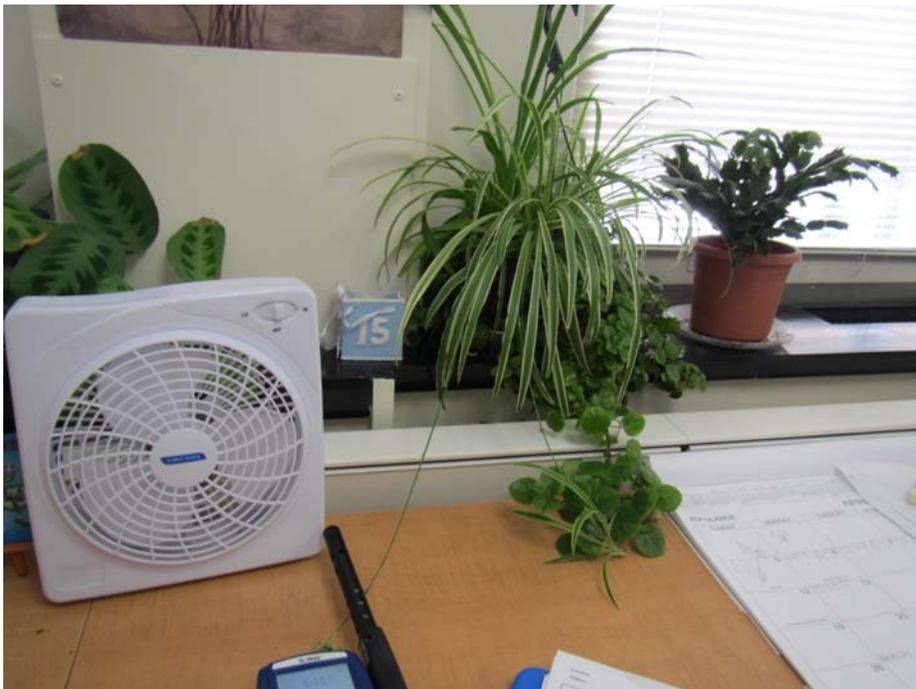
**Picture 2**

No water-damaged ceiling tiles or other building materials were observed during this visit, apart from a few water-damaged windowsill areas where plants or other water containers had been located in the past. Plants were observed in several areas, including on porous materials (Pictures 2 and 3). Plants, soil and drip pans can serve as sources of mold/bacterial growth. Plants should be properly maintained, over-watering of plants should be avoided and drip pans should be inspected periodically for mold growth. Plants should also be placed away from ventilation sources to prevent the aerosolization of related materials.

**Plants in an office**

5. Ensure that plants are properly maintained, not overwatered, and not placed on porous materials.
6. Properly maintain humidifiers.
7. Consider placing water dispensing equipment in non-carpeted areas or on a waterproof mat.

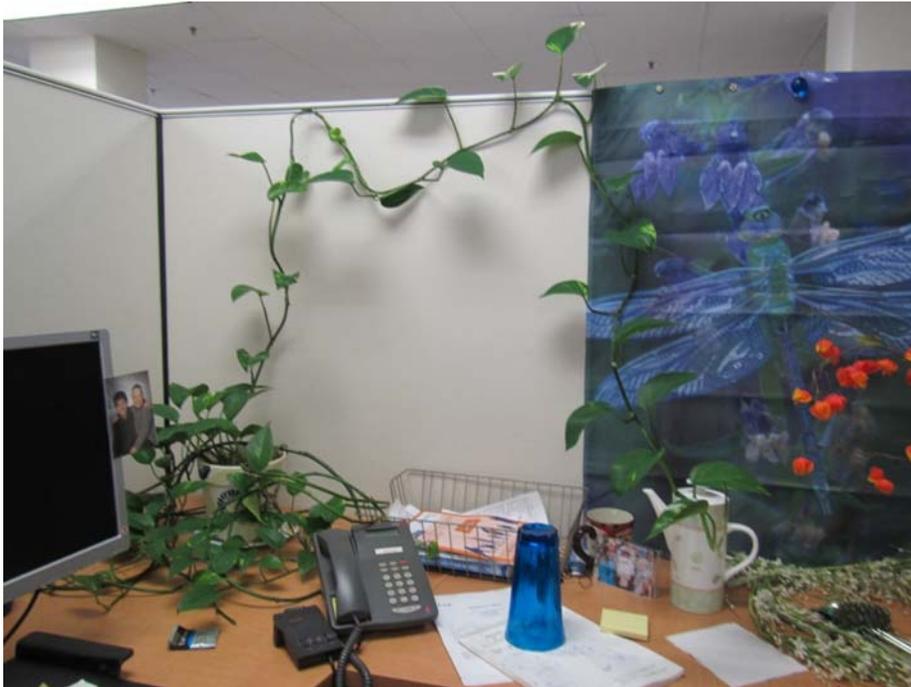
**Picture 3**

**Plants draped on porous cubicle wall**

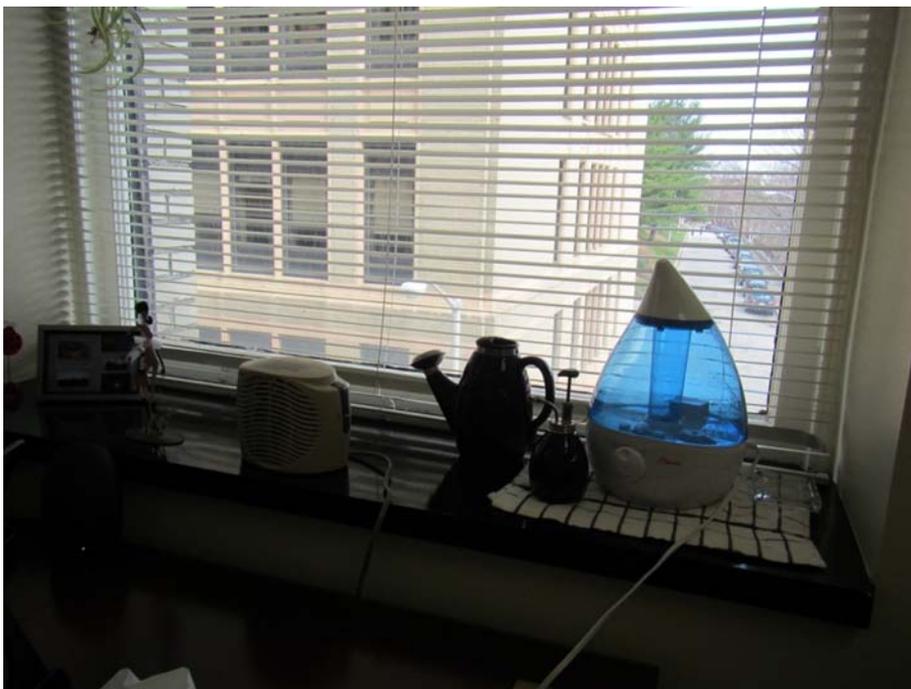
**Picture 4**

A humidifier was seen in an office (Picture 4). These appliances should be kept clean in accordance with manufacturer's instructions, as stagnant water can be a source of odors or microbiological pollutants.

**Humidifier in an office**

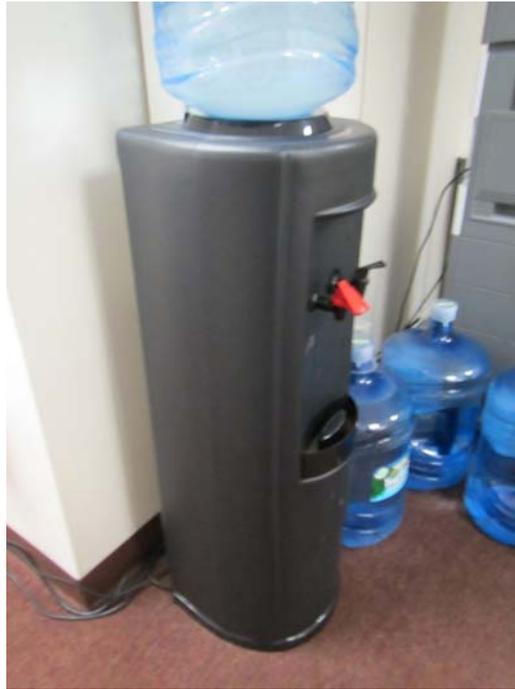
**Picture 5**

Water coolers were observed in carpeted areas (Picture 5). Spills or leaks from these appliances can moisten carpeting and lead to microbial growth. Water dispensing equipment should be located in non-carpeted areas or on a waterproof mat.

**Water cooler on carpet**

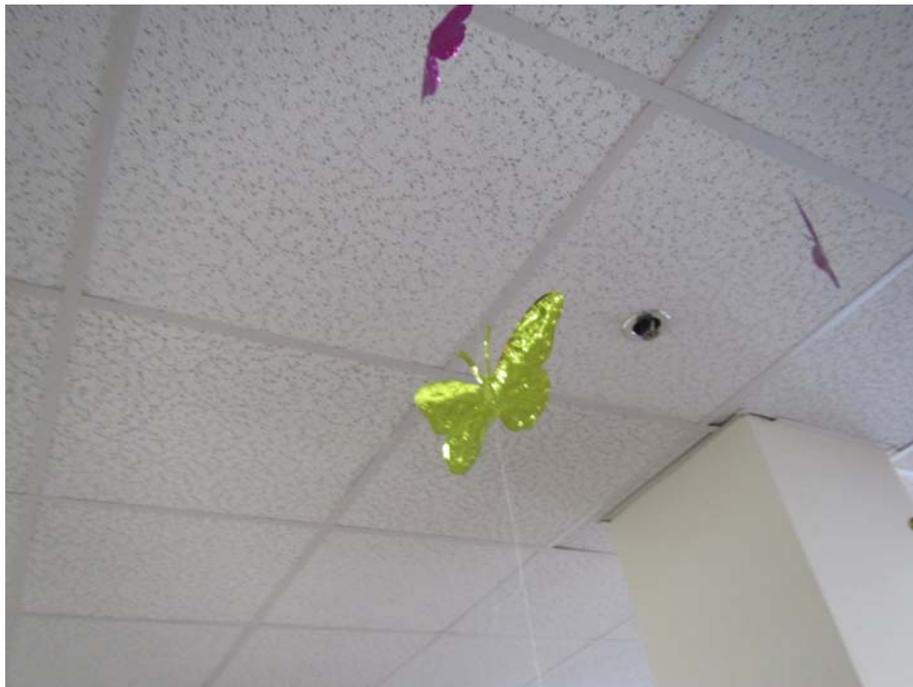
**Picture 6**

In one location, items were observed hanging from the ceiling tile system (Picture 6). Hanging of items from the ceiling is not recommended as disruption of the ceiling tile system can release dusts from tiles or from above the tiles into occupied areas.

**Items hanging from ceiling tiles**

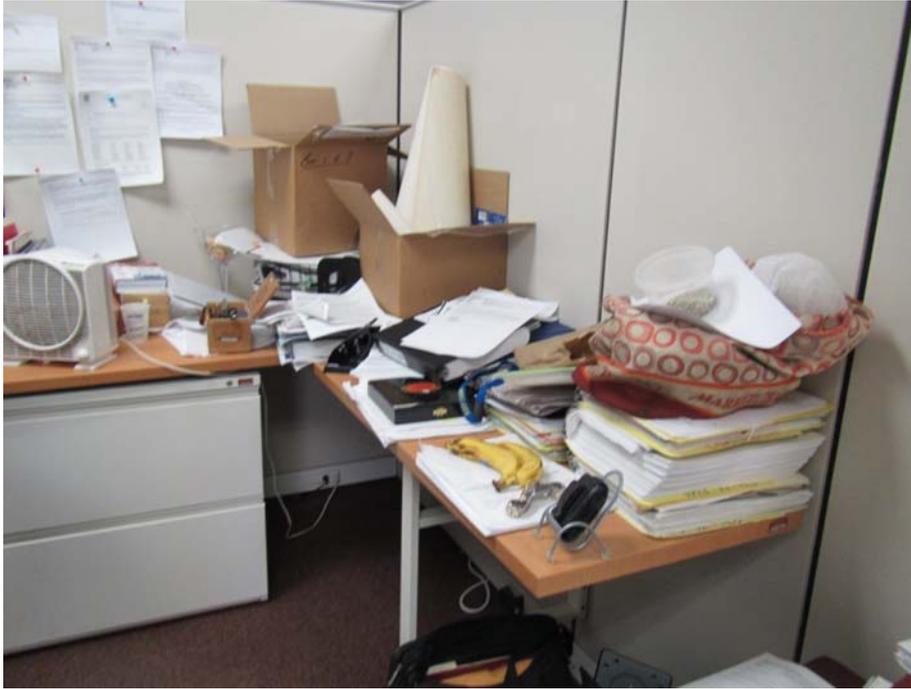
**Picture 7**

In several areas, items were observed on the floor, windowsills, tabletops, counters, bookcases and desks (Picture 7). The large number of items on flat surfaces provides a source for dusts to accumulate and makes it difficult for custodial staff to clean. Items should be relocated and/or be cleaned periodically to avoid excessive dust build up.

**Clutter and items in an office**
