# **INDOOR AIR QUALITY ASSESSMENT**

**Swanson Road Intermediate School  
10 Swanson Road  
Auburn, MA**

Prepared by:  
Massachusetts Department of Public Health  
Bureau of Environmental Health  
Indoor Air Quality Program  
July 2016

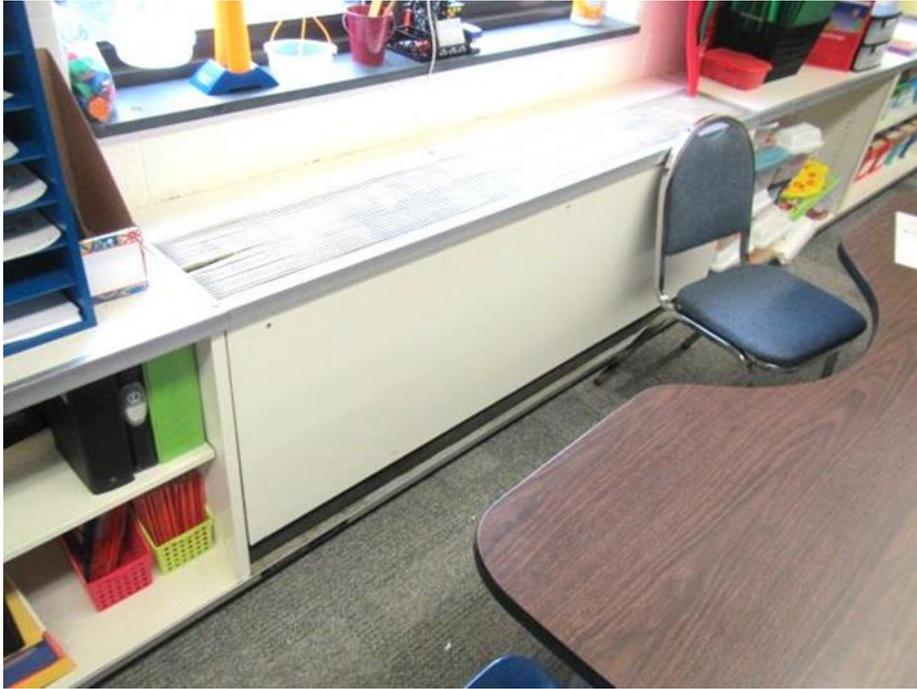
**Picture 1**

Fresh air is provided by a combination of unit ventilators (univents) located in individual classrooms along the outside wall (Picture 1) and air handling units (AHUs), which serve central areas. Unit ventilators draw fresh air through a vent on the exterior wall (Picture 2). Air is mixed with return air from the room, filtered, heated (if needed) and delivered back to the room. Air from the AHUs is filtered, heated/cooled and delivered to rooms via ducted supply vents (Picture 3). Most univents were off at the time of the visit, reducing the amount of fresh air being delivered to classrooms, and many were blocked on top or in front by items and furniture (Picture 4).

**Unit ventilator (univent)**

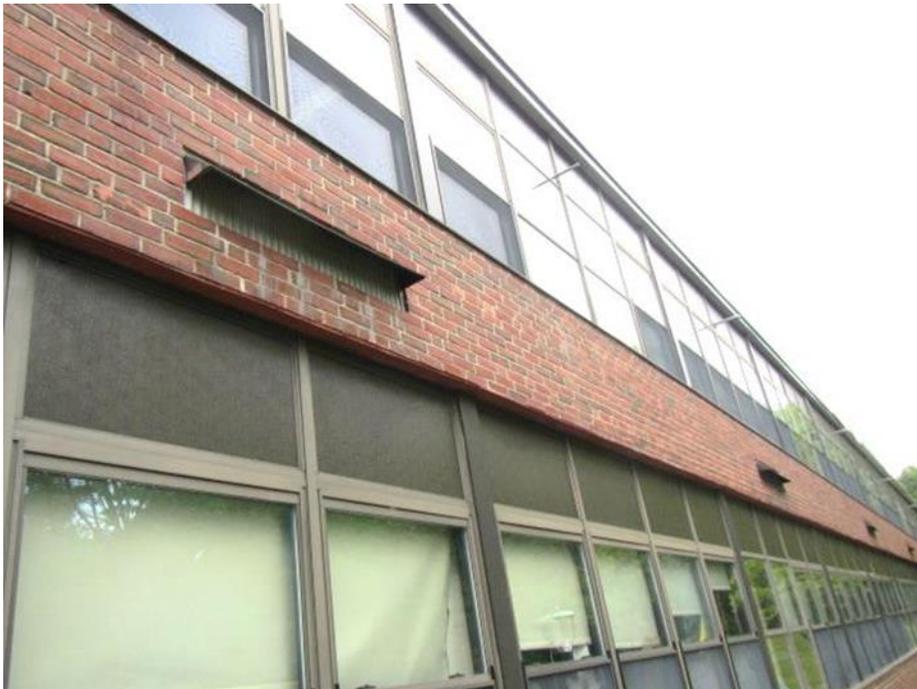
**Picture 2**

**Univent fresh air intake**

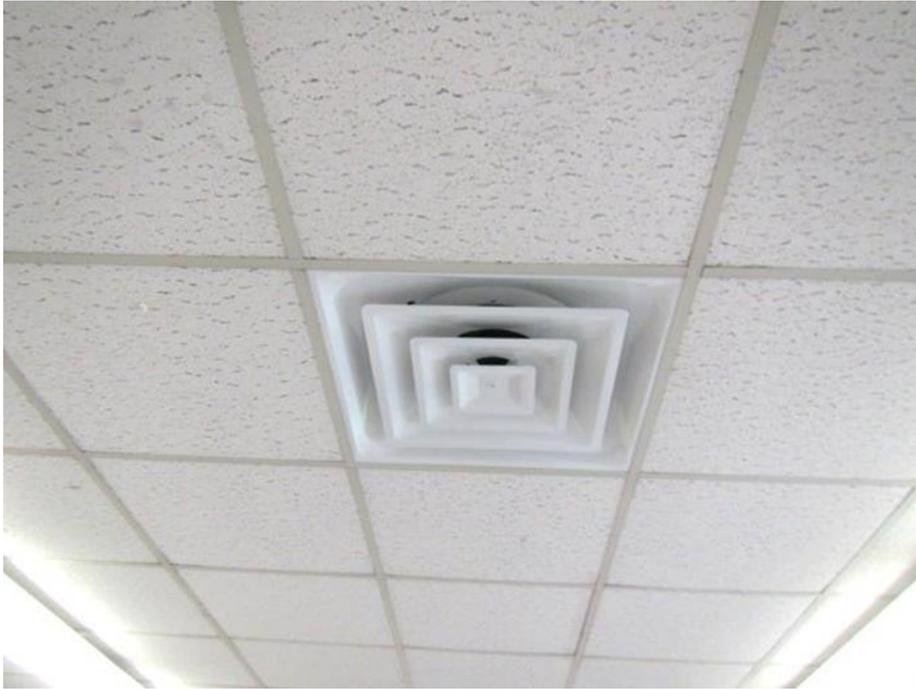
**Picture 3**

**Typical supply vent**

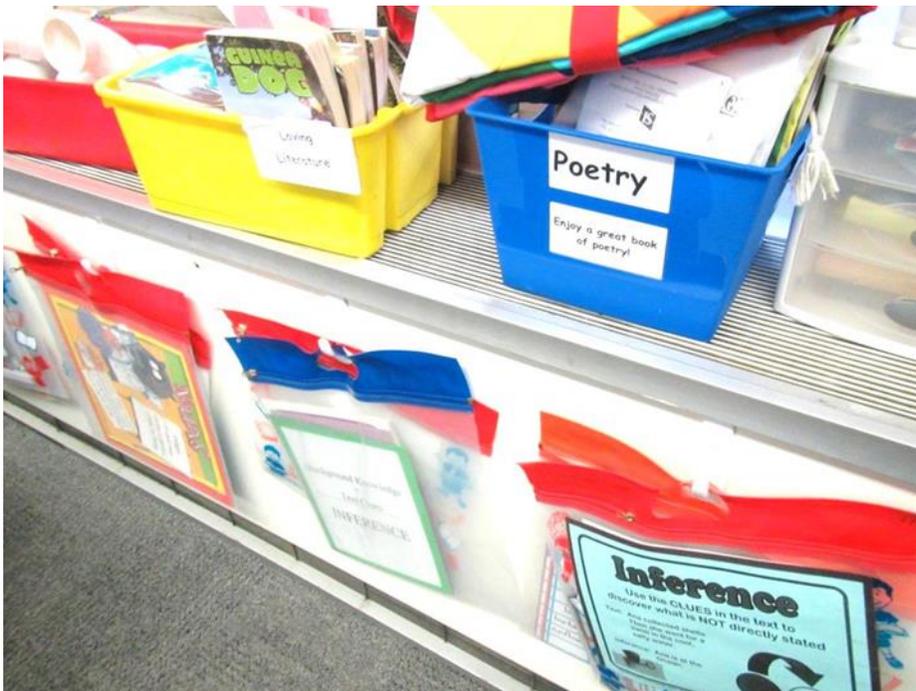
**Picture 4**

**Top of univent blocked by items**

3. Remove blockages from the top and front of univents and from exhaust vents.
4. Consider plans for overhaul or replacement of univents that are at/near the end of their useful life.

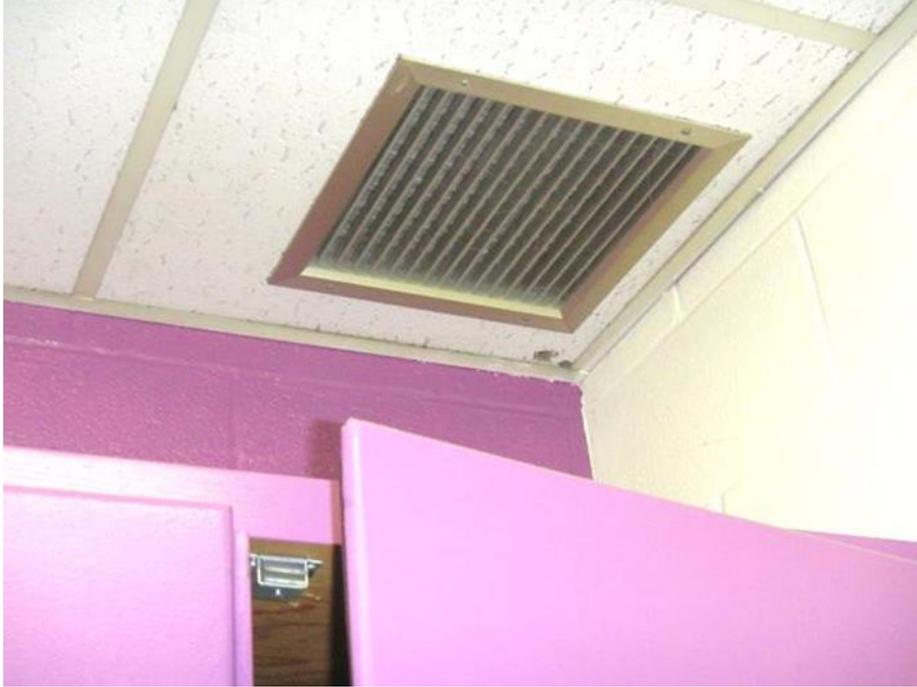
**Picture 5**

Exhaust vents are located on the walls or ceilings of classrooms and offices (Picture 5) and are ducted to fans on the roof. Additional exhaust vents are located in toilet rooms and other areas. While all classroom exhaust vents checked were operational, many were blocked by furniture and items (Picture 6), reducing the ability of the exhaust system to remove stale air. Some restroom exhaust vents were examined and weak or no draw from them was observed; motors, belts and power for these should be examined/repared to ensure they are operational.

**Ceiling-mounted exhaust vent in classroom**

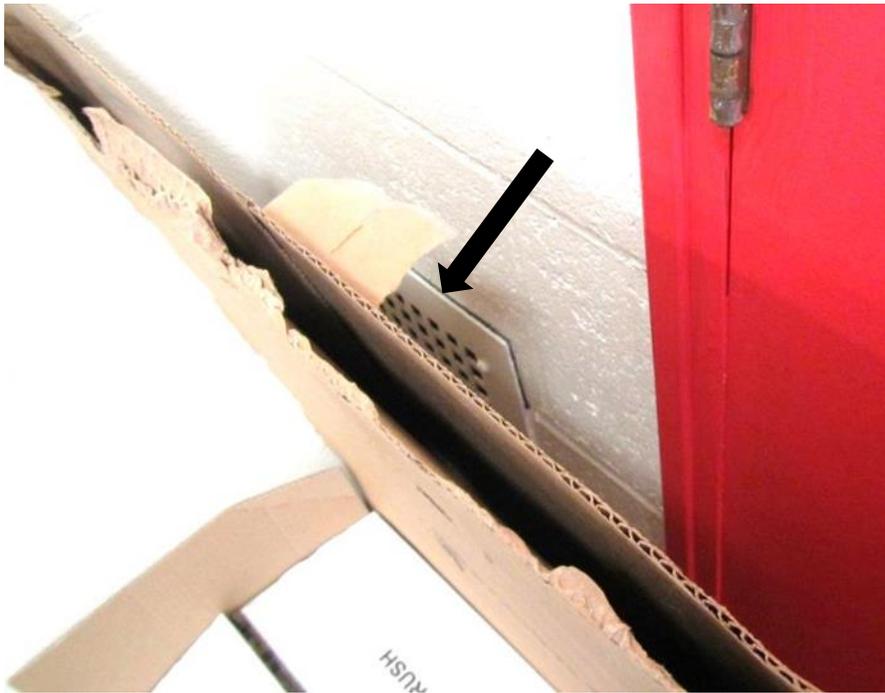
**Picture 6**

**Wall-mounted exhaust vent (arrow) blocked by cardboard**

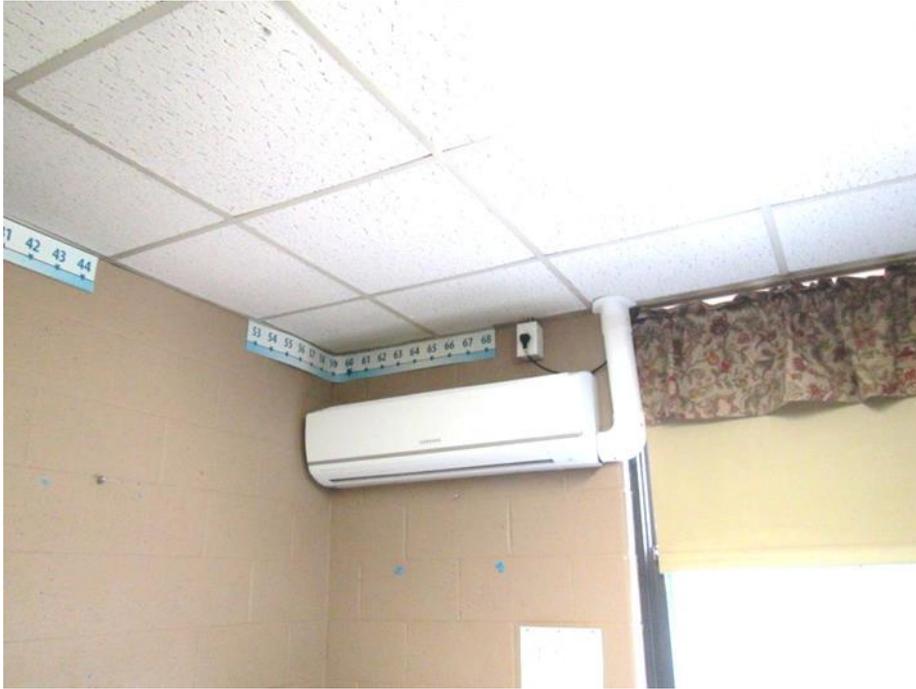
**Picture 7**

The AHU provides cooling as well as heating to areas it serves. Cooling in areas with univents is provided by ductless air conditioning units hung on walls (Picture 7). These units are connected to heat pumps using chilled refrigerant to provide cooling during the warmer months, and can also provide heating during the colder months.

Ductless air conditioners have condensate drains. Most of these are directed outside and drain by gravity, but some had pumps. These units should be checked periodically to ensure drainage hoses are intact, not clogged, and that pumps are operational to prevent stagnant water and leaks. A classroom sink had a gap in the backsplash (Picture 8; Table 1), which can allow for moistening of the wood material and potential microbial growth.

**Wall-mounted ductless air conditioning unit**

10. Monitor ductless air conditioning condensate drains to ensure they do not have clogs or standing water and that pumps are operational.
11. Repair sink backsplashes to render them watertight. Refrain from storing porous or significant amounts of materials under sinks.

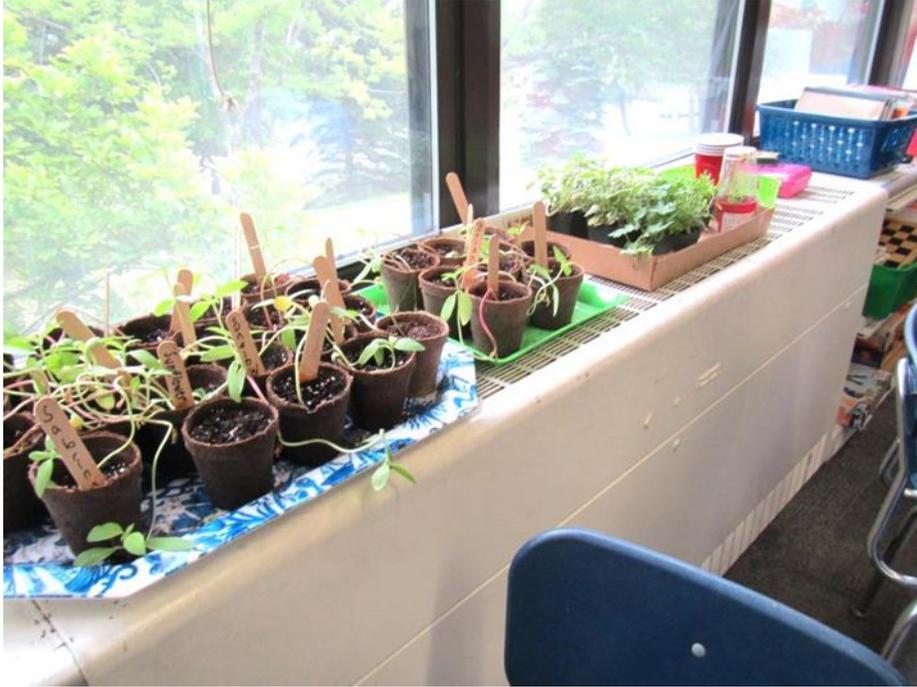
**Picture 9**

Plants were observed in a few areas including on univents (Picture 9; Table 1). Plants can be a source of pollen and mold, which can be respiratory irritants to some individuals. Plants should be properly maintained and equipped with drip pans and should be located away from air diffusers to prevent the aerosolization of dirt, pollen and mold.

**Plants on univent**

13. Keep plants in good condition, avoid overwatering, and remove from the airstream of univents and other air sources.

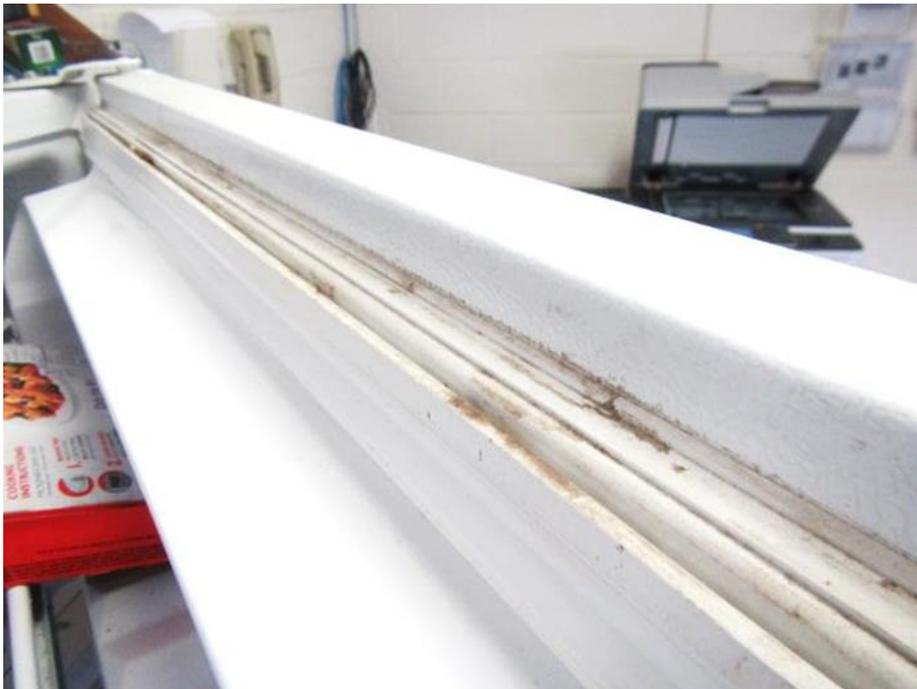
**Picture 10**

There were several refrigerators in the building, and one was found to have mold on the gasket (Picture 10). Refrigerators should be cleaned regularly to prevent microbial growth and odors.

**Stained refrigerator gasket**

14. Ensure refrigerators are cleaned out regularly and that spills are cleaned promptly to prevent odors. Clean stained gaskets with an antimicrobial solution or, if they cannot be cleaned, replace.

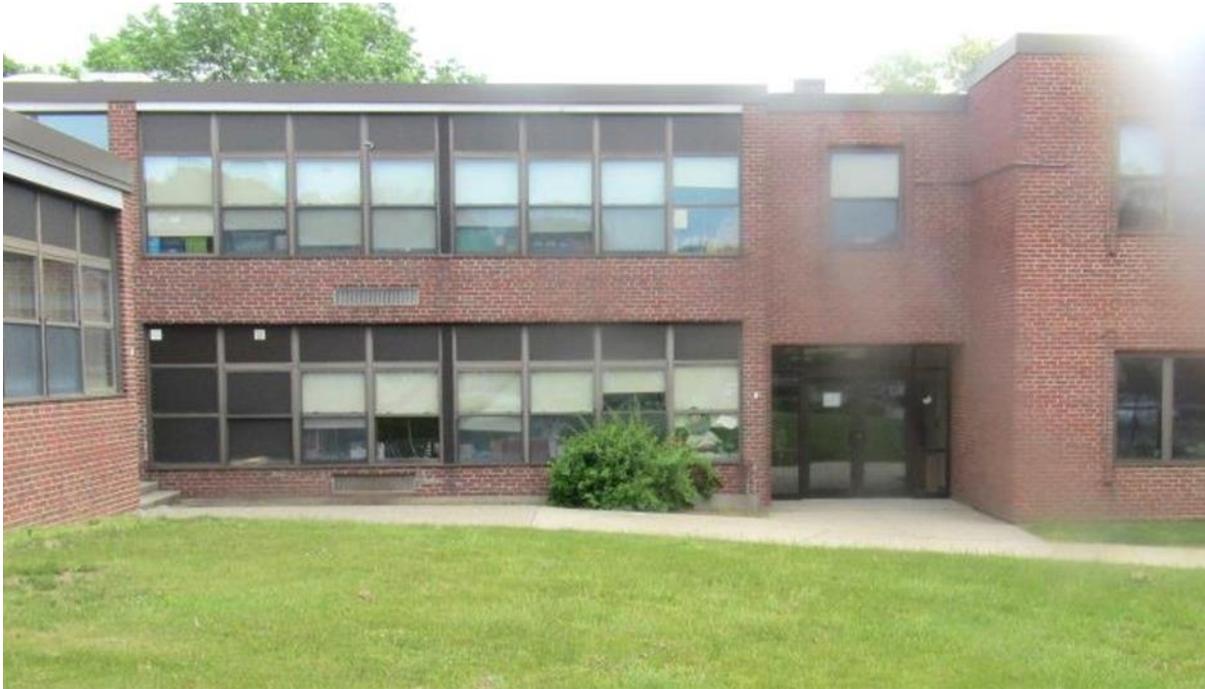
**Picture 11**

The outside of the building was examined for conditions that may impact IAQ. A bush was noted along the outside of the building (Picture 11) and some trees/shrubs in the courtyard were close to the foundation and overhanging the roof (Picture 12). Plants close to the exterior can prevent walls from drying and lead to drainage problems/deterioration of the building envelope. When near air intakes, they can also be a source of odors, pollen and debris to the inside of the building.

**Shrub near side of building**

15. Remove plants to about five feet away from exterior walls/foundation, including in the courtyard.
16. Clean moss from the south side of the building.

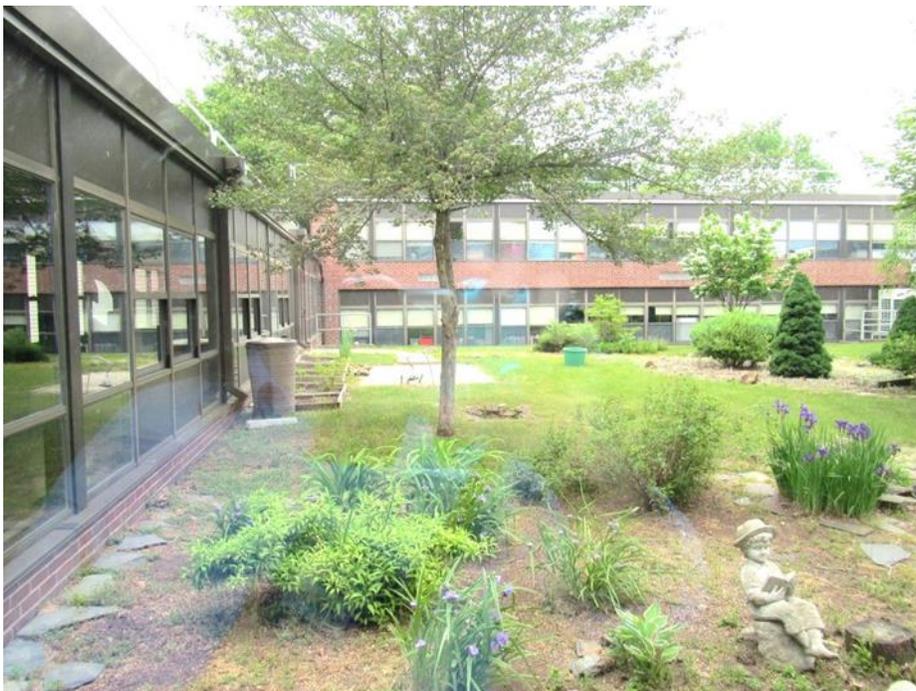
**Picture 12**

**Plants and trees in the courtyard**

17. Consider removing the water feature in the courtyard.
18. Repair any breaks in the skirt/undercarriage of the modular classrooms to exclude pests.
19. Repair/replace weather-stripping on exterior doors and monitor for light and drafts.

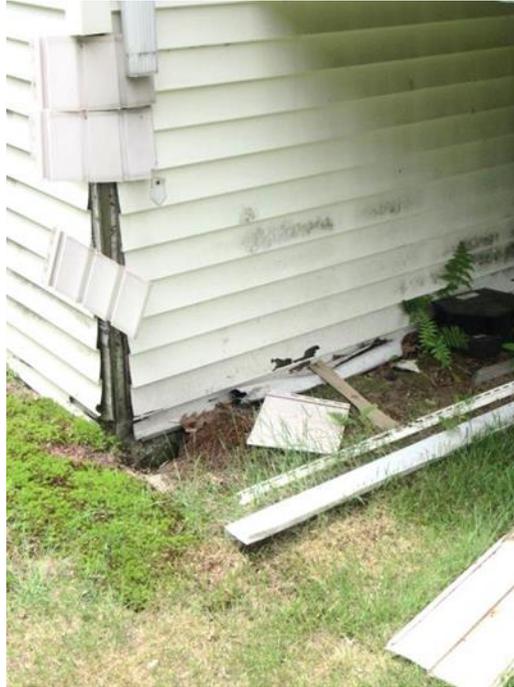
**Picture 13**

Some downspouts were missing or damaged (Picture 13), which can allow water to accumulate against the foundation. The north (shady) side of the building had moss/mold staining (Picture 14) that should be cleaned. The courtyard has a small water feature. These can be difficult to maintain and lead to stagnant water, odors, and pests including mosquitoes.

**Broken downspouts and siding**

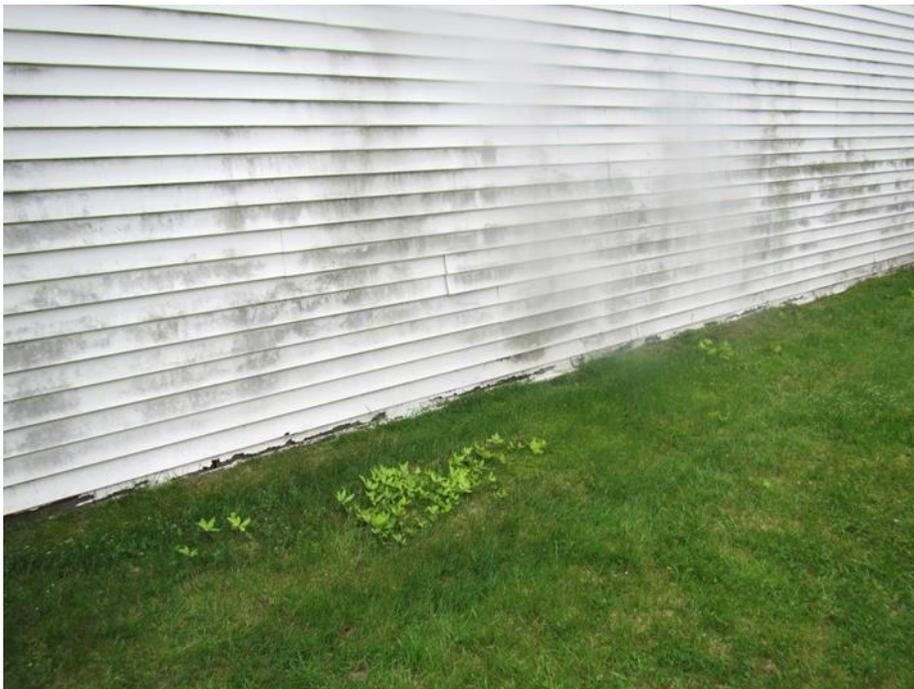
**Picture 14**

**Moss/mold accumulations on north side of modular building**

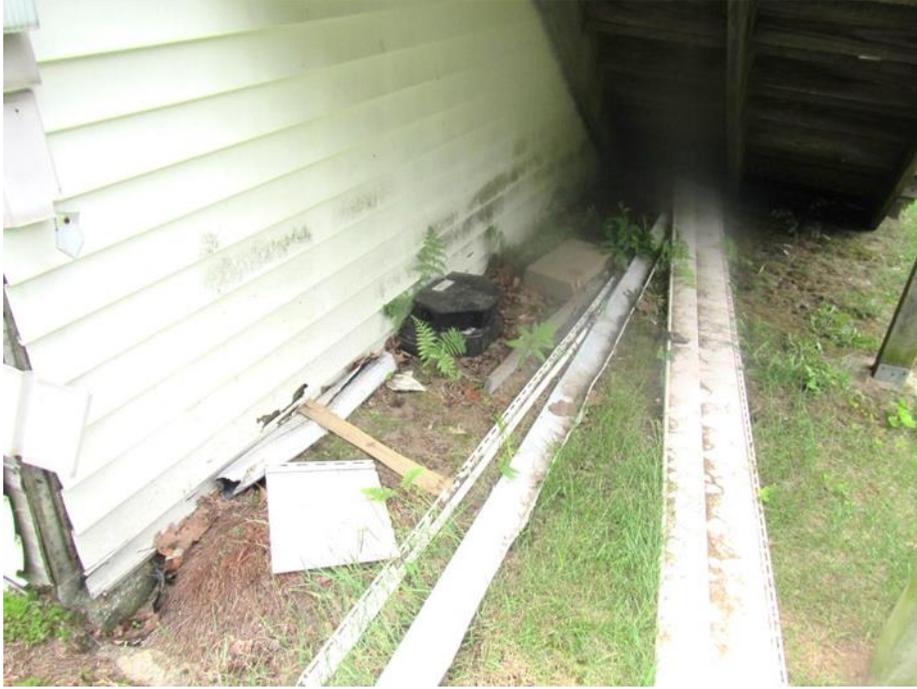
**Picture 15**

The vinyl skirting of the modular classrooms was damaged in several areas (Pictures 15 and 16) that could allow harborage for pests. Some exterior doors were missing weather-stripping (Table 1), which can allow moisture, unconditioned air and pests into the building.

**Deterioration at base of modular classroom**

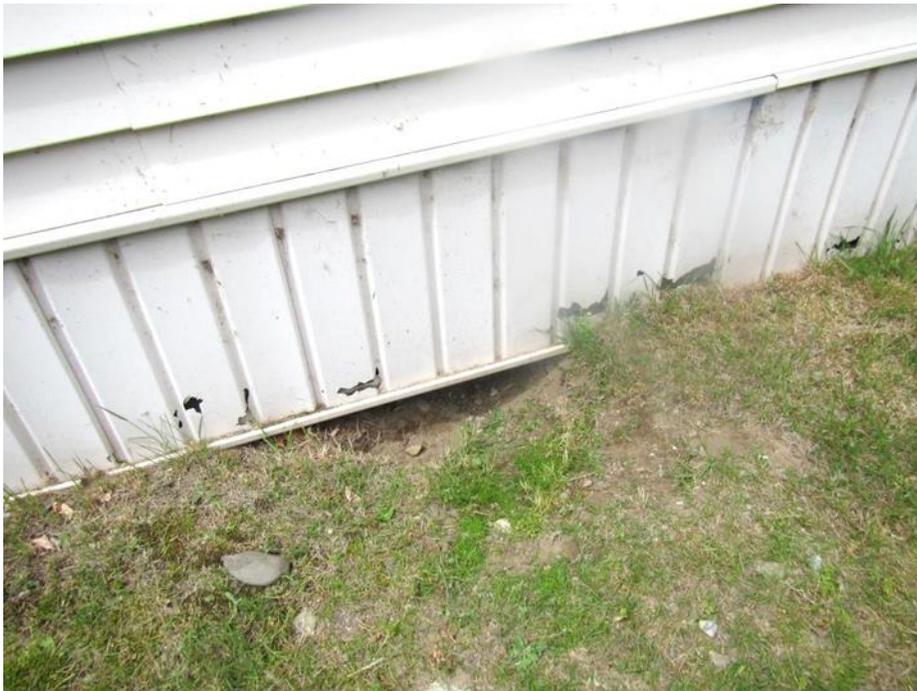
**Picture 16**

**Hole/potential harborage under skirt of modular classroom**

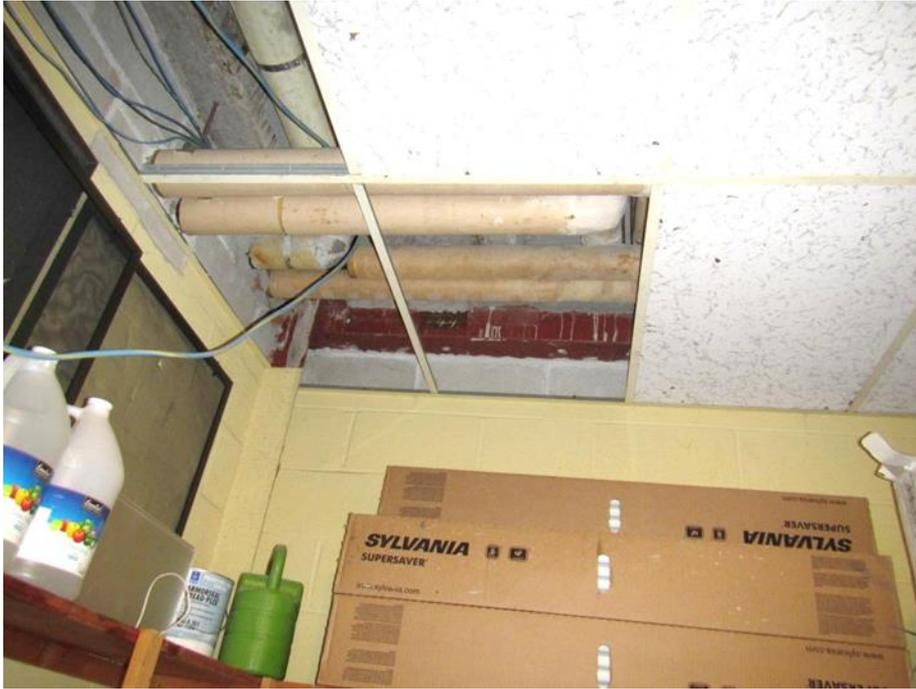
**Picture 17**

Additionally, no exhaust ventilation was observed in janitorial closets, which contain mops and cleaning chemicals, which can be sources of odors. Janitorial closets also had missing ceiling tiles (Picture 17) that can allow odors from the closets to traverse into occupied spaces. Missing/ajar tiles were also observed in occupied areas; tiles should be replaced flush with the ceilings to provide a barrier to dusts and odors between areas.

**Missing tiles in janitorial closet**

21. Ensure the ceiling tile system is intact with all tiles in place to prevent migration of dusts and odors to occupied areas.
22. Change filters regularly in univents (2 to 4 times a year), and vacuum the cabinets of debris each time the filters are changed. Consider upgrading to a MERV 9 filter if current univents are capable of operating with the higher-efficiency filters.

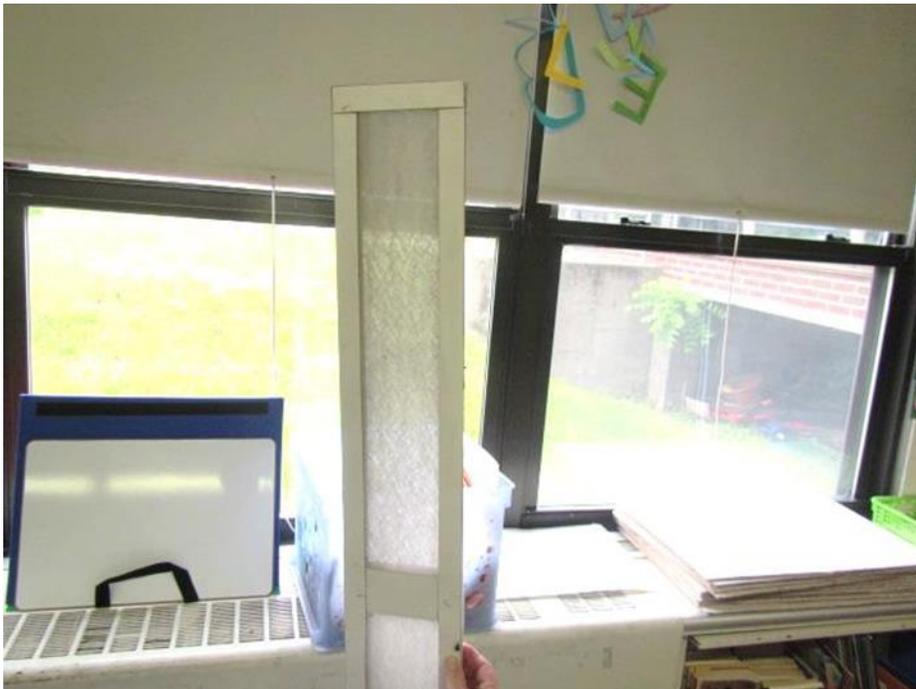
**Picture 18**

Filters were examined from a univent (Picture 18). It appeared recently changed/clean and well-fitted, but of a mesh type that provides minimal filtration. A pleated filter with a Minimum Efficiency Reporting Value (MERV) value of at least 9 is recommended. Because of the age of the univents, use of a higher-efficiency filter may reduce flow or cause mechanical stress, so univents should be evaluated to ensure higher-efficiency filters can be used. Filters should be changed 2 to 4 times a year. Having univents turned on and equipped with good filtration should help reduce levels of particulate matter in the building.

**Mesh-type univalent filter**

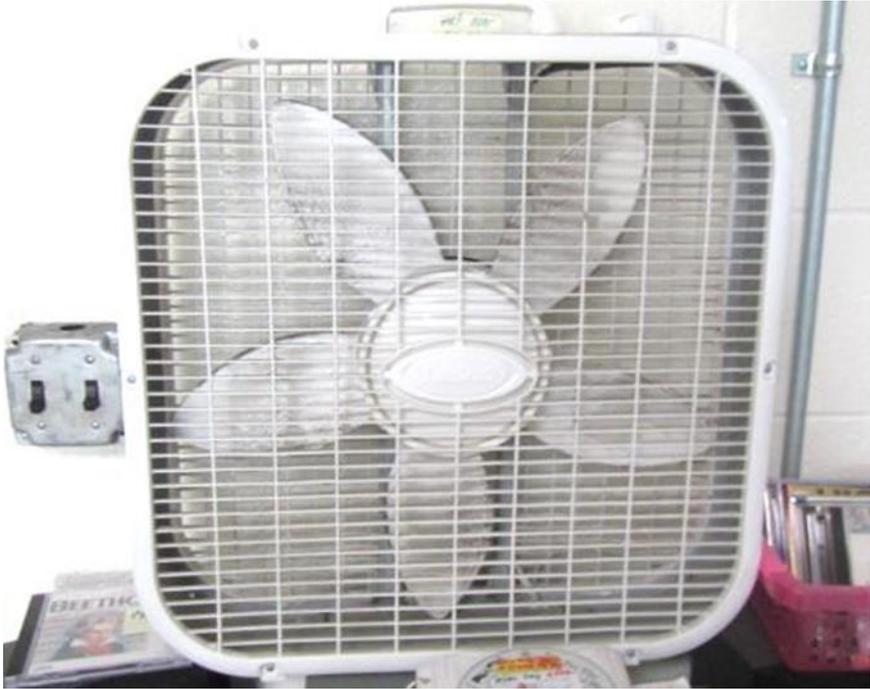
**Picture 19**

Some personal fans, supply and exhaust vents were observed to be dusty (Picture 19; Table 1). Univent cabinets had dust and debris in them as well (Table 1). In some areas, items were observed on the floor, windowsills, tabletops, counters, bookcases, and desks (e.g., Picture 3; Table 1). The numerous items/irregular surfaces make it difficult for custodial staff to clean.

**Dusty fan**

23. Clean supply and exhaust vents and personal fans regularly to prevent aerosolization of debris.
24. Clean carpeting, area rugs and plush/upholstered items regularly in accordance with IICRC recommendations (IICRC 2012). If carpeting is too old and worn to be effectively cleaned, consider replacement.
