# **WATER DAMAGE/REMEDIATION ASSESSMENT**

**Woods Memorial Library  
19 Pleasant Street  
Barre, Massachusetts**

Prepared by:  
Massachusetts Department of Public Health  
Bureau of Environmental Health  
Indoor Air Quality Program  
August 2016

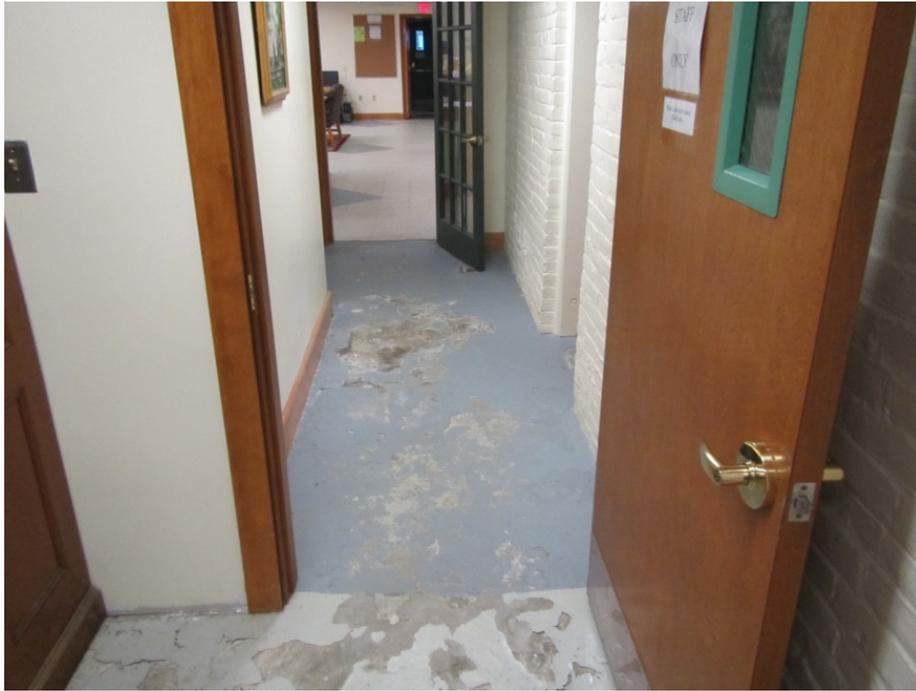
**Picture 1**

The hallway floor of the original building appears to be cement. Paint was peeling from the floor surface. BEH staff conducted moisture testing of the cement at the center of floor where paint was peeling. Results demonstrated that the cement was wet (Pictures 1 and 2).

**Location of peeling floor paint**

Floor covering used in this hallway needs to be non-porous to prevent water damage/mold growth. It is likely a vapor barrier should be installed over the cement to reduce moisture movement. Additional work regarding drainage around this building may also be useful in reducing moisture to the building.

1. Consult with drainage and waterproofing professionals to examine the best practice for preventing/minimizing water penetration through the basement cement floor.

2. It is recommended to use non-porous floor covering with a moisture-resistant adhesive.
3. Do not store anything on or in contact with the floor. Ensure all shelving is raised (e.g., using wedges) to prevent the trapping of water vapor in ground floor area.
4. Refer to resource manual and other related IAQ documents located on the MDPH's website for further building-wide evaluations and advice on maintaining public buildings. These documents are available at: <http://mass.gov/dph.iaq>.

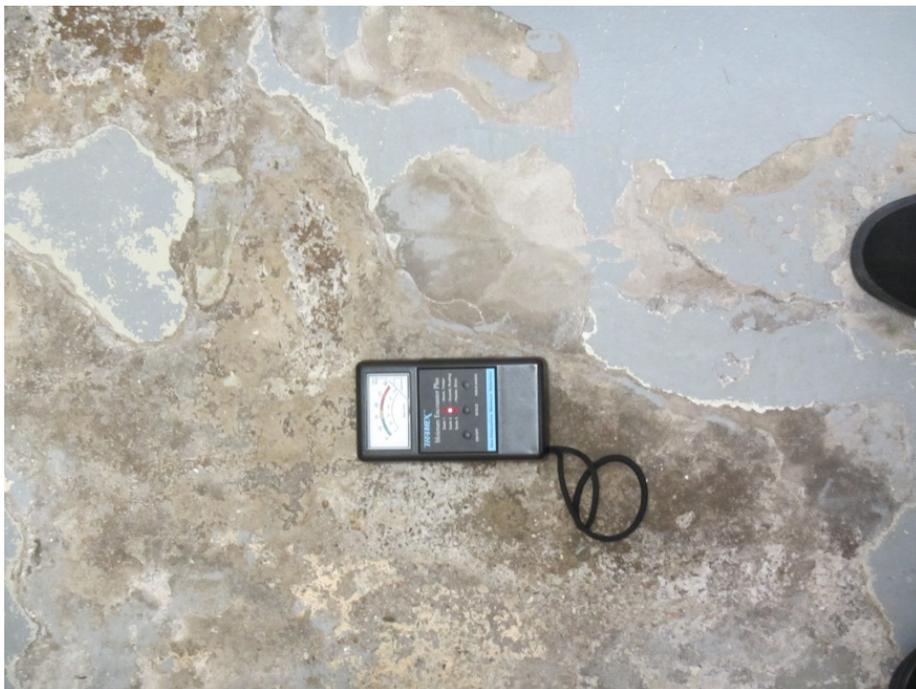
**Picture 2**

**Moisture measurement indicating floor cement is wet**
