INDOOR AIR QUALITY ASSESSMENT

**Department of Revenue
90 Everett Avenue
Chelsea, MA**

Prepared by:
Massachusetts Department of Public Health
Bureau of Environmental Health
Indoor Air Quality Program
September 2016

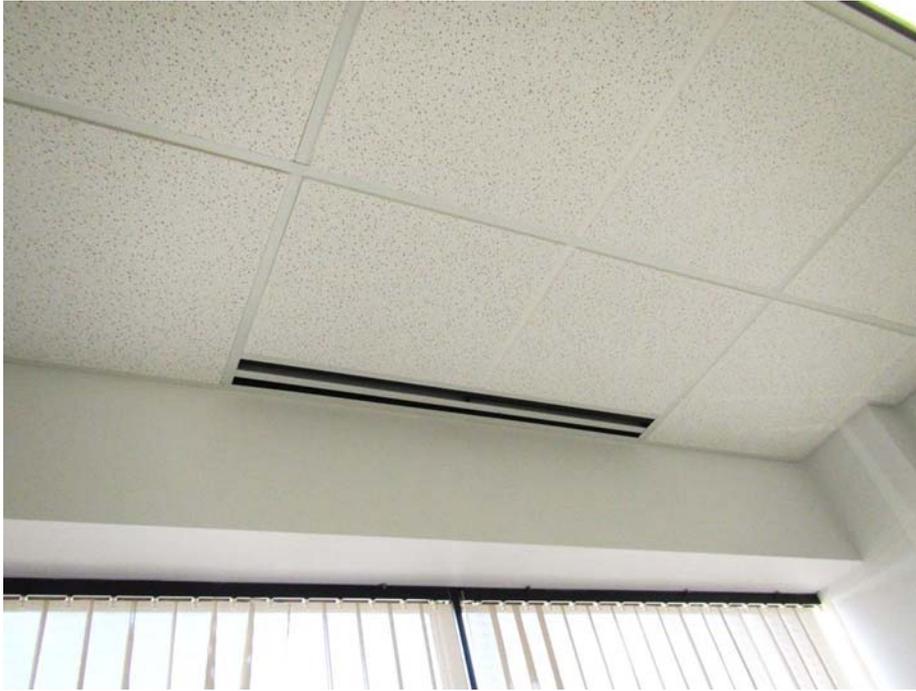
Picture 1

Fresh air is provided by air handling units (AHUs) located on the roof. Air from the AHUs is filtered, heated/cooled, and delivered to rooms via ducted supply vents (Pictures 1 and 2). Air is returned/exhausted through vents in the ceiling (Picture 3).

Air supply vent next to the windows

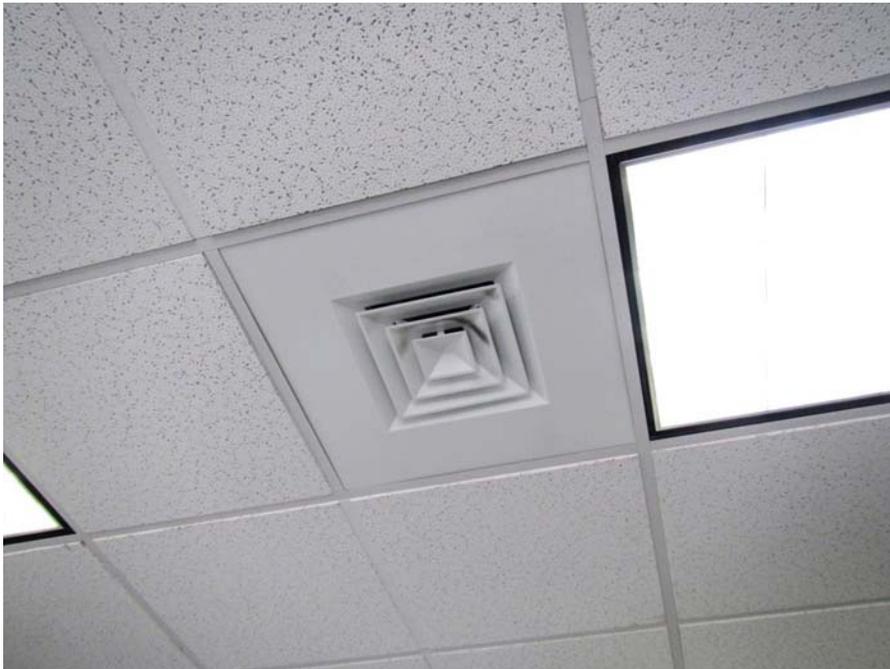
Picture 2

Supply vent

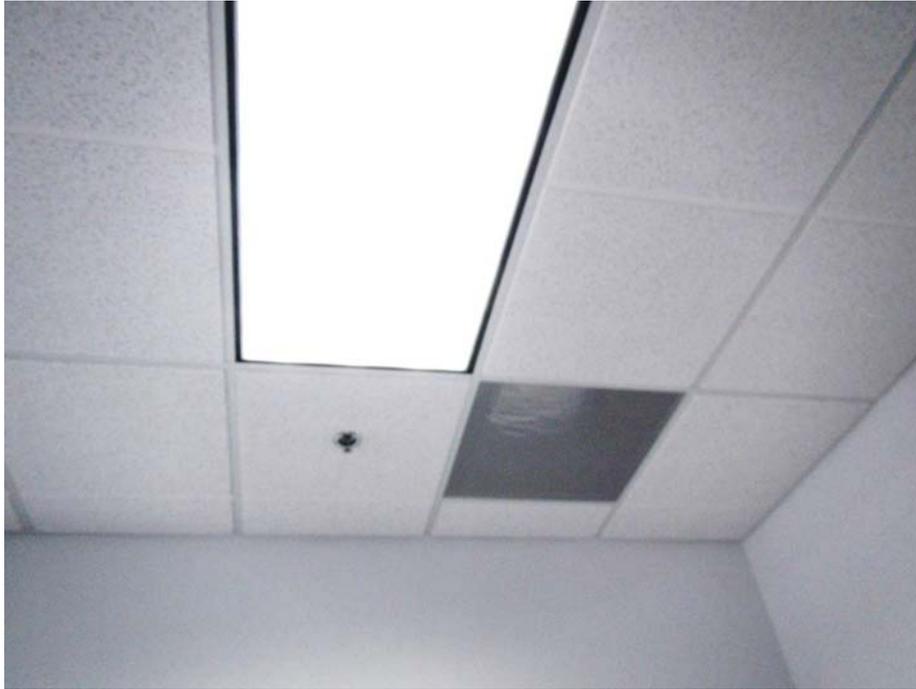
Picture 3

Typical exhaust vent

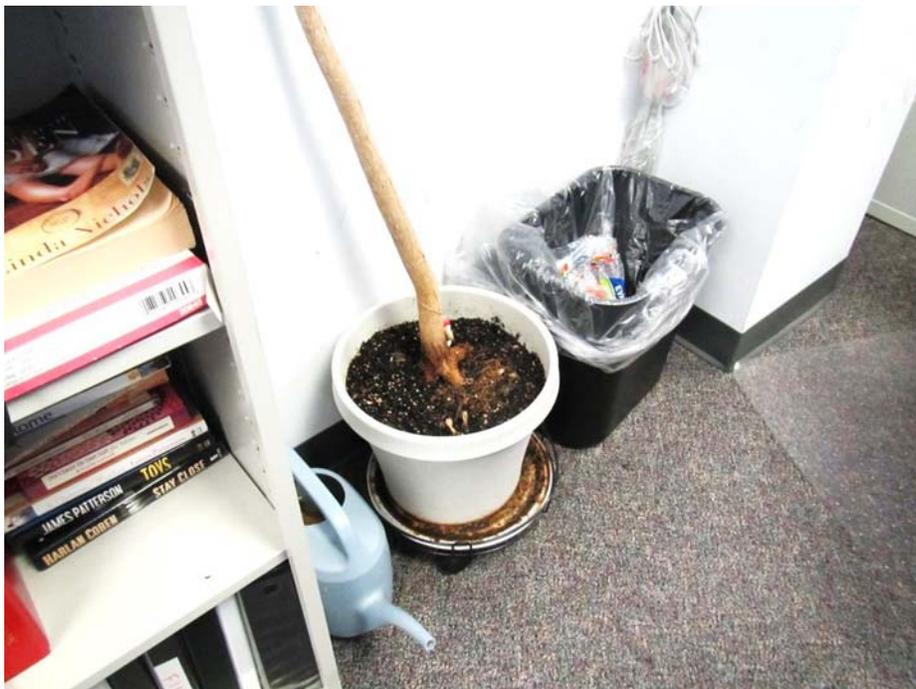
Picture 4

Plants were observed in office areas (Table 1; Pictures 4 and 5). Plants can be a source of pollen and mold, which can be respiratory irritants to some individuals. Plants should be properly maintained and equipped with drip pans to prevent water damage to porous materials. Plants should also be located away from air diffusers to prevent the aerosolization of dirt, pollen, and mold.

Plant drip pan in need of cleaning and undersized/overwatered

4. Repair conditions leading to ceiling leaks and water-damaged ceiling tiles, and replace the tiles.
5. Keep indoor plants in good condition, avoid overwatering, and avoid placing them on porous items such as carpets or paper. Also, keep plants out of the air stream of supply vents.

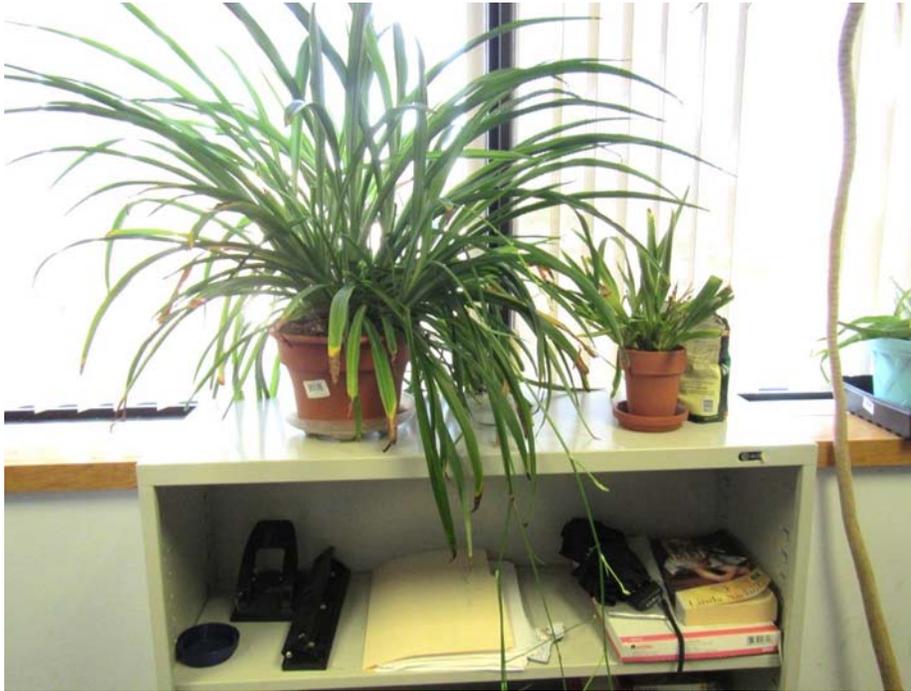
Picture 5

Plants in an office

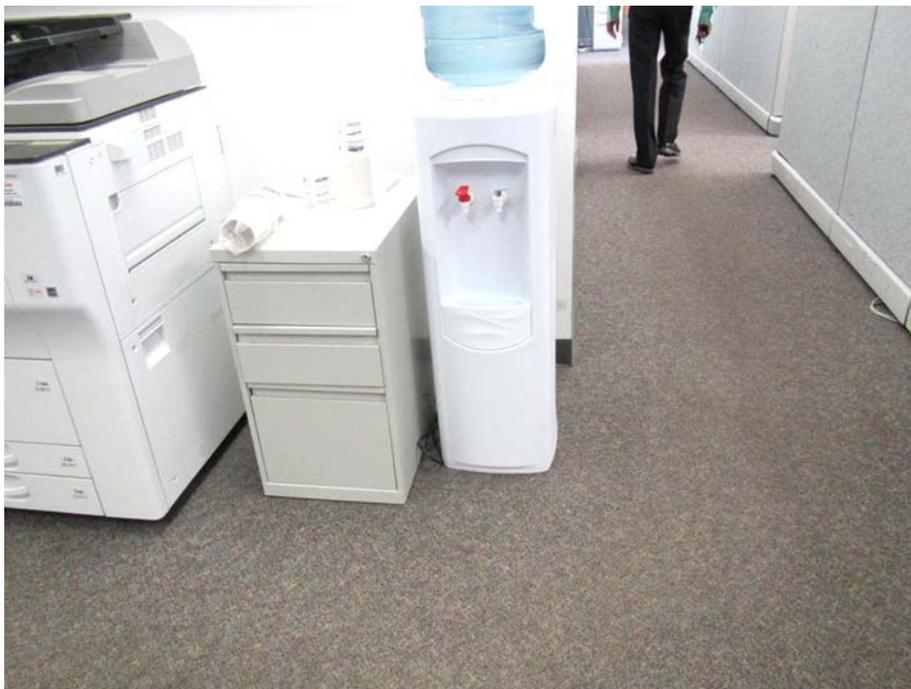
Picture 6

Small refrigerators and water dispensers were observed in carpeted areas (Picture 6). These appliances may spill or leak and lead to carpet damage and microbial growth. It is recommended that these appliances be located in areas without carpeting or on waterproof mats. Carpet squares could also be replaced with tile in areas where water dispensers and refrigerators are located.

Water cooler on carpet

6. Consider locating refrigerators and water dispensers in non-carpeted areas or place on a waterproof mat.
7. Clean refrigerator spills promptly and clean refrigerators out regularly to avoid odors and microbial growth.

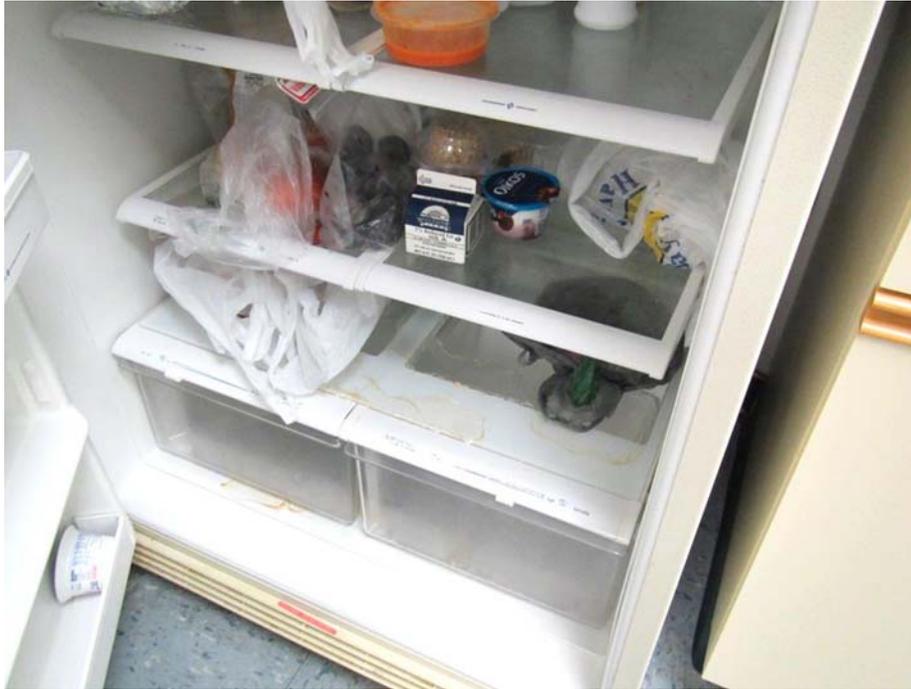
Picture 7

One of the refrigerators in a break room had evidence of a spill inside (Picture 7). Refrigerators should be kept clean to prevent odors and microbial growth. One of the break room sink cabinet had water stains (Picture 8), which suggests that leaks or condensation is occurring. The area underneath sinks tends to be a moist environment, so storage of porous items or large amounts of items should be avoided. These areas should be checked periodically for leaks and dampness.

Spills/stains in the refrigerator

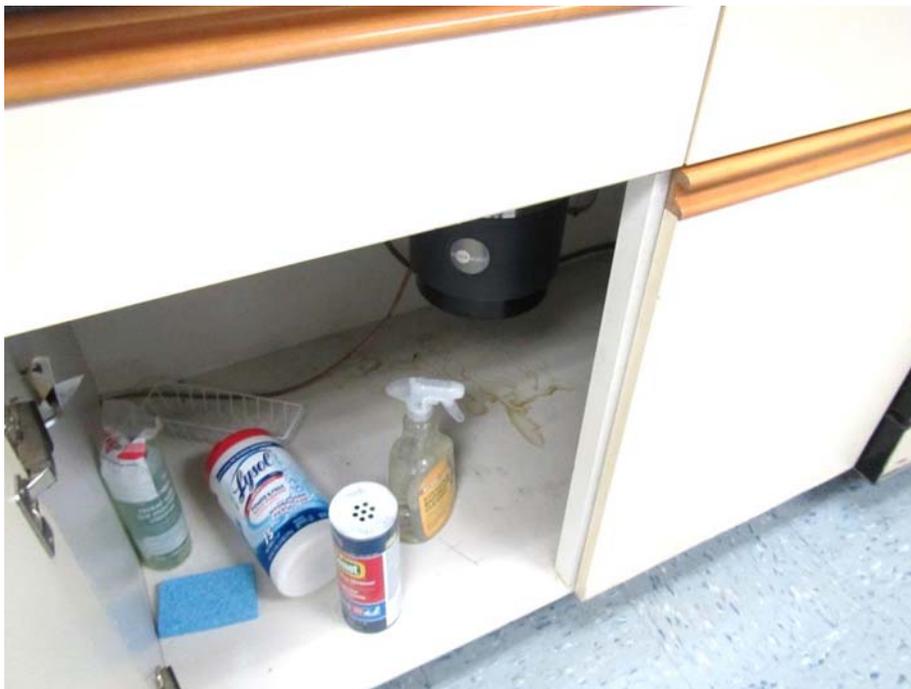
Picture 8

Exposure to low levels of total volatile organic compounds (TVOCs) may produce eye, nose, throat, and/or respiratory irritation in some sensitive individuals. To determine if VOCs were present, BEH/IAQ staff examined rooms for products containing VOCs. BEH/IAQ staff noted hand sanitizers, cleaners, and dry erase materials in use within the building (Picture 8;

Water stains and cleaning products under sink

8. Avoid storing porous items or large amounts of items under sinks.

10. Reduce the use of cleaning products, sanitizers, and scented products.
11. Change filters on AHUs on a regular schedule at least twice a year.
12. Clean carpeting in accordance with IICRC recommendations (IICRC, 2012).

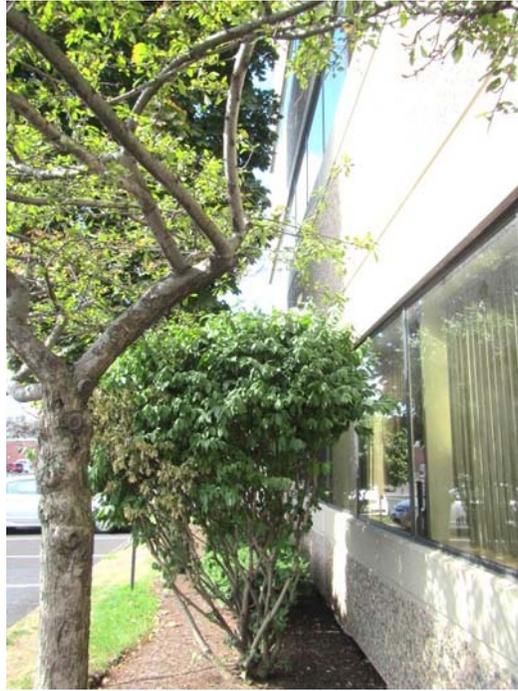
Picture 9

Plants and trees were observed very close to and touching the exterior of the building envelope (Picture 9). This can lead to deterioration of the building envelope due to root infiltration and dampness against the exterior surface. Plants can be a source of debris and pollen to air intakes. Plants should be trimmed away from the building and from overhanging the roof.

Trees and bushes against the building exterior
