# **INDOOR AIR QUALITY ASSESSMENT**

**North Shore Community College  
McGee Building  
300 Broad Street  
Lynn, Massachusetts**

Prepared by:  
Massachusetts Department of Public Health  
Bureau of Environmental Health  
Indoor Air Quality Program  
March 2016

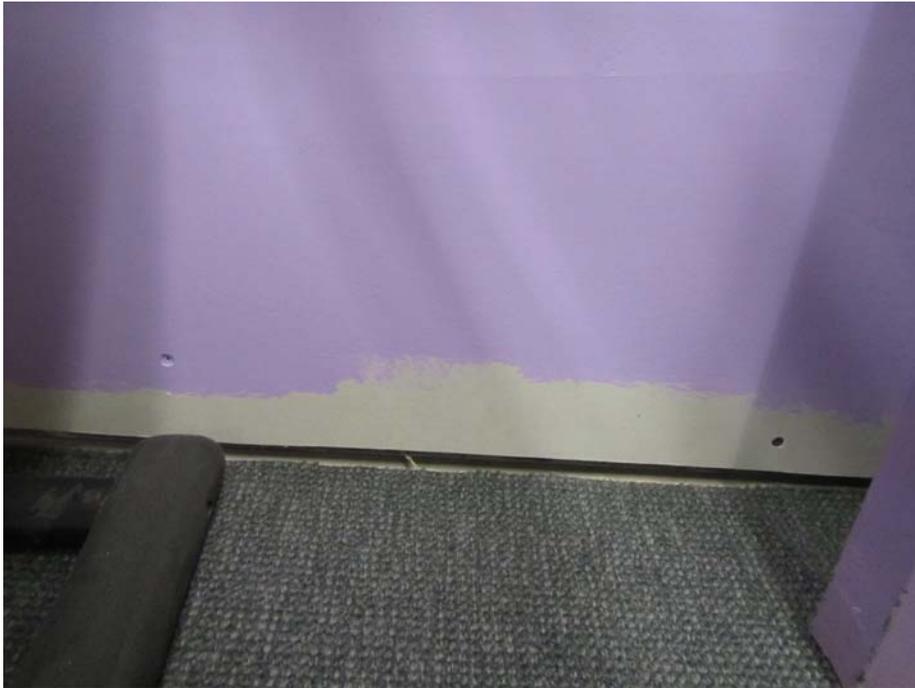
**Picture 1**

- The removed GW was then replaced and painted. Most GW was replaced to allow about a half inch space at the bottom to prevent water wicking in the future (Pictures 1 to 3).

**Area of replaced GW (note space at bottom to prevent wicking)**

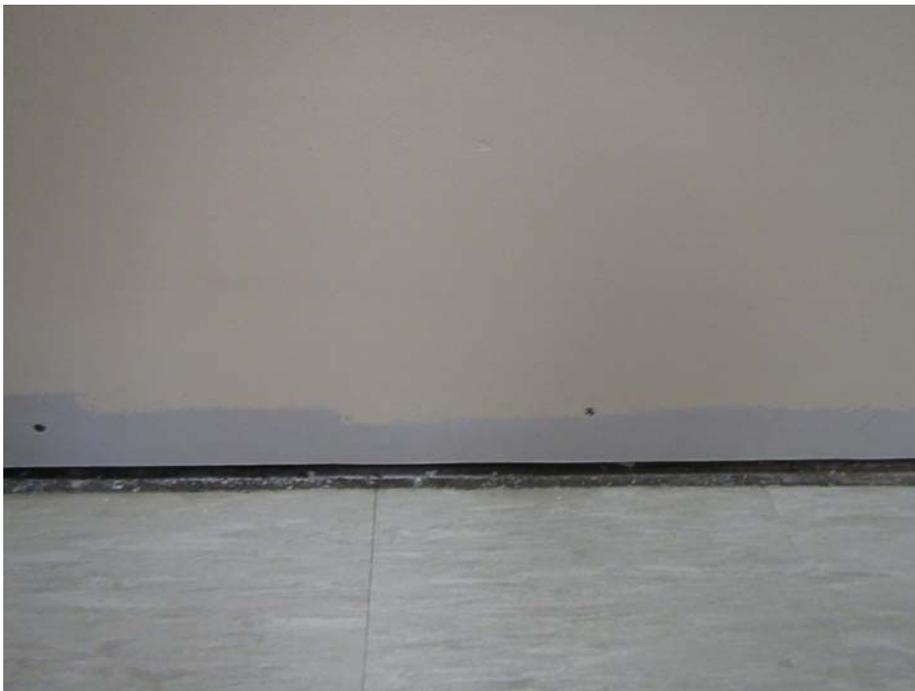
**Picture 2**

**Area of replaced GW**

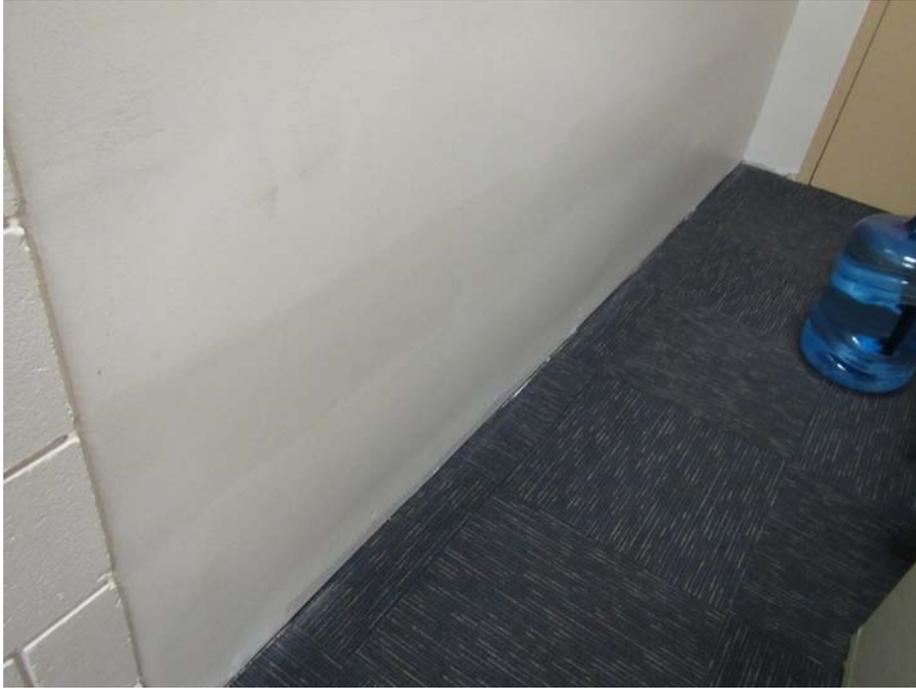
**Picture 3**

**Area of replaced and repainted GW**

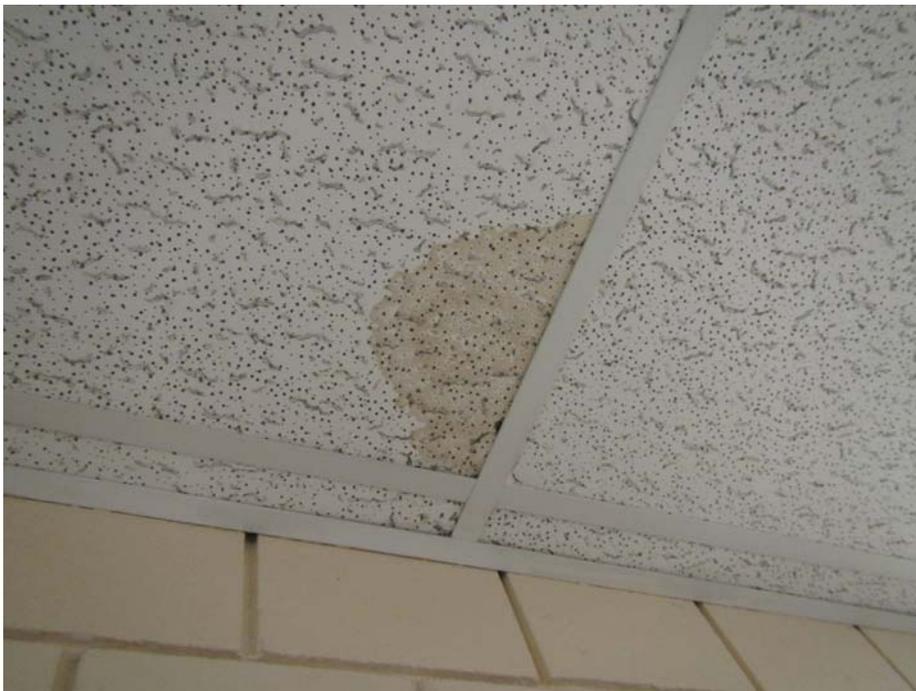
**Picture 4**

- One water-damaged ceiling tile was observed in the W171 office suite (Picture 4). This water damage appeared to be historic and unrelated to the recent flooding. The source of this leak should be investigated and repaired if necessary. Any porous materials (e.g., ceiling tile) not dried within 48 hours should be discarded and replaced.

**Water-damaged ceiling tile in suite W171**

3. Investigate the source of the water-damaged ceiling tile in office suite W171 and repair if necessary. Any porous materials (e.g., ceiling tile) not dried within 48 hours should be discarded and replaced.

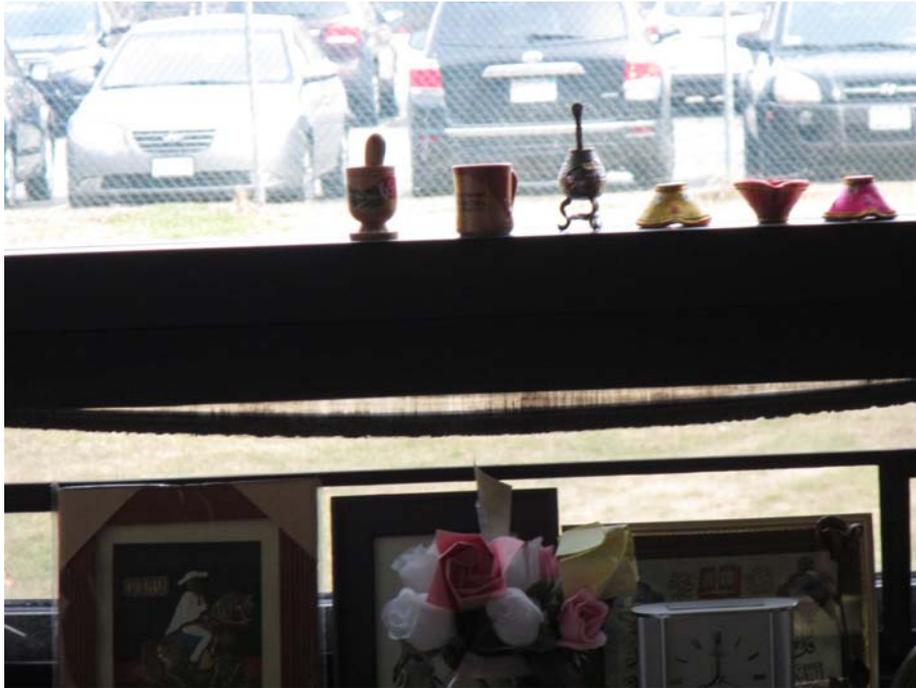
**Picture 5**

- No further signs of water damage were observed during the most recent site visit.
- The window gasket in office W117 appeared to require repair (Picture 5). Water intrusion may damage porous building materials.

**Loose window gasket in office W117**

4. Repair window gasket in office W117 to prevent water intrusion.
5. Supply and exhaust vents should be cleaned regularly to avoid aerosolizing accumulated particulate matter.

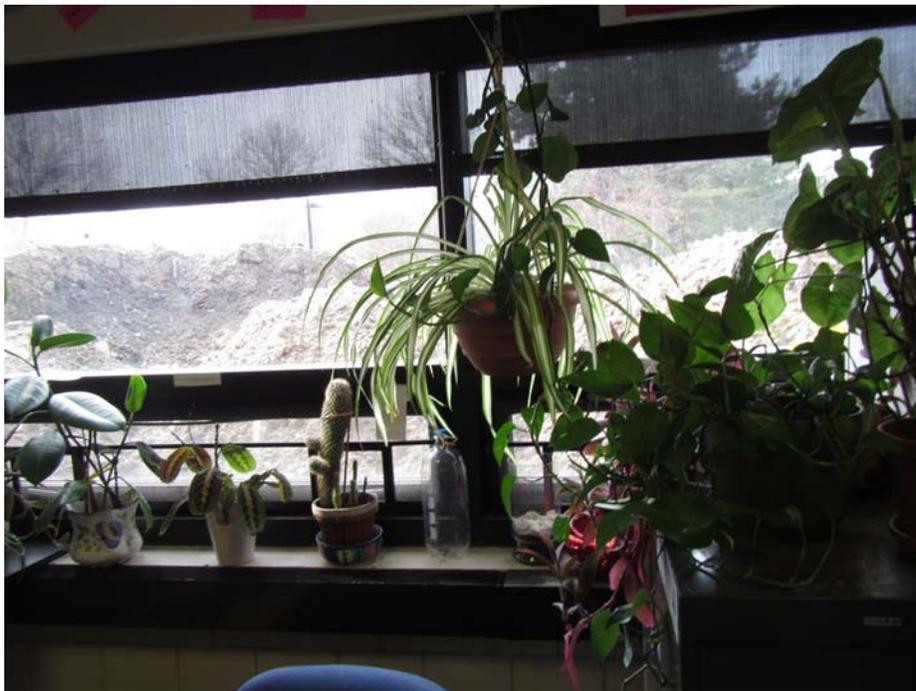
**Picture 6**

- Plants were noted in several areas (Picture 6). Plants can be a source of pollen and mold, which can be respiratory irritants to some individuals. Plants should be properly maintained and equipped with drip pans and should be located away from air diffusers to prevent the aerosolization of dirt, pollen and mold.

**Plants in occupied area**

9. Plants should be properly maintained and equipped with drip pans and should be located away from air diffusers to prevent the aerosolization of dirt, pollen and mold.

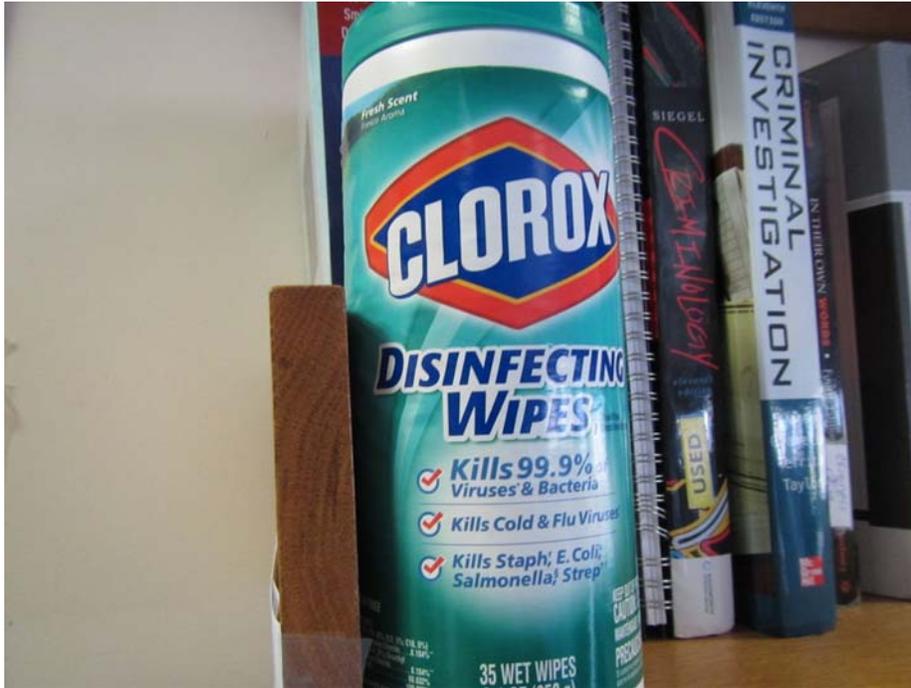
**Picture 7**

- IAQ staff noted air fresheners, scented hand sanitizers, cleaners, and dry erase materials in use (Table 1, Picture 7). All of these products have the potential to be irritants to the eyes, nose, throat, and respiratory system of sensitive individuals and their use should be minimized.

**Scented cleaning wipes**

8. Minimize the use of air fresheners, scented hand sanitizers, cleaners, and dry erase materials within the building. These products have the potential to be irritants to the eyes, nose, throat, and respiratory system of sensitive individuals.

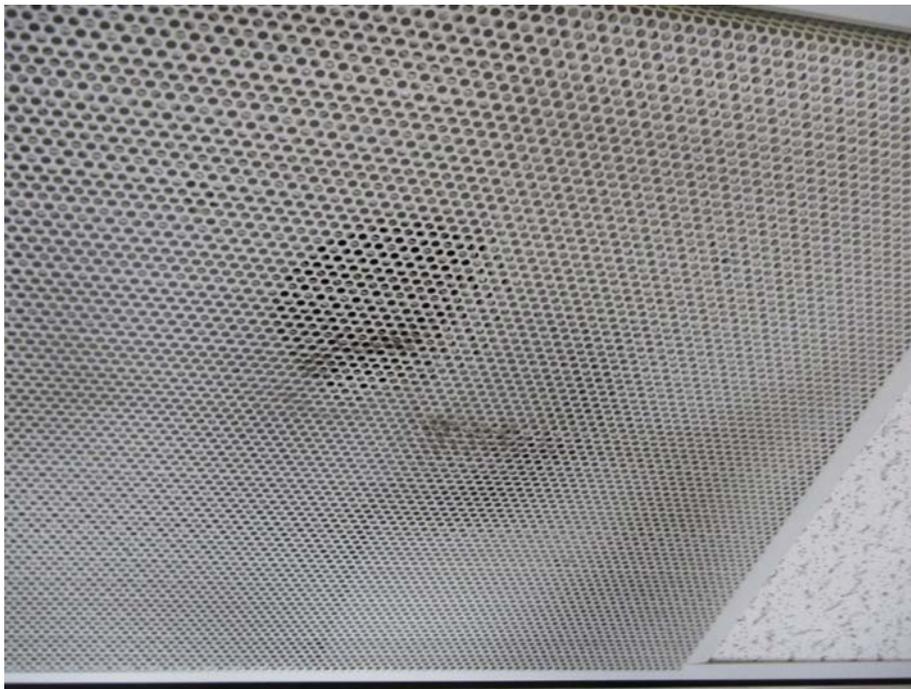
**Picture 8**

- Supply and exhaust vents were noted to be dusty in several areas throughout the first floor (Picture 8). These vents should be cleaned regularly to avoid aerosolizing accumulated particulate matter.

**Dust/debris on ceiling vent**

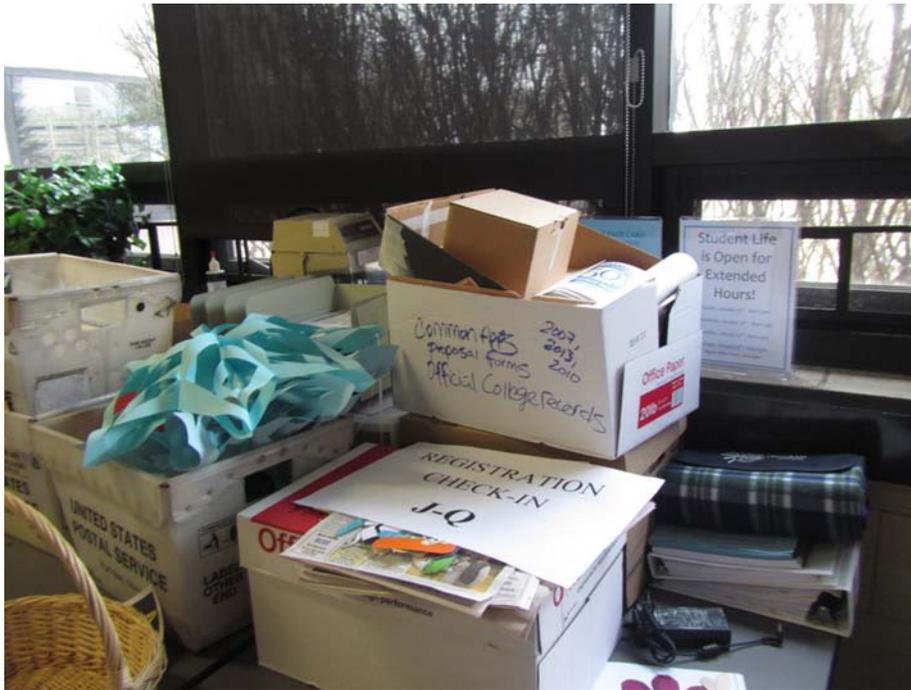
**Picture 9**

- In several areas, items were observed on the floor, windowsills, tabletops, counters, bookcases, and desks (Picture 9). The large number of stored items provides a source for dusts to accumulate. These items (e.g., papers, folders, boxes) make it difficult for custodial staff to clean. Once aerosolized, they can act as irritants to eyes and respiratory system. Items should be relocated and/or be cleaned periodically to avoid excessive dust build up.

**Accumulated items on surfaces**

7. The large number of stored items (e.g., papers, folders, boxes) make it difficult for custodial staff to clean. Items should be relocated and/or be cleaned periodically to avoid excessive dust build up.
