INDOOR AIR QUALITY ASSESSMENT

**Department of Revenue
1 Federal Street
Springfield, MA**

Prepared by:
Massachusetts Department of Public Health
Bureau of Environmental Health
Indoor Air Quality Program
May 2016

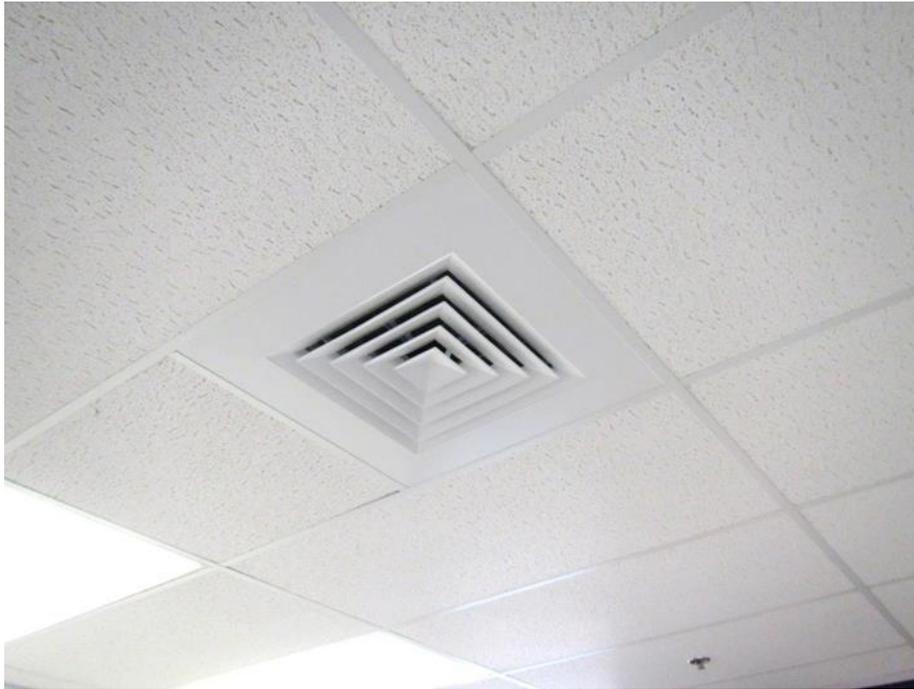
Picture 1

Fresh air for the space is provided by air handling units (AHU) via ducts to supply vents (Pictures 1 - 3). Ducted wall-mounted or ceiling-mounted exhaust vents remove stale air (Picture 4). Draw of air from restroom exhaust vents in the men's and women's restrooms appeared to be weak or non-existent.

One type of supply vent in the DOR offices

1. Operate the HVAC system during all occupied periods to provide continuous fresh air and exhaust ventilation.
2. Ensure fans/motors for restroom exhaust vents are operational and on during occupied periods.
3. Continue with regular maintenance of HVAC components and filter changes at least twice a year.

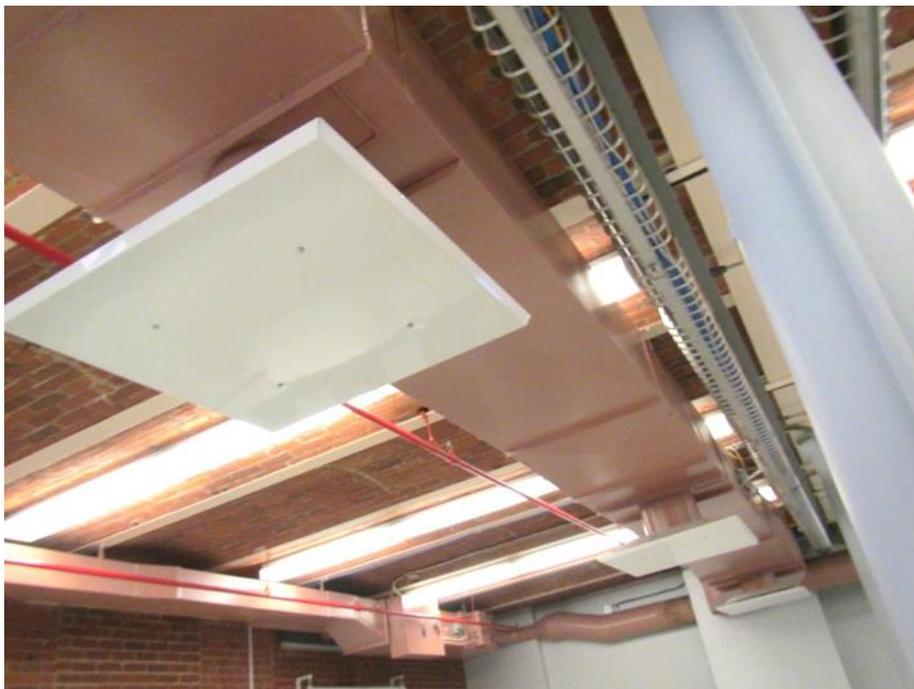
Picture 2

Supply vent in open areas of the DOR office

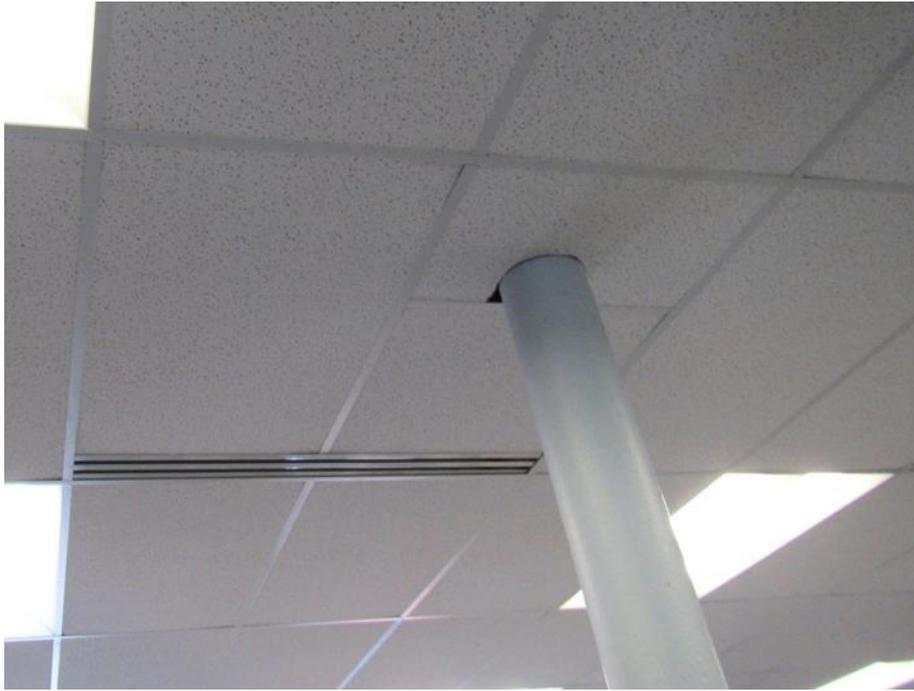
Picture 3

Slot-style supply vent

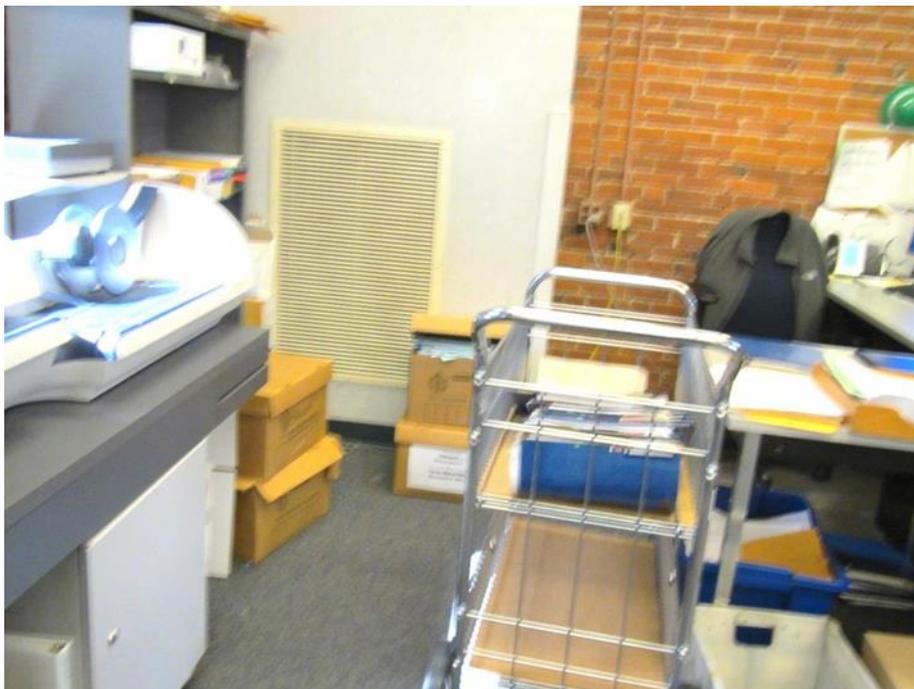
Picture 4

Wall-mounted exhaust vent

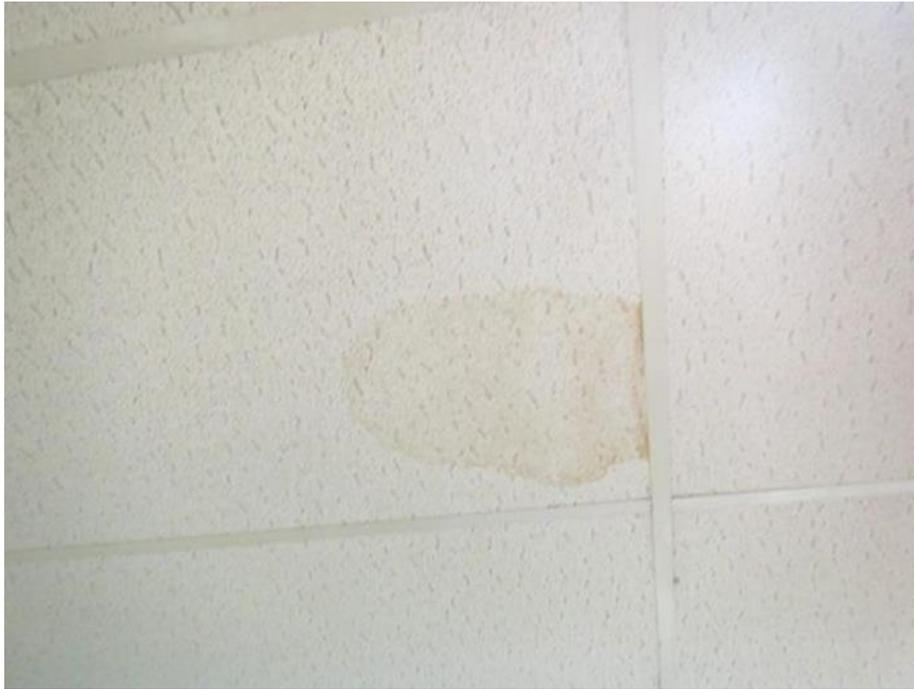
Picture 5

A single water-damaged ceiling tile was observed in the men's restroom (Picture 5). This likely stems from a plumbing leak in a space above. Once that leak has been repaired, the ceiling tile should be replaced.

Water-damaged ceiling tile in men's restroom

6. Repair plumbing leaks and replace stained ceiling tiles.
7. Consider putting water dispensers and refrigerators on waterproof mats or in areas without carpeting. During carpet replacement, areas of tile may be used in places where dispensers and refrigerators will be located.

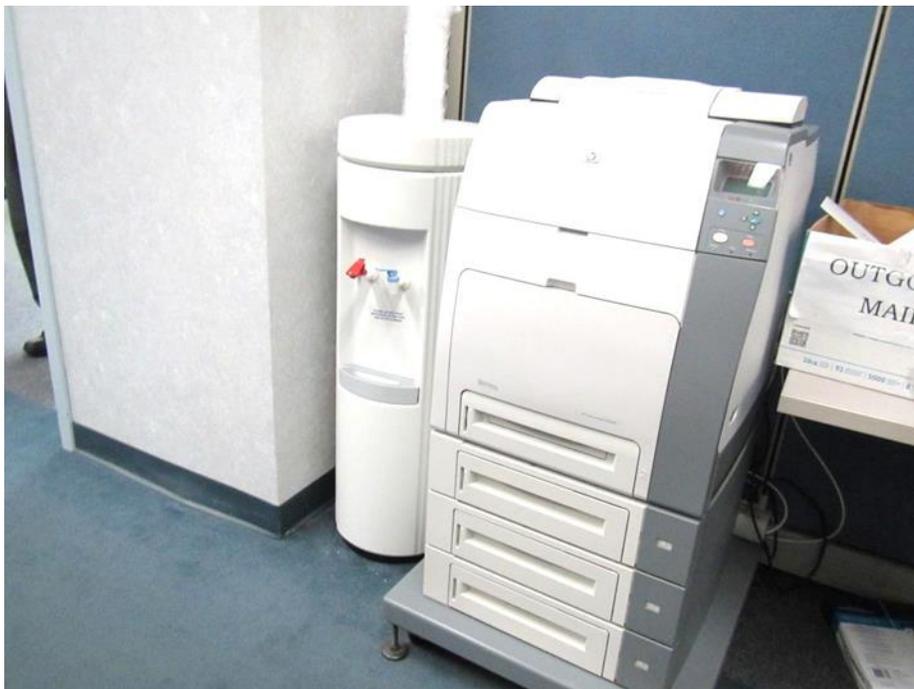
Picture 6

Water coolers and small refrigerators were observed on carpeting (Picture 6). Spills and leaks from these appliances can moisten carpeting and lead to microbial growth and odors.

Water cooler on carpet
