INDOOR AIR QUALITY ASSESSMENT

**Department of Revenue Office
540 Myles Standish Boulevard
Taunton, MA**

Prepared by:
Massachusetts Department of Public Health
Bureau of Environmental Health
Indoor Air Quality Program
July 2016

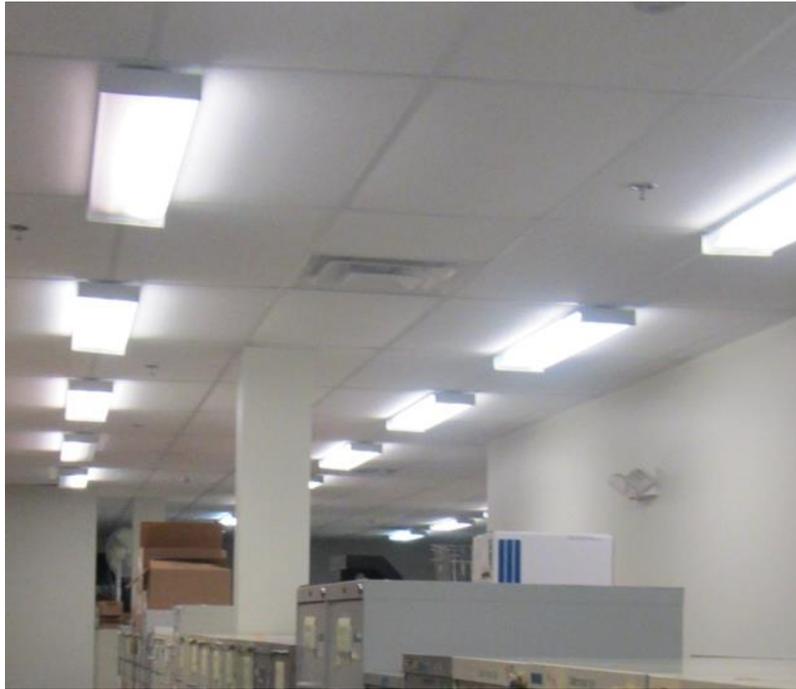
Picture 1

Fresh air is provided by air handling units (AHUs) located on the roof. Air from the AHUs is filtered, heated/cooled, and delivered to rooms via ducted supply vents (Picture 1). Air is returned/exhausted through vents located around lights (Picture 2). Direct exhaust ventilation was present in restrooms and some conference rooms.

Supply vent

11. Clean supply and exhaust vents and personal fans regularly to prevent aerosolization of debris.
12. Refer to resource manual and other related IAQ documents located on the MDPH's website for further building-wide evaluations and advice on maintaining public buildings.

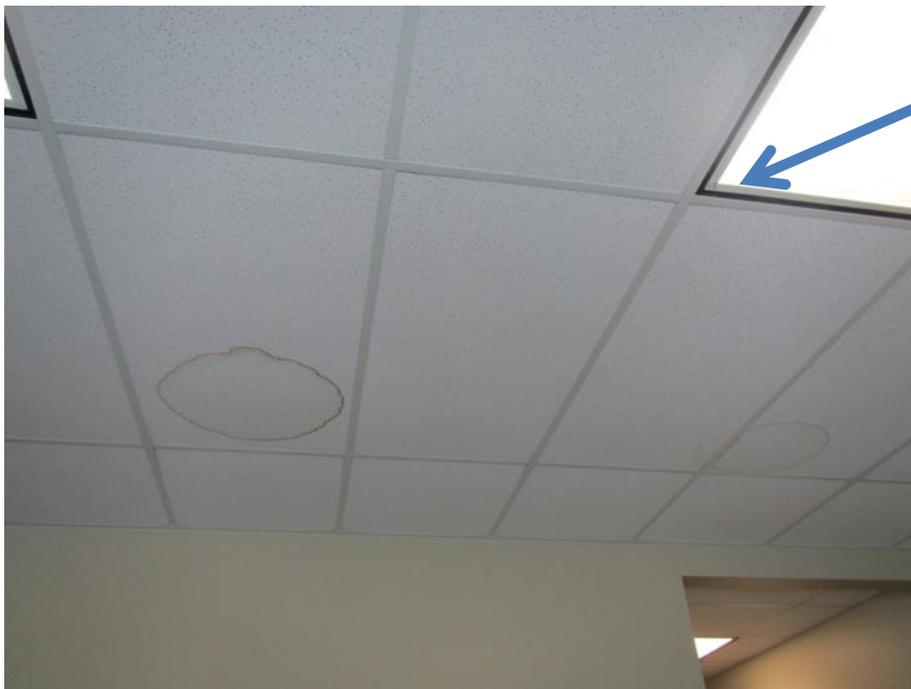
Picture 2

Stained ceiling tiles were observed in a few places on the second floor (Picture 2; Table 1). It was reported that the roof leaks sometimes during heavy rain events. Water-damaged ceiling tiles can provide a source for mold and should be replaced after a water leak is discovered and repaired.

Vent around light fixture (arrow) and water-damaged ceiling tile

3. Consider having direct exhaust installed in kitchen and copy areas to remove odors and particulates generated in these areas.
4. Repair roof/plumbing leaks and replace stained ceiling tiles.

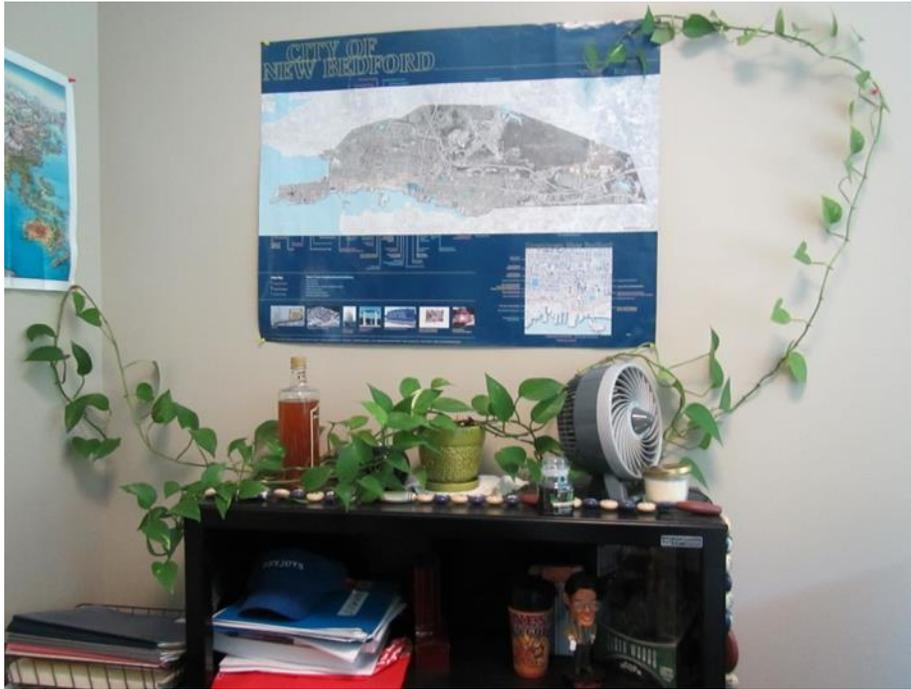
Picture 3

Plants were observed in offices (Pictures 3 and 4; Table 1). Plants can be a source of pollen and mold, which can be respiratory irritants to some individuals. Plants should be properly maintained and equipped with drip pans to prevent water damage to porous materials. Plants should also be located away from air diffusers to prevent the aerosolization of dirt, pollen, and mold. Water coolers, fountains, and small refrigerators were found located in carpeted areas where they can moisten the carpet and lead to microbial growth (Picture 5; Table 1).

In some offices, items such as paper, boxes and decorative items make it harder for custodial staff to clean. Fan blades on personal fans had settled dust and debris, which can be reaerosolized and cause irritation.

Plant in an office and a personal fan

5. Keep plants in good condition, avoid overwatering, and avoid placing them on porous items such as carpets or paper.
6. Place refrigerators and water dispensing equipment in areas without carpeting or use a waterproof mat underneath them.

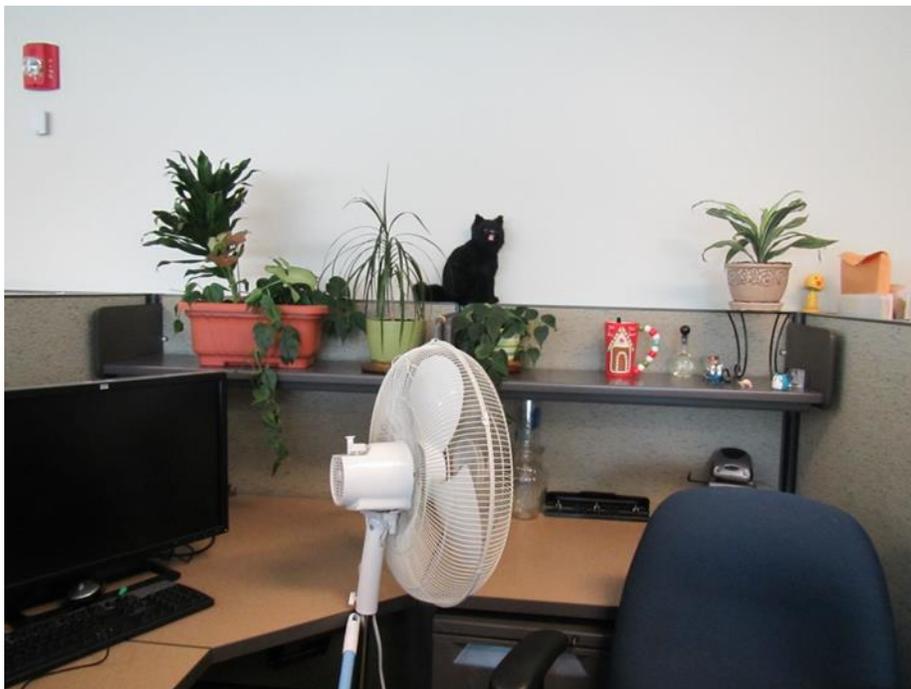
Picture 4

Plants and a stand fan

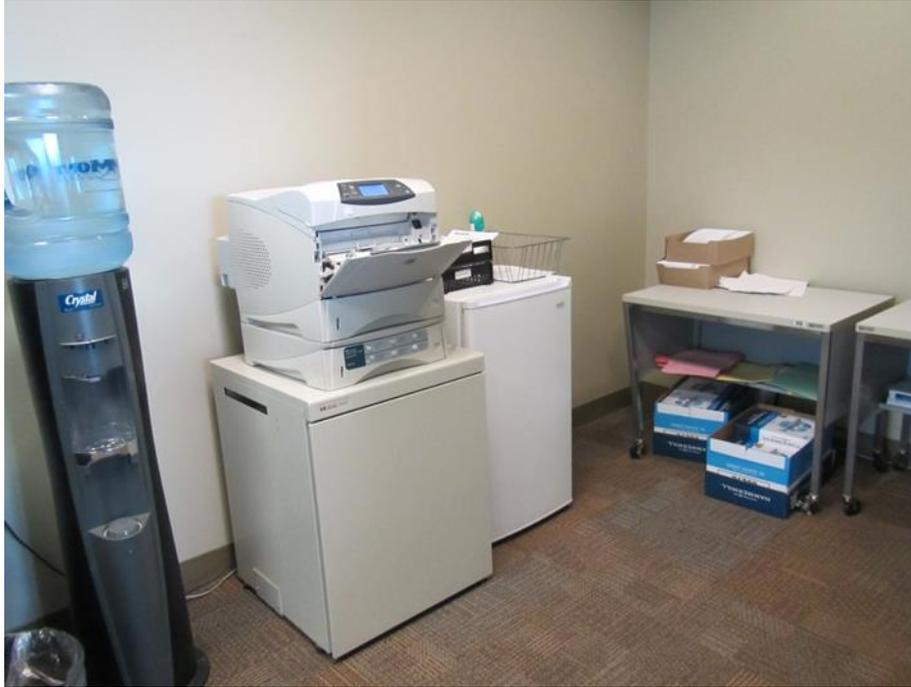
Picture 5

Water cooler and small refrigerator on carpet

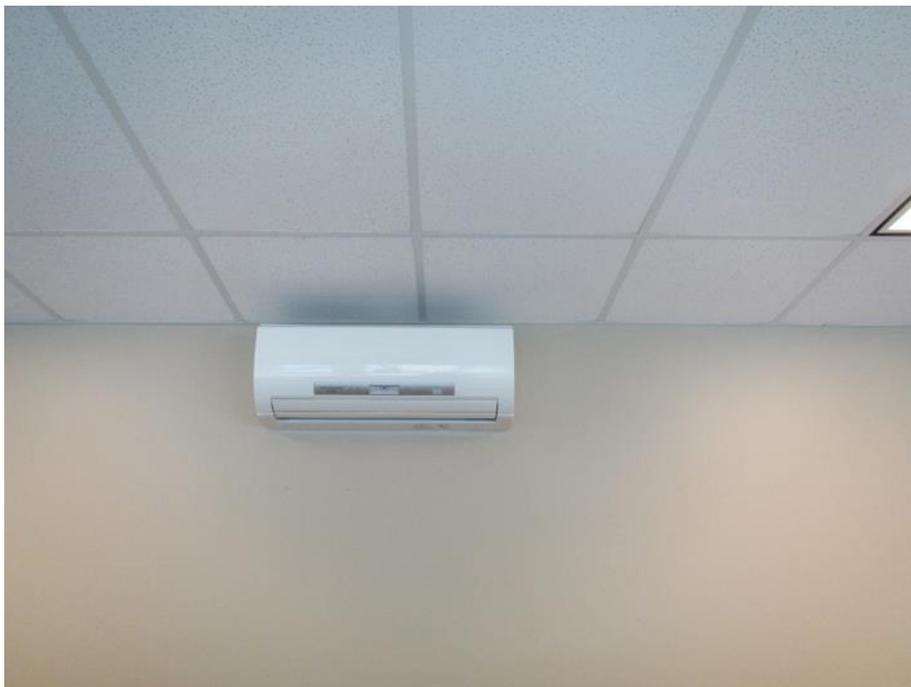
Picture 6

Ductless air conditioning units were observed along the south side of the building (Picture 6), to help with temperature control in areas subject to solar heating. Ductless air conditioning units have condensate drains, hoses, and sometimes pumps that need to be kept in good working order to prevent stagnant water and leaks.

Ductless air conditioning unit

7. Ensure ductless air conditioning condensation collecting systems are monitored and maintained to prevent stagnant water and leaks.
8. Reduce use of cleaning products, sanitizers, and scented products.

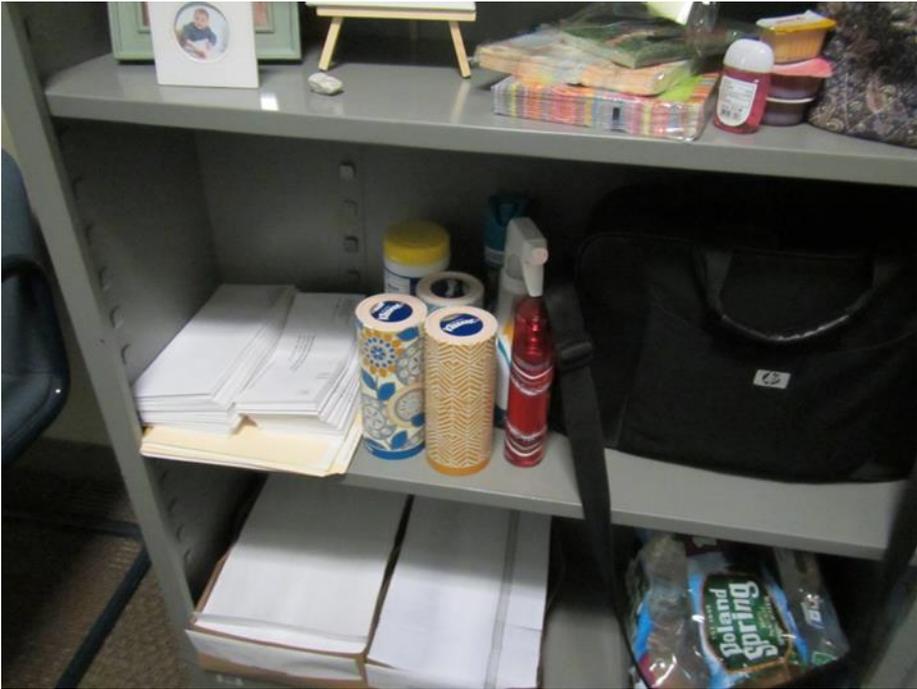
Picture 7

Exposure to low levels of total volatile organic compounds (TVOCs) may produce eye, nose, throat, and/or respiratory irritation in some sensitive individuals. To determine if VOCs were present, BEH/IAQ staff examined rooms for products containing VOCs. BEH/IAQ staff noted air fresheners, hand sanitizers, cleaners, and dry erase materials in use within the building (Picture 7; Table 1). All of these products have the potential to be irritants to the eyes, nose, throat, and respiratory system of sensitive individuals.

Cleaning products/sanitizers
