# **INDOOR AIR QUALITY ASSESSMENT**

**Department of Mental Health  
Case Management Wing, Hadley Building  
167 Lyman Street  
Westborough, MA**

Prepared by:  
Massachusetts Department of Public Health  
Bureau of Environmental Health  
Indoor Air Quality Program  
July 2016

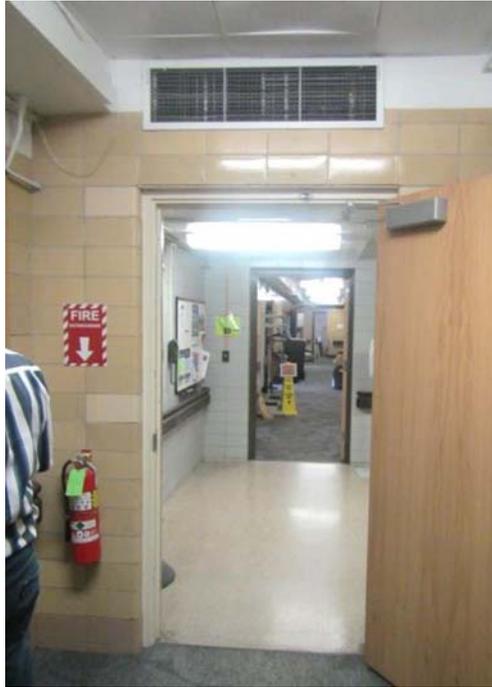
**Picture 1**

The Case Management wing is not fully equipped with a central HVAC system. Fresh air for the case management wing is mostly provided by openable windows. Most offices have two openable windows and a window-mounted air conditioner (AC). However, there was a vent at the end of the hallway (Picture 1), which was said to provide a mechanical means of outside air to the hallway. This system was reported to be under repair at the time of the assessment.

**Vent at end of hallway**

1. Continue with plans to repair hallway air handling unit. Consider long-term plans to work with an HVAC engineer to determine if units can be retrofitted with chiller/AC capabilities.

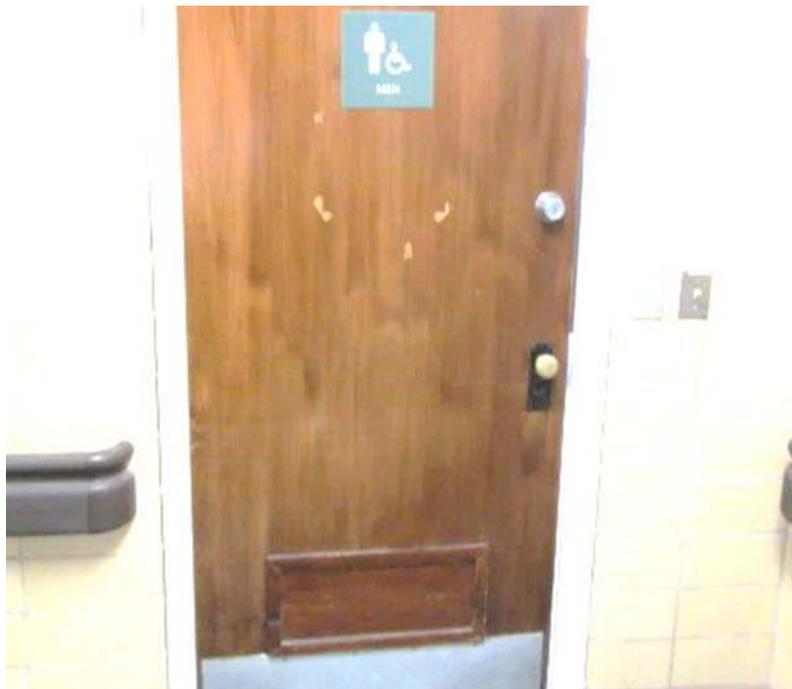
**Picture 2**

Restrooms are equipped with local exhaust vents to remove odors and moisture; however several of these were not operating during the assessment. Several of the restrooms had passive door vents which were found to be sealed (Picture 2). These vents should be restored to provide make-up air while exhaust vents are operating.

**Restroom passive door vent sealed**

2. Ensure fans/motors for restroom exhaust vents are operational. Restore passive door vents to provide make-up air.
3. Use open windows (weather permitting), to temper rooms and provide fresh air.

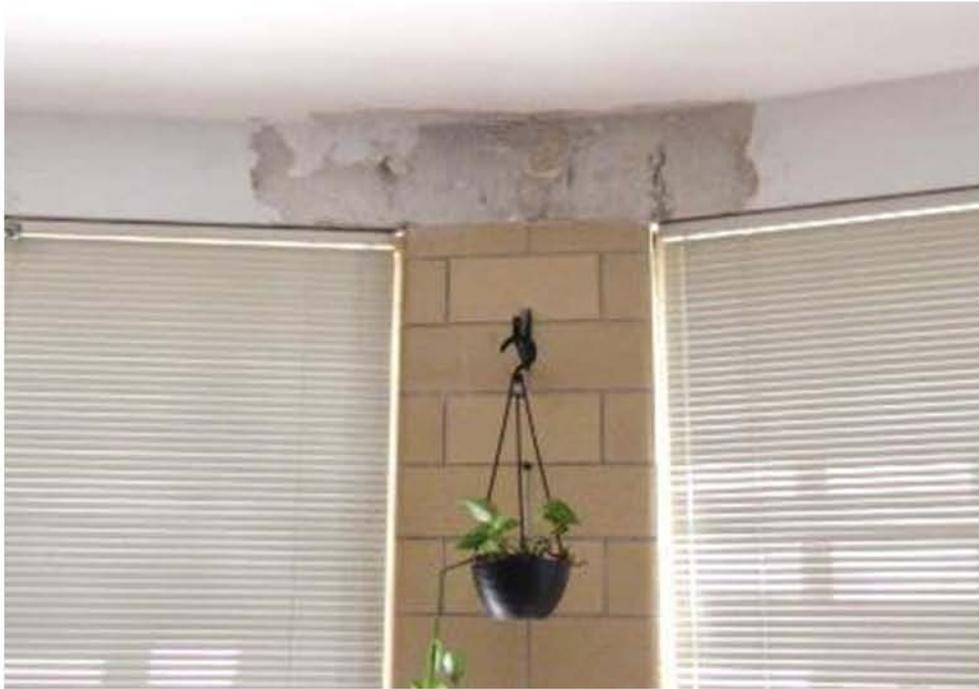
**Picture 3**

A few areas (Library and 119) exhibited signs of historic water damage in the form of peeling paint and water-stained plaster (Pictures 3 and 4). At the time of assessment, repointing/waterproofing activities were being conducted on the exterior of the building outside the Library (Picture 5).

**Water-damaged plaster and peeling paint in the Library**

5. Continue with plans to repaint/waterproof the exterior. Once repairs complete, clean and repaint areas of water damage/peeling paint (e.g., 119, Library).

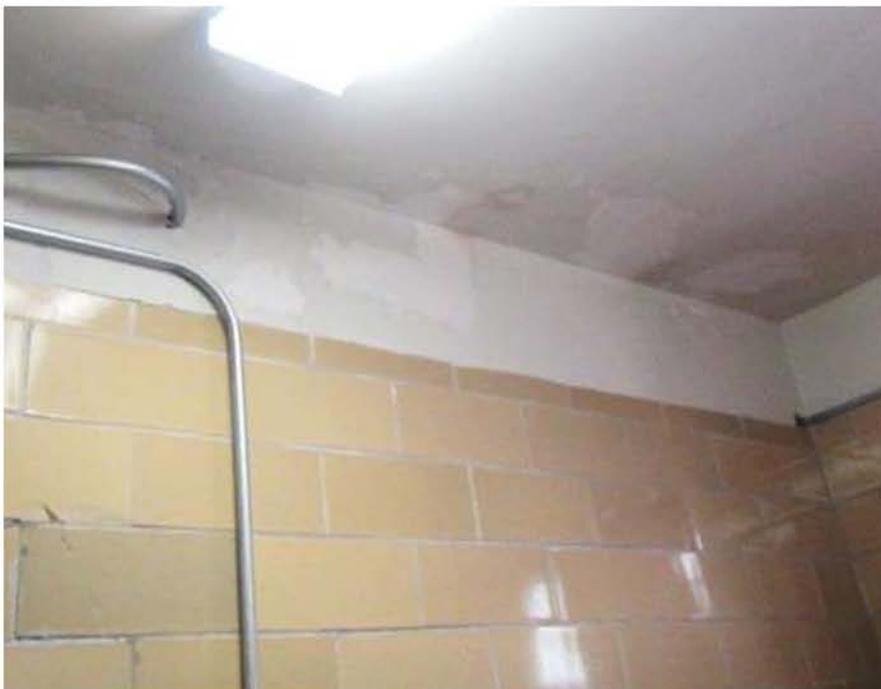
**Picture 4**

**Water-damaged ceiling/wall plaster and peeling paint in Room 119**

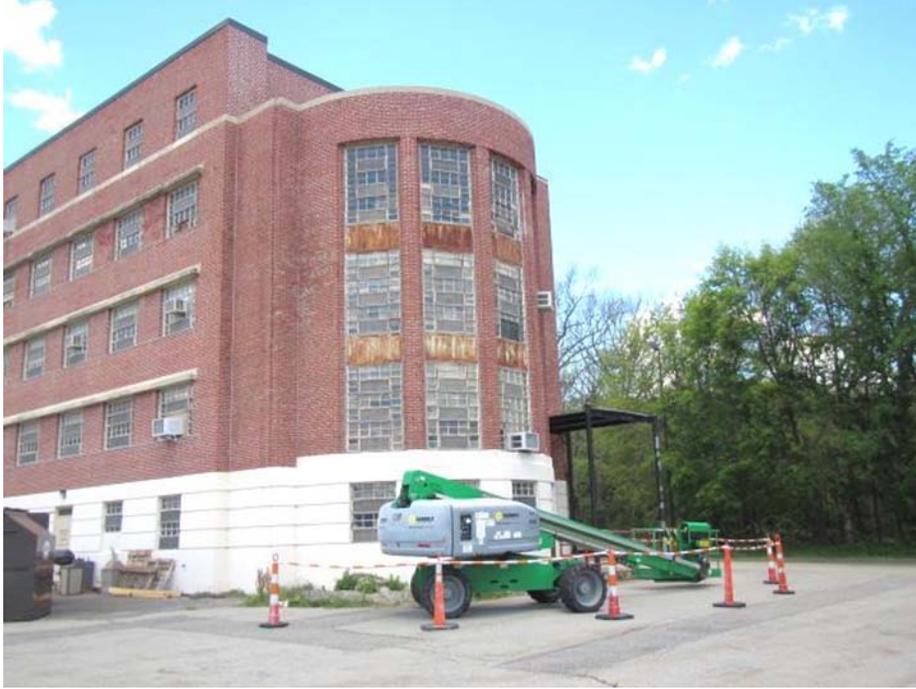
**Picture 5**

**Repointing/waterproofing activities outside of Library**

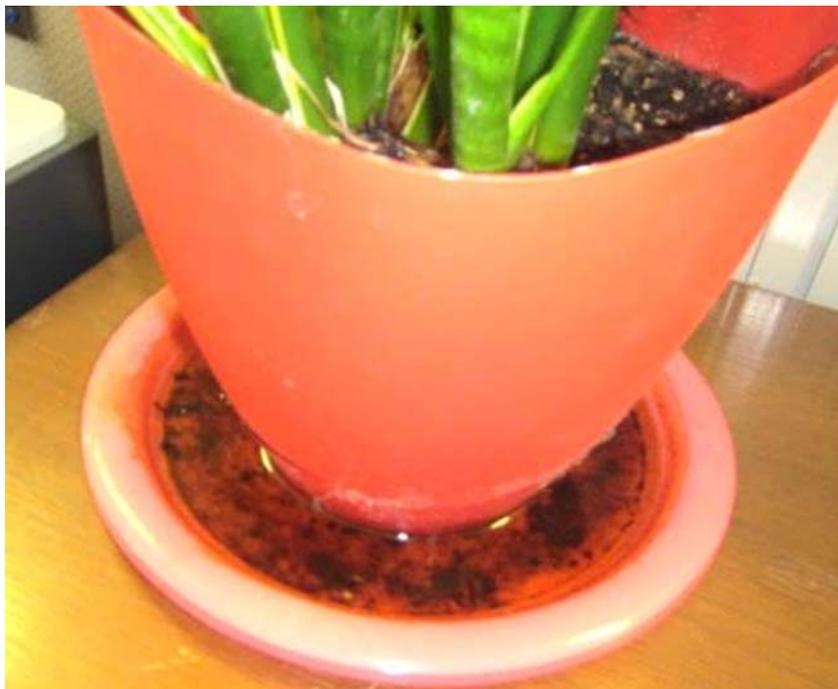
**Picture 6**

Plants were observed in several areas (Table 1). Plants, soil, and drip pans can serve as sources of mold/bacterial growth (Picture 6). Plants should be properly maintained, over-watering of plants should be avoided, and drip pans should be inspected periodically for mold growth.

**Standing water/debris in drip pan**

9. Indoor plants should be properly maintained and equipped with drip pans to prevent water damage to porous building materials and be located away from ventilation sources to prevent the aerosolization of dirt, pollen or mold.

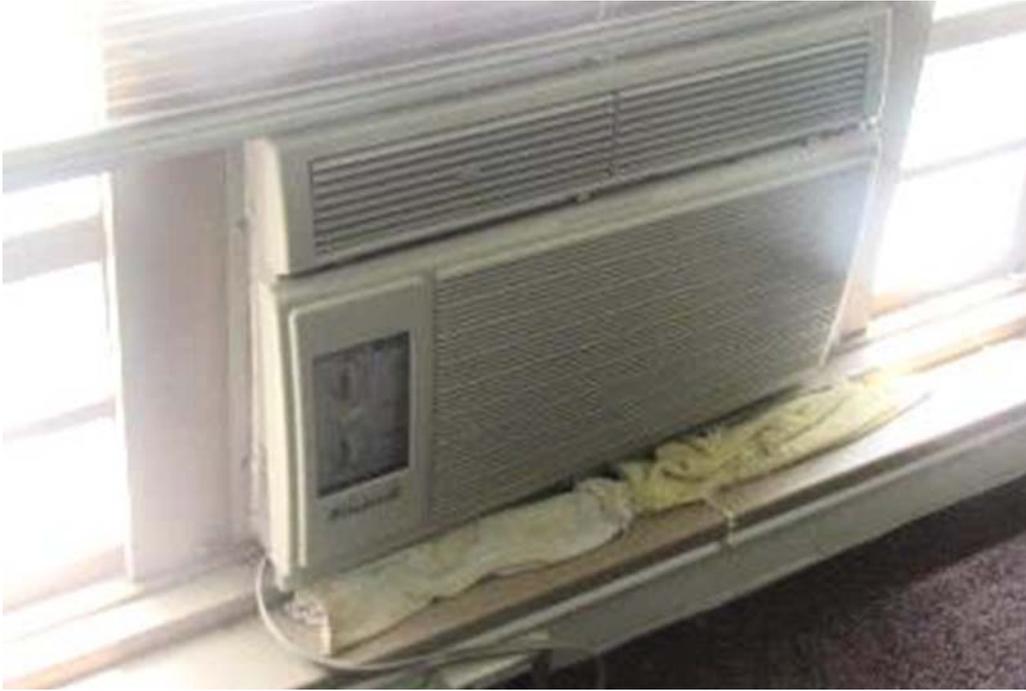
**Picture 7**

Room 133 was equipped with a two ductless AC units. These units have condensation drains that are typically pumped to the outside of the building. These units should be regularly inspected to insure that the condensation drains and pumps are working properly and are not clogged or leaking. Room 134 had cloth stationed beneath the window AC (Picture 7), to presumably seal drafts or perhaps absorb leaks. This material is porous and can grow mold if wet repeatedly.

**Cloth below AC in room 134**

7. Regularly inspect the ductless AC units for proper condensation drainage.
8. Ensure window ACs are sealed properly to eliminate drafts and or/water penetration. Refrain from using cloth/porous materials around AC units.

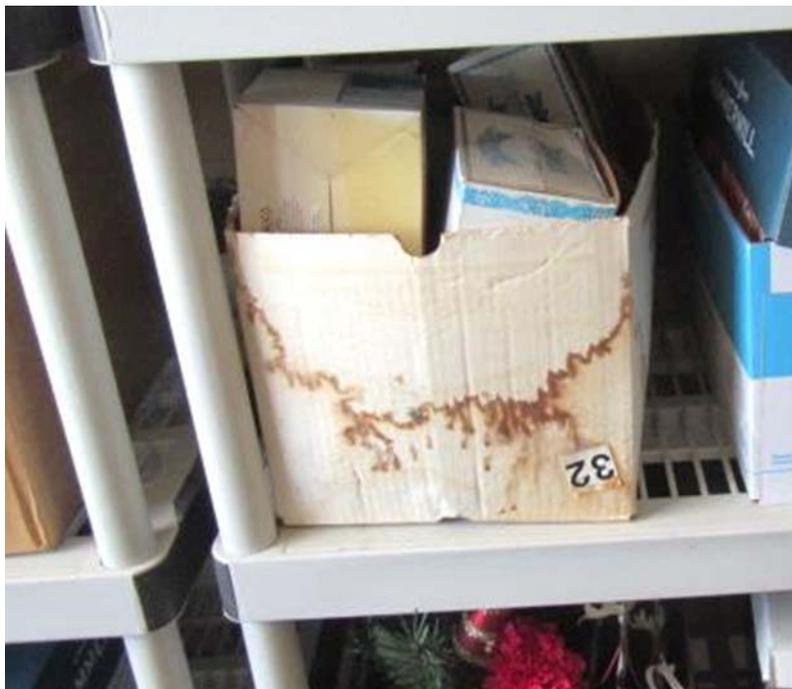
**Picture 8**

A severely water-damaged box was observed in the storeroom (Room 128, Picture 8). This box and its contents should be evaluated and if found to be mold-colonized or odorous, should be discarded.

**Water-damaged box in storeroom**

10. Examine water-damaged box/contents in storeroom 128, discard if moldy.
11. Clean AC filters prior to and periodically/as needed during the cooling season.
12. Clean supply and exhaust vents and personal fans regularly to prevent aerosolization of debris.
13. Clean carpeting annually or semi-annually in soiled high traffic areas as per the recommendations of the Institute of Inspection, Cleaning and Restoration Certification (IICRC, 2012).
14. Consider reducing the amount of items stored in offices to make cleaning easier. Periodically move items to clean flat surfaces.
15. Refer to resource manual and other related IAQ documents located on the MDPH's website for further building-wide evaluations and advice on maintaining public buildings. These documents are available at: <http://mass.gov/dph/iaq>.
