INDOOR AIR QUALITY ASSESSMENT

**Frontier Regional School District Administration Building
219 Christian Ln RFD1
Whately, MA**

Prepared by:
Massachusetts Department of Public Health
Bureau of Environmental Health
Indoor Air Quality Program
April 2016

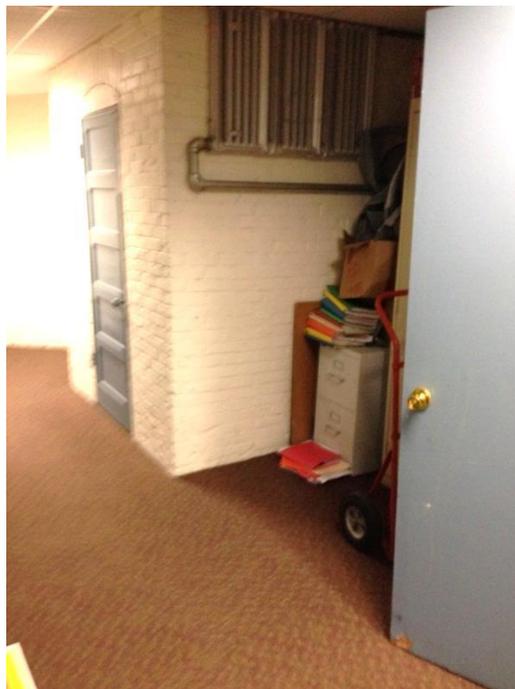
Picture 2

Ventilation was originally provided by grated, louvered, wall vents (Picture 1). The wall vents are connected by a ventilation shaft to vault-like “air-mixing” rooms in the basement (Pictures 2 through 4). Air movement in such a system is provided by the stack effect. Heating elements located in the base of the ventilation shaft warm the air (Picture 3), which rises up the ventilation shaft. This system was designed to draw outside air into the air-mixing rooms through windows, which are currently kept closed. Although this system has been abandoned most of the ducts, shafts, and vents are still present, creating pathways for air to migrate between areas of the building.

Air mixing room

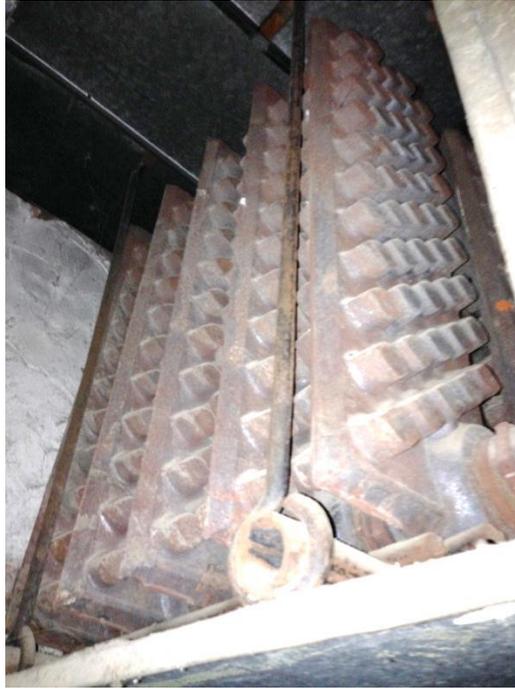
Picture 3

Heating element at base of fresh air supply

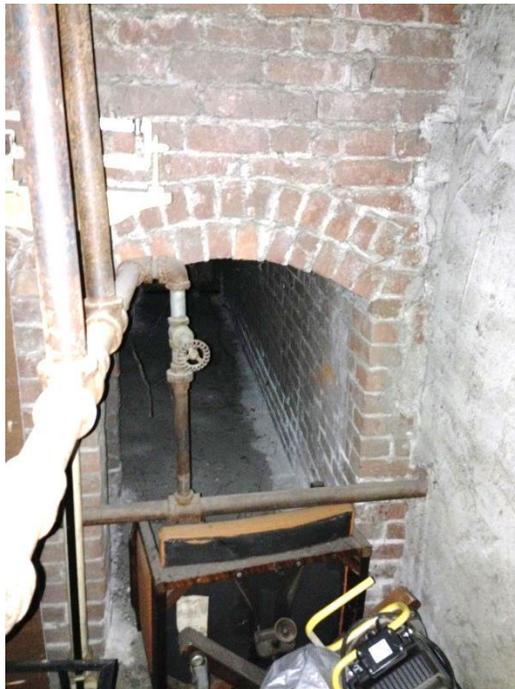
Picture 4

Base of return vent connected to rooftop air shafts

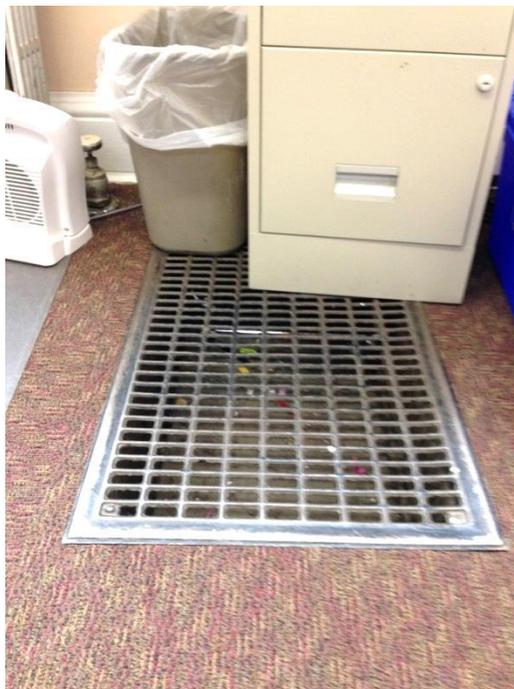
Picture 6

BEH/IAQ staff examined the basement and found an air mixing room directly below offices in the front of the building. The ceiling has two louvers that open to allow air to be drawn into the mixing room as part of the gravity ventilation system (Pictures 5 and 6). Of note, is a hinged door (Picture 7), which appears to open into the original furnace that remains abandoned in place (Picture 8). The current functional furnace appears to have a flue that is connected to the original chimney for the old furnace. If the connection between the old furnace and chimney were not properly disconnected, it is feasible that furnace exhaust may be penetrating the air mixing room located below the front offices. Furnace exhaust could then enter occupied space via the ceiling louvers. Exposure to products of combustion from oil burning furnaces is a significant source of respiratory irritants and carbon monoxide. It is highly recommended that the chimney be inspected and properly separated from the old furnace if not already done.

Open louver in floor of office

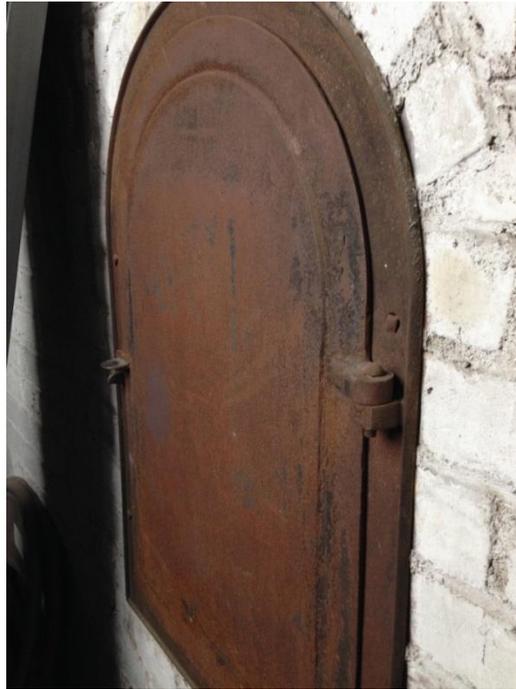
Picture 7

Door that opens into the original furnace

2. Permanently seal/render airtight the louvers in the ceiling shown in Picture 5.
3. Permanently seal the furnace door shown in Picture 7.
4. Install carbon monoxide detectors in each occupied level of the building.

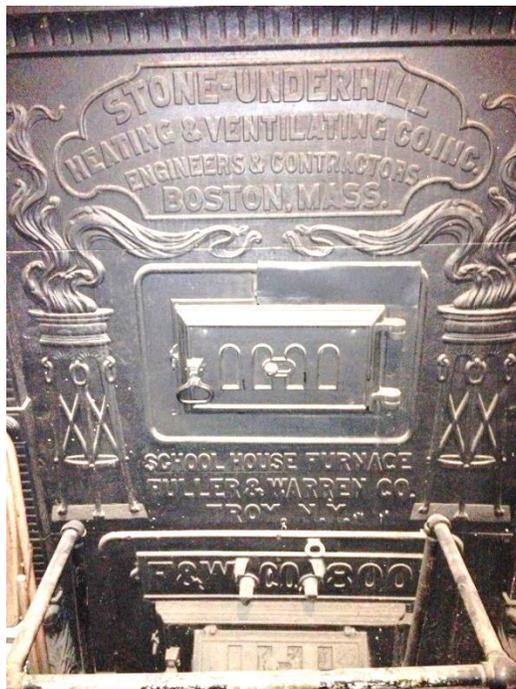
Picture 8

Original furnace in basement

1. Determine if: a) the current operating furnace is properly connected and venting from the building, and b) if the original furnace is still connected to the chimney. The old furnace should be disconnected from the chimney completely, in order to prevent products of combustion from entering occupied space.

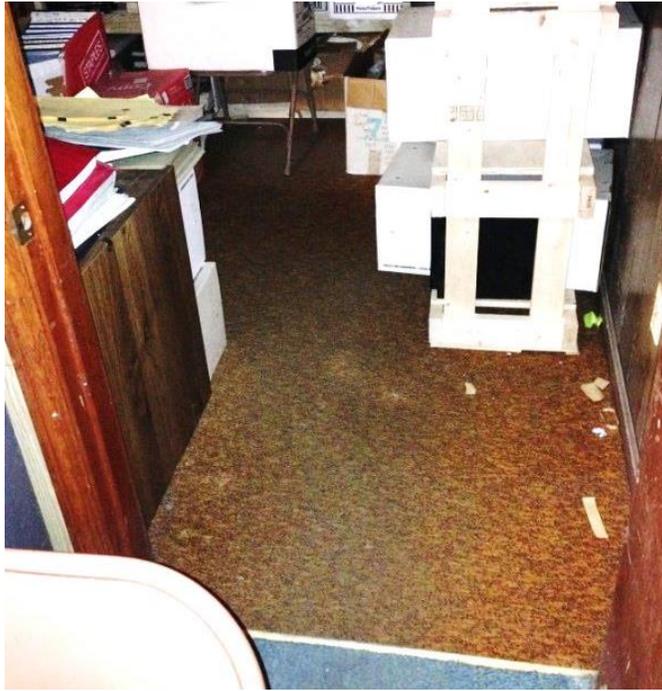
Picture 9

A large number of records are stored in a below-grade carpeted area (Picture 9). Some parts of the building contain wall-to-wall carpet that is likely over 15 to 20 years old. The average lifespan of carpeting is approximately eleven years (Bishop, 2002). It was unclear if the building has a regular carpet cleaning program. The Institute of Inspection, Cleaning and Restoration Certification (IICRC), recommends that carpeting be cleaned annually (or semi-annually in soiled high traffic areas) (IICRC, 2012).

A significant musty odor exists in the records area, due to moistening of materials on the floor from condensation that occurs during hot and humid weather. The US Environmental Protection Agency (US EPA) and the American Conference of Governmental Industrial

Records room in basement with carpet

5. Install bird screens on all ventilation shafts and vents. Have the airshafts properly cleaned/of bird waste as needed.
6. Remove carpeting from the records room. Carpeting in below grade spaces is *not* recommended due to the likely generation of condensation during hot, humid weather on a basement floor/foundation that is not insulated.

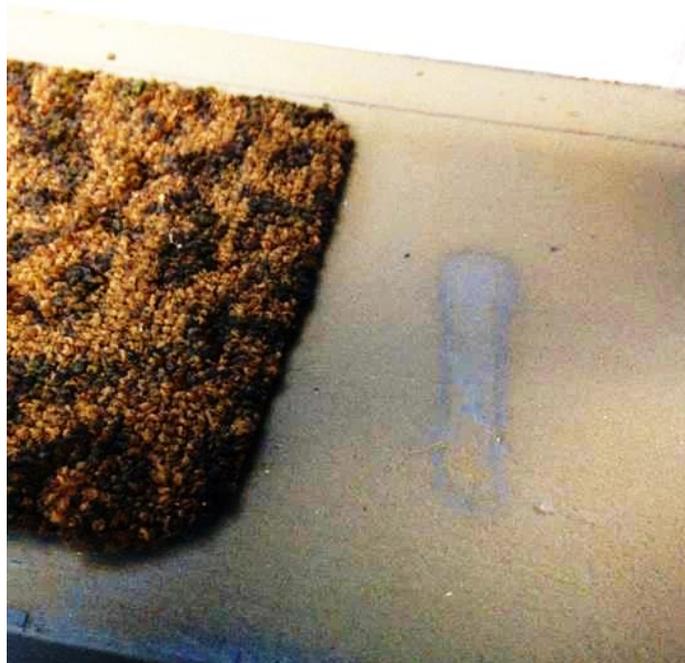
Picture 12

Staff also report that the building was significantly impacted by wind-borne top soil from the farm immediately adjacent to the building (Picture 12). As described by building occupants, the dust forms a fine coating on surfaces inside the After School Program and window frames/sills with west-facing offices on the first floor. Top soil can contain a number of microorganisms (e.g., bacteria and mold), minerals, various pesticides used in farming, and vermiculite, all of which can be respiratory irritants.

**Topsoil on stairs inside after school room
Photo taken by Frontier Regional School District personnel on February 24, 2016**

10. Windows in occupied spaces cannot be sealed to prevent topsoil from entering the building since windows are the sole source of fresh air for occupied spaces. Methods to reduce the amount of airborne dust should include dust control measures (e.g., by the farm). If not obtainable, the installation of a covered chain link fence of sufficient height to intercept windblown topsoil is recommended.
