## Occupational Fatality Report

### Tow Truck Operator Fatally Injured When Struck by a Box Truck While Assisting a Motorist – Massachusetts

Release Date: January 4, 2017  
Investigation: # 15-MA-007-01

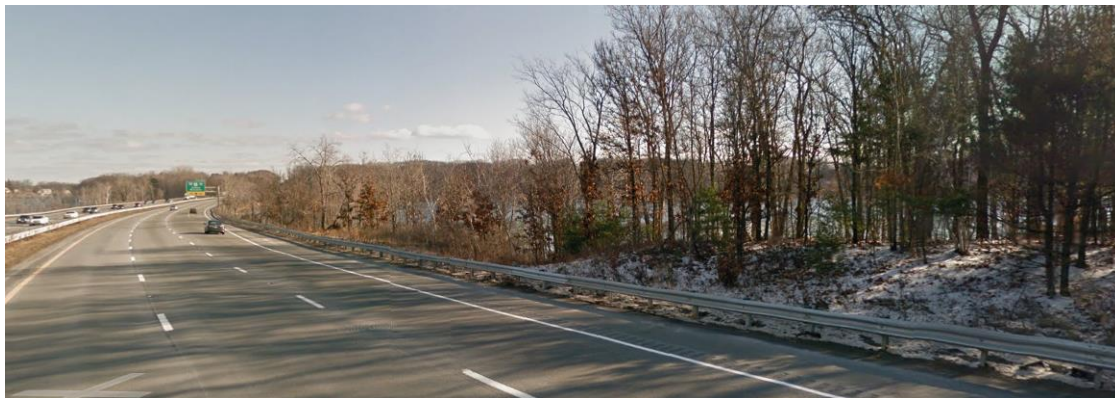
**Figure 1 – Incident location and surrounding area**

The incident occurred on an interstate highway that was comprised of asphalt and primarily ran east and west in a relatively suburban area. At the location of the incident, the highway was relatively straight and was a six lane roadway, with three travel lanes and two shoulders in each direction. The speed limit for the highway was posted at 65 miles per hour (mph). The incident occurred on the eastbound side of the highway. The three eastbound travel lanes were approximately 12 feet wide and the travel lanes were separated by white dashed (skip) lines. The north side of left-hand travel lane was bordered by a paved shoulder with a painted solid yellow line separating the shoulder and the left travel lane.

The shoulder located at the south side of the right-hand eastbound travel lane, also paved, was separated from the travel line by a solid white line. Immediately inside the shoulder was a rumble strip that was approximately 16 inches wide and parallel to the solid white line. This shoulder was approximately 9 ½ feet wide, and on the south side of the shoulder was a metal guardrail. At the time of the incident, the shoulder was approximately 8 ½ feet wide due to accumulated snow on top of and around the guardrail.

The incident occurred on a Wednesday afternoon in February and the temperature was 21 degrees Fahrenheit with clear skies and no wind. In the three weeks leading up to the incident, the area had experienced multiple snow storms and blizzards and received approximately 60 inches of snow. This resulted in a snow bank located on the right side of the road that partially covered the guardrail and extended some into the paved shoulder.

The victim drove his flatbed tow truck to the incident location and positioned his truck on the right shoulder about 12 feet in front of the car. The truck was slightly angled and the truck's left rear tire was about 10 inches inside the solid white painted line that separates the shoulder and the right travel lane. The left rear corner of the flatbed was only about 3 ½ inches inside the white painted line. The truck's flashing yellow warning lights were activated, including the light bar on top of the cab when the victim exited the truck's cab. After talking with the operator of the car, the victim who was wearing an ANSI Class 3 compliant jacket, prepared to load the car onto the flatbed. Due to the guardrail and the snow bank, the victim was unable to access the flatbed controls on the right side (passenger side) of the truck, which were furthest from moving traffic.

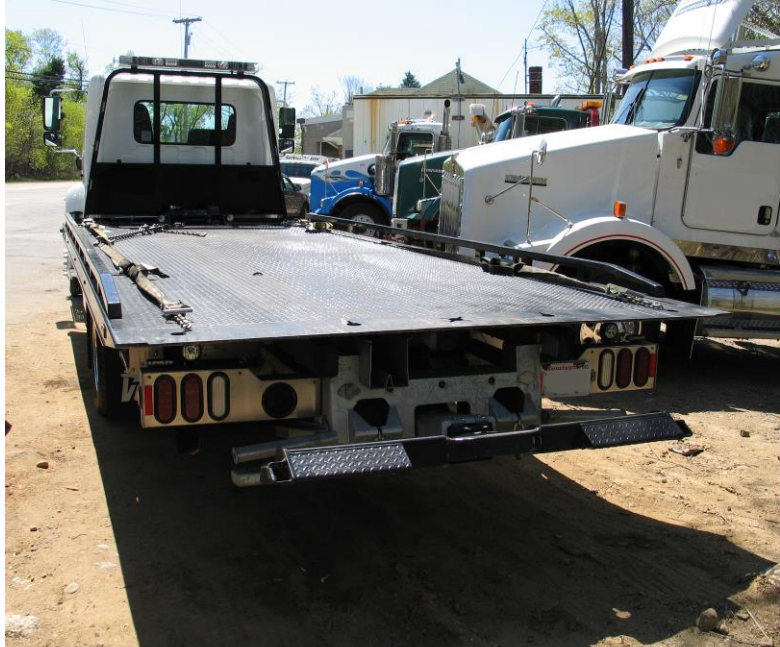
**Figure 2 – Similar flatbed tow truck as the one involved in the incident**

The victim was driving his regularly assigned light duty tow truck. The six wheeled truck was manufactured in 2007 and was equipped with a two door day cab (non-sleeper cab) and a 21 foot flatbed. The truck had controls for the flatbed located on both sides of the truck. On top of the truck's cab there was a yellow light bar. The truck had two axles, six tires, and was approximately 35 feet long, 7 feet wide and 12 feet high.

**Discussion:** The flatbed tow truck involved in the incident was equipped with tow equipment control levers for the flatbed tow truck on both the driver's and passenger's sides of the truck. In this incident, the control levers being used at the time of the incident were the control levers located on the driver's side of the truck, which was the side closest to oncoming traffic. The victim was using these controls due to a guardrail and an accumulation of snow making the controls on the passenger side of the truck inaccessible. The employer had a policy that when possible employees use the control levers located on the side of the truck that are the farthest from approaching traffic. But, as in this incident, these control are not always accessible.
