# MA FACE

## Occupational Fatality Report

### Refuse Collector was Fatally Injured when Struck by a Backing Refuse Collection Truck - Massachusetts

Release Date: February 26, 2013  
Investigation: # 11-MA-019-01

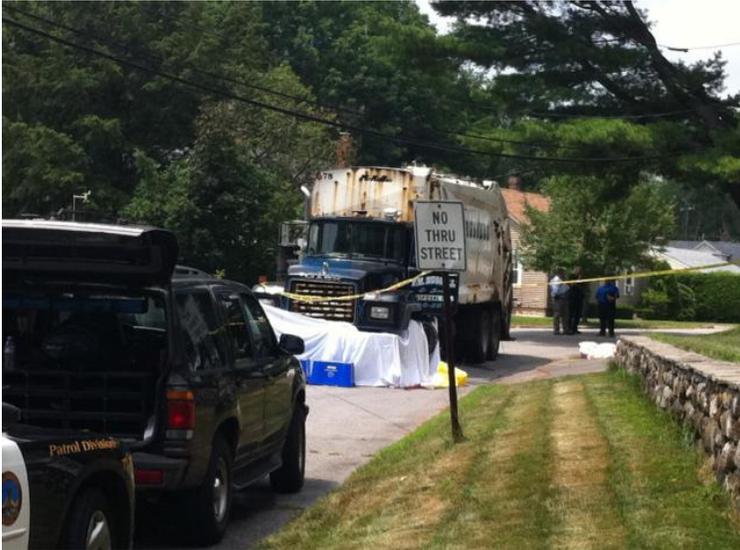
The refuse collection truck involved in the incident was manufactured and purchased by the company in 2002. The ten wheeled truck, with double dual rear wheels, was equipped with a

rear loading hopper and a hydraulic powered compressing mechanism. The truck also had a functioning backup alarm (Figure #1).

**Figure 1 – Refuse collection truck after the incident**

Multiple co-workers called for emergency medical services (EMS). Personnel from the local and state police departments, fire department and EMS all arrived within minutes of the calls. The victim was pronounced dead at the incident location. After the incident the truck was examined by the state police and was found to be in good condition.

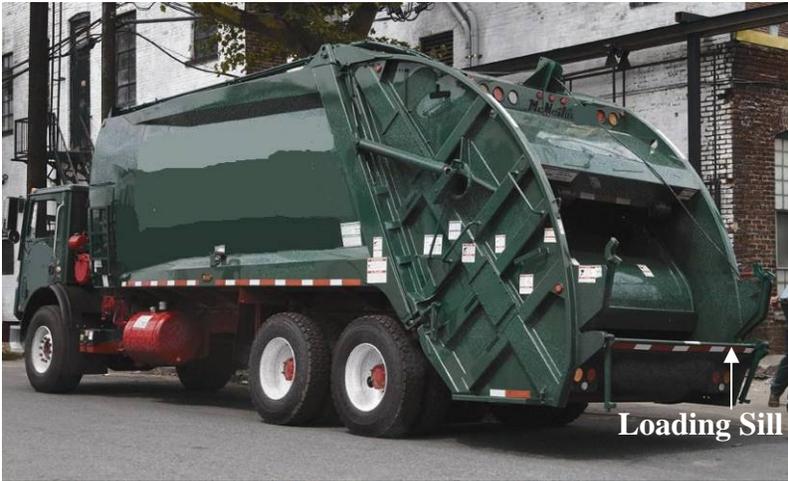
**Figure 2 – Rear view of similar refuse collection truck**

**Discussion:** In this incident, the refuse collection truck was backing down a dead-end roadway with two of the victim's co-workers standing on the truck's rear riding steps. As the truck backed, the victim attempted to climb onto the truck's rear loading sill apparently to ride the truck to the end of the street. While climbing onto the truck's sill the victim fell from the truck.
