## **Massachusetts FACE • Occupational Fatality Report**

### **School Traffic Supervisor was Fatally Injured when Struck by a Motor Vehicle - Massachusetts**

**Investigation: # 08-MA-046-01**

**Release Date: July 14, 2010**

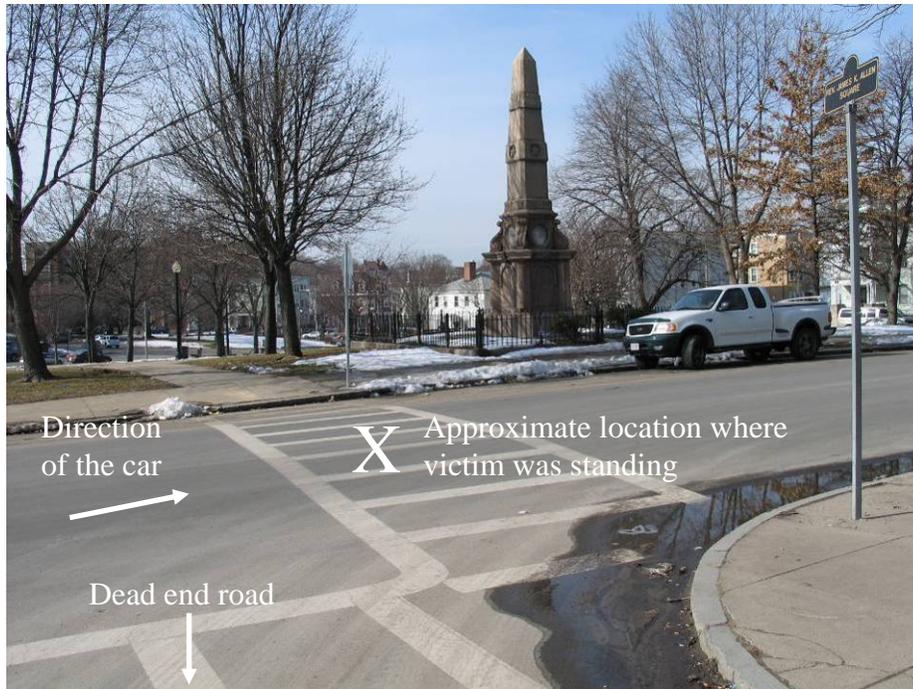
Both roadways handle two-way traffic and are approximately 56 feet wide, but do not have center yellow divided lines. The roadway's painted markings consist of white fog lines at the edges of the roads and crosswalks. There are two white painted crosswalks at the T-shaped

intersection. The two painted crosswalks have two white parallel lines that run the width of the roadway and white longitudinal lines that are parallel to traffic flow. One of the crosswalks is located at the west end of the dead-end roadway at the T-shaped intersection. The other crosswalk is located on the main roadway at the northern side of the T-shaped intersection. The latter is the crosswalk the victim was located in at the time of the incident (Figure 1). A few hundred feet south of the T-shaped intersection is a skewed four-way intersection where there are no stop signs and traffic travels quickly up to and through the intersection (Figure 2).

**Figure 1 – T-shaped intersection where the victim was assigned.**

In this case, an evaluation of the area around the school, that included these two crosswalks, might have revealed that traffic control devices were needed to make the area safer for students and School Traffic Supervisors. The school crosswalk where the victim was assigned had no traffic control devices at the time of the incident. Since the incident, three traffic control devices have been installed: two fluorescent yellow-green school crossing sign assemblies; and one fluorescent yellow-green school crosswalk sign.

**Discussion:** In this case, prior to the incident there were no signs indicating the school crosswalk or other traffic control devices. Since the incident, some fluorescent yellow-green school crosswalk signs have been installed in the area. Municipalities should evaluate school crosswalks to ensure that they are as visible as possible to motorists. Some options to help increase the visibility of school crosswalks and catch the attention of motorists include:

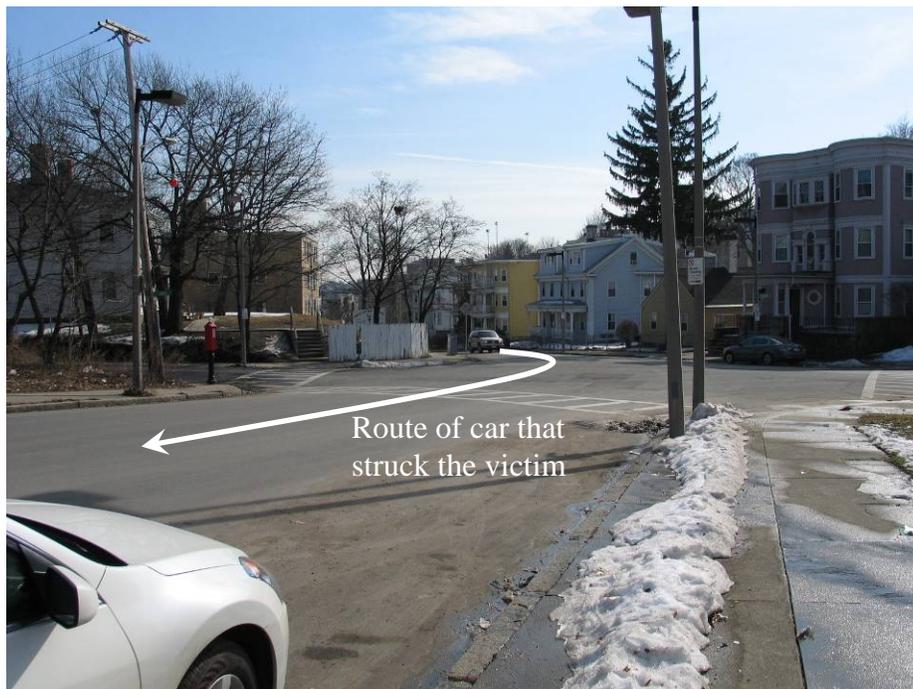
Prior to the incident the victim had finished crossing a group of students from the park location, eastward across the main road. Once the students were on the sidewalk, the School Traffic Supervisor stayed on the sidewalk with the students to attend to a student. When finished attending to the student the School Traffic Supervisor noticed that another student had crossed through the park and was at the edge of the roadway waiting to be crossed. The victim stepped into the crosswalk while signaling for all traffic to stop. The victim walked to the middle of the roadway within the crosswalk and the student started crossing. The victim then noticed a motor vehicle, a passenger car, traveling on the main roadway heading north towards the T-shaped intersection (Figure 3). This motor vehicle had previously turned right at the skewed four-way intersection onto the main roadway where the victim was positioned.

**Figure 2 – Skewed four-way intersection south of the incident location.**

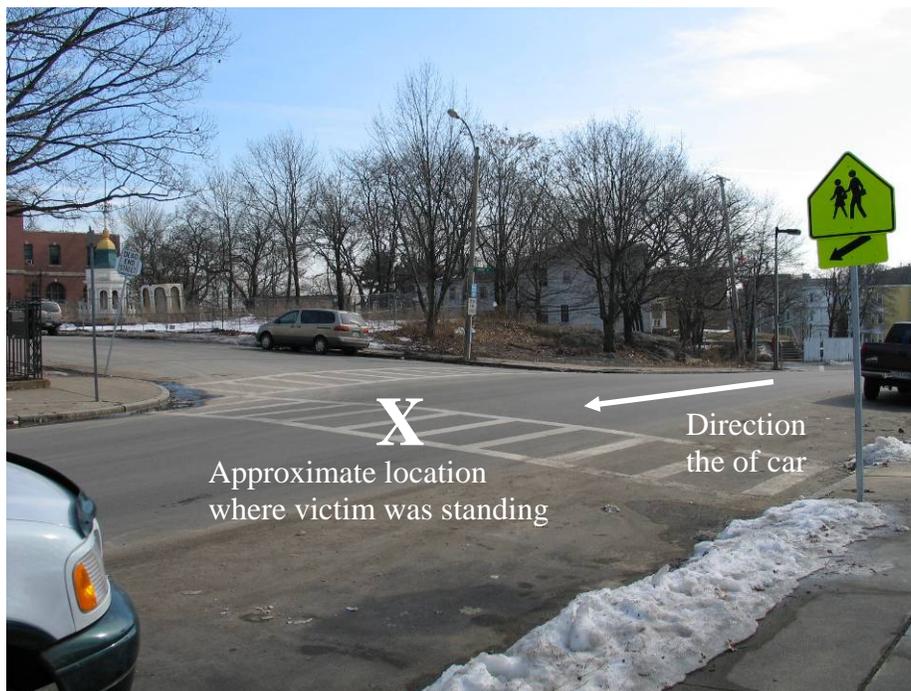
Since the incident, the city has installed three fluorescent yellow-green school crosswalk signs. One of the signs is located on the south side, facing traffic traveling west on the dead-end roadway toward the T-shaped intersection. The other two fluorescent yellow-green school crosswalk signs are located on the main roadway. One crosswalk sign faces traffic traveling north on the main roadway just beyond the intersection near the crosswalk where the incident occurred. The other faces traffic traveling south. Two of the three fluorescent yellow-green school crosswalk signs have the supplemental diagonal downward pointing arrow showing the actual location of the crosswalk. This combination of the two signs is called a school crossing sign assembly. The school crosswalk sign that does not have the diagonal downward pointing

arrow was the sign located on the main roadway facing traffic traveling north, the same direction the motor vehicle that struck the victim was traveling.

**Figure 3 – Incident location with a school crossing assembly sign added after the incident.**

As recommended by the Manual on Uniform Traffic Control Devices (MUTCD) the signs posted at school crosswalks should include the school crosswalk sign supplemented with a diagonal downward pointing arrow showing the location of the crosswalk (school crossing sign assembly).<sup>1</sup> In this case, a diagonal downward pointing arrow sign should be added to the fluorescent yellow-green school crosswalk sign on the main roadway facing motorists traveling north to make a complete school crossing sign assembly.

The MUTCD also recommends using school advance warning sign assemblies in addition to school crossing sign assemblies. School advance warning sign assemblies consist of two signs: a school crosswalk sign; and a supplemental "AHEAD" sign or a sign showing the distance until the crosswalk posted below the school crosswalk sign. School advance warning sign assemblies

should be posted in advance of the school crosswalk sign assemblies and facing traffic approaching the crosswalk from either direction.<sup>1</sup>
