## **Massachusetts FACE • Occupational Fatality Report**

### **Laborer Dies after Falling From an Aluminum Extension Ladder at a Residential Construction Site - Massachusetts**

Investigation: # 08-MA-042-01  
Release Date: June 4, 2010

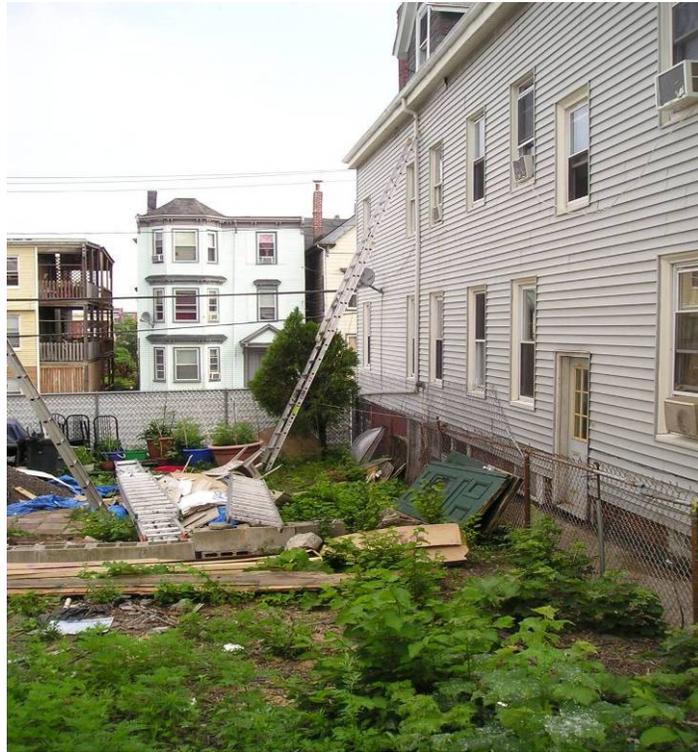
At approximately 5:00 p.m. the victim and the co-worker went to the neighboring house to start the repair (Figure 1). The right side yard property line of the three-family house they had been working on all day was the same property line for the backyard of the neighboring house where the piece of siding was going to be reattached. A chain link fence ran along this property line. The distance between the neighboring house and the chain link fence was approximately three feet. This entire three foot distance was a poured concrete pathway that ran along the rear of the house. The pathway led to the street and approximately five feet in from the street there were concrete stairs within the pathway.

**Figure 1 – Incident location with an extension ladder set up in a similar location as it was at the time of the incident.**

The section of vinyl siding that was loose was approximately six feet long and six inches wide. The piece was located in the middle of the back side of the house up at the roof's edge approximately 20 feet high (Figure 2). The victim and the co-worker brought a 32 foot aluminum extension ladder to the back of the house. The company owned this ladder and although at the time of the investigation, the company owner did not know the ladder's rating, it was reported that the ladder was one year old and in good shape. When setting up the ladder, the victim and co-worker positioned the base in the right side yard of the three-family to help angle the ladder. The ladder extended up and over the chain link fence, with the top of the ladder placed against the house just under the loose section of vinyl siding. The ground where the base of the ladder was positioned was a flat and grassy; the ladder was extended approximately 20 feet (Figures 1 and 2).

**Discussion:** In this case, it appears that a combination of ladder set up, including lack of stability accessories, and overreaching / overexertion from the ladder on which the victim was working, contributed to this incident. To minimize the hazard of falling from an unstable extension ladder, ladder stabilizers (also known as standoffs) should be used at all times. Ladder outriggers are also available and can help stabilize a ladder during use. In addition, following the procedures outlined below will help prevent falls from extension ladders.

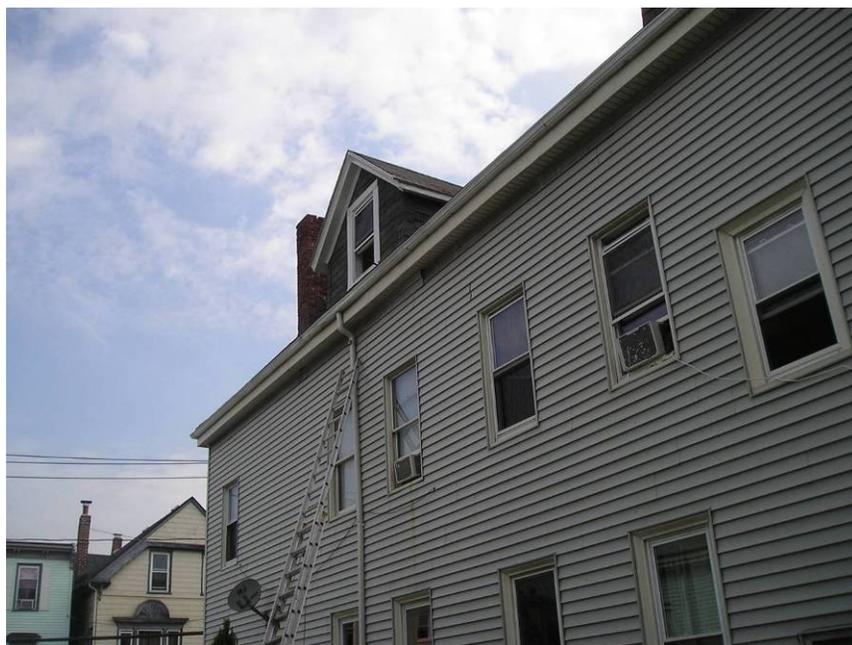
**Figure 2 – Neighboring house where the incident took place. Note the loose piece of vinyl siding to the right and above the top of the ladder.**

The victim grabbed some nails and a hammer and then climbed the ladder. He was not wearing a tool belt and was not carrying other tools in his pockets. The co-worker was holding the base of the ladder, which was reported as a common practice. Once at the top section of the ladder, near the location of the loose piece of vinyl siding, the victim placed the hammer into the house's gutter. While standing on the ladder, the exact rung is unknown, he leaned to the right side and using both hands, grabbed on to the loose piece of vinyl siding and pushed on the piece of siding towards the house in an upward motion. The victim lost his balance and fell off the ladder towards the right, falling approximately 20 feet to the concrete below landing on the concrete steps. The ladder fell towards the left also landing on the ground below.
