## **Massachusetts FACE • Occupational Fatality Report**

### **Municipal Laborer Dies after Falling Off the Back of a Forward Moving Refuse Collection Truck – Massachusetts**

**Investigation: # 09-MA-020-01**  
**Release Date: November 6, 2009**

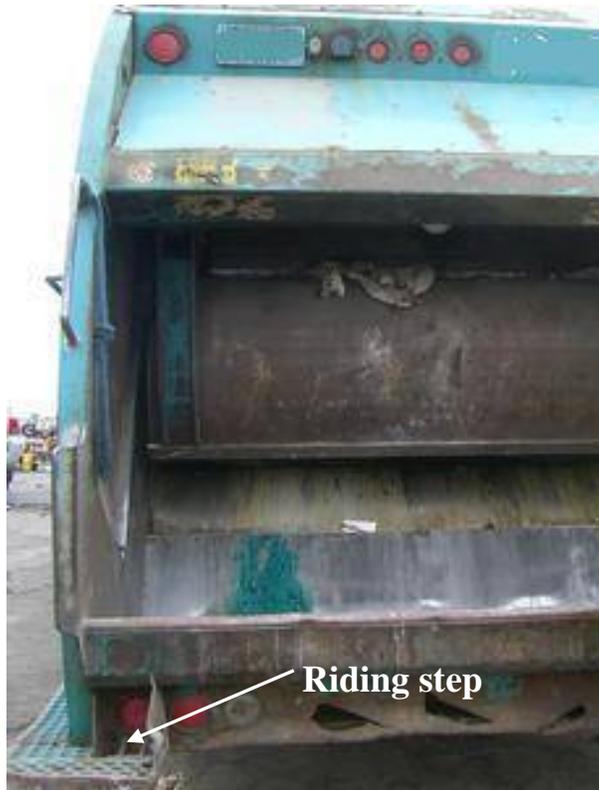
The truck involved in the incident is a cab-over design manufactured in 2001 with two bucket seats inside the cab. The truck's body is a rear loading compacting unit that was also manufactured in 2001. The truck is equipped with riding steps located on both the left and right rear sides of the truck (Figure 1). The riding steps start approximately two feet in from either side of the rear of the truck and wrap around the sides of the truck. Located at both rear corners of the truck are vertical grab handles. There are also horizontal grab handles located on the rear sides of the truck above where the riding steps wrap around from the back of the truck to the sides (Figure 1). On the day of the incident, the victim was working from the driver's side of the truck and the second thrower was working from the passenger side of the truck.

**Figure 1 – Truck involved in the incident.**

The city owns 22 trucks that are used for refuse collection. Sixteen of the trucks, including the truck involved in the incident (Figure 1), are packers and are used for trash collection; six trucks are recyclers used to collect materials to be recycled. Of the 16 packers, five are newer trucks and the cabs of these trucks seat three people. The remaining 11 packers are older cab-over style trucks where the cabs seat two people. The city has 12 collection routes on Monday and Tuesday, and 10 collection routes on Wednesday and Thursday. Friday is usually the scheduled maintenance day for the trucks, which is typically performed in-house. The city has collection routes that require both two and three man crews, with twice the number of routes that require the three man crews. The three man crews are made up of two throwers and a truck driver, compared to the two man crews that are made up of one thrower and one truck driver. It was reported that on average 18,000 stops per day are made between trash and recycling collection and over 200 tons of trash and 35 tons of recycling are collected each day. The throwers are part of a collective bargaining unit.

**Recommendation #1: Employers should ensure that employees are never located on refuse collection trucks' rear riding steps when the trucks are traveling faster than 10 miles per hour or traveling more than 0.2 mile.**

In this case, the victim and a co-worker were standing on the rear riding steps of the refuse collection truck as it traveled from one refuse pickup location to the next. Although, it appears that the distance between the two locations was less than 0.2 mile, the speed the truck was traveling was approximately 30 – 33 mile per hour, far faster than 10 miles per hour recommended by NIOSH. Employers should routinely state and enforce these rules for all work crew members, throwers and especially truck drivers.

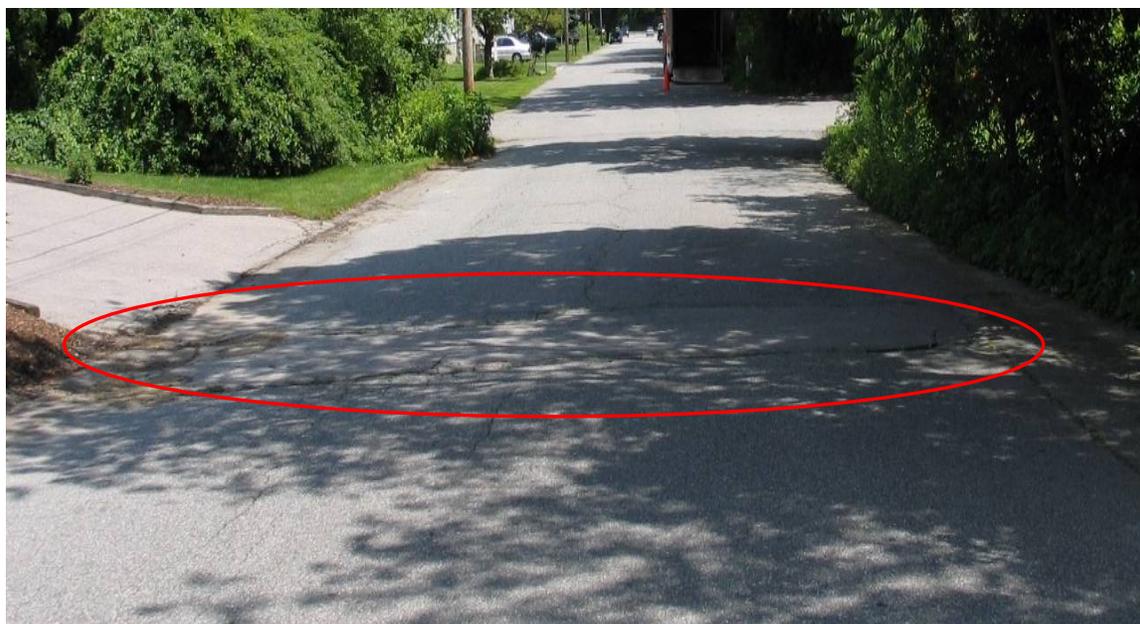
At the time of the incident, the roadway was dry and the temperature was approximately 50 degrees Fahrenheit. The roadway on which the incident took place is a non-divided two-lane secondary roadway paved with asphalt. The roadway is 29 feet wide and does not have markings that would distinguish individual lanes or the roadway edge. Traffic moves in the easterly and westerly directions with a maximum posted speed limit of 30 miles per hour. At the incident location, there is a slight rectangular depression in the roadway (Figure 2). It was reported that this depression is from a trench that had been dug across the roadway and patched with asphalt sometime during the 1990's. The depression is as long as the width of the roadway (29 feet) and eight feet wide.

Immediately prior to the incident, the two throwers placed refuse from a residence into the truck's hopper and climbed onto the truck's riding steps. The truck took off in an easterly direction for the next stop which was one of the next houses. While traveling to the next stop, the truck passed over the depression in the roadway. The depression caused the truck to bounce and it appears that this is when the victim fell from the truck. The co-worker on the back of the truck with the victim kept his grip/balance and did not see the victim fall off the truck. The truck driver reported that after traveling over the depression, he looked in the driver's side rear view mirror and observed the victim falling from the truck. As the victim fell from the back of the truck, the back of his head struck the roadway. The truck driver immediately slowed down and stopped the truck.

**Figure 2 – Location of the incident. Roadway depression is circled in red.**

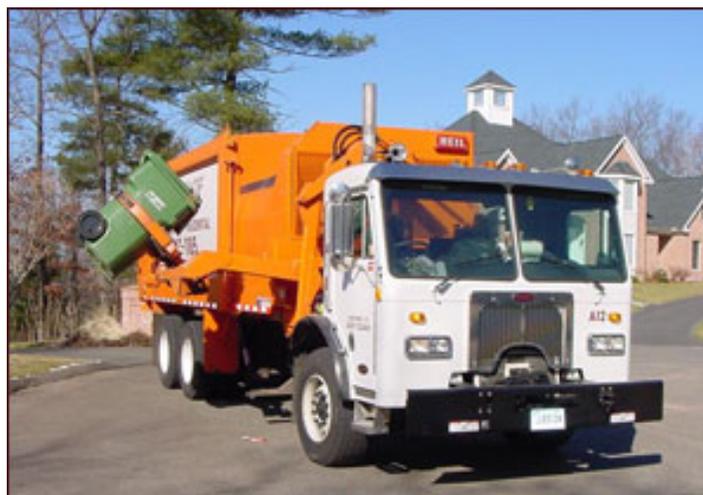
**Discussion:** In this case, the city was preparing to pilot an automated refuse and single stream recycling pilot program for refuse collection in four city neighborhoods. This program will implement the use of large wheeled carts (65-gallon and 95-gallon) that residents wheel to the street curb. Most collection trucks will have crews of two workers, including the drivers. The trucks will be newly purchased with or retrofitted with an automated arm that will hook onto the carts and dump the cart's contents into the truck's hopper (Figure 3).

**Figure 3 – Automated collection truck.**

Automated systems will reduce the need for workers to ride on the truck's rear riding steps and limit the amount they are lifting each day. As with all new processes, a complete hazard analysis should be performed prior to and during the implementation stages of this program.<sup>4</sup>
