## **Massachusetts FACE • Occupational Fatality Report**

### **Warehouse Worker Fatally Injured when Struck by Falling Metal Grates – Massachusetts**

**Investigation: # 09-MA-042-01**  
**Release Date: May 20, 2011**

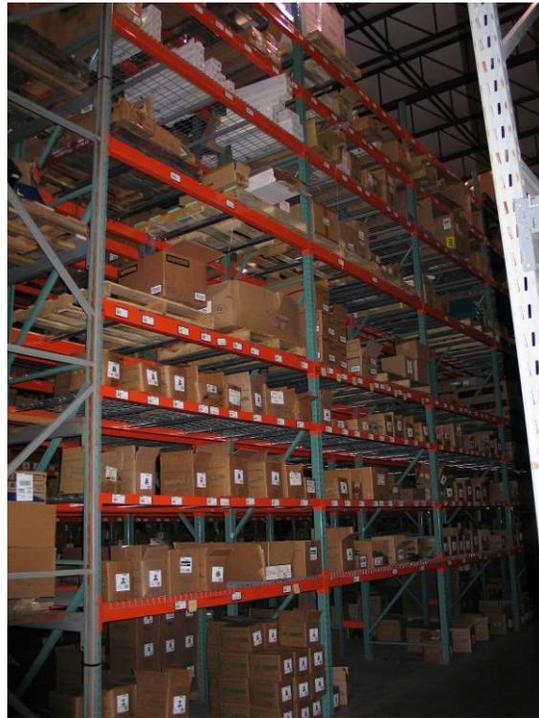
**Figure 1 – Warehouse rack system**

The company's main location, which is the location where the incident took place, has offices and a large warehouse. The warehouse section of the building is 63,000 square feet with a ceiling height of 35 feet. The company installed all new rack systems prior to moving into the new building. The company also purchased all new powered industrial trucks at this same time. The warehouse was set up with multiple rows of the rack systems. Some of the rows of the rack system had two rack systems against each other back to back with a one foot space, that the company representative called a flue. Other aisles had single rows of racks. The top levels of the racks were approximately 20 feet high. There were approximately seven levels within each rack section, although the number per rack did vary. Each level had either metal rack shelving or a number of cross beams intended to support pallets. Those levels with metal shelving had two grates approximately 46 inches deep and 42 inches wide. These grates could hold boxed or

loose materials or two standard 48 inch by 40 inch pallets side by side with some pallet overhanging the front or back of the shelf (Figure 1).

**Discussion:** The spare rack shelving was stored on the topmost shelf because the workers had not needed it since moving to the new warehouse. While it is efficient for warehouse operators to store infrequently used items in the least accessible space, it is important to ensure that all materials are stored safely and securely.<sup>1</sup> Many rack manufacturers recommend stringing netting, cables, or gates across the front of rack bays to prevent falling materials, whether they fall as the result of fork trucks striking the rack system, shifting over time from vibration, or, in this case, direct impact.<sup>2,3</sup> This restraint method should not be used in lieu of proper product bundling and inventory monitoring, but can further prevent materials from falling.

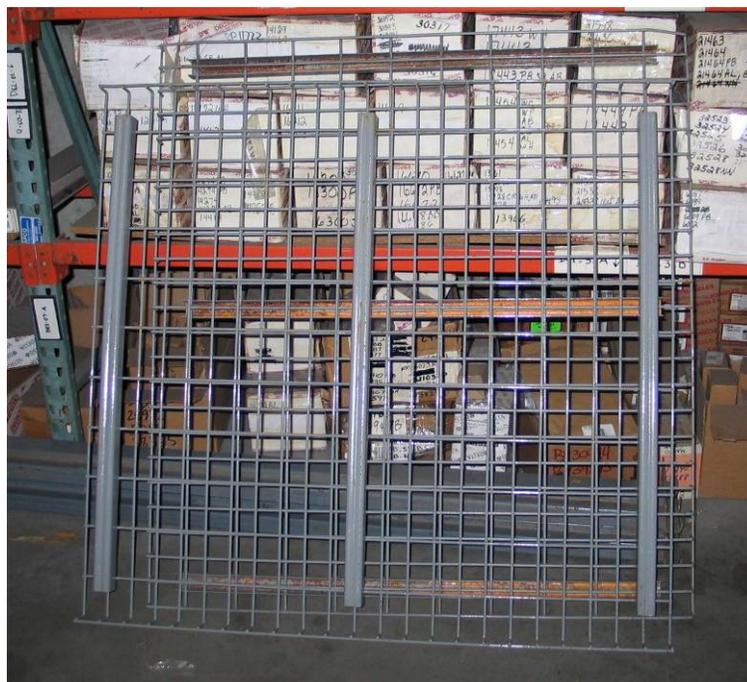
**Figure 2 – The older metal rack grates**

The company also brought some of their old rack systems with them from the previous building location to the new building for potential future use. Prior to the incident, the company had set up a few of the old rack systems to prepare for the arrival of product from their out of state subsidiary distribution warehouse that was being closed. Not all of the older rack systems were used, and 14 metal grates from the old rack system remained stacked on a pallet with plastic wrapped around them. This pallet had been stored on the top shelf of a new rack since the company moved into the building (Figure 2 - shows two of the older metal grates).
