2. Summary of Current Conditions

This chapter summarizes existing conditions at Trailside, to help frame the issues, program, and design recommendations addressed in Chapters 3 and 4. Much of the information contained here was presented in greater detail as the Master Plan Phase 1 submittal: Summary of Findings. The complete building inventory and evaluation has been updated and is included as Appendix A. For brevity, Appendices included in the Summary of Findings, such as American Zoological Association (AZA) standards and cultural resource documents, are not contained in this Master Plan. The site and building inventory for this section was conducted in Summer 2007, so a few site conditions have changed with the ongoing installation of the NSTAR exhibit, accessibility improvements, new fencing and relocation of program animal holding structures, and the picnic area.

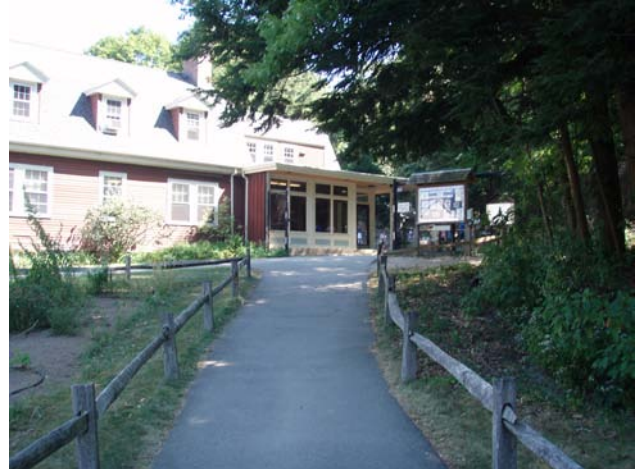
Many of walks and paths at Trailside currently exceed the five percent (5%) threshold for accessible walks. Additionally, the surface material of many of the paths does not meet the recommendations of the ADA, which does not recognize loose gravel as a universally accessible surface treatment. For universal access, acceptable walking surfaces are stable, firm, and slip-resistant, with the exception of those walks within animal containment areas.

View up the steep path leading from the south parking lot to the existing Museum building entrance and outdoor exhibit area (Pressley Associates, 2007).

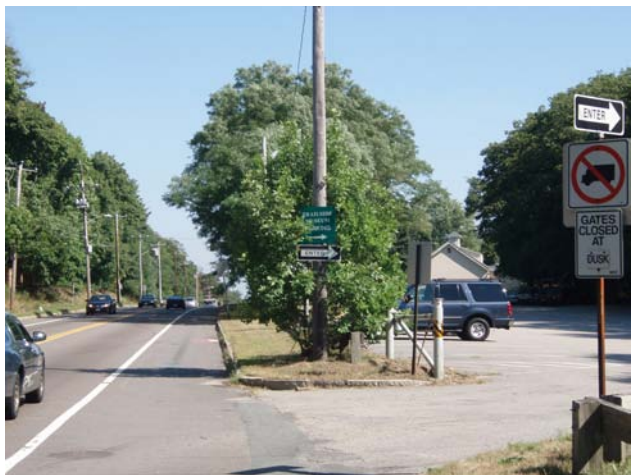
Entrance to the south parking lot, note the small green parking sign at the center of the image (Pressley Associates, 2007).

Service access to the Trailside Museum building is facilitated by a bituminous concrete walk/drive that extends perpendicular to Canton Avenue along the south side of the building. Service access to all of Trailside's facilities interferes with the visitor experience, creating an unsafe condition, and parked maintenance and program vehicles (at the garage) present a visual intrusion in the exhibit area. No loading or unloading zone for cars, vans, and/or school busses is provided. Given the large visitation by school groups, the addition of a loading zone may both increase visitor safety and benefit the entrance and arrival experience.

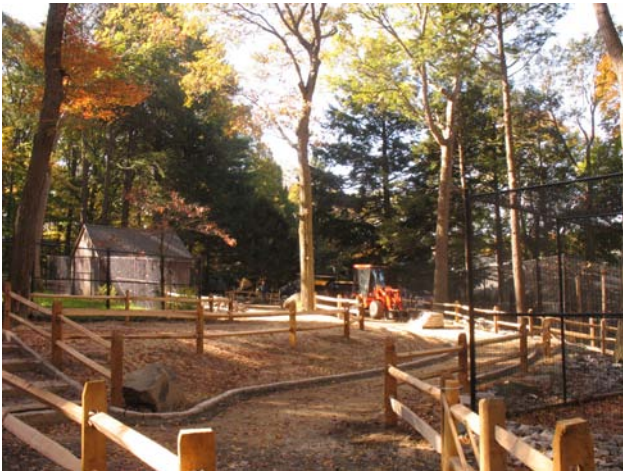
New path under construction within the animal enclosure area (Pressley Associates, 2008).

the 2008 site improvements are complete, the exhibit area will contain an elongated inner loop of compacted stonedust, most of which is accessible, with spur trails connecting to specific exhibits, pond, and picnic area. From the Museum entrance, the River Otter exhibit serves as the focal point of the animal enclosures; from there, visitors can explore the outdoor live animal exhibits, principally turtles, Snowy Owl, White-tailed Deer, and Red Tailed Hawks, with new Rocky Outcrop exhibit for Red Fox and a new fenced enclosure for Turkey Vulture.² Although some wide granite steps have been added to connect portions of the exhibit paths at varying elevations, overall the improvements create accessible viewing to most of the enclosures and are a enormous improvement to the site.

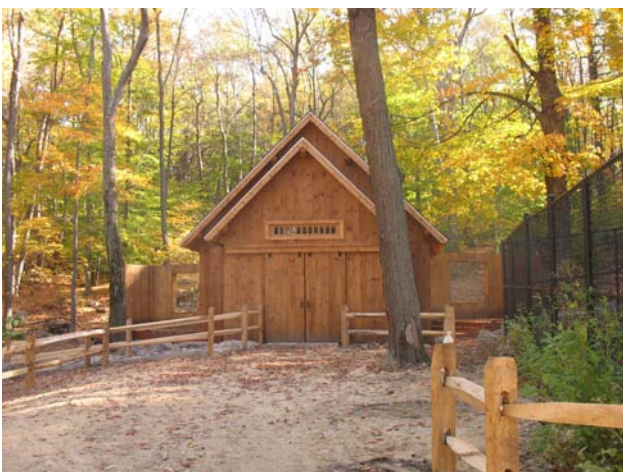
New NSTAR Rocky Outcrop exhibit, nearly complete (Pressley Associates, 2008)

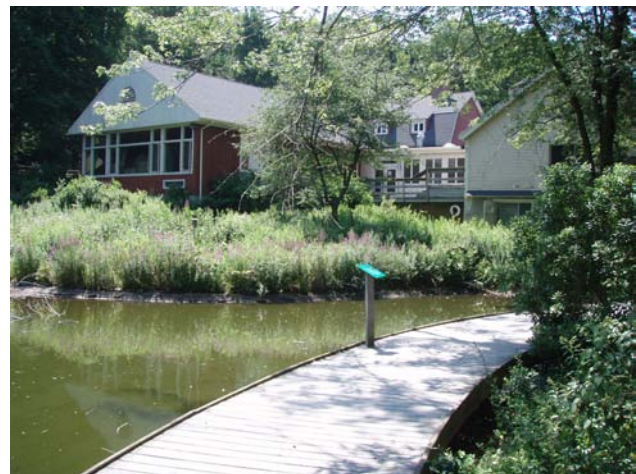
Five (5) small green signs, located around the pond, provide interpretive information about the pond ecosystem. Two of these signs, however, are faded beyond legibility. Informational signs at both entrances to the pond walk provide additional information and identify the donors who contributed to the construction of the walk. Locking split-rail gates at each entrance restrict access to the pond.

Northern side of the existing Trailside Museum building from the synthetic wood boardwalk, note the faded green interpretive sign (Pressley Associates, 2007).

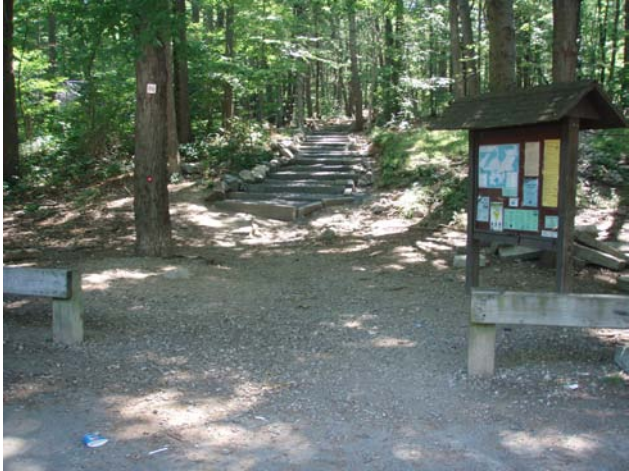
Informational sign and Red Dot Trail entrance at the south parking lot (Pressley Associates, 2007).

The Red Dot Trailhead, which is the most popular trail in the Blue Hills Reservation leading to the summit of the Great Blue Hill and to the Blue Hill Observatory, is located in the south parking lot. The trailhead has both an informational board and directional signs at its entrance. However, the entrance to the trail is partially obstructed by parked vehicles. A set of new granite stairs with stone dust treads in good condition begins the

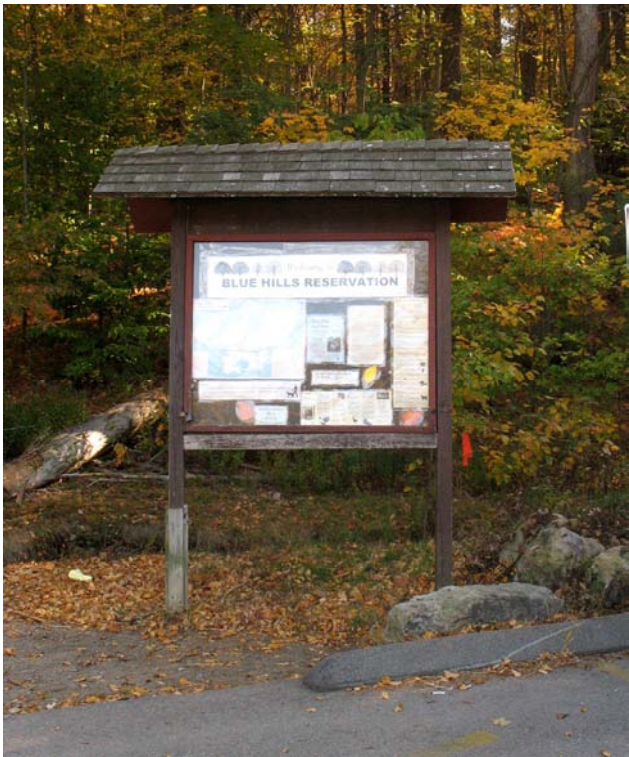
Existing kiosk at the entrance to the Wolcott Path at the north parking area (Pressley Associates 2008).

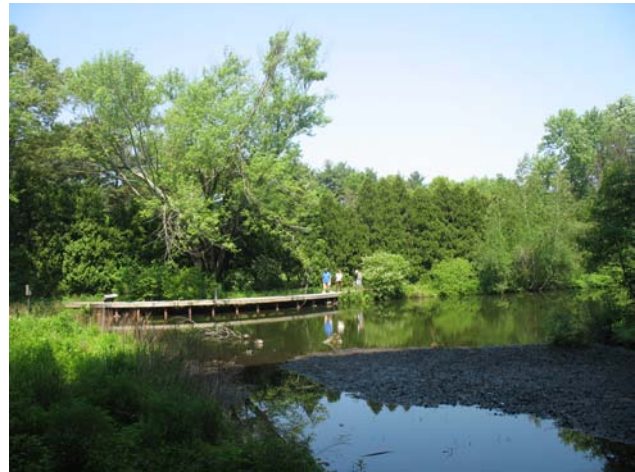
Westerly view of the pond showing the boardwalk (Pressley Associates, 2007).

The pond was constructed in 1960 with an asphalt bottom to ensure retention of water, and is approximately point four five (.45) acres in size. The man-made pond is dependent upon rainfall to supply it with water, with some water channeled down the slope in the existing drainage swales. During dry spells, the bottom of the pond is exposed along the eastern side. Discharges from flushing and cleaning of the River Otter and turtle enclosures flow into the pond along the east side.

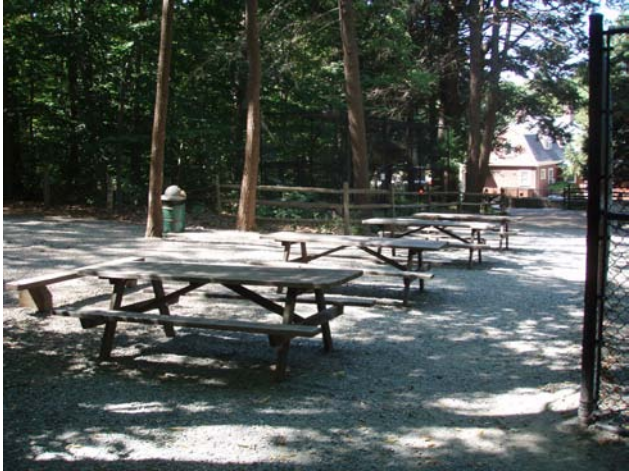
Site furnishing at Trailside are minimal. Four (4) wooden picnic tables were located in 2007 near the White-tailed Deer enclosure, along with two (2) trash receptacles and served as the eating/picnic area for Trailside. The furnishings were in good condition, located in the shade of mature trees. Four (4) brown painted wooden benches, located around the Turtle enclosure, are another popular location for resting and eating at Trailside. The benches are in fair condition and in need of a fresh coat of paint.

Wooden picnic tables in the loose gravel area adjacent to the White-tailed Deer enclosure, prior to 2008 improvements (Pressley Associates, 2007).

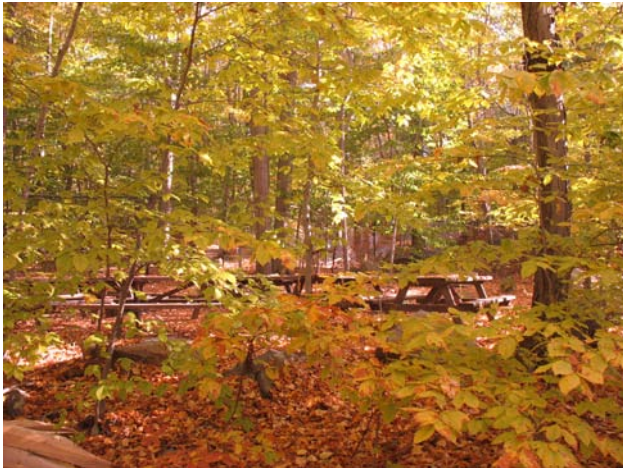
New picnic area under development on the north side of the outdoor exhibit area (Pressley Associates, 2008).

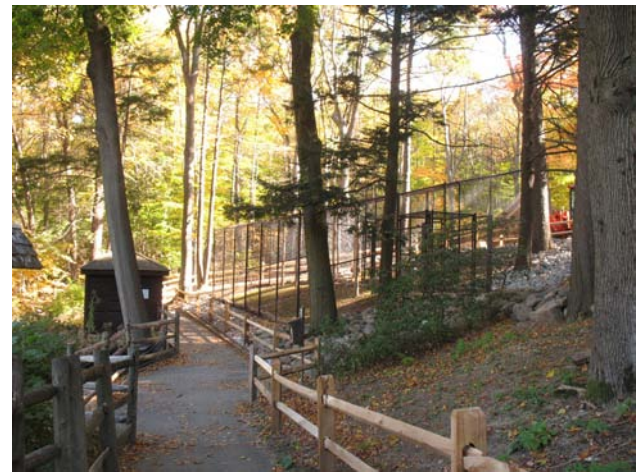
Split-rail fences border many of Trailside's walks and paths, including portions of the walk from the south parking lot to the entrance to the Trailside Museum building, the entrance path from the north parking lot to the Trailside Museum building, and visitor paths within the outdoor exhibit area. In general, the split-rail fence is in good condition, with many new segments added in 2008.

Section of new and old split-rail fence on the path above the pond, between the duck blind and Turkey Vulture enclosure (Pressley Associates, 2008).

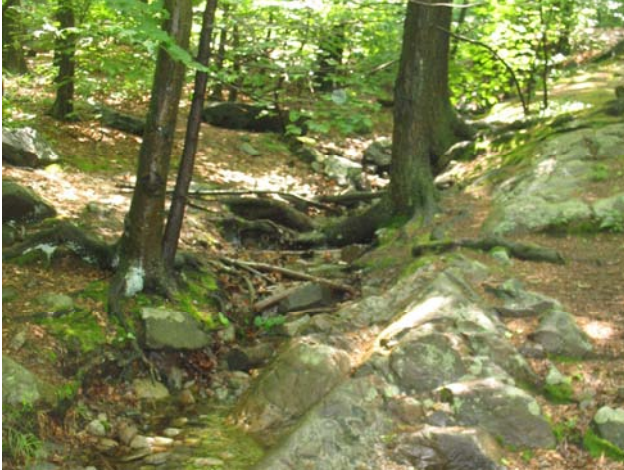
Rocky outcrop and stormwater drainage swale at the Trailside Museum (Pressley Associates, 2007).

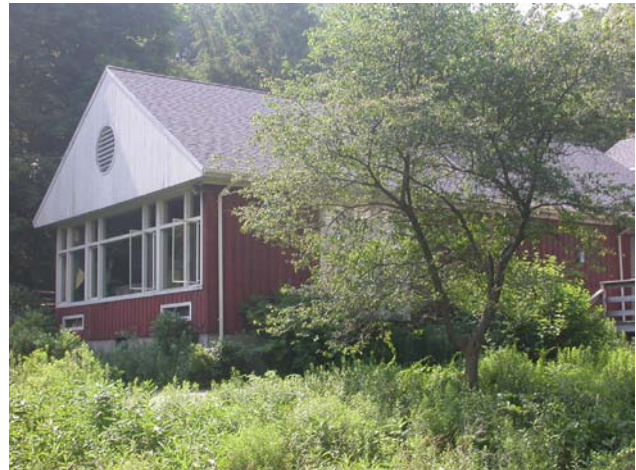
The Exhibit Wing is a single large hall with a vaulted ceiling under a gable roof. The major floor beams are steel and the roof beams are laminated wood, with the remainder built in ordinary wood construction on concrete foundations. It has large windows at the north end, overlooking the pond. Below the hall is a dirt-floored crawlspace currently used for storage. Nearly half of the exhibit hall has a raised floor level, built above a single structural floor deck.

View of the Exhibit Wing from the pond boardwalk (Schwartz/Silver Architects, 2007).

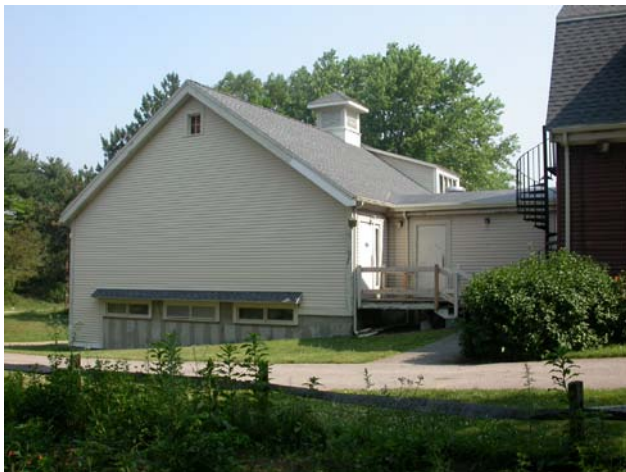
Trailside Museum Lecture Wing from the approach walk (Schwartz/Silver Architects, 2007).

The Lecture Wing contains a single large hall on the first (public) level, a staff wood shop and animal care facility at the lower level, and a storage loft above part of the main hall. The structure is concrete block clad in wood, with major columns made from complete tree trunks and major beams of sawn and laminated timber. The lower level has a slab on grade with walk-out openings to the boardwalk along the pond. The exposed wood and vaulted ceiling give the main hall a somewhat rustic character, which is compromised by the low level of daylight in the room except for a single large window overlooking the pond.

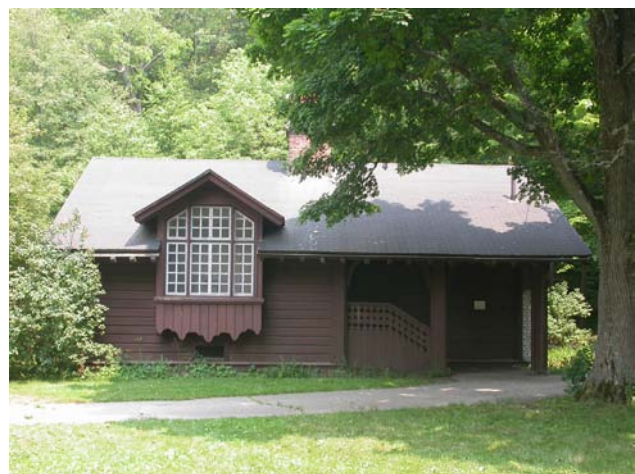
The historic "Sanitary", designed in 1904 by Stickney & Austin, stands outside the outdoor exhibit area, at the south end of the north parking lot beyond the perimeter fence. The building was erected as a roadside convenience, and designed in a rustic chalet style with dark-stained wood ornament, projecting square windows and deep roof overhangs.

Historic Stickney & Austin-designed "Sanitary" known as the Canton Ave. restroom building (Schwartz/Silver Architects, 2007).

The Canton Ave. Restroom is being rehabilitated in 2008, with accessible restrooms added to the east side and heat so it can now be used year-round. It is the only designated historic resource at Trailside.

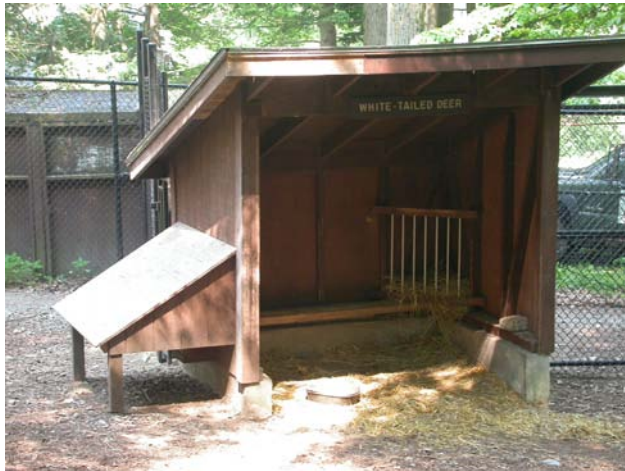
These are simple wood structures directly related to live animal exhibits, holding areas, or viewing of animals. They are in good condition but their disposition in any future project should follow from the requirements of new or renovated exhibits. The 2008 improvements to the outdoor animal enclosures consolidated the functions of some of the smaller structures, such as the holding areas for program birds.

Deer shed (Schwartz/Silver Architects, 2007).

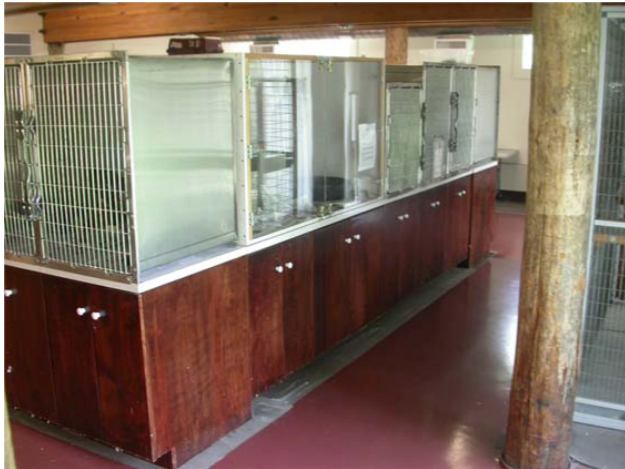
Animals going out for off-site programs have a circuitous path that takes them through public areas and up narrow outdoor stairs.

Program animal holding cages (Schwartz/Silver Architects, 2007).

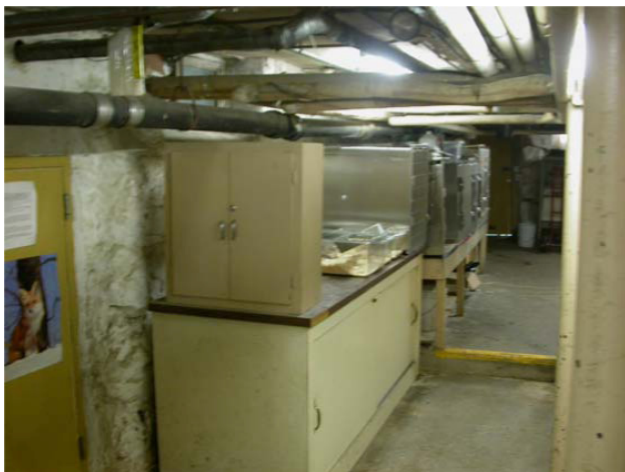
This space has no apparent heating or cooling capability. There is a (undersized) window mounted ventilation fan (that is currently inoperable) that would exhaust air and odors into the main entry plaza. There are multiple electrical extension cords and jerry-rigged lighting fixtures that are suspect. This area is filled with cages and counters for kennels and crates wherever possible. There are also aquatic tanks for turtles. The reptiles are kept in the furnace room adjacent to the quarantine area, so they get the necessary heat during the heating season. In 2007, the poisonous snakes that were not on exhibit were also housed in the furnace room, but they have since been moved to either the animal care area or the upstairs exhibit hall.

Animal quarantine area (Schwartz/Silver Architects, 2007).

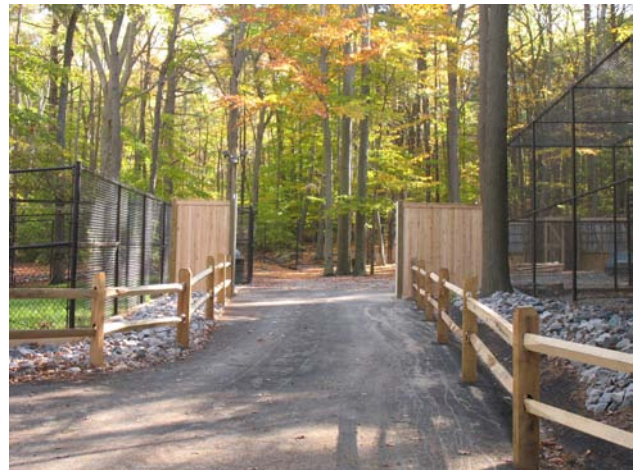
The White-tailed Deer enclosure is located within small area with several native trees. Compaction and erosion are evident and the health of the trees will soon begin to suffer. At the time of the site inventory in Summer 2007, a male White-tailed Deer was in residence in the enclosure. Two (female) fawns, born in May 2008, are currently in quarantine at Trailside pending their move into the new enclosure. The interior of the enclosure was planted with grass, which was thriving in Fall 2008.

New fencing for deer enclosure (right) (Pressley Associates, 2008)

These animals could use a much larger and more interesting enclosure as they require much more enrichment opportunities than this exposed site. The exhibit fence existing in 2007 was of the proper height, but it is also quite obvious on all four sides and all views are through the fence.

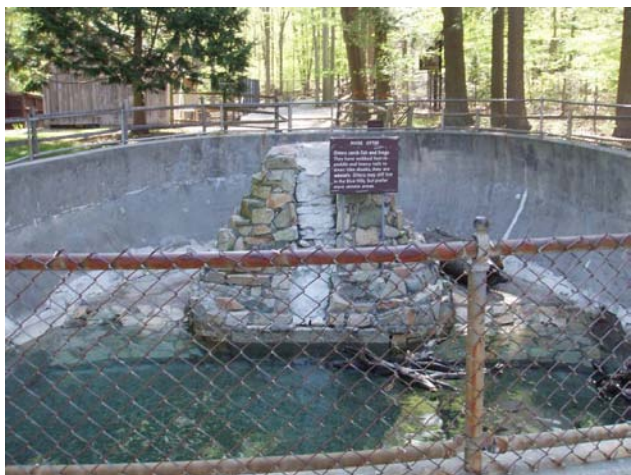
The River Otter is a great exhibit animal for Trillside, yet this exhibit is quite poor. The exhibit currently houses a single female River Otter. The exhibit consists of a very small circular pool with a large composite rock feature in the center. When the animal is in the pool it is eight feet to ten feet (8'-10') below viewing elevation with a rusting short chain-link fence surrounding the enclosure. The visitors can view from three hundred sixty degrees (360°). Together with the viewing angle, this exhibit has psychological and behavioral implications for the Otter. The redeeming feature is the central rock, which provides appropriate level viewing, yet creates a dangerous place for keepers to access and clean properly.

The water is non filtered and must be dumped and refilled as necessary, which is a waste of water and may result in poor water quality for an animal that spends a large portion of the day swimming. The water is quite shallow and doesn't provide enough enrichment or educational opportunities for this great species.

Existing River Otter exhibit (Pressley Associates, 2007).

There are no soft substrates for digging and fur maintenance, or any live plants. There are small deadfall elements, which are useful for the River Otter to interact with.

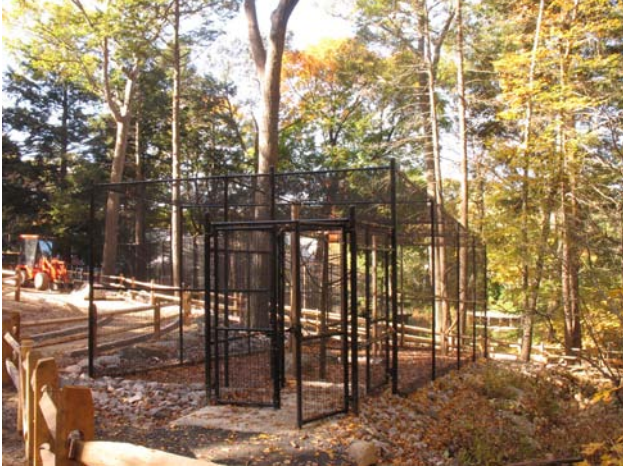
In 2007, the owl and hawk cages lacked secondary containment with a single keeper service gate. This problem was solved in 2008 with the new fence enclosures, which have an additional vestibule and are constructed of plastic-coated wire mesh to prevent rust. The new enclosures are also larger.

New fence enclosure with vestibule for Red-tailed Hawks (Pressley Associates, 2008).

Ultimately, a new set of exhibits should be planned if there is a desire to maintain these species in the collection. Alternatively, proper raptor mews can be built in association with an outdoor amphitheater for flight demonstrations and educational talks if there is a desire and skill set to accomplish this highly educational form of display.

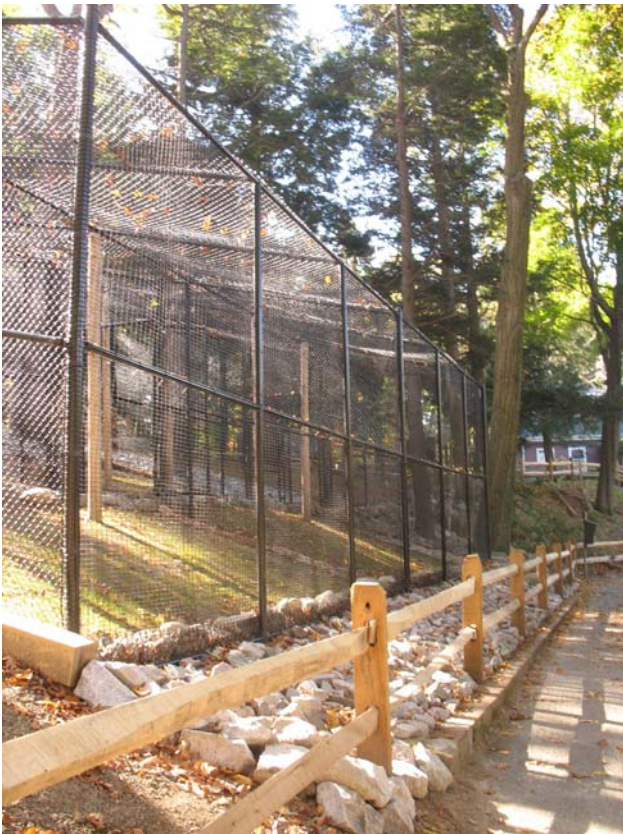
New enclosure for Turkey Vulture (Pressley Associates 2008).

In 2007, the abandoned fox exhibit was empty and its wire fence was rusting so badly that it was unfit for animals. Subsequently, DCR did remove the enclosure and replaced it with a new fenced enclosure, with vestibules, which will be used for the Turkey Vulture exhibit. This exhibit has a suitable visitor barrier and can be viewed both from the upper and lower paths within the outdoor exhibit area. The new Turkey Vulture enclosure, has space for two separate exhibits and a Common (Northern) Raven may be added to the second enclosure.

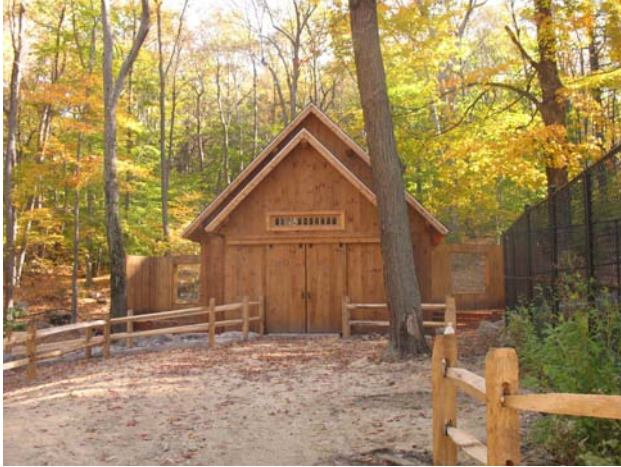
New Rocky Outcrop Exhibit building (Pressley Associates, 2008).

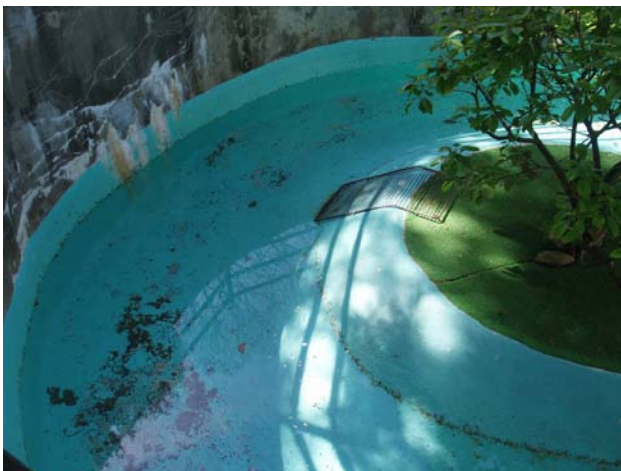
The Turtles must be taken off exhibit during the long winter months and during the summer they are brought in and out daily because of theft in the past.

Existing Turtle exhibit (Pressley Associates, 2007).
