IL17 Nantucket Eelgrass Restoration
2024 Post-Planting Assessment Report
Nantucket Land & Water Council

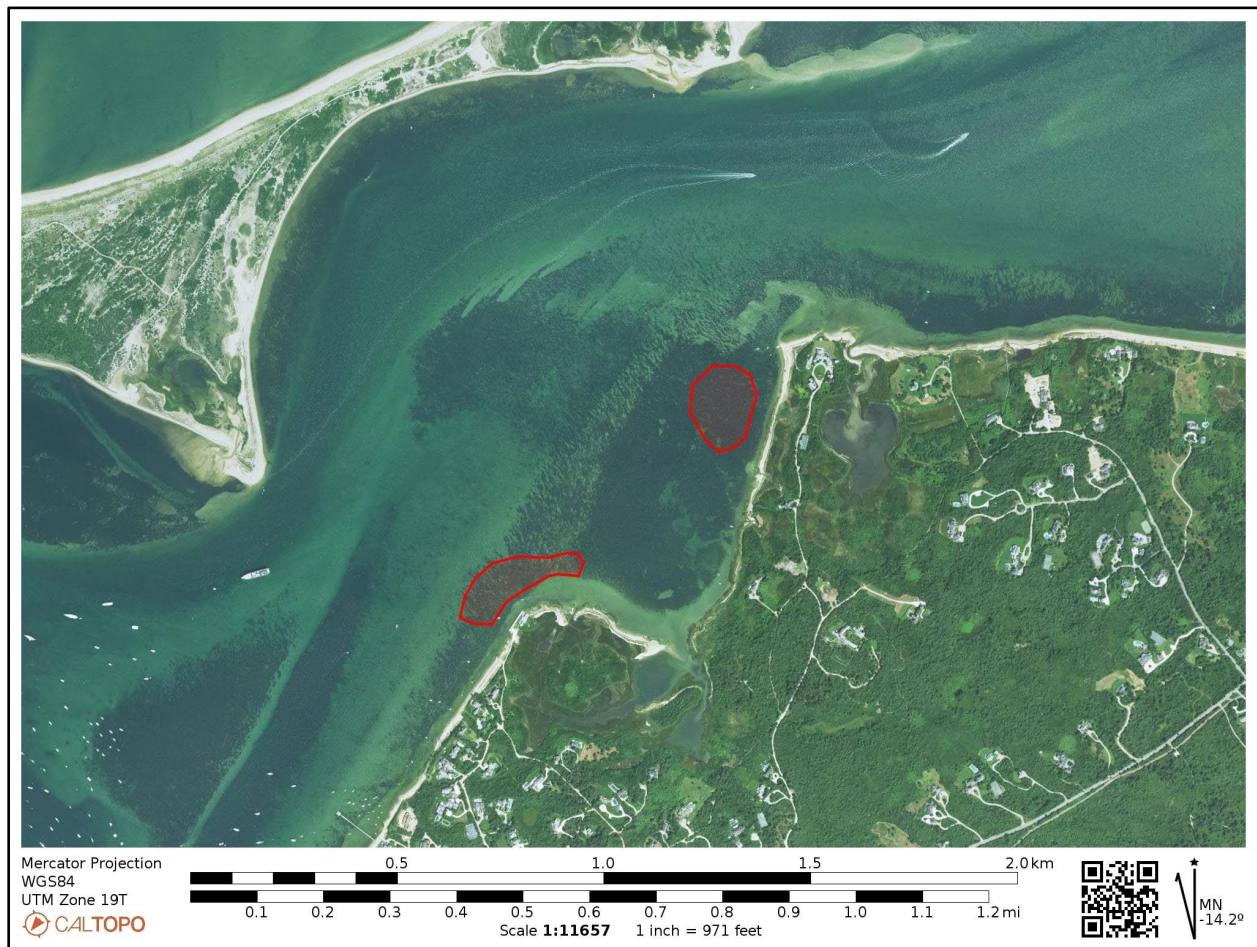
Figure 1. Map showing harvest location for *Z. marina* reproductive shoots.

The main focus for the summer of 2024 was the collection of eelgrass (*Zostera marina*) reproductive shoots for the extraction of seeds. Reproductive shoots were collected from Pimney's Point and Shimmo Creek from June 7th to June 13th (Figure 1). Snorkelers harvested the shoots from the base directly above the rhizome to maintain the integrity of the subsurface root structure. In total, 25,678 shoots (~950,000 seeds) were collected.

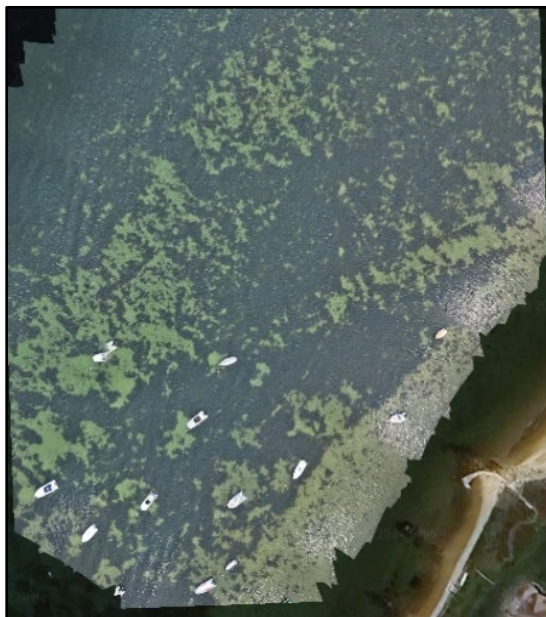
Throughout the summer of 2024, surveys of the Monomoy restoration site (Site A) showed a success rate of around 90%. Seeds and transplanted shoots have taken root at the bottom (Figure 2). The height of the bed ranged from 28-45 cm throughout the site, with densely growing shoots. The bed has also extended well beyond our restoration plot and is approximately 1.5 acres in extent.

Figure 2. Drone images of Monomoy restoration site. August of 2024 (Left) and July of 2022 (Right).
