I-90 ALLSTON INTERCHANGE A MULTIMODAL TRANSPORTATION PROJECT

Task Force Meeting
June 3, 2021

February 2021 Bridge Inspection - Methods

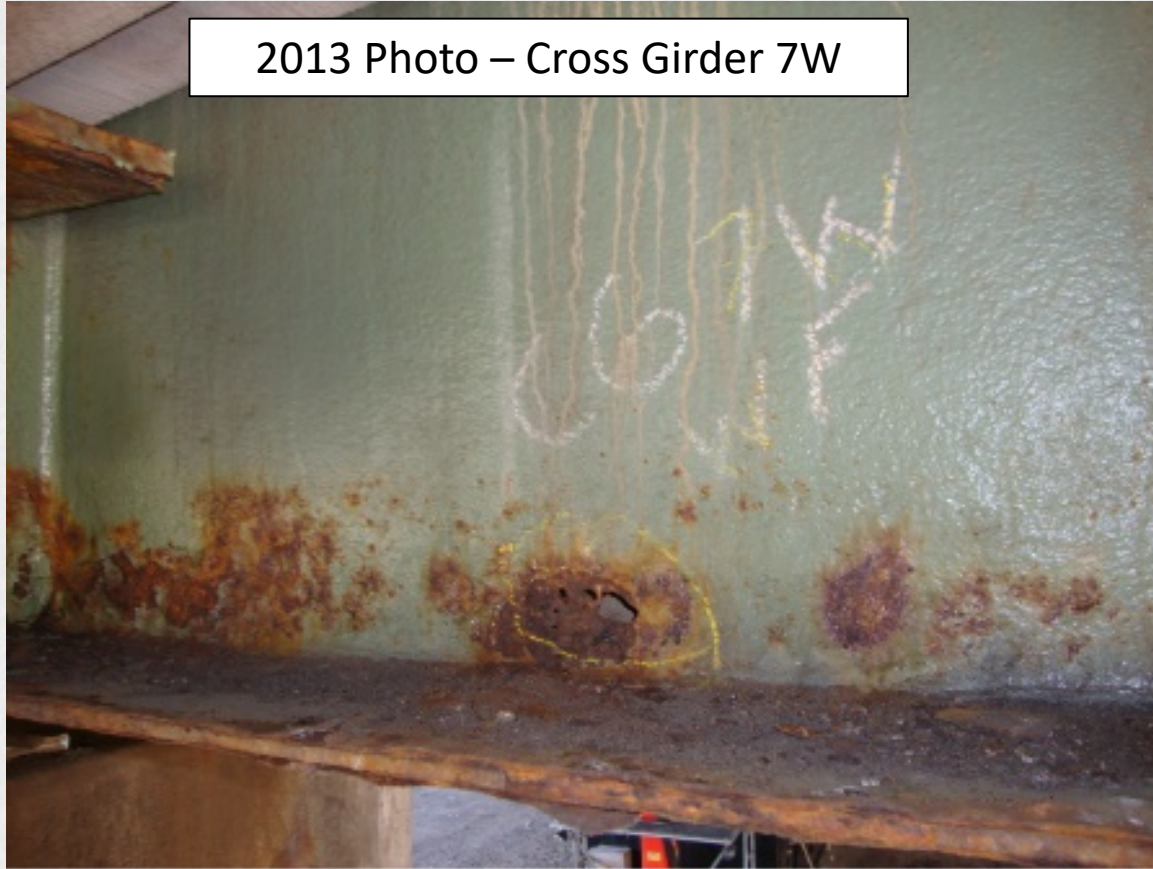
2013 Photo – Cross Girder 7W

Note the change in section loss on the steel at this same location over the past 8 years in these 2 photos

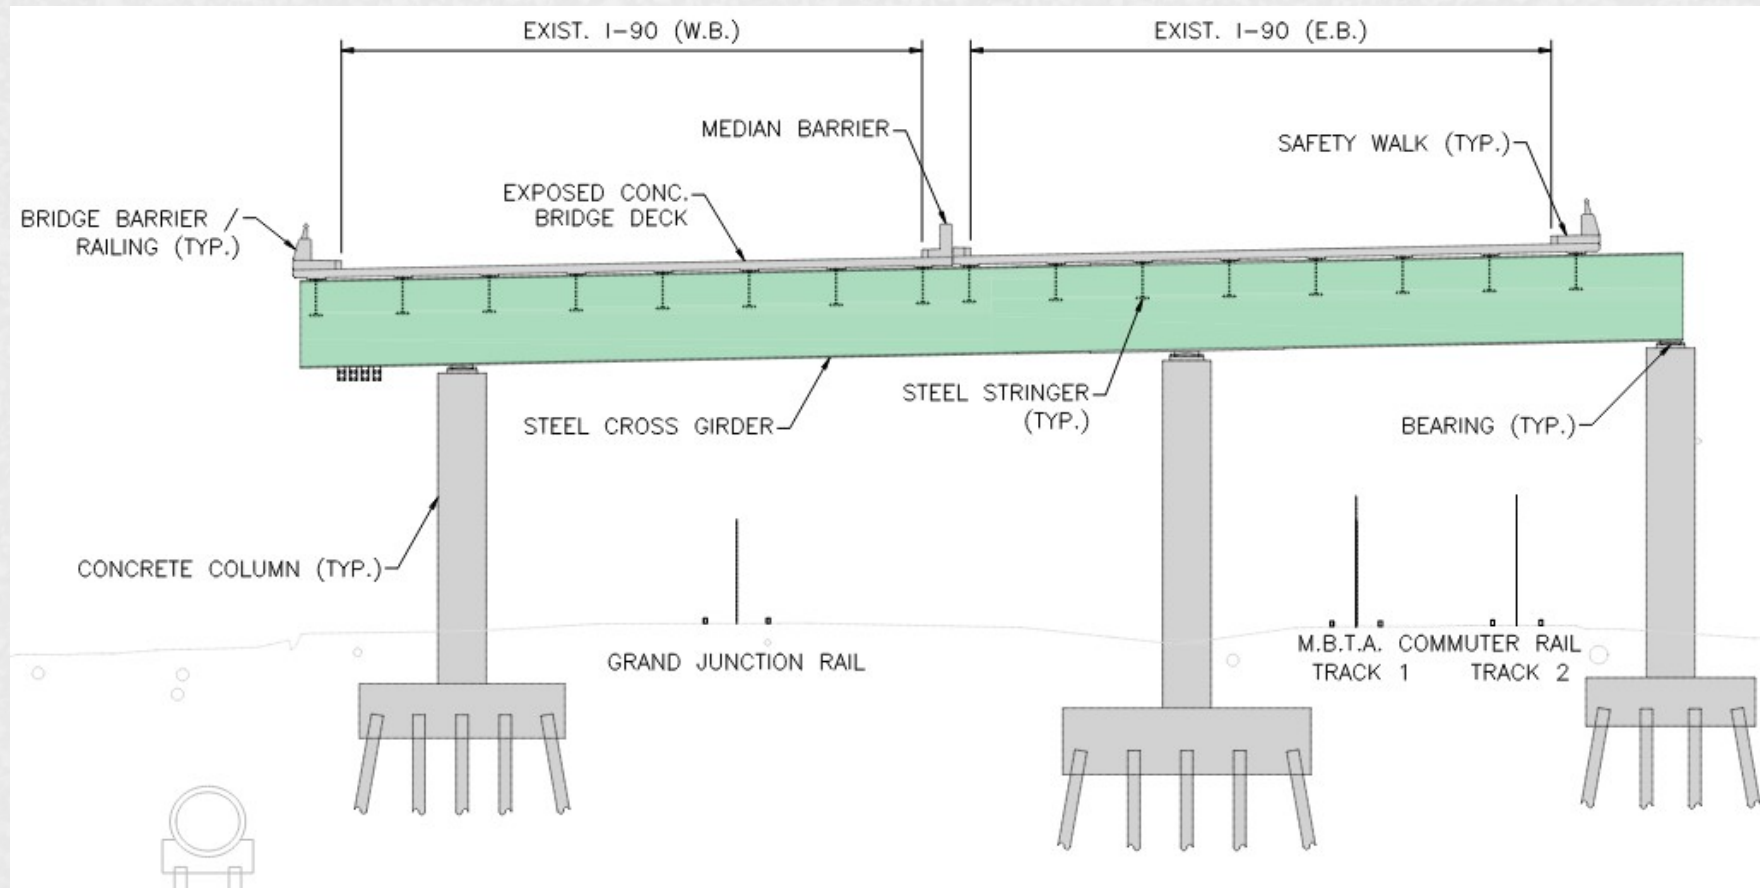
- **Typical Viaduct Configuration:**
 - **Concrete Deck & Railings supported by Steel Stringers supported by Steel Cross Girders supported by Concrete Columns and Foundations**

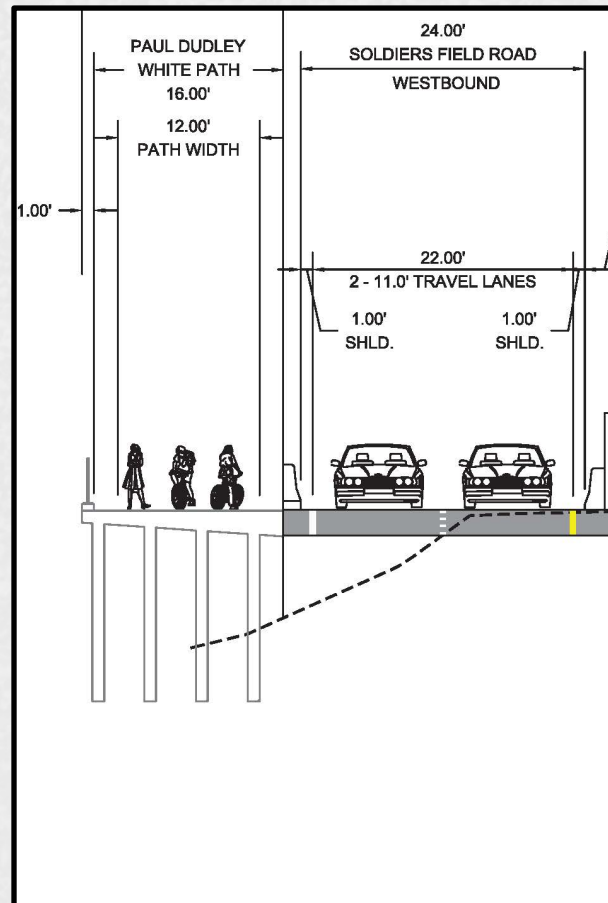
Scoping Summary Report

- Modified At-Grade Option includes refinements resulting from additional stakeholder engagement since publication of the Scoping Summary
