IDENTIFYING LOCATIONS FOR EELGRASS HABITAT RESTORATION IN THE ANNISQUAM RIVERAnthony R. Wilbur¹, Phil Colarusso², Tay Evans³, and Dave Sargent⁴

¹ Massachusetts Office of Coastal Zone Management, Executive Office of Energy and Environmental Affairs, Commonwealth of Massachusetts, Boston, Massachusetts

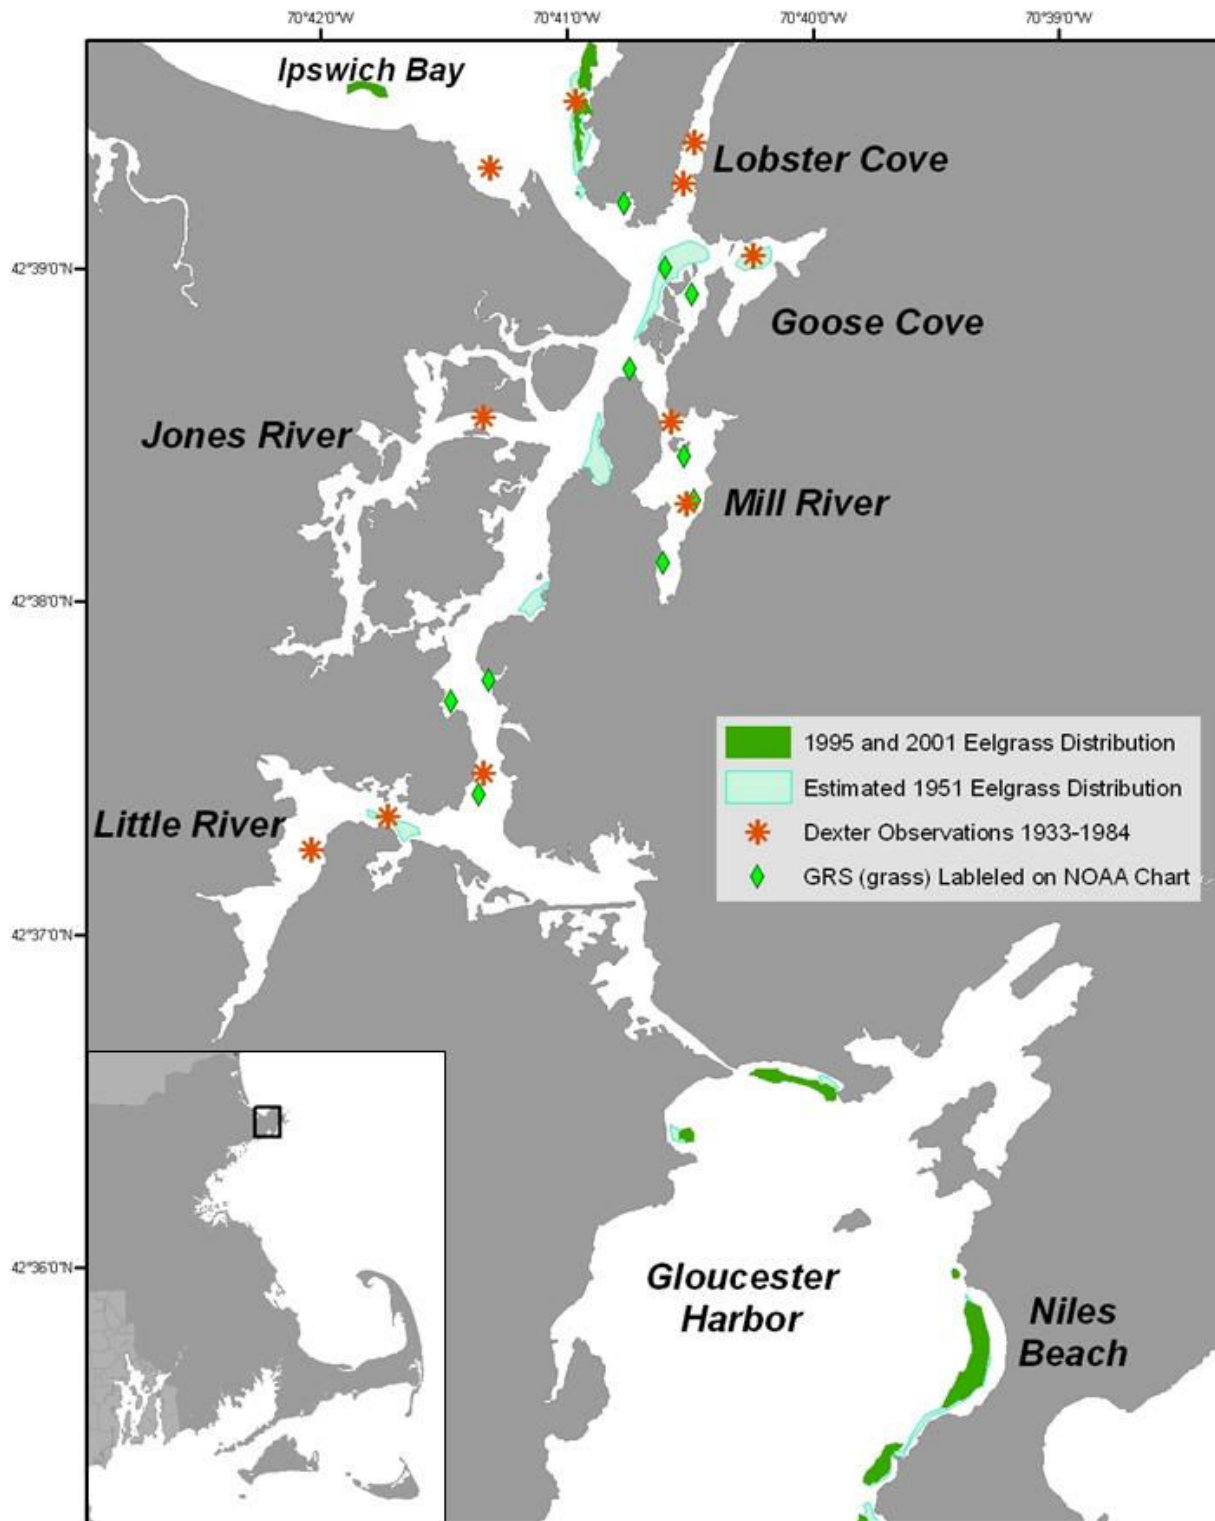
Figure 1. Study area map, showing the current distribution of eelgrass in 1995 and 2001 mapped from aerial photography (MassGIS 2006), estimate of presence of eelgrass in 1951 mapped from historical aerial imagery (light blue polygon; Costello personal communication), observations from 1933-1984 (Dexter 1985), and NOAA nautical chart GRS labels.

and anecdotal evidence. Addy and Alyward (1944) documented the presence of eelgrass in the Annisquam River in 1943, and Dexter (1985) monitored eelgrass around Cape Ann from 1933 to 1984. These accounts indicate that eelgrass recovered from the wasting blight after the 1930s and was broadly distributed throughout the Annisquam River (Figure 1).

The Annisquam River is located in northern Massachusetts Bay and connects Gloucester Harbor to Ipswich Bay. Eelgrass was mapped by the MassDEP along the north shore of Massachusetts in 1995 and 2001 (MassGIS 2006; Figure 1). There are also records of the historic presence of eelgrass in the Annisquam River available from 1951 aerial photography (Costello personal communication), an eelgrass monitoring study from 1933-1984 around Cape Ann (Dexter 1985), and “GRS” marks – meaning grass and interpreted as submerged vegetation – on NOAA Nautical Chart 13279. Mapping data and anecdotal information provided an indication of the current and historic occurrence of eelgrass (Figure 1).

Eelgrass was historically found throughout the Annisquam River but is now largely absent and limited to waters north of the Annisquam River (Figure 1). Eelgrass beds north of the Annisquam River appear stable, and the discovery of eelgrass throughout the shallow waters of Ipswich Bay indicate that a source of viable seeds and fragmented reproductive shoots should be available to the Annisquam River. While fragmented reproductive shoots can contain and disperse viable seeds over long distances (Harwell and Orth 2002), seeds released within beds quickly sink to the seafloor (Orth et al. 1994). Eelgrass has not recovered in the Annisquam River and it is unknown if seeds or fragmented reproductive shoots are sufficiently abundant and transported from these northern waters to locations that are suitable for survival and growth in the Annisquam River.

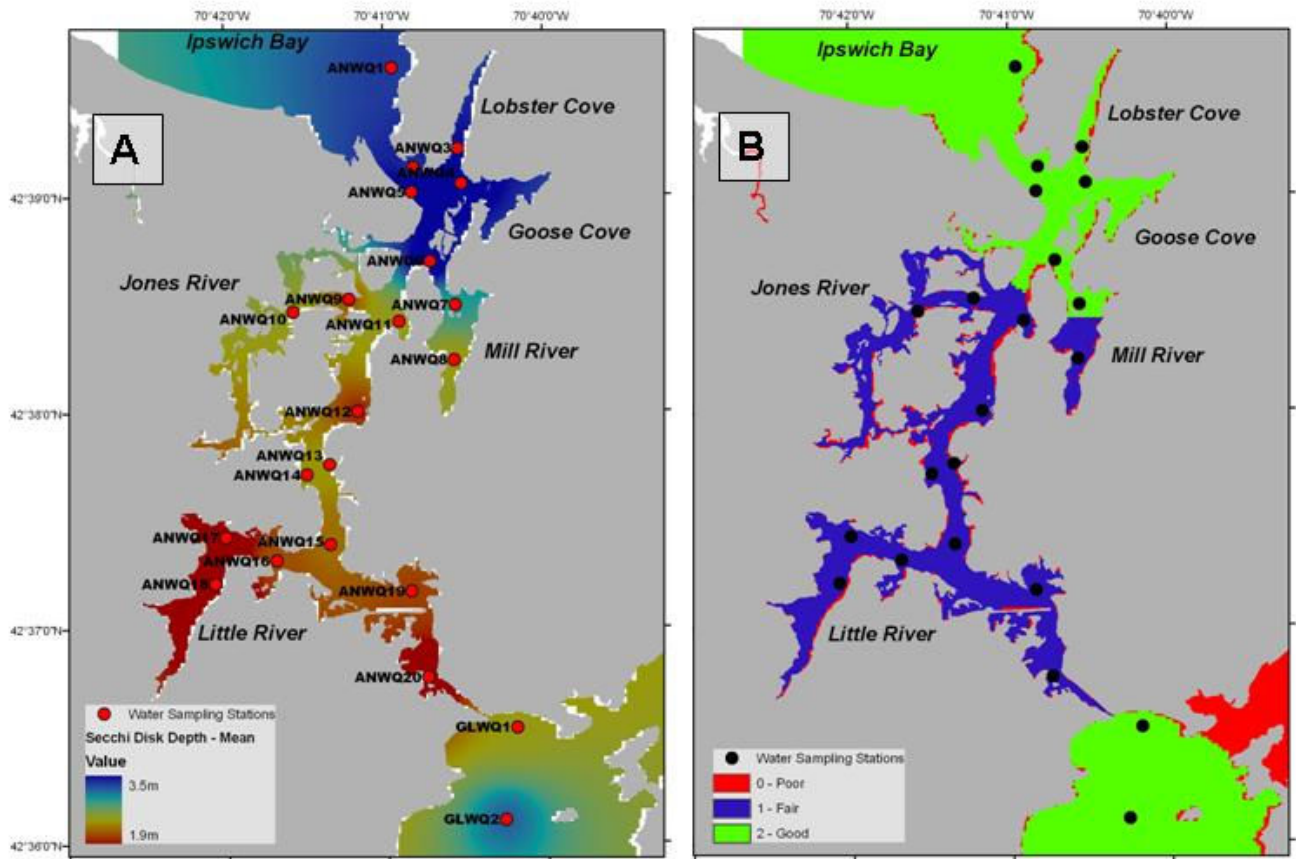
Figure 2. A) Inverse distance weighting (IDW) interpretation of mean Secchi disk depth and B) water quality classes used in the preliminary transplant suitability index (PTSI) for Annisquam River. See Wilbur (2007) for full description of water clarity study in the Annisquam River.

Two water quality classes (i.e., good and fair) were assigned to the Annisquam River (Figure 2b). Mean Secchi disk depth greater or equal to 3 meters was classified as good (rank=2), and Secchi depth less than 3 meters was classified as fair (rank=1). The water quality classes were combined with the other parameters in the PTSI to identify potential sites for test transplants.

The PTSI (Short et al. 2002a) was used to prioritize locations for test transplants of eelgrass. Although water quality seemed relatively degraded in the upper reaches of the Little River, with mean Secchi depth below 2.5 meters (Figure 2a), compared to other areas in the Annisquam River, water quality was classified as fair, which receives a rank of one (1). Water quality classified as poor receives a rank of zero (0) in the PTSI, and since the index is multiplicative, a zero rank for any parameter would eliminate an area from consideration. The fair classification allowed the identification of potential locations for eelgrass restoration in the Little River. However, current water quality conditions in the upper portions of the Little River should be improved before substantial efforts are made to transplant or seed eelgrass in the area. No test sites were located in the upper reaches of the Little River for this study.

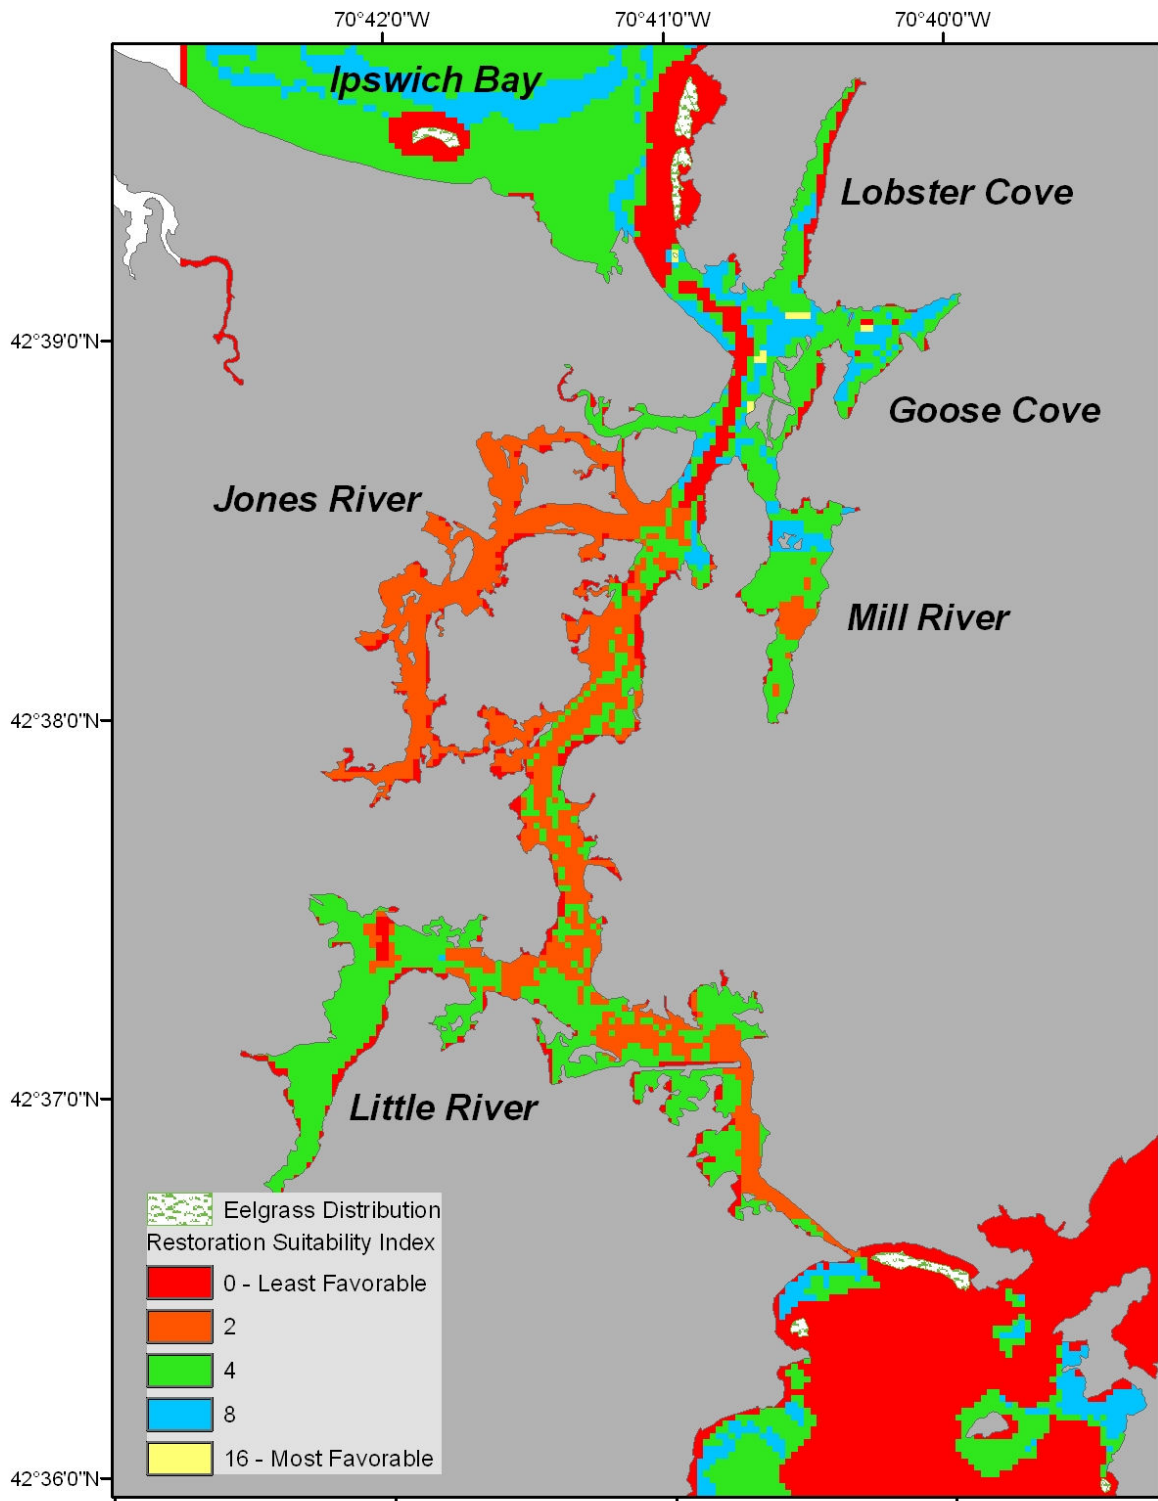
Figure 3. Preliminary transplant suitability index (PTSI) results for the Annisquam River. PTSI rankings range from 0 (red; least favorable) to 16 (yellow; most favorable).

PTSI scores were higher in the northern sections of the study area, particularly in Ipswich Bay, in and around Goose Cove, and the northern section of the Mill River, and scores were lower in the Jones River and southern waters (e.g., Little River) of the Annisquam River (Figure 3). The most favorable conditions (PTSI=16) were found within and adjacent to Goose Cove. Favorable conditions (PTSI=4 to 8) were also identified adjacent to Coffins Beach (i.e., Ipswich Bay), within and surrounding Lobster Cove, and the northern sections of Mill River (Figure 3). Much of the Little River had a PTSI rank of four. Model results also demonstrated favorable PTSI rankings (PTSI=4 to 8) in Gloucester Harbor, including the western harbor (adjacent to Stage Head and Freshwater Cove) and around Tenpound Island (Figure 3).

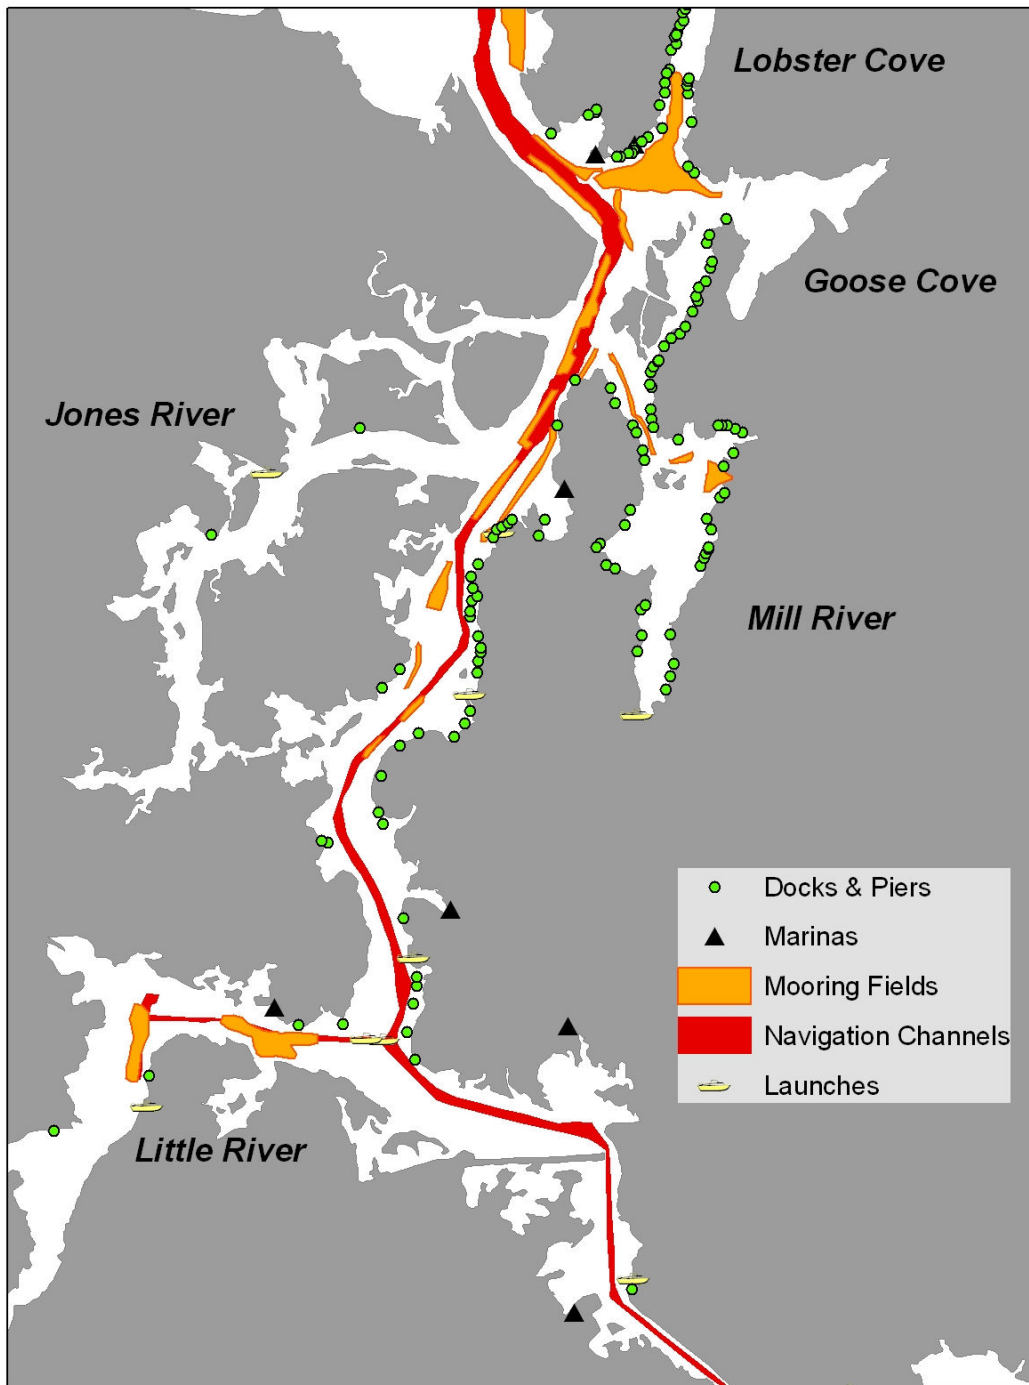
Figure 4. Map showing the location and extent of boat launches, navigation channels, mooring fields, marinas, and docks and piers in the Annisquam River.

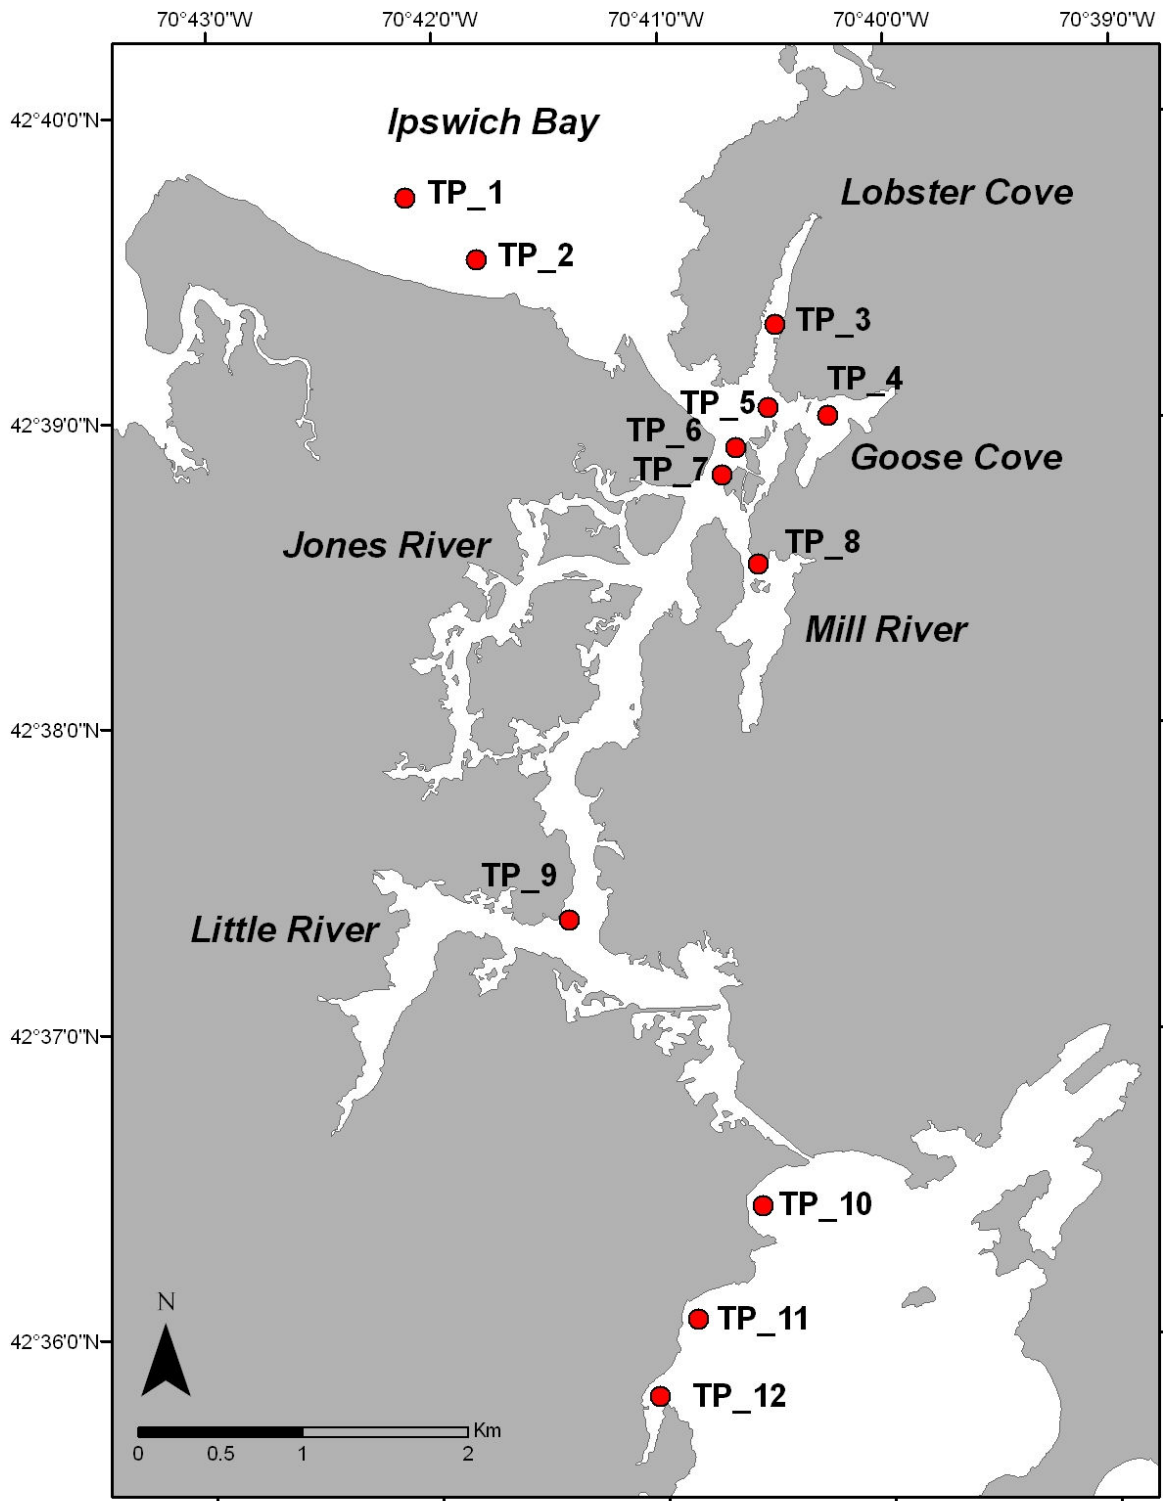
Figure 5. Preliminary locations of test plots that were visited for field observations (see Appendix B for coordinates of sites).

Based on PTSI results and human uses, 12 sites were identified as potential locations for test transplants (Figure 5). Each site was visited to further assess potential anthropogenic disturbances or other natural resources (Table 3). A substantial abundance of eelgrass was distributed throughout Ipswich Bay in early summer 2007 in areas that were not mapped in 1995 or 2001 (MassGIS 2006). The presence of eelgrass eliminated TP-1 and TP-2 from consideration for test transplants. Abundant lobster fishing gear was observed at stations TP-6 and TP-7. The lobster gear presented a conflicting use and potential direct disturbance to transplants, removing TP-6 and TP-7 from consideration. The other sites were slightly moved, as needed, to minimize potential conflicts.

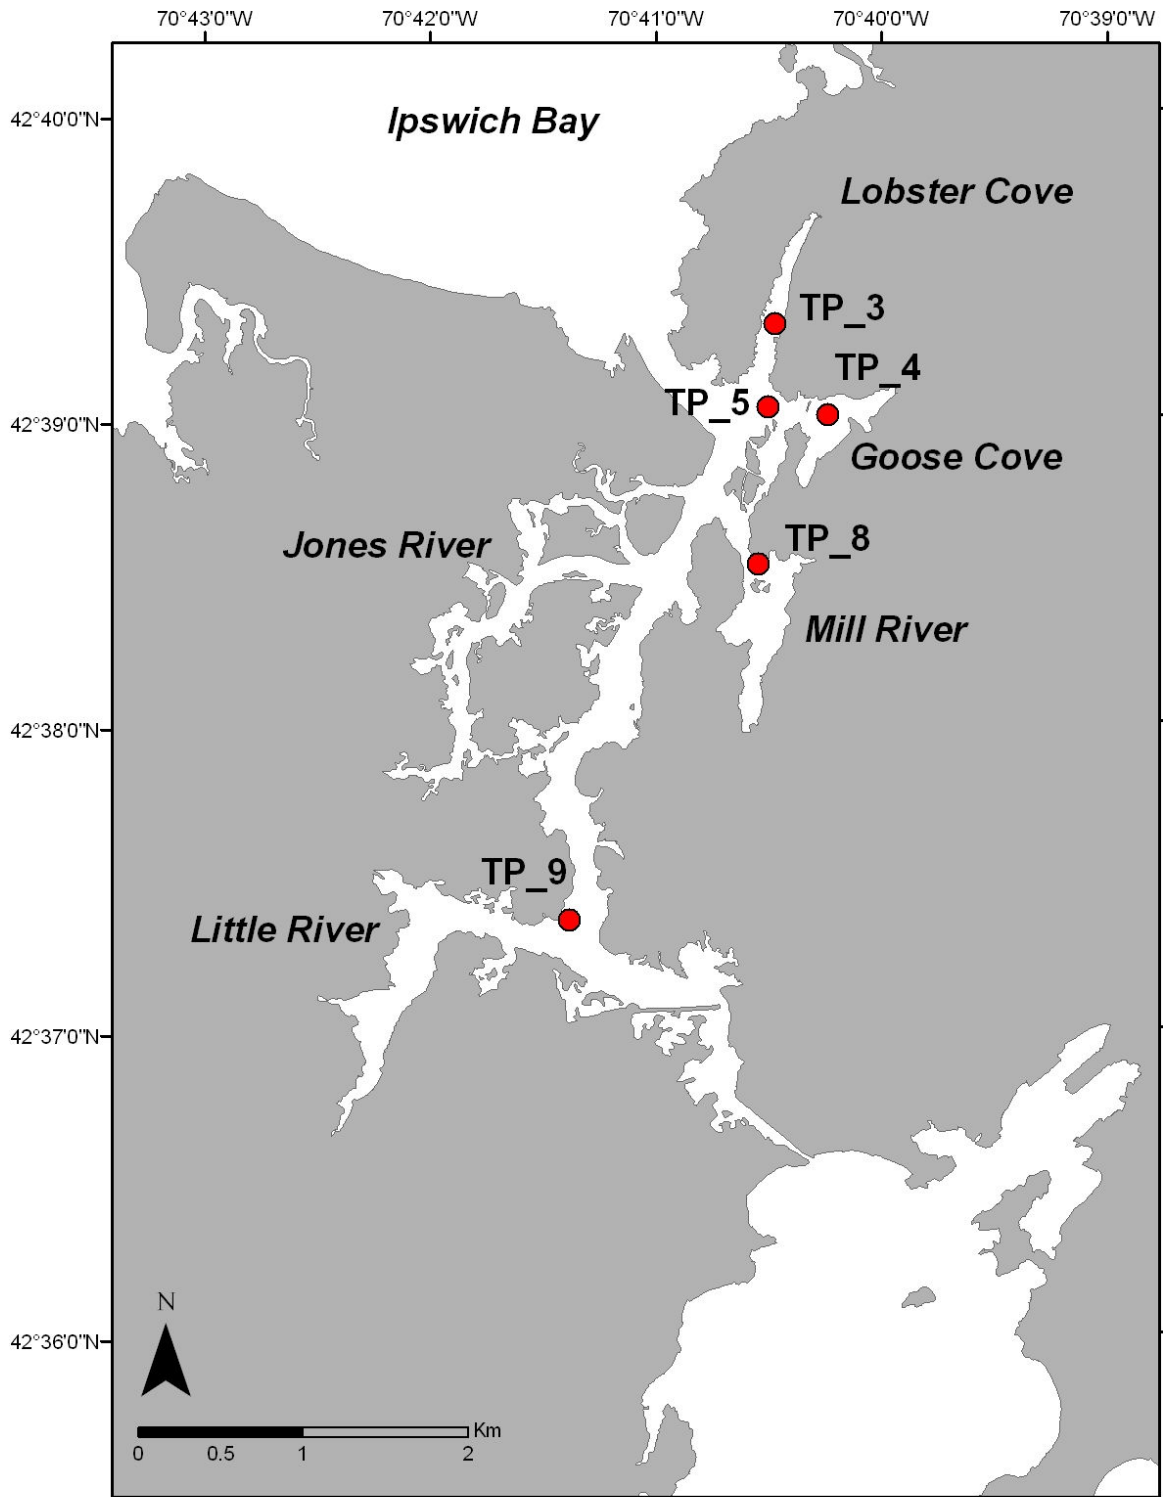
Figure 6. Final location of test plots: Lobster Cove (TP-3), Goose Cove (TP-4), outside of Goose Cove (TP-5), Mill River (TP-8), and the mouth of the Little River (TP-9).

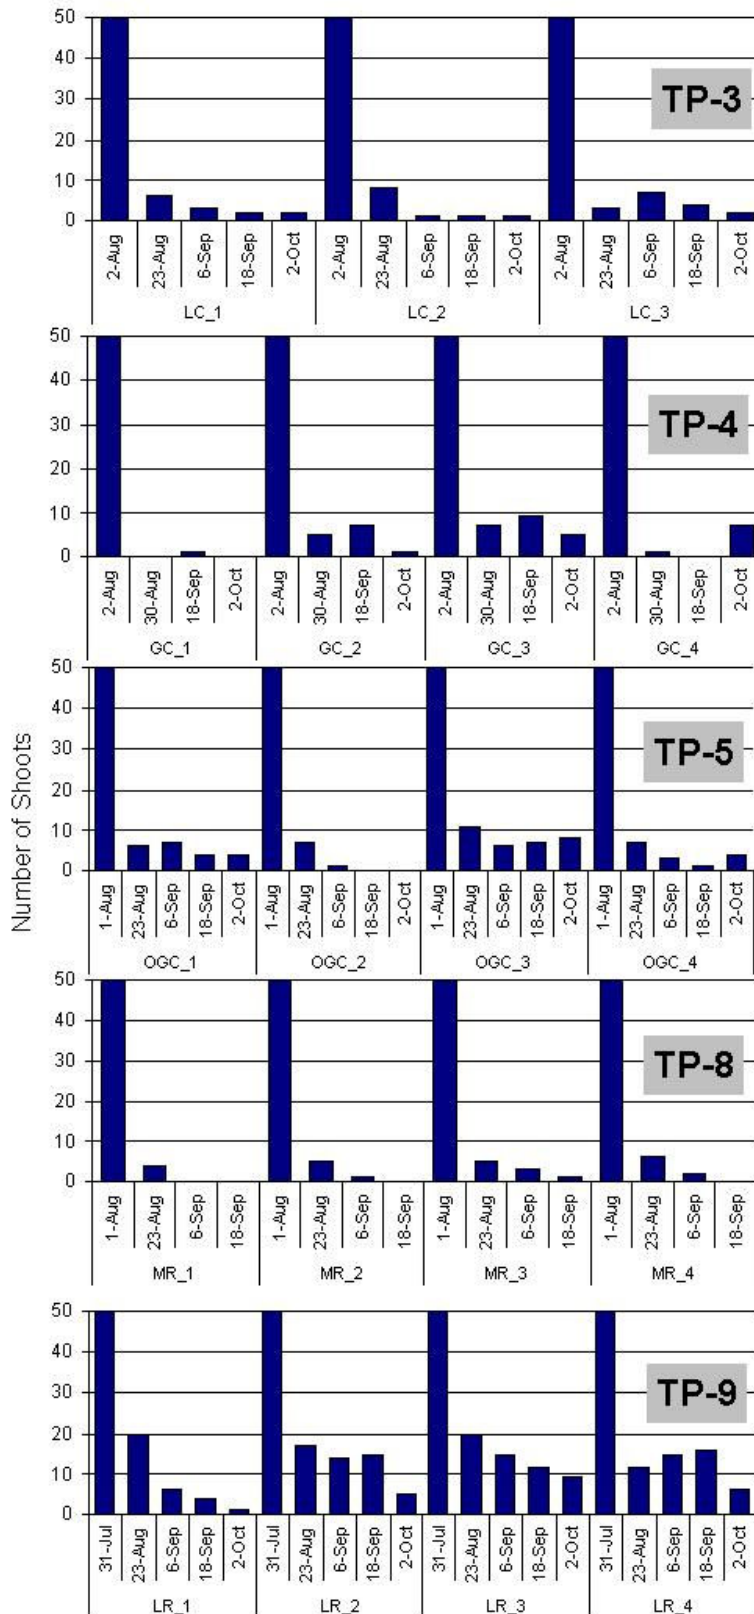
Figure 7. Shoot counts of test transplants at Lobster Cove (TP-3), Goose Cove (TP-4), outside of Goose Cove (TP-5), Mill River (TP-8), and the mouth of the Little River (TP-9).

A precipitous decline in shoots was observed at all sites, with extensive mortality and/or loss (e.g., shoots dislodged from frames) between the day of transplanting and the first monitoring date (Figure 7). Shoot counts were collected from 23 August to 2 October. Each site was visited on four dates, except Mill River, which was only monitored on three days. The largest decline in shoots was observed between transplant date (31 July to 2 August) and the first monitoring date (23 August and 30 August).
