*Presentation to*

**MA Water Resources Commission**

**Quinapoxet Dam Removal**

April 10, 2025

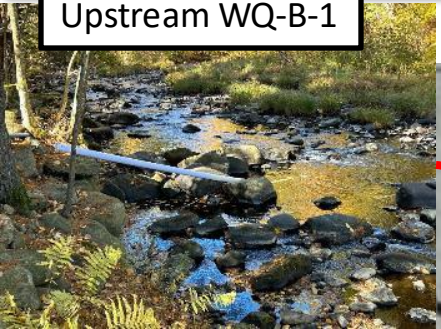
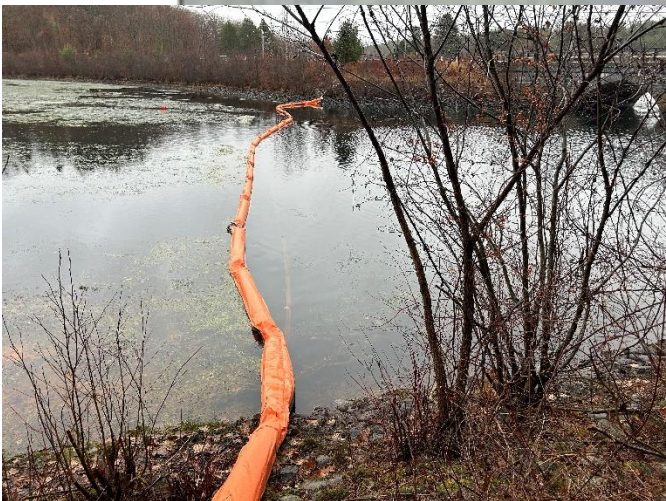
Upstream WQ-B-1

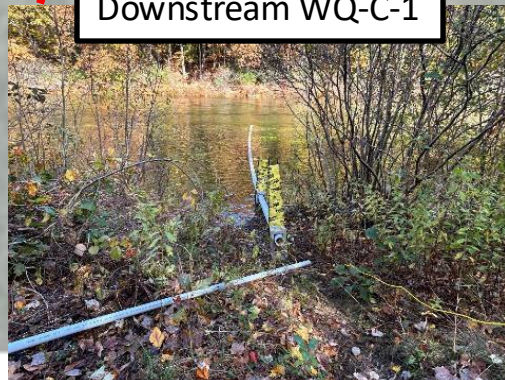
Downstream WQ-C-1

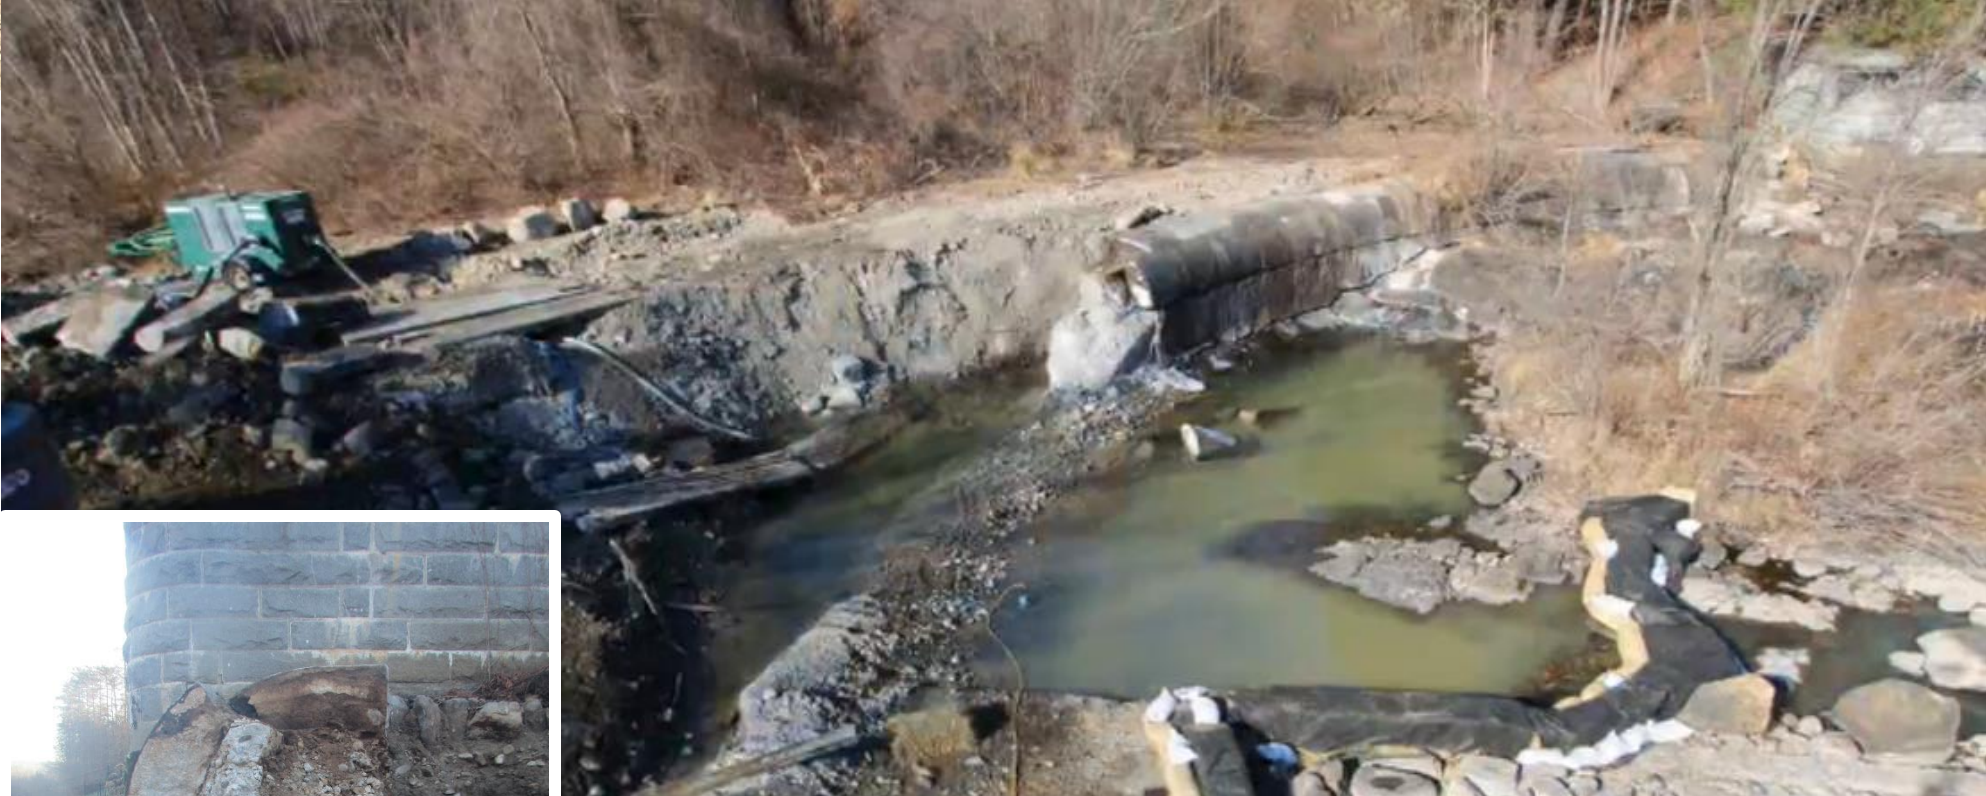
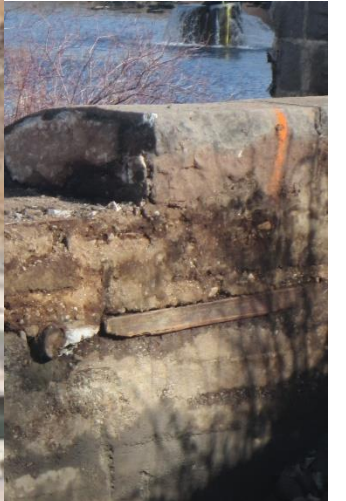
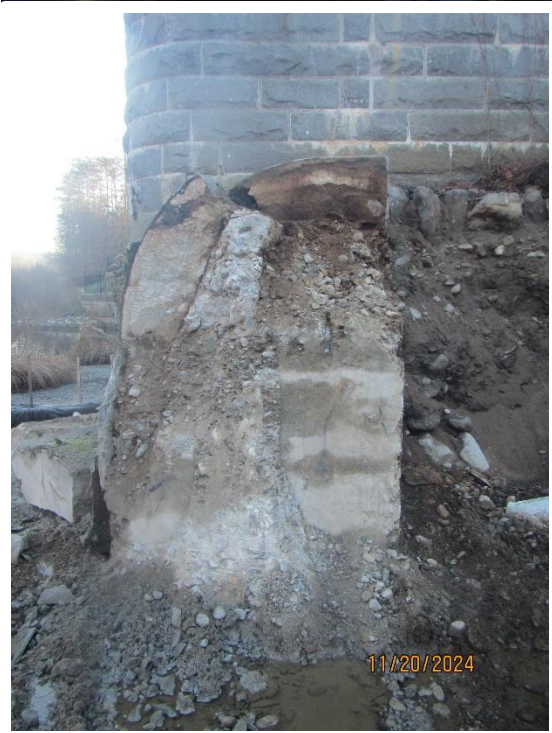
# Demo details...

Capstone removal 11.06 -11:16

Spillway core demo 11.16 – 11.25 (Sat 11.16, Mon. 11.18 – Fri. 11.22, and then Mon. 11.25)

Total of 7 days to take it down.

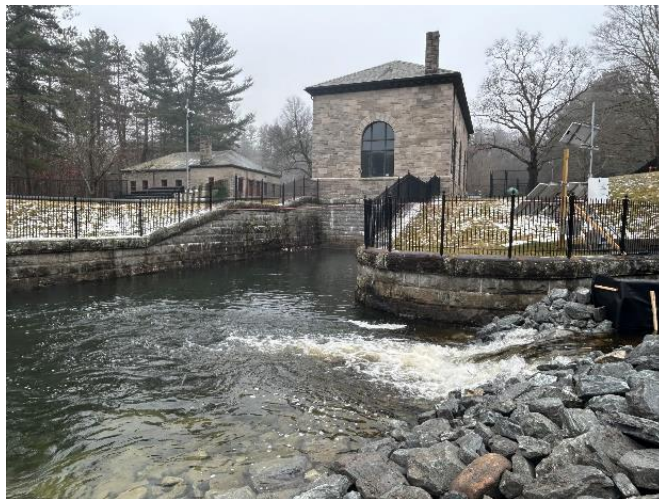
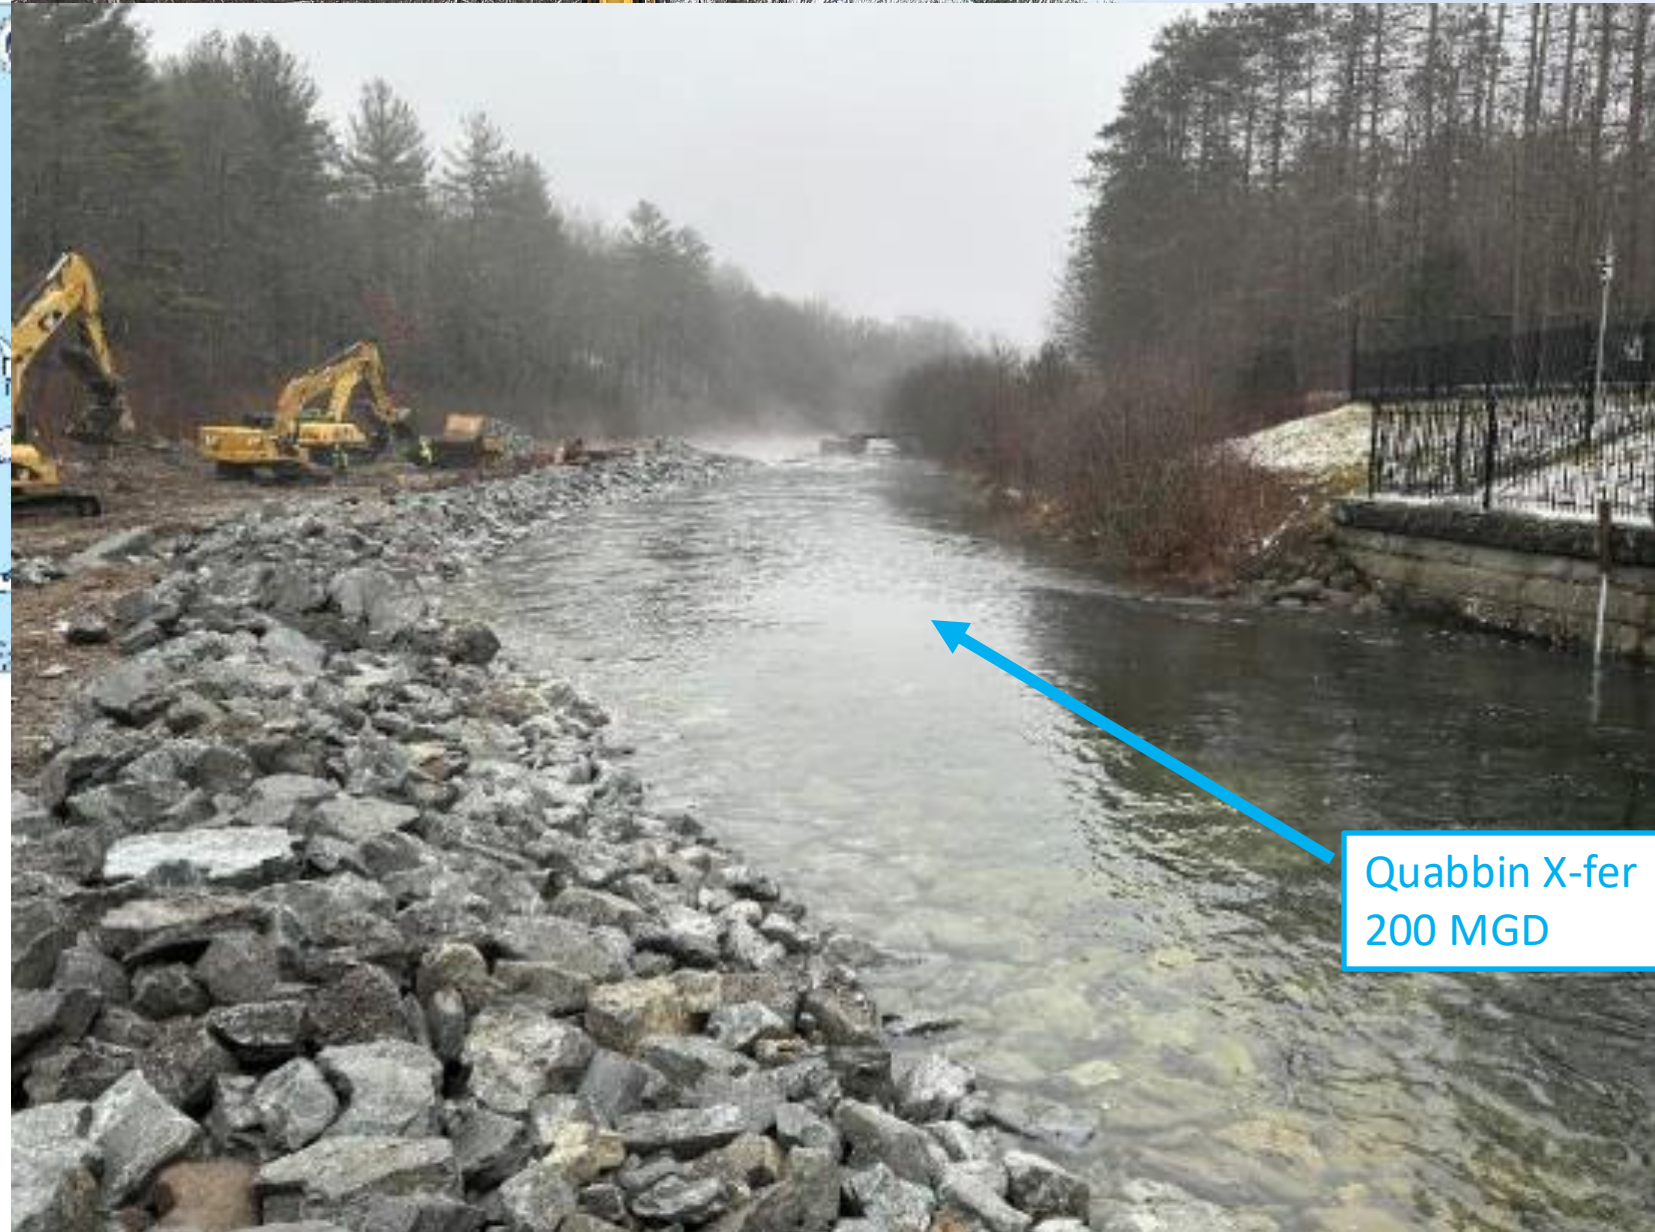
# Accelerated Tailrace Berm Extension due to critical drought Nov. 2024

Quabbin X-fer  
200 MGD

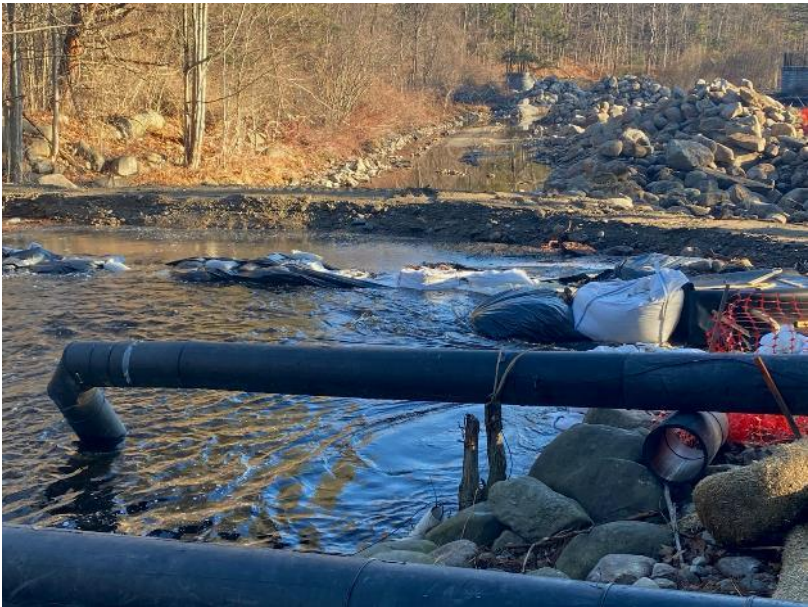
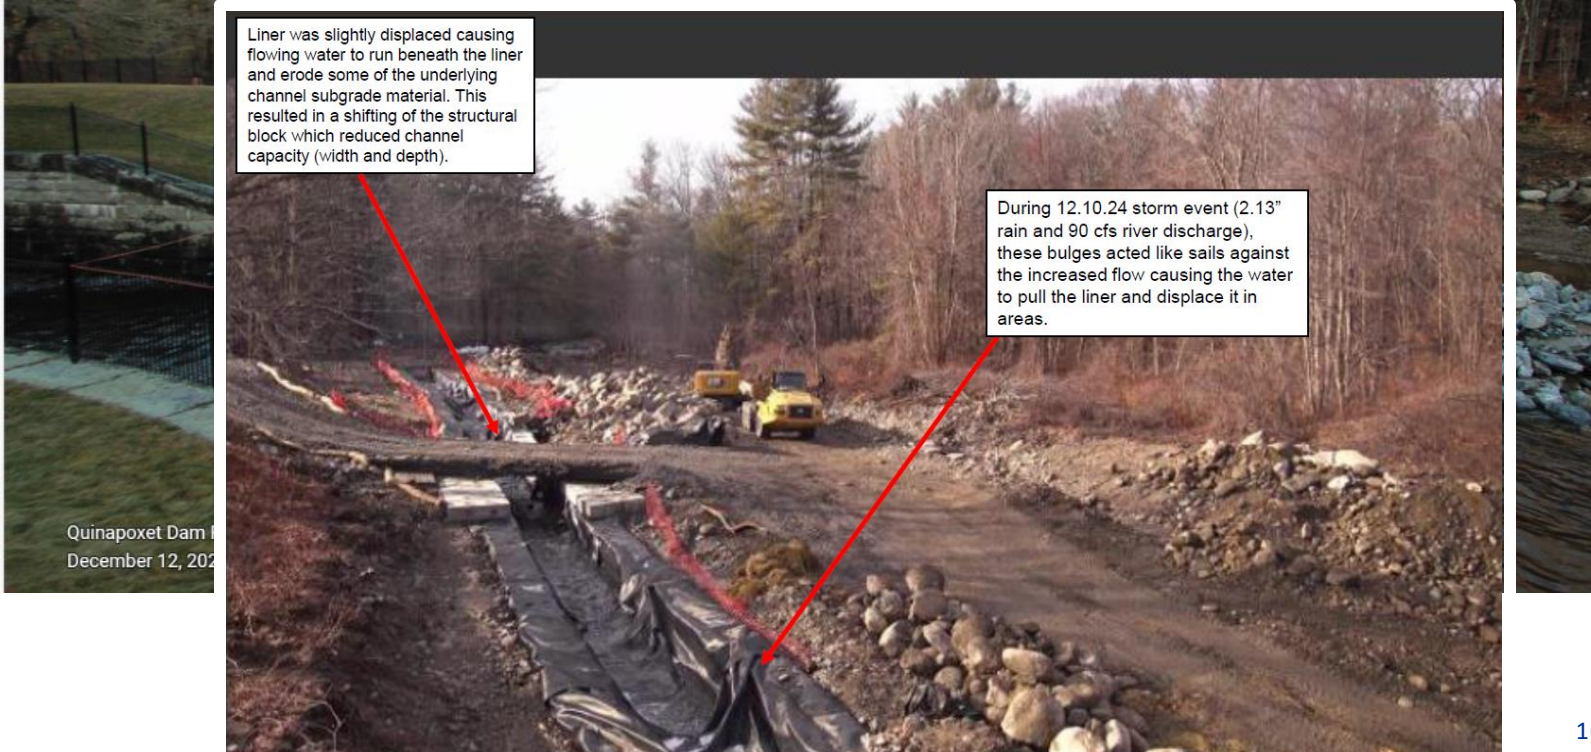
# How channel responded ot 12.10.24 rain event

70 cfs

Liner was slightly displaced causing flowing water to run beneath the liner and erode some of the underlying channel subgrade material. This resulted in a shifting of the structural block which reduced channel capacity (width and depth).

During 12.10.24 storm event (2.13" rain and 90 cfs river discharge), these bulges acted like sails against the increased flow causing the water to pull the liner and displace it in areas.

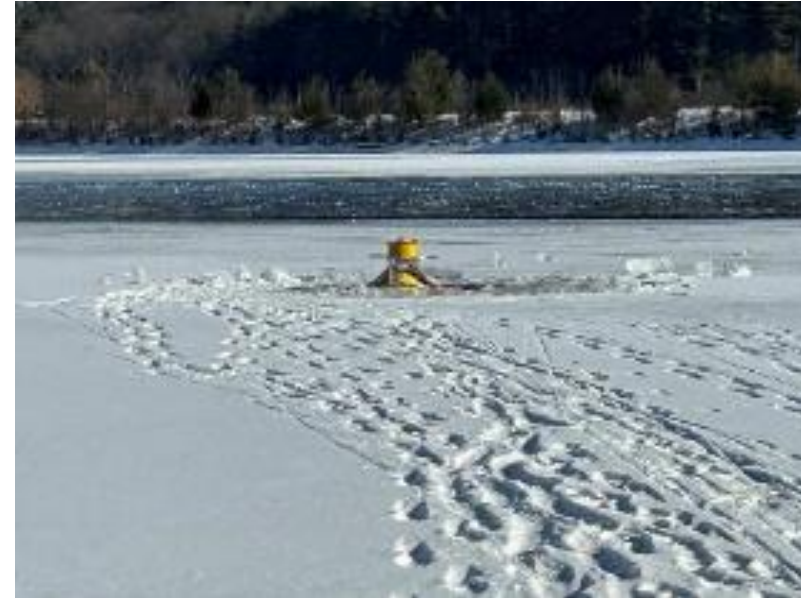
WQ -C1 downstream of site

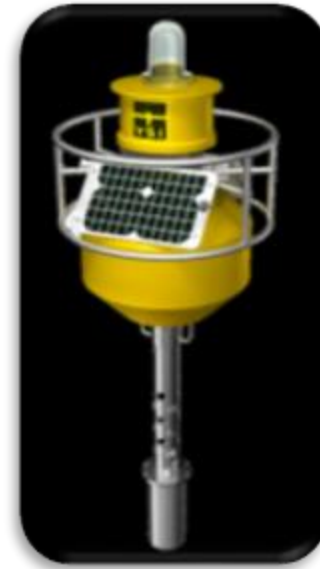
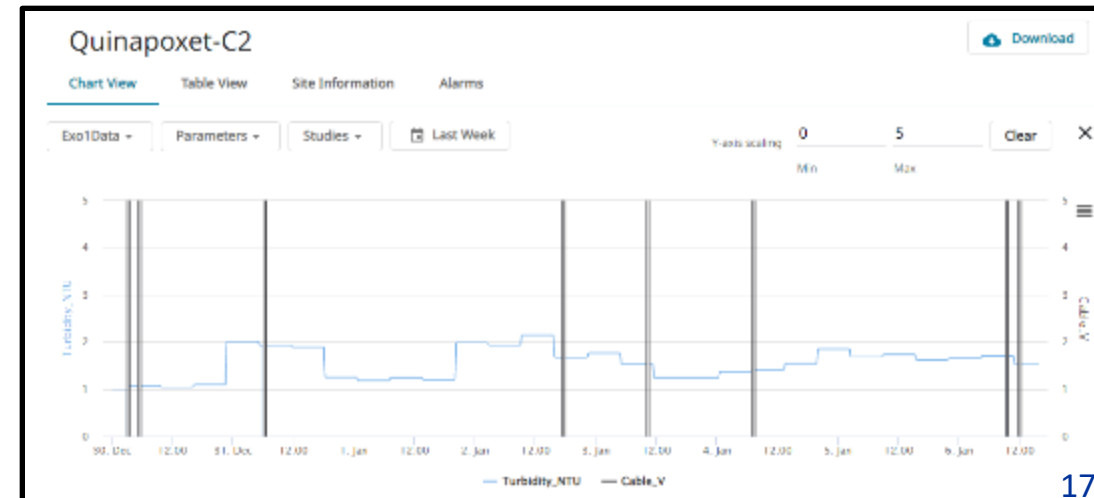
C2 FD Buoy, Quinapoxet Basin

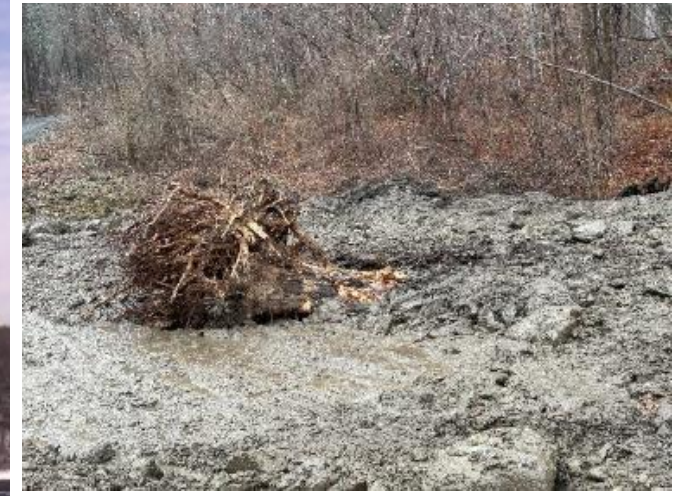
Restored floodplain bank

Embedded rootwads

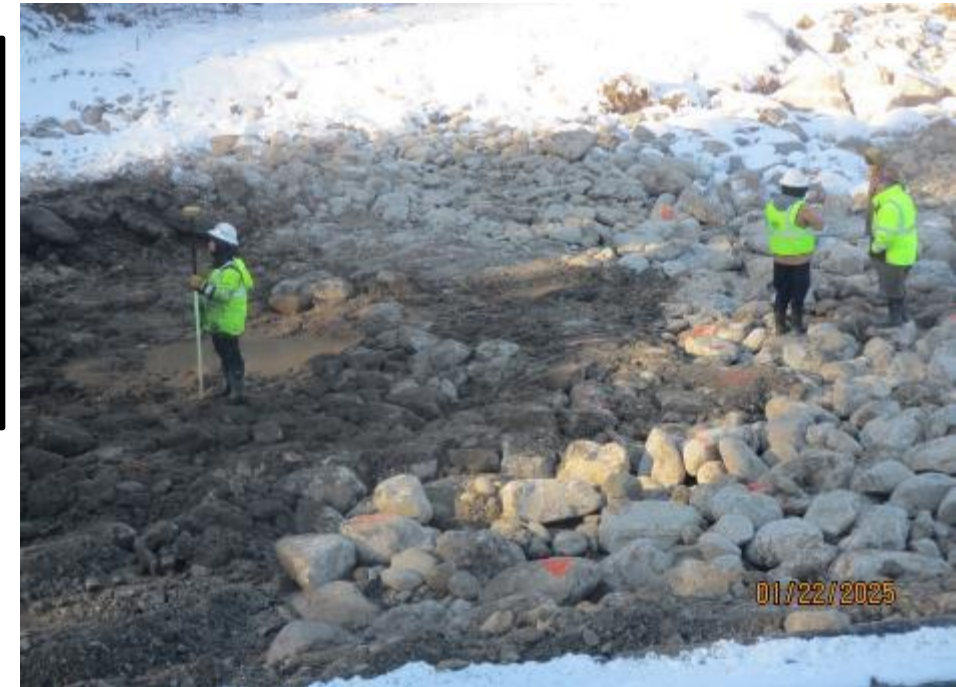
Placement of rock for riverbed riffle

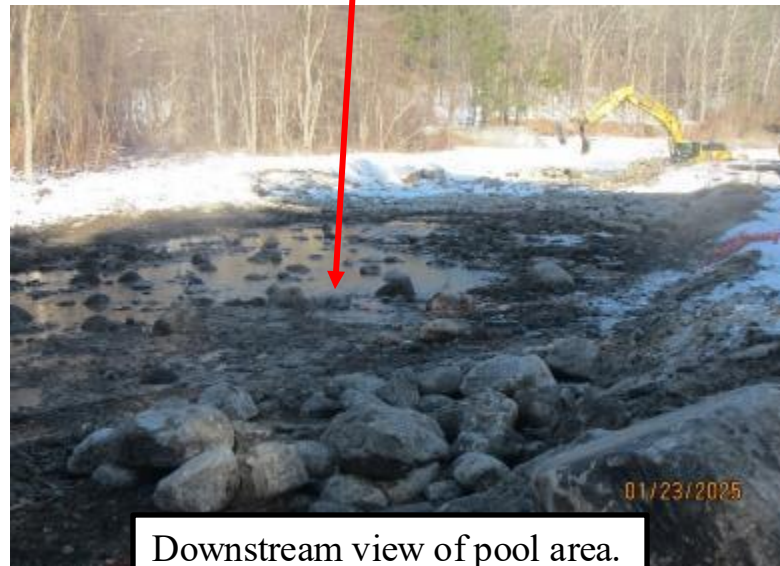
Checking riverbed grades

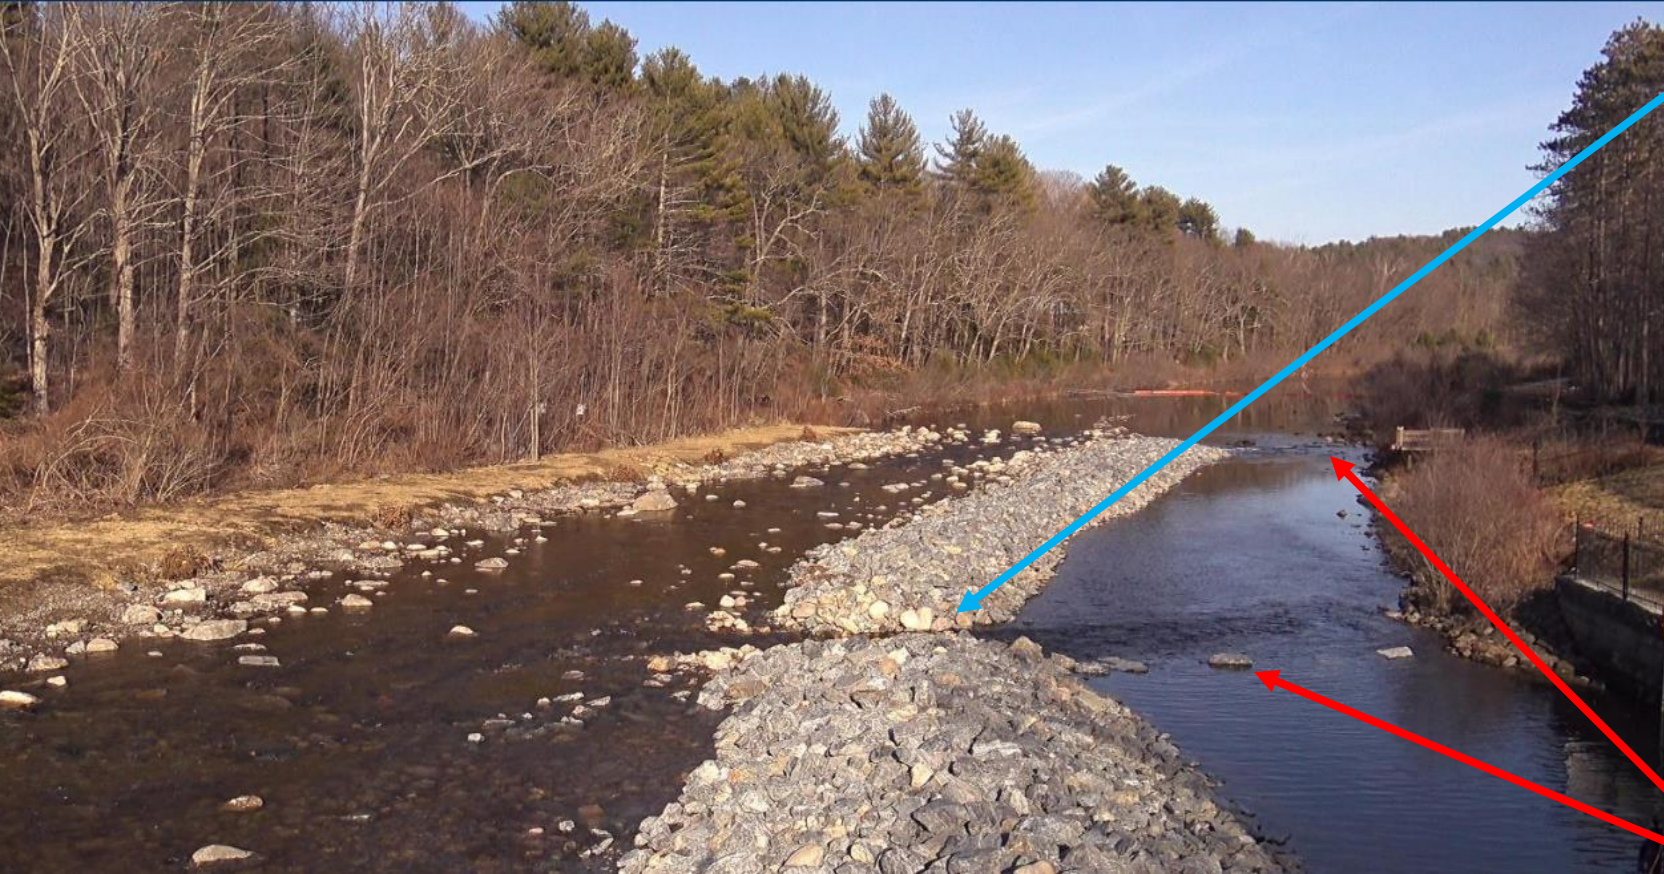
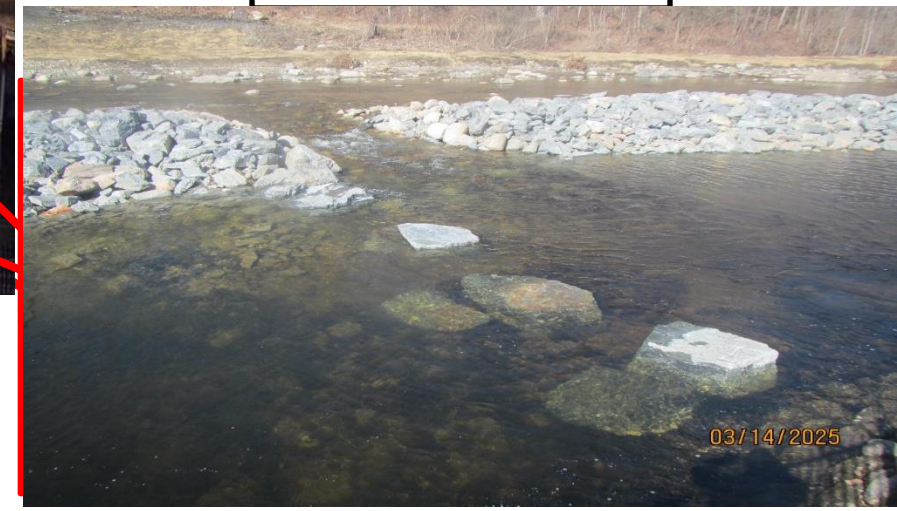
# Tailrace extension fish structures and kayak takeout

Fish deterrent structures

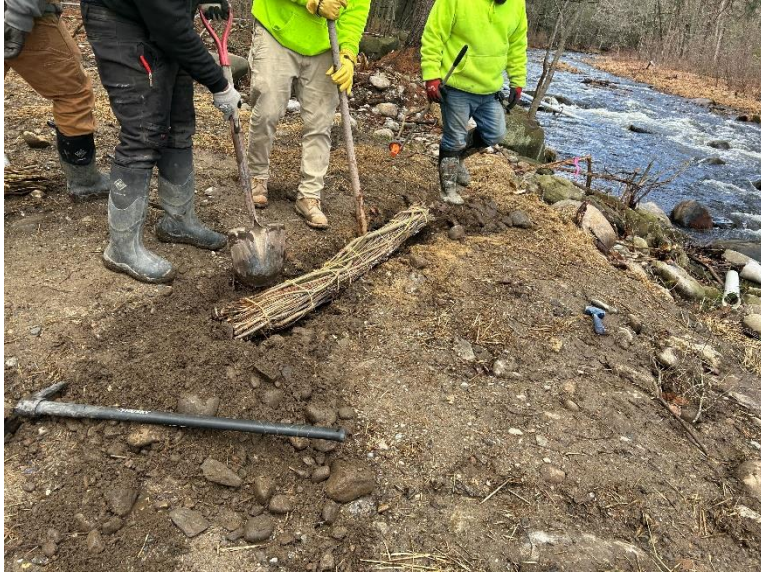
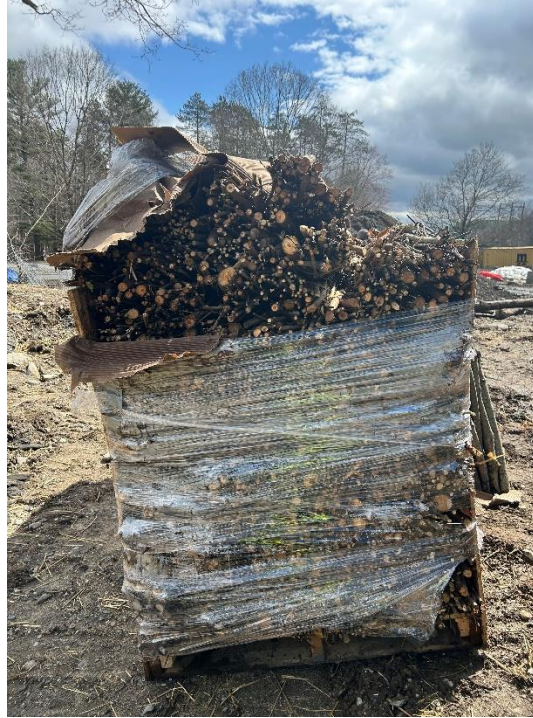
- Willow Fascines

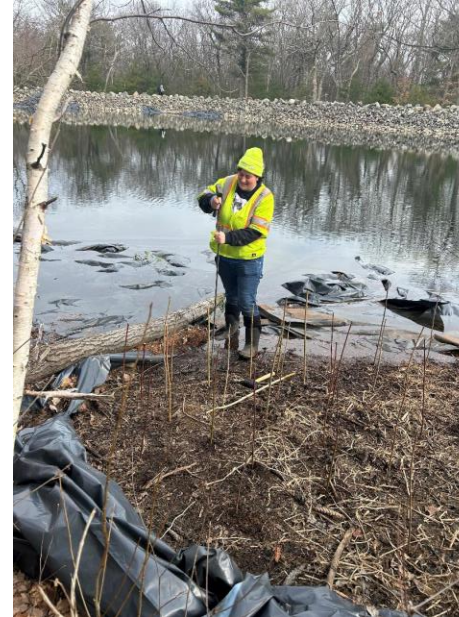
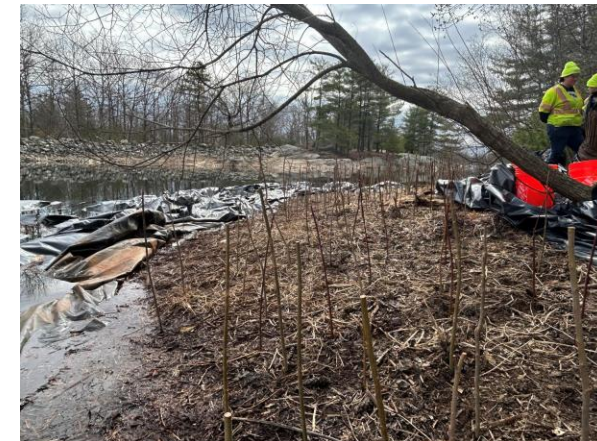
Live Stakes

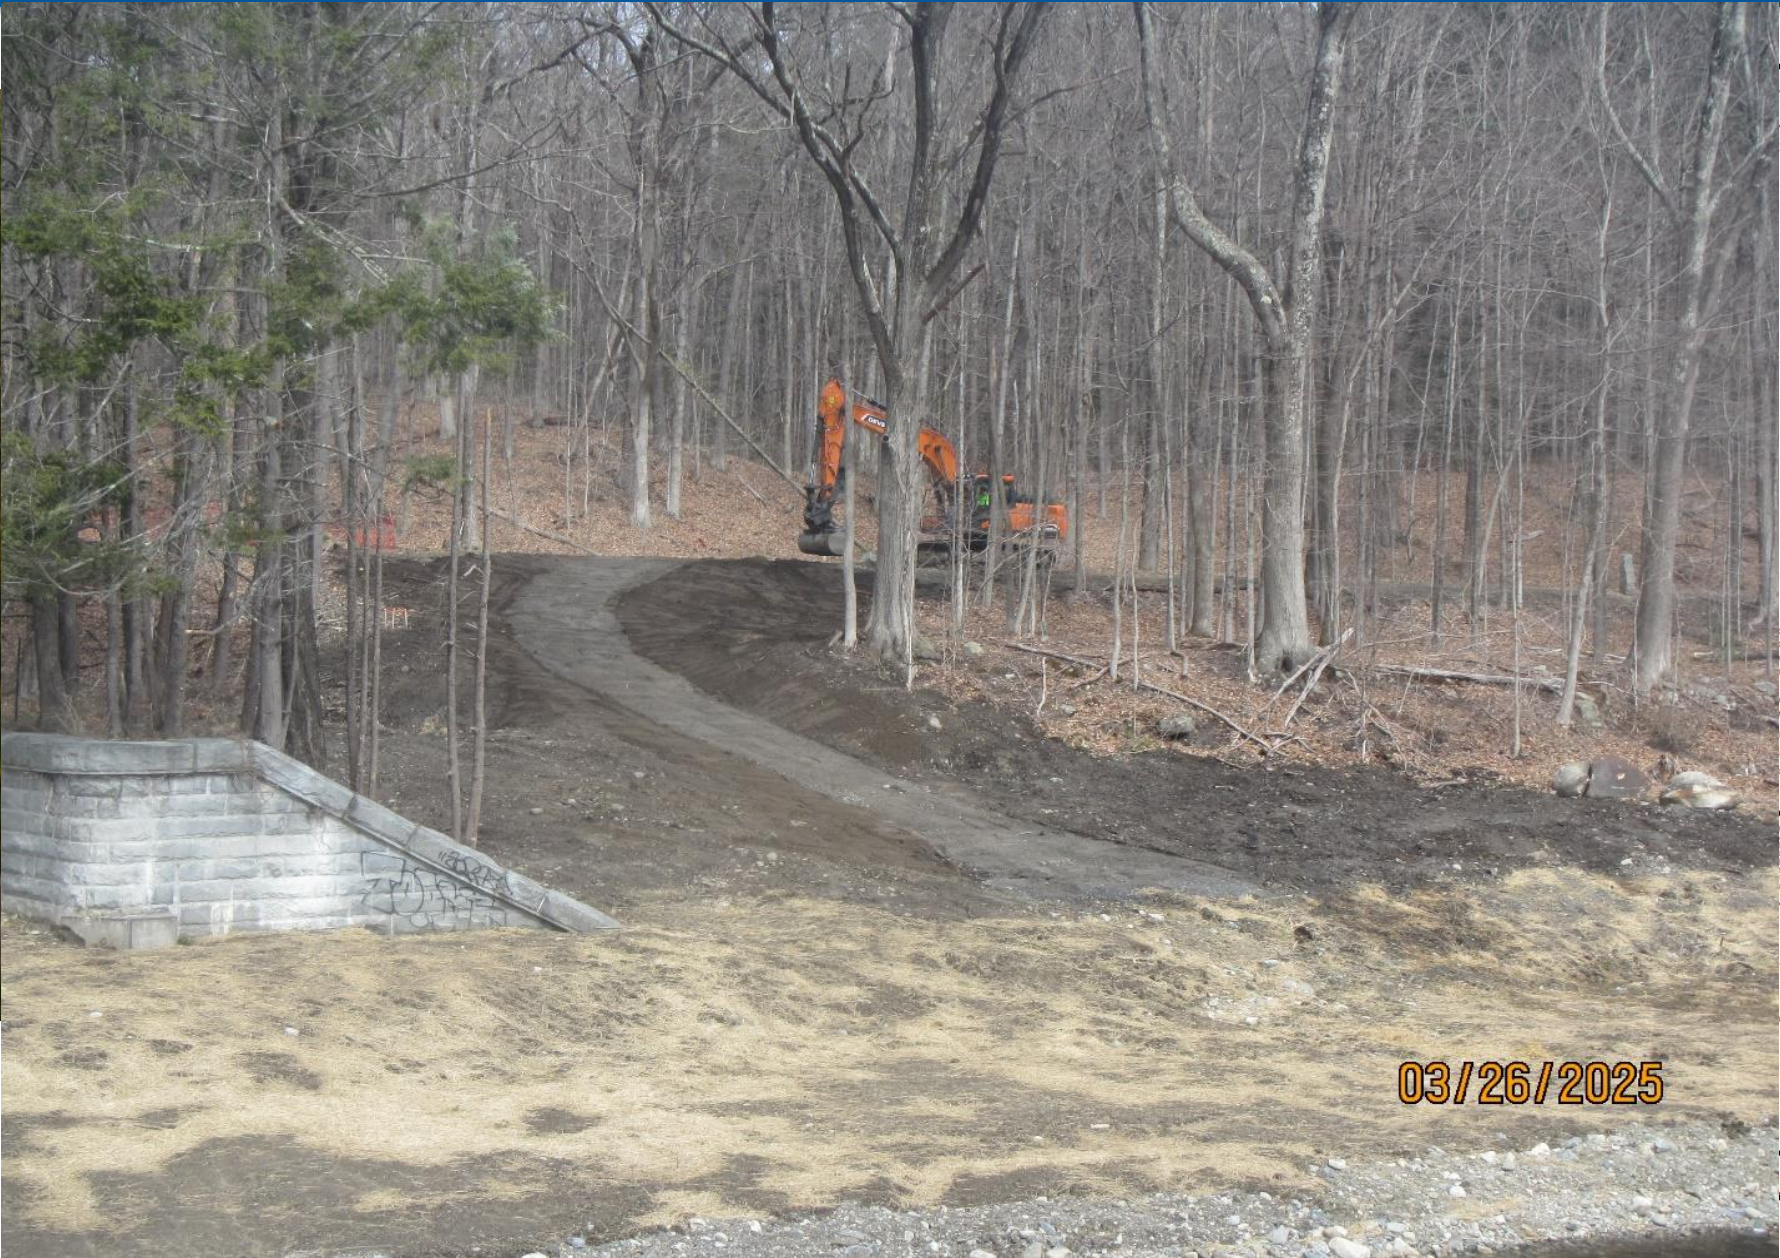
SP-7

ALLEGED FISHING PLATFORM SITE INSET AND DETAILS

SITE PLAN - TRAIL AND FISHING PLATFORM  
QUINAPPOSET DAM REMOVAL PROJECT  
QUINAPPOSET RIVER  
HYDE PARK  
WEST BOSTON, MASSACHUSETTS
