Massachusetts Department of Public Health
Bureau of Environmental Health

**Updates on Environmental Radiation
Monitoring Activities at
Pilgrim Nuclear Power Station (PNPS)**

April 2014

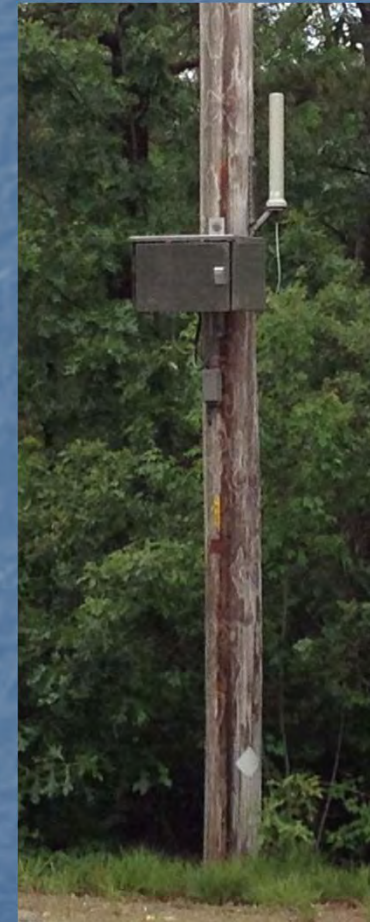
- The MDPH real-time monitoring system currently has 14 monitors
- Three monitors were relocated in 2013
 - Gurnet Point
 - Plymouth Waterfront
 - Old Colony Place
- All three have co-located wind speed and direction measuring capacity
- As with all monitors, data is reported to a central computer remotely accessible and checked daily by MDPH staff
- Monitors are calibrated annually according to Envinet specifications to ensure data quality

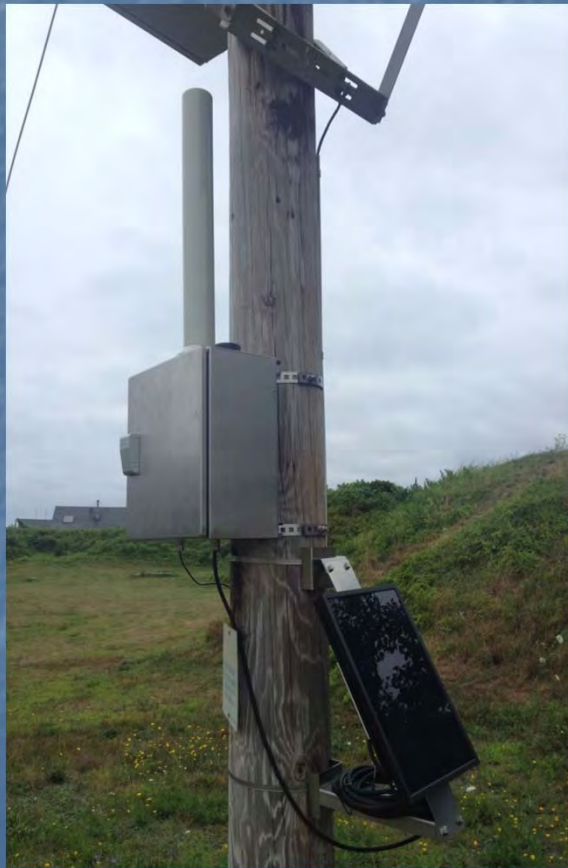
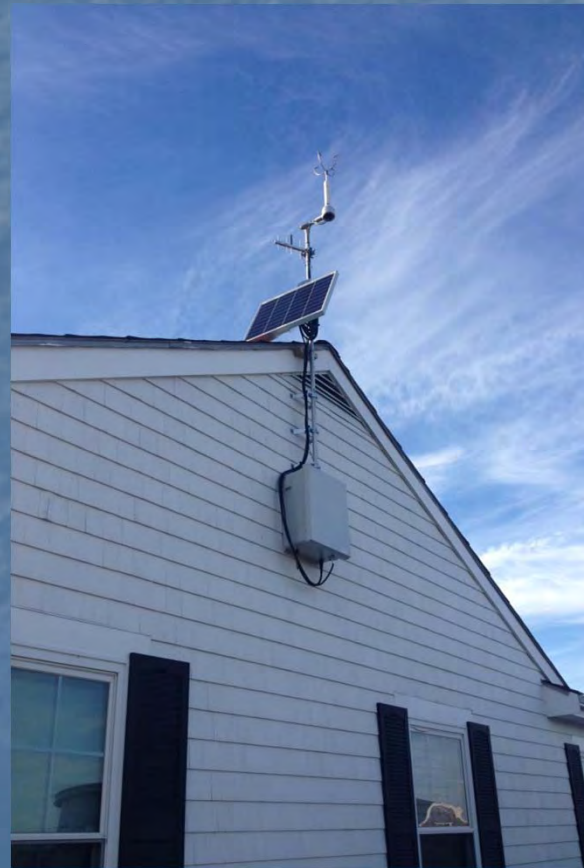
- Real-Time radiation monitor and anemometer at Gurnet Point:

- Real-time radiation monitor system has been enhanced with state-of-the-art anemometers (wind speed and direction sensors) that are solar powered and transmit data wirelessly to a central computer
- MDPH consulted with experts to ensure anemometers were placed at optimal locations designed to take the sea breeze effects into account:
 - Plymouth Waterfront
 - Gurnet Point
 - Old Colony Place
 - Duxbury (Spring 2014)
- Continuous wind speed and direction data are being logged at 1 minute, 10 minute, and hourly intervals and transmitted to a central location remotely accessible by MDPH staff like the radiation data
- These enhancements provide a robust system of watchfulness

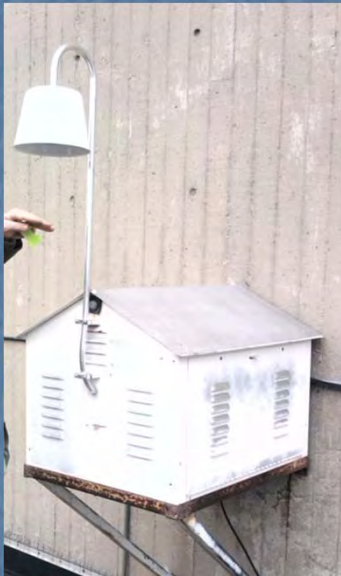
■ Routine Monitoring - PNPS

- Conducted as part of MDPH regulatory requirements
- Samples collected both within and outside 10-mile Emergency Planning Zone (EPZ)
- Analysis by Massachusetts Environmental Radiation Laboratory (MERL)
- Sampling includes air, surface water, sediment, milk, shellfish, lobster, fish, Irish moss, crops (e.g. cranberries)

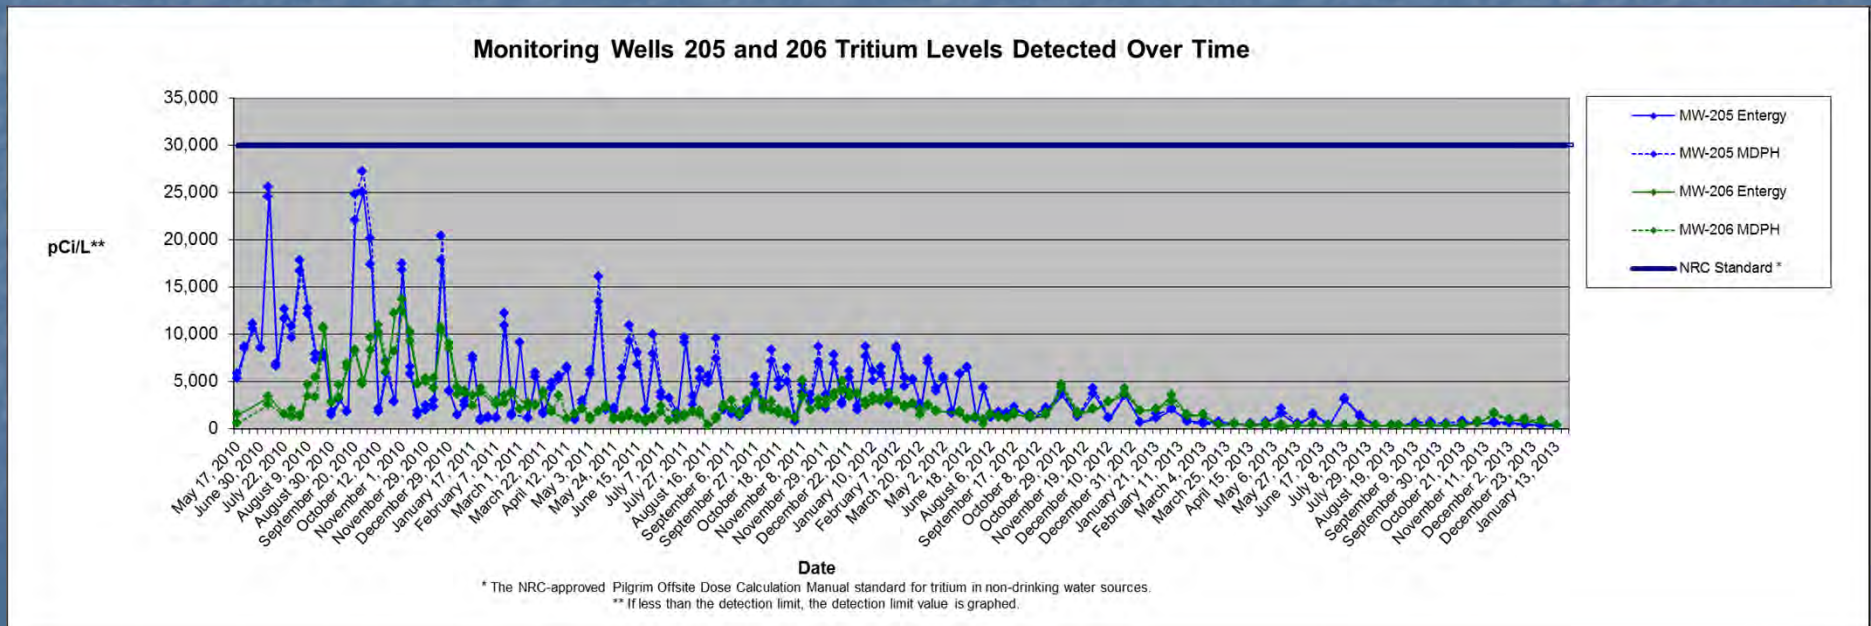
- Data for MW205 and MW206, the initial wells with elevated tritium levels, have been trending downward
- Wells will continue to be closely monitored to determine whether any patterns emerge
