DAVID MINDESS ELEMENTARY SCHOOL ASSESSMENT REPORT Ashland, MA

January 2017

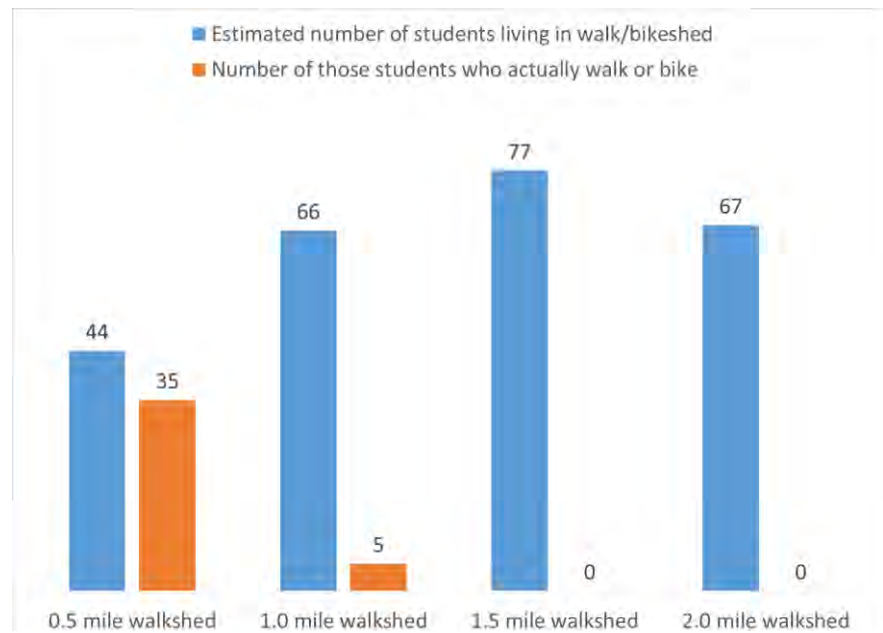
Figure 1: Numbers of students living within walkable/bikeable distances of school compared to numbers that actually walk or bike.

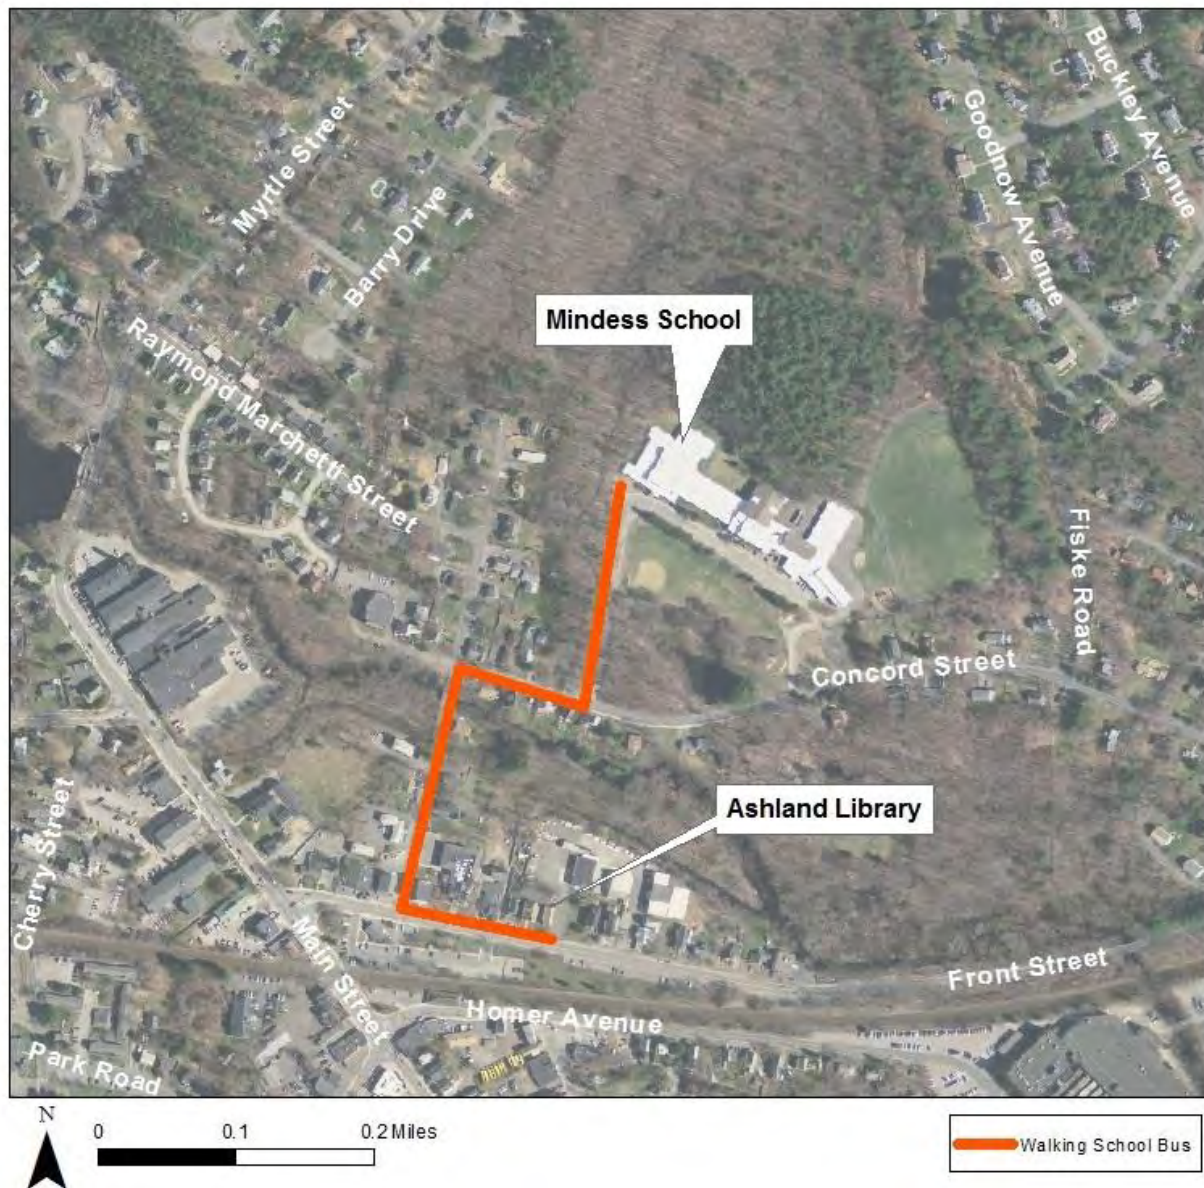
Parents lead a walking school bus from the Ashland Library to the Mindess School on Wednesdays in the fall and spring months as shown in Figure 2. On International Walk to School Day, the School organizes a group walk following the same route. The school buses drop off the students near the Ashland Library so that bused students can participate.

Figure 2: Walking School Bus route

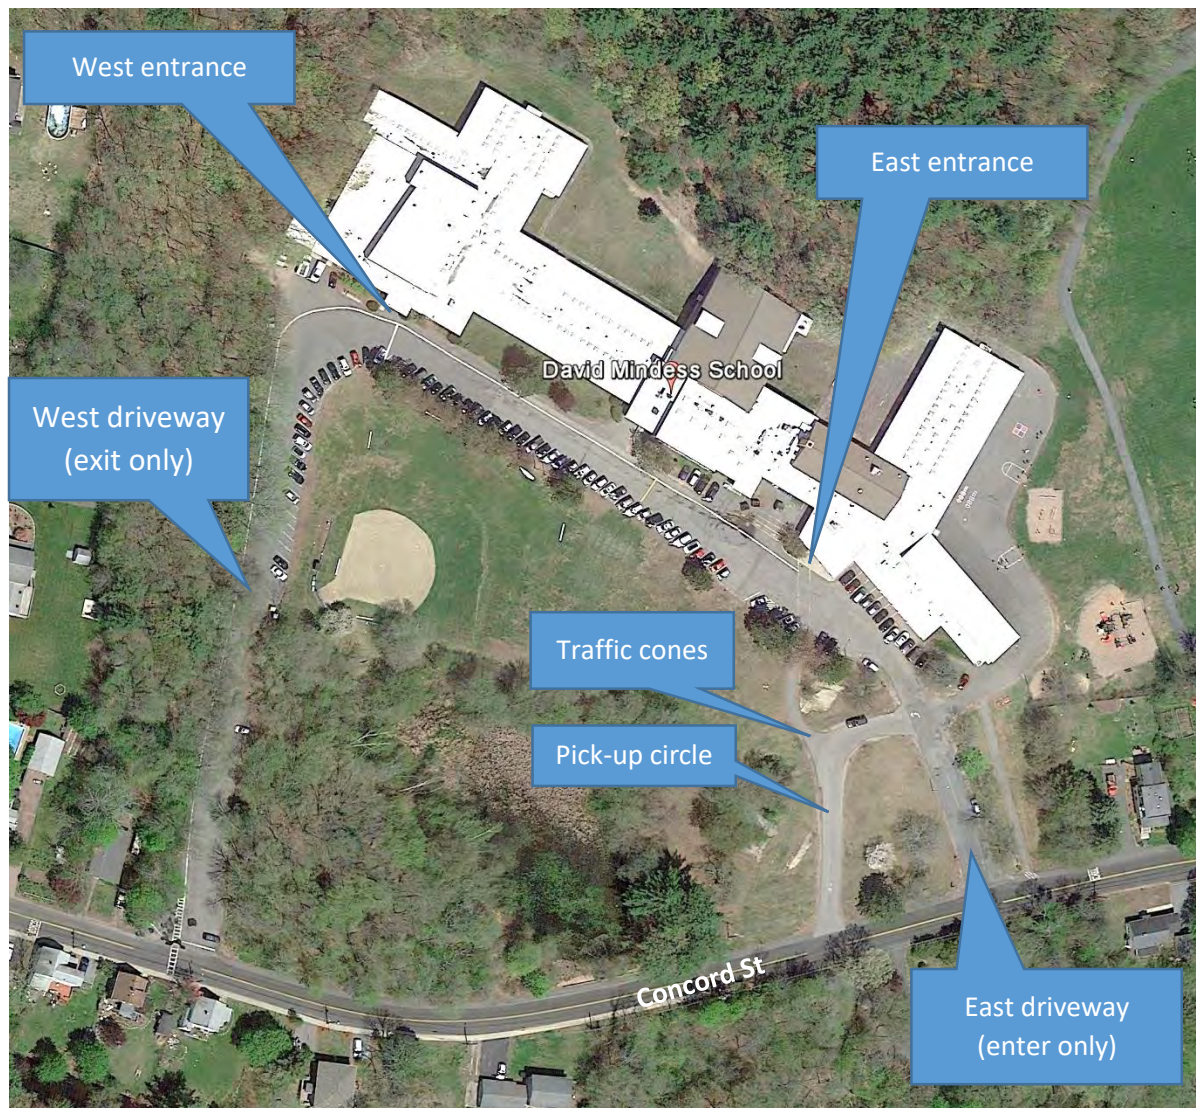
Figure 3 shows the Mindess School campus and access points.

Figure 3: Mindess School campus

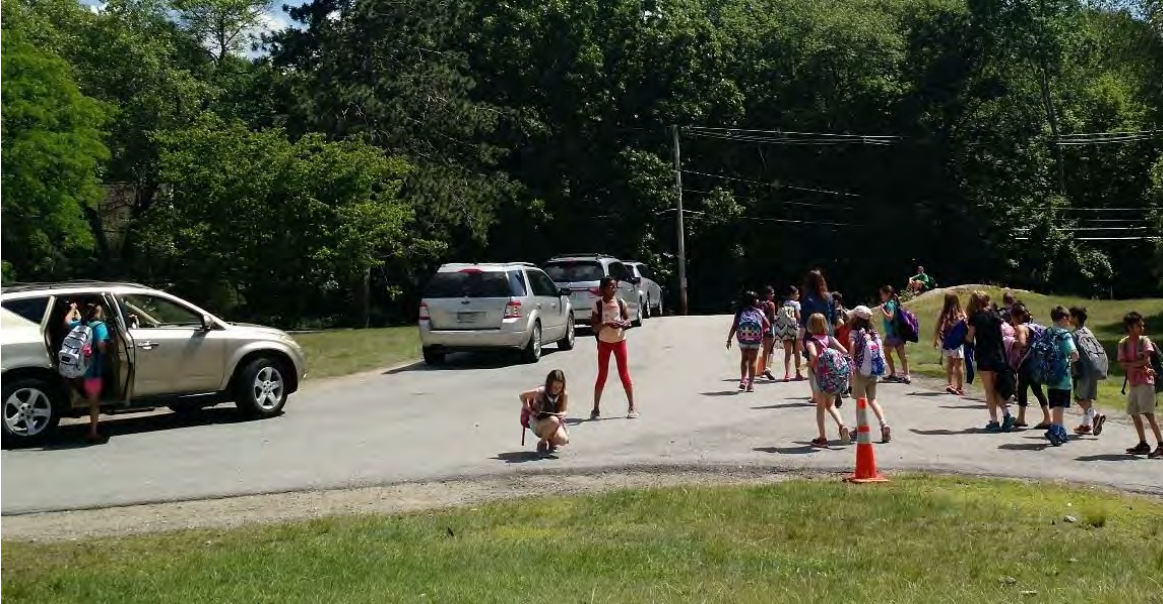
Orange cones are arranged along the side of the circle to prevent students from entering the travel lane; however, students do not comply with this barrier. Students were observed playing in the travel lane, standing with their backs to traffic, using iPads and mobile phones, and generally demonstrating unsafe behavior (Figure 4).

Figure 4: The pick-up queue during dismissal.

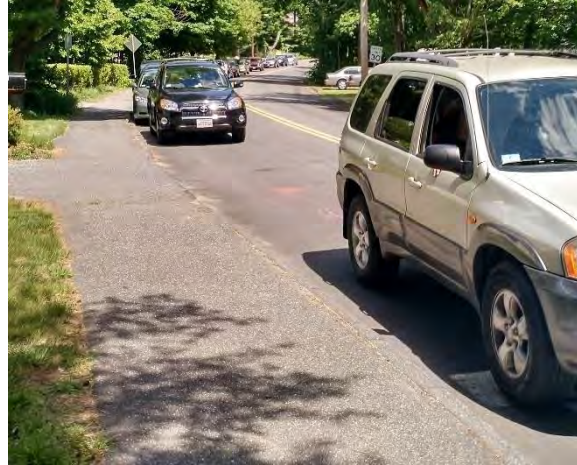
During the walk audit (described in more detail below), parents were observed queuing in the pick-up circle and along Concord Street (Figure 5) about 40 minutes before dismissal. Concord Street is a two-way, two-lane road with no parking. There were approximately 80 vehicles in the queue, which extended past Fiske Avenue. The queuing vehicles blocked the eastbound lane on Concord Street for about 40 minutes prior to dismissal and 10 minutes after dismissal. Several cars were observed driving eastbound in the westbound lane for 600 feet or more to bypass the queue. The 80-vehicle queue moved through the pick-up circle in 12 minutes. There is a 5-minute idling policy at the school, though this was not enforced during the walk audit.

Figure 5: Vehicle queue of parents prior to dismissal on Concord Street.

- *Educational and enforcement campaign to address queuing and idling.*
Parents should be encouraged to arrive at the school at the actual dismissal time. If parents were to arrive at dismissal, they would likely wait a maximum of 10-15 minutes in the queue to pick up children, as opposed to the 40-50 minutes they currently wait idling along Concord Street, blocking the westbound travel lane and creating unsafe conditions. School staff and law enforcement can actively warn parents who are queuing and idling for a targeted period before handing out tickets and fines. The school should also enforce the no parking rule along the “sidewalk” in the West Driveway where students walk and bike.

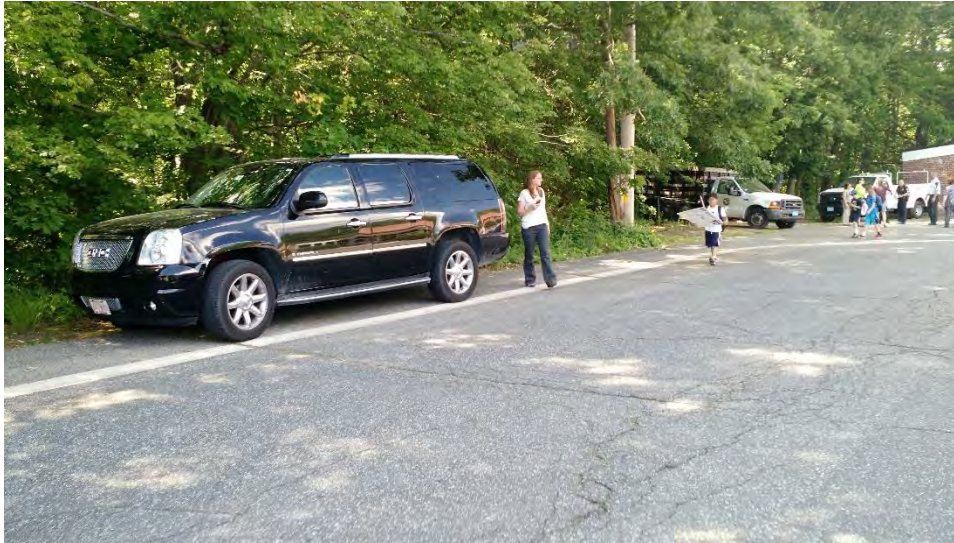
Figure 6: SUV parked in designated walking space at dismissal on the West Driveway

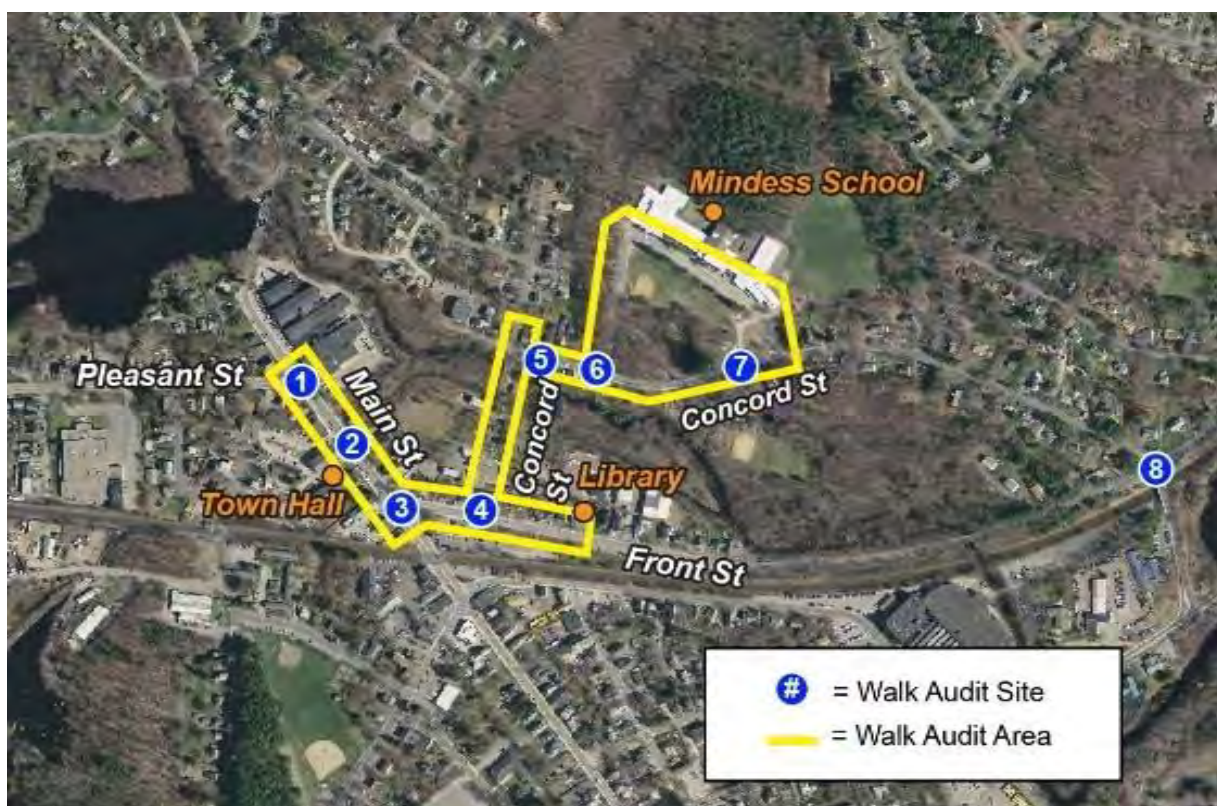
Figure 7 shows eight critical sites observed during the walk assessment. The study area (within the yellow line) was selected for high numbers of student residences within walking distance to the school and confirmed by the school champion as an area in need of bicycle and pedestrian improvements.

Figure 7: Walk audit study area

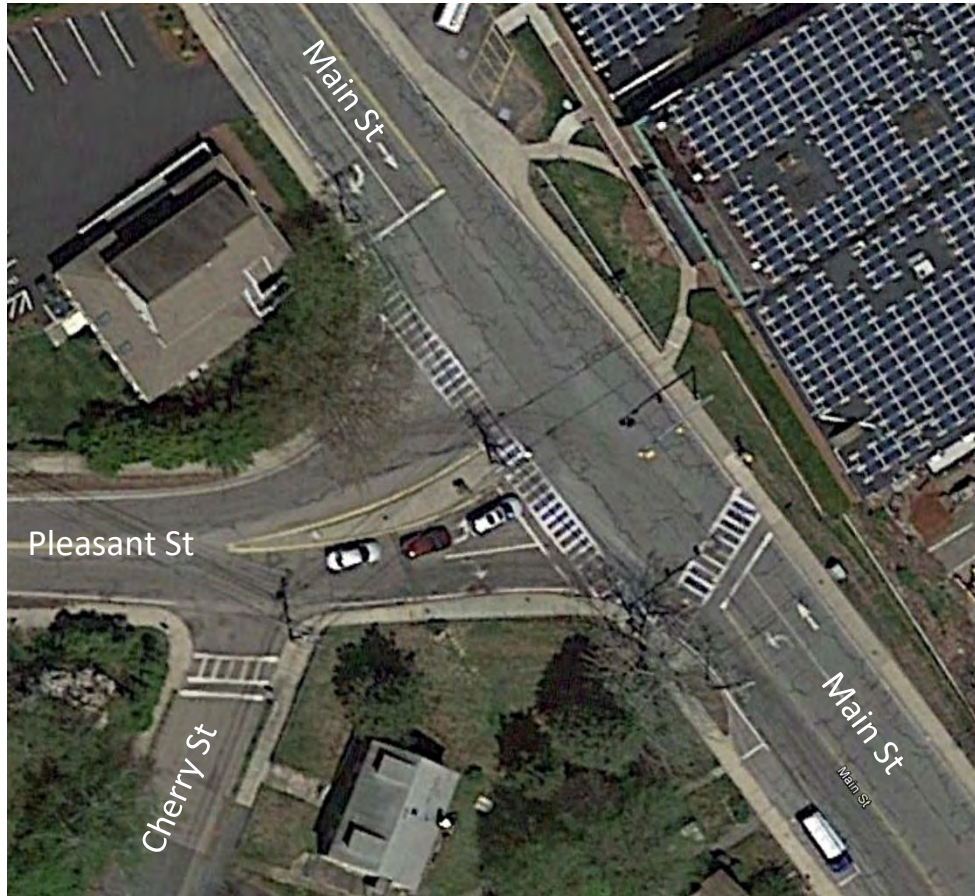
Figure 8: Site #1-Intersection of Pleasant Street and Main Street

The intersection of Main Street at Pleasant Street is a signalized T-intersection. Main Street runs in the general north-south direction with Pleasant Street intersecting from the west. Sidewalks are present along both sides of Main Street and Pleasant Street. Land use is primarily residential and commercial at this location. There is no on-street parking in this area. Cherry Street intersects Pleasant Street from the south approximately 85' to the west of Main Street. The Ashland MBTA Commuter Rail parking lot is located on Pleasant Street.

The intersection of Main Street at Pleasant Street experienced 12 reported collisions within the three year time period (2012 through 2014), averaging approximately 4 crashes per year. All reported collisions resulted in property damage only. Of the 12 crashes reported during this period, four were either sideswipe or angle type and five were rear-end crashes. In 2013, there was one reported rear-end collision involving a school bus that resulted in property damage only. It was observed that 50% of the crashes occurred during the drop-off and/or pick-up peak travel hours and another 33% occurred during wet/icy roadway conditions.

Potential recommendation: Add curb extensions to Pleasant Street and realign the crosswalk on Main Street to shorten crossing distances for pedestrians.

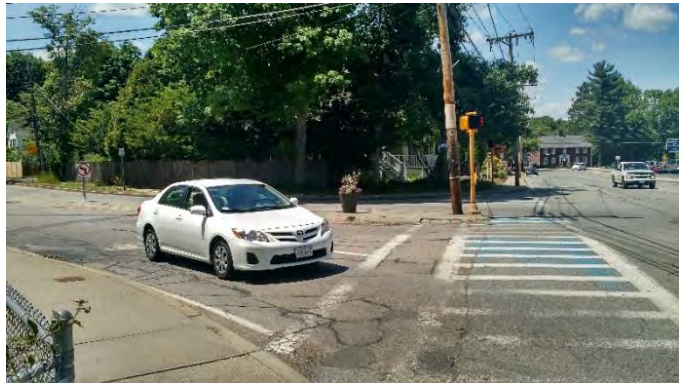
Figure 9: Intersection of Pleasant Street and Main Street, looking north on Main Street with Pleasant Street on the left.

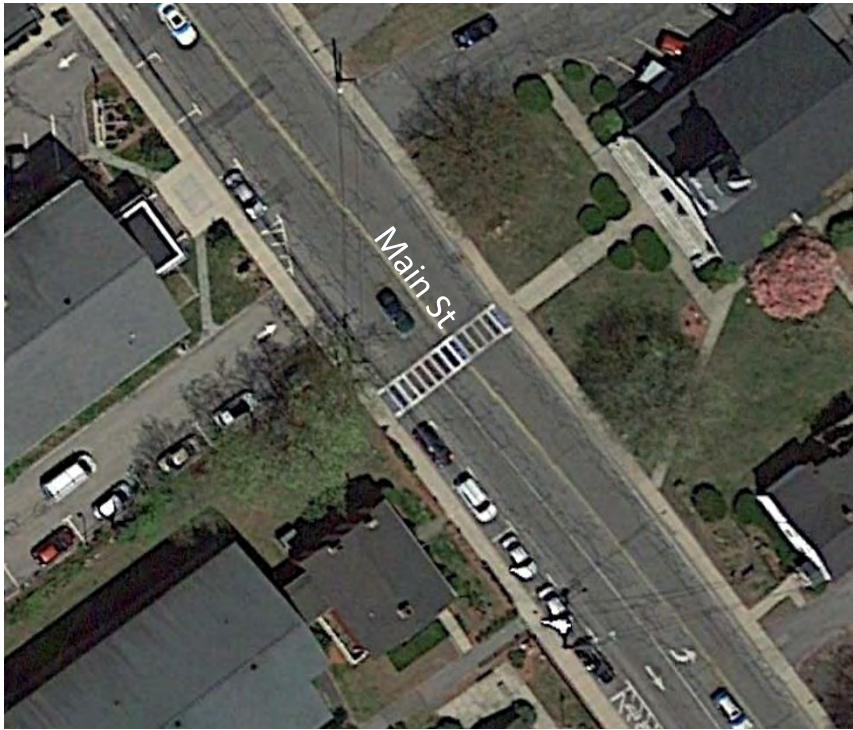
Figure 10: Site 2 - Midblock crosswalk on Main Street

There is an unsignalized mid-block crosswalk across Main Street, just south of the Ashland Town Hall, at the Federated Church of Ashland. There is one travel lane in each direction at this point on Main Street, and a southbound left-turn lane for Front Street begins at the crosswalk. There are sidewalks on both sides and curb ramps for the crosswalk. The exit driveway from Town Hall is immediately north of the crosswalk, and there is on street parking on the west side of Main Street in this area. “Pedestrian Crossing” and “State Law Yield to Pedestrians” signs are provided for both approaches, with the warning of a \$100 fine. Participants on the walk assessment reported high levels of pedestrian activity at this location related to the church and Town Hall.

- Long crossing distance
- Lack of visibility
- Potential for multiple threat crash due to the added left turn lane

Potential recommendation: Add curb extension at crosswalk.

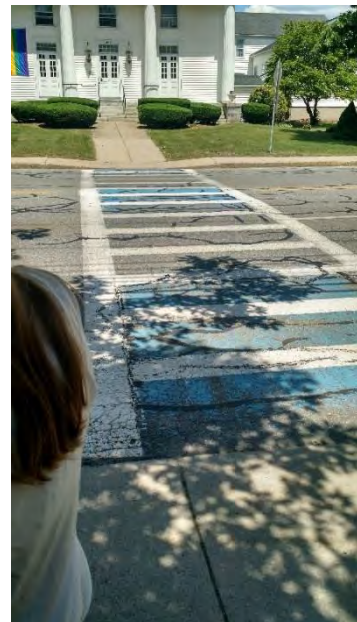
Figure 11: Mid-block crosswalk on Main Street. View looking east across Main Street.

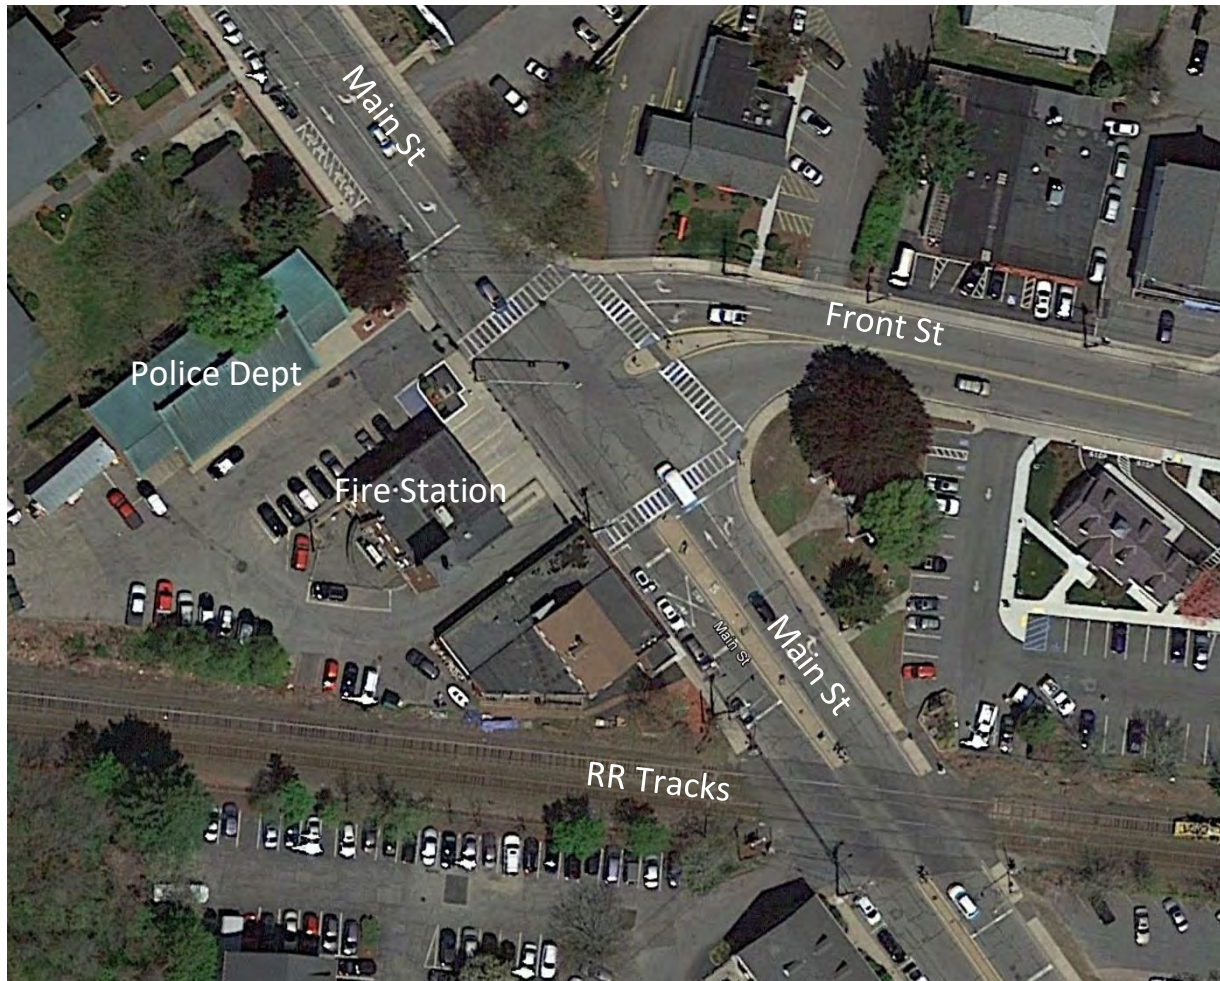
Figure 12: Site #3-Intersection of Main Street and Front Street

The intersection of Main Street at Front Street forms a signalized three-legged intersection. Main Street runs in the general north-south direction with Front Street intersecting from the east. At the intersection, Main Street consists of one through lane and one turning lane in both directions. Front Street consists of one left-turn lane and one right-turn lane. There are median islands on Front Street and on the northbound Main Street approach.

The majority of the reported collisions resulted in property damage only, however two were reported to have resulted in personal injury. Of the ten crashes reported during this period, four were rear-end crashes. In 2013,

there was one reported collision involving a vehicle traveling southbound that struck a pedestrian. It was also observed that 30% of the crashes occurred during the drop-off and/or pick-up peak travel hours and another 10% occurred during wet/icy roadway conditions.

Add curb extensions and widen the pedestrian refuge on Front Street to shorten pedestrian crossing distance. Add curb ramps to crossings on Main Street to accommodate people with mobility challenges.

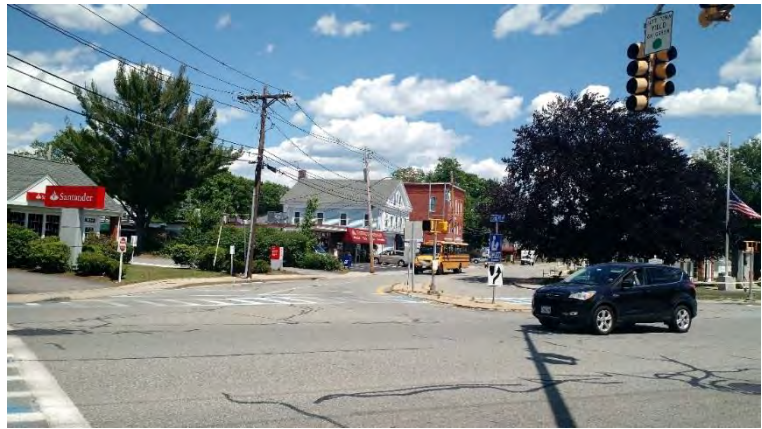
Figure 13: Intersection of Main Street and Front Street. View looking east on Main Street towards Front Street.

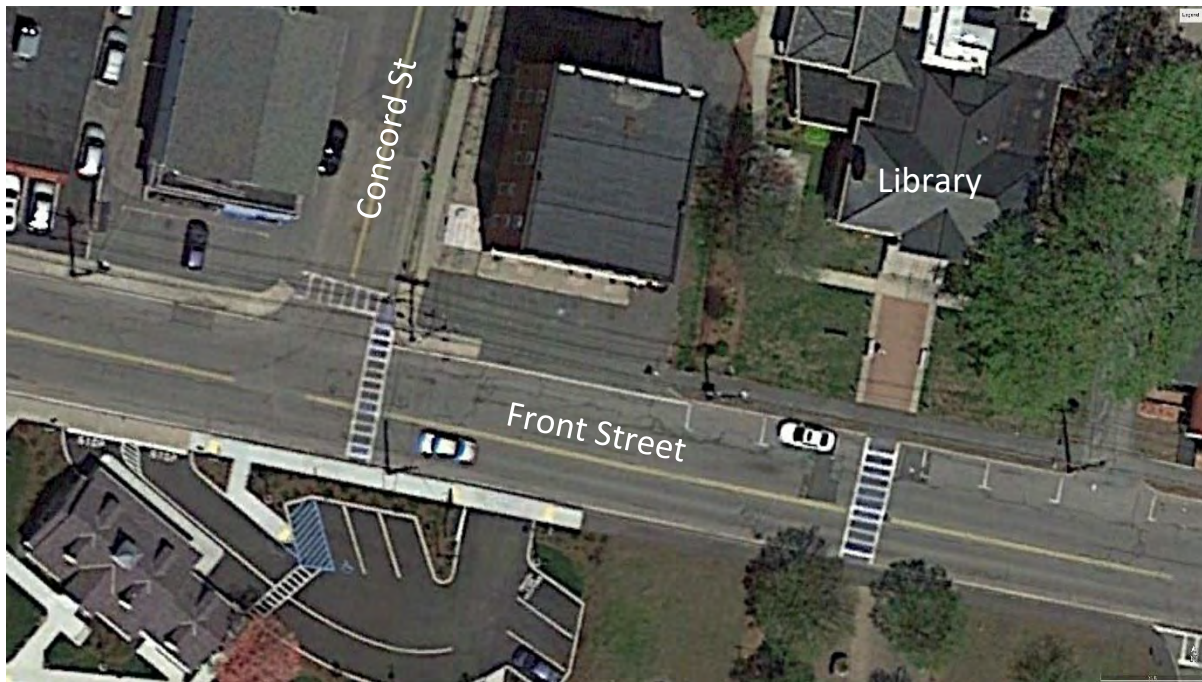
Figure 15: Site #4-Intersection of Front Street and Concord Street

The intersection of Concord Street at Front Street is a minor-leg stop-controlled, T-intersection. Front Street runs east-west with Concord Street intersecting from the north. Front Street is uncontrolled and Concord Street is stop-controlled, and there is one lane on each approach. Land use is primarily commercial and retail at this location.

The location experienced seven reported collisions from 2012 through 2014, averaging approximately 2.3 crashes per year. Of the seven crashes reported, one collision resulted in personal injury. Three reported crashes were either sideswipe or angle type and two were rear-end crashes. It was observed that 57% of the crashes occurred during the drop-off and/or pick-up peak travel hours and none occurred during wet/icy roadway conditions.

- **Missing sidewalk at parking lots on northern side of Front Street**
- **Long crossing distances**
- **Lack of pedestrian visibility**

Potential recommendation: Add two pedestrian warning signs at the uncontrolled crosswalk across Front Street at Concord Street, and two rectangular rapid flashing beacons at the mid-block crosswalk connecting the municipal parking lot to the library at Front Street. Construct concrete sidewalk with granite curbing across the driveway to better define the sidewalk space from parking. Construct a curb extension at the midblock crossing on the north side of

Front Street. Realign the crosswalk across Front Street at Concord Street so the crosswalks do not provide apex style curb ramps. Add ADA compliant ramps with detectable warning pads at both crosswalks, and restripe the crosswalk with high-visibility ladder style markings.

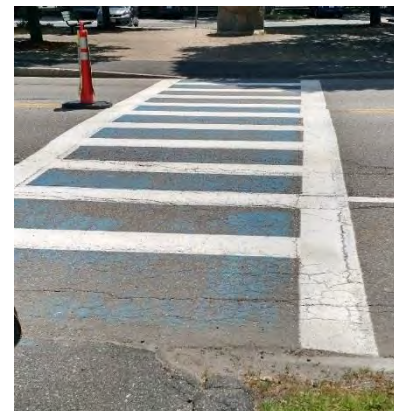
The Mindess School walking school bus starts at the parking lot on the south side of Front Street across from the library. There is a mid-block crosswalk across Front Street in front of the library with an in-street pedestrian sign. The walking school bus crosses Front Street using this crosswalk and turns west toward the Concord Street intersection, where it turns north towards the Mindess School. Participants on the walk assessment reported that in addition to students crossing the street as part of the walking school bus, this crosswalk has a high level of pedestrian activity related to the library, a church, and senior housing. There is on-street parking on the north side of Front Street on either side of the crosswalk, which may reduce visibility.

Figure 14: Mid-block crosswalk at Library on Front Street. View looking south across Front Street.

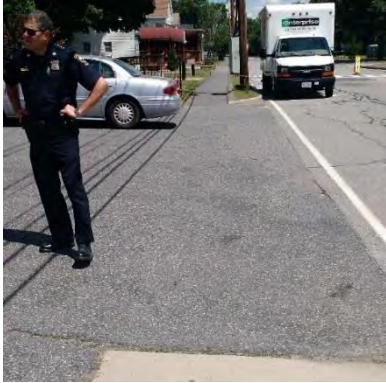
Figure 16: Parking lot at the intersection of Concord Street and Front Street. View looking east on Front Street.

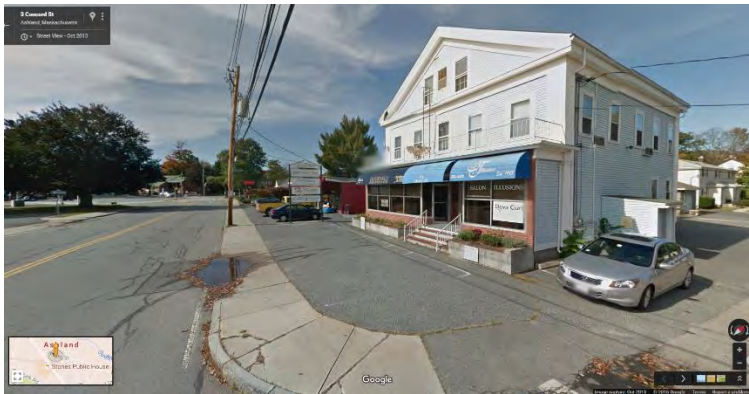
Figure 17: Driveway access on Front Street northwest of intersection with Concord Street

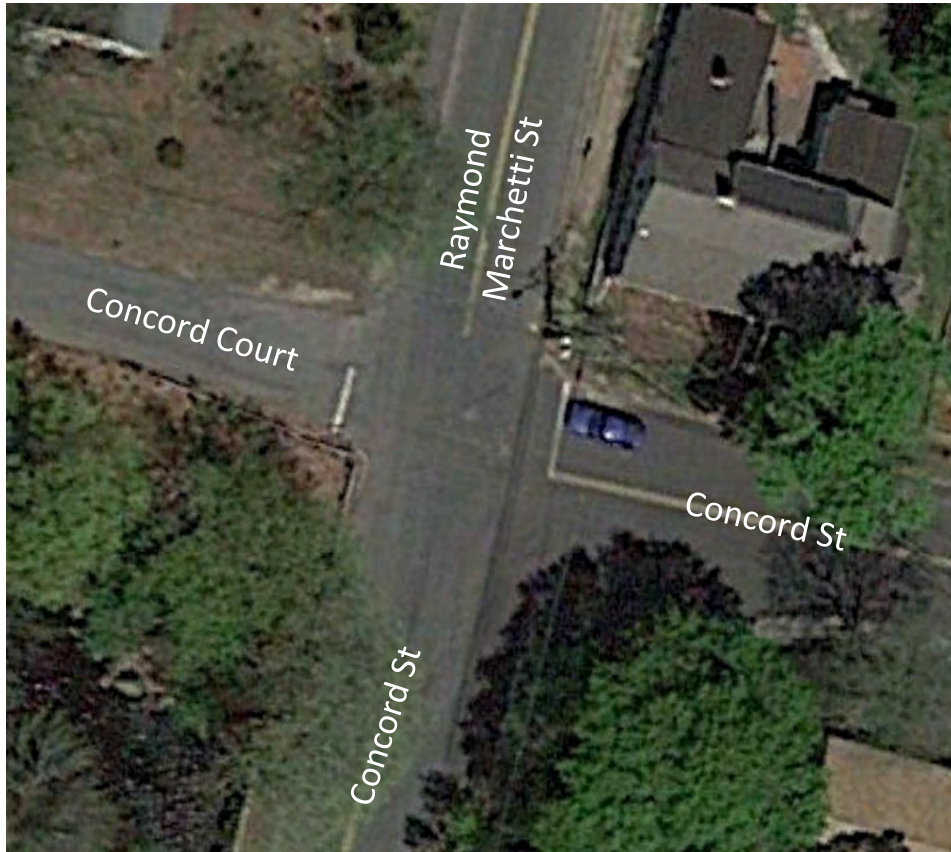
Figure 18: Site #5: Concord Street and Raymond Marchetti Street

The intersection of Concord Street at Raymond Marchetti Street is a four-way, east-west stop-controlled intersection immediately west of the Mindess School. Raymond Marchetti Street approaches from the north and Concord Court approaches from the west. Concord Court is a dead-end residential road. Concord Street approaches the intersection from the south and turns right at Raymond Marchetti Street, to continue eastbound toward the school. At the intersection, the eastbound and westbound approaches are stop-controlled while the northbound and southbound approaches are uncontrolled. All approaches consist of one lane. Land use is primarily residential at this location. Walk assessment participants noted that vehicles on Concord Street may make the turn to continue on Concord Street at high speeds. The southeast corner of the intersection has an extremely wide corner radius, which may facilitate these high speed turns.

the west side of Raymond Marchetti Street. With the missing sidewalks and crosswalks, there is no safe route between the school and the neighborhoods on the west side of Raymond Marchetti Street.

- **Missing sidewalks and crosswalks**
- **Wide northbound right turning radius**

Construct a sidewalk on the north side of Concord Street and on the west side of the Mindess School West Driveway. Reinstall the existing crosswalk with ramps to cross Concord Street at the Mindess School West Driveway. Install a crosswalk and accessible ramps on either side to cross Concord Street at Raymond Marchetti Way. Reduce the wide corner radius on the southeast corner of Concord Street.

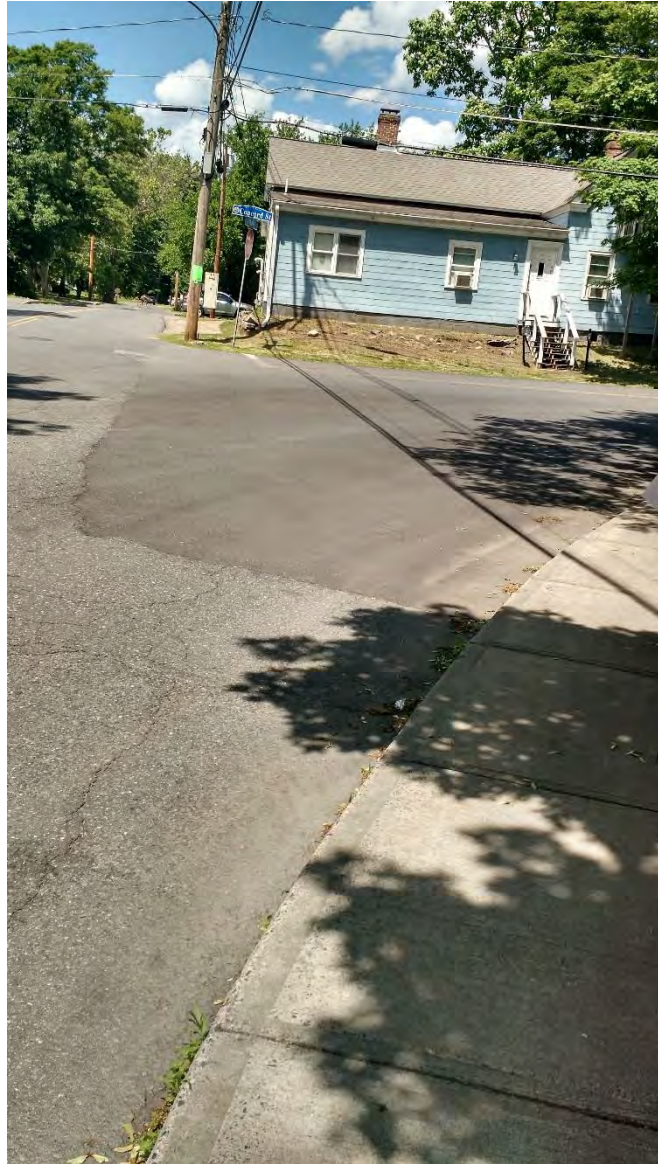
Figure 19: Intersection of Concord Street and Raymond Marchetti Way. View looking north from southeast corner.

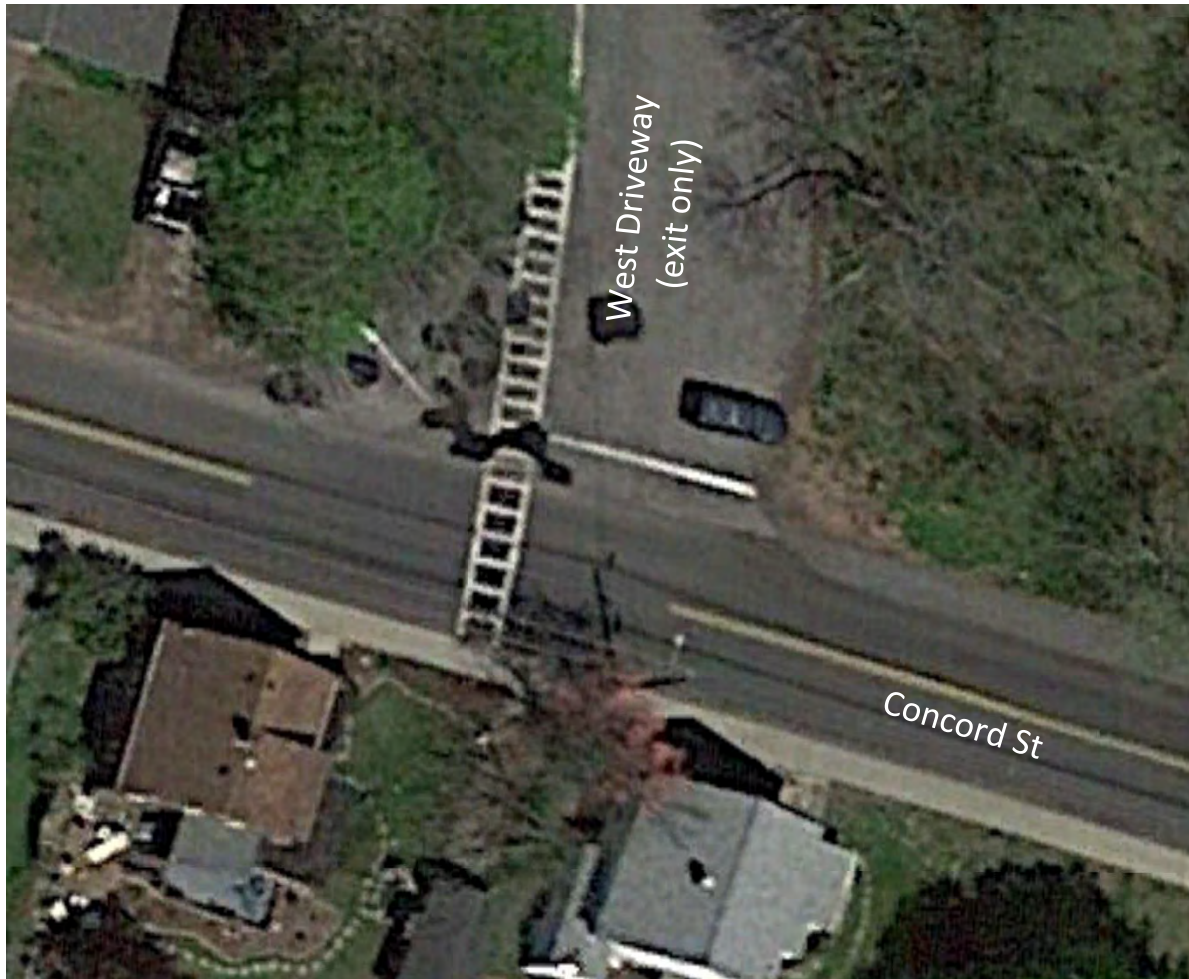
Figure 20: Site #6: Concord Street and the Western School Driveway

The western school driveway intersects Concord Street from the north and is exit only. Concord Street in this area is one lane in each direction. There is a sidewalk on the south side of Concord Street from the intersection with Raymond Marchetti Street to just west of the School's middle driveway, and on the north side of Concord Street from School's western driveway to Fountain Street in the east. Although exit-only with no lane markings, the western driveway is wide enough to accommodate two lanes of traffic. There is a painted buffer along the west side of the driveway which serves as a "sidewalk," but does not offer physical separation from traffic. Walk assessment participants observed a vehicle parked in the painted "sidewalk," forcing students exiting via this driveway to walk in the travel lane.

There is a crosswalk across Concord Street at the western driveway, connecting to the painted driveway “sidewalk.” The wide corner radii of the western driveway creates a long crossing distance. Additionally, right-turning vehicles exiting the School queue up in the crosswalk.

- **Driveway configuration**
- **Long crossing distance**
- **Wide corner radius**
- **Missing sidewalks along driveway and along Concord Street west to Raymond Marchetti Street**
- **Poor visibility due to curvature of Concord Street and vegetation**

Potential recommendation: Construct a sidewalk along the east side of Raymond Marchetti Way and an off-road path connecting this new sidewalk to the Mindess School west driveway. Procure an easement from one or more property owners to construct the path. Ideally, this recommendation would be completed in tandem with the recommendation for Site #5, which includes a sidewalk on the northern side of Concord Street and west side of the Mindess School West Driveway.

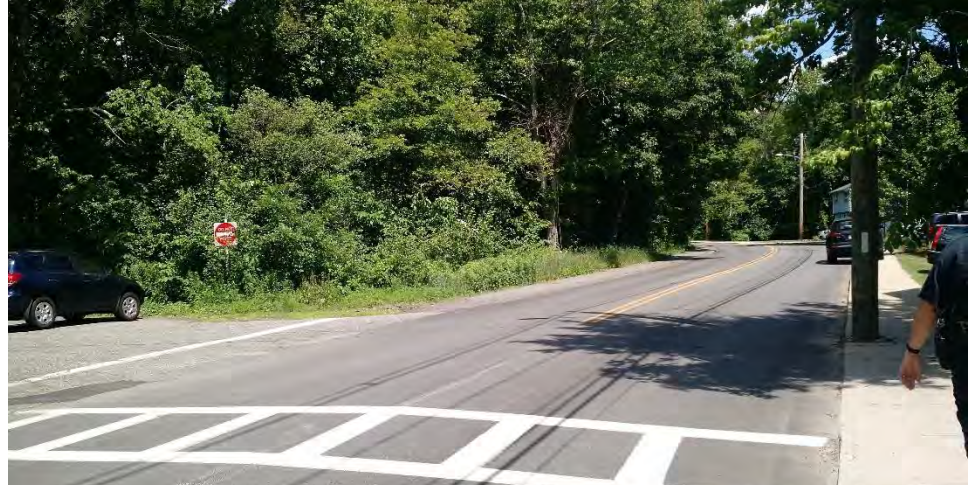
Figure 21: Crosswalk at Concord Street and West Driveway of Mindess School. View looking east on Concord Street with the driveway on the left.

On approach to the crosswalk, sight lines for westbound vehicles are limited due to vegetation along the northern side of Concord Street and due to the horizontal curvature of Concord Street. Several participants of the walk assessment suggested that pedestrians would be safer accessing the school via a crosswalk at the corner of Concord Street at Raymond Marchetti Street. However, there is no sidewalk on the northern side of Concord Street to connect this intersection to the School.

- *Crossing guard stationed at the intersection of Concord Street and the West Driveway.*
Adding a crossing guard at this corner would provide assistance to the walking school bus and likely encourage more families to walk and bike. The majority of school traffic passes through this intersection at dismissal, which may make it challenging for students walking and bicycling. The crossing guard should be moved to the intersection of Concord Street and Raymond Marchetti Street if a sidewalk and crosswalk are constructed on the northern side of Concord Street as recommended below.

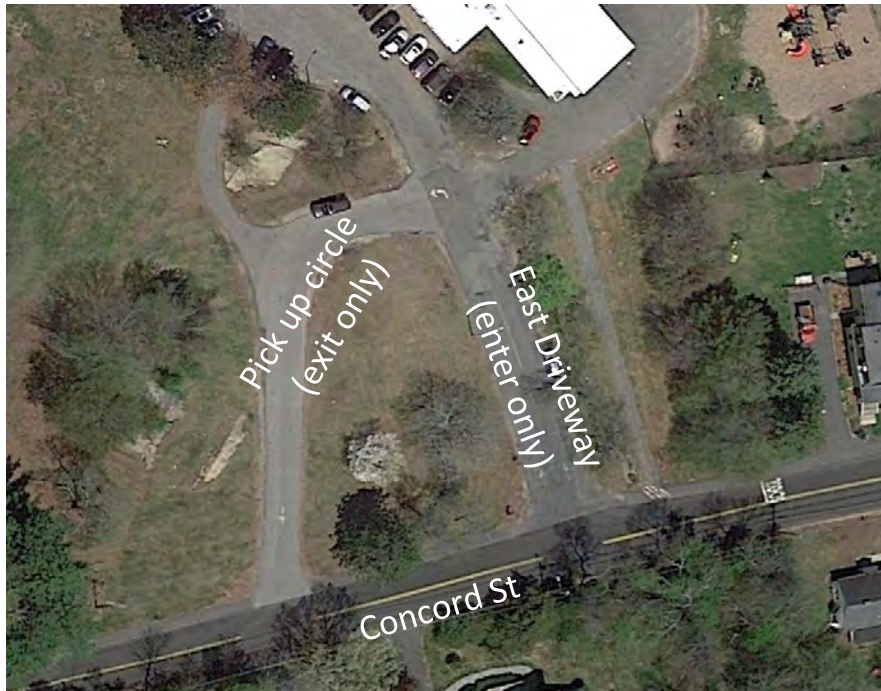
Figure 22: Concord Street and the east driveway

The east driveway is a two-lane enter-only driveway providing access for all vehicles to the school, school parking lot and the pick-up circle utilized for private vehicle pick-up. The middle driveway is a one lane exit-only driveway from the parent pick-up circle.

The intersection of Concord Street at Fiske Road (to the east of the East Driveway) experienced two reported collisions within the three year time period (2012 through 2014), averaging less than one crash per year. All reported collisions resulted in property damage only. One reported crash was an angular crash while the other was a single vehicle collision that crashes with a fixed-object. Both crashes occurred during the drop-off and/or pick-up peak travel hours and 50% occurred during wet/icy roadway conditions.

- **Disorganized behavior during dismissal period on the school driveway**

Potential recommendation: See the non-infrastructure recommendations in Section 5.1 above.

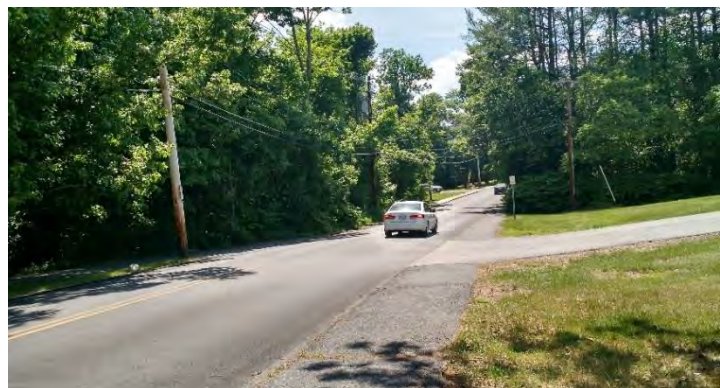
Figure 23: Looking west on Concord Street with the east driveway on the right.

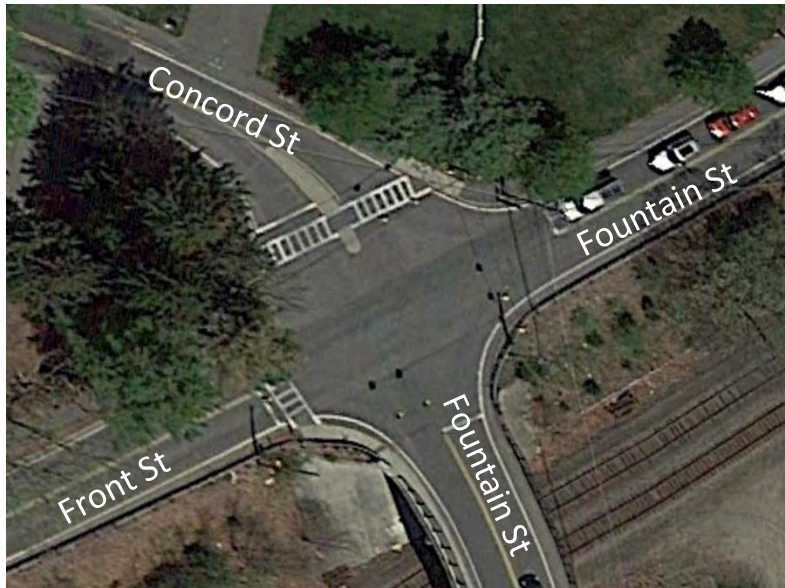
Figure 24: Site #8: Concord Street and Fountain Street

Participants on the walk audit noted that the intersection of Concord Street and Fountain Street is an important connection for students walking to the Mindess School. There is one lane on each approach and a temporary traffic signal in place due to construction. There is a sidewalk on the north side of Front/Fountain Streets, the east side of Concord Street, and the west side of northbound Fountain Street. There are crosswalks with curb ramps across the eastbound and southbound approaches. Both Fountain Street and Concord Street have wide curb radii at the intersection, resulting in long crosswalks.

The intersection of Front Street at Concord Street and Fountain Street experienced seven reported collisions within the three year time period (2012 through 2014), averaging approximately 2.3 crashes per year. Of the seven crashes reported, one collision resulted in personal injury. Three reported crashes were either sideswipe or angle type and two were rear-end crashes. It was also observed that 57% of the crashes occurred during the drop-off and/or pick-up peak travel hours and no crashes occurred during wet/icy roadway conditions.

Potential recommendation: Construct curb extensions to shorten the crossing distance across Concord Street and Front Street.

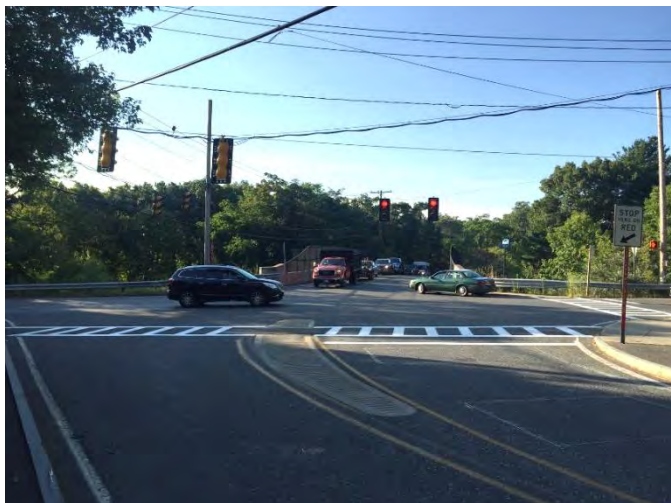
Figure 25: Intersection of Front Street and Concord Street. View looking south on Concord Street.

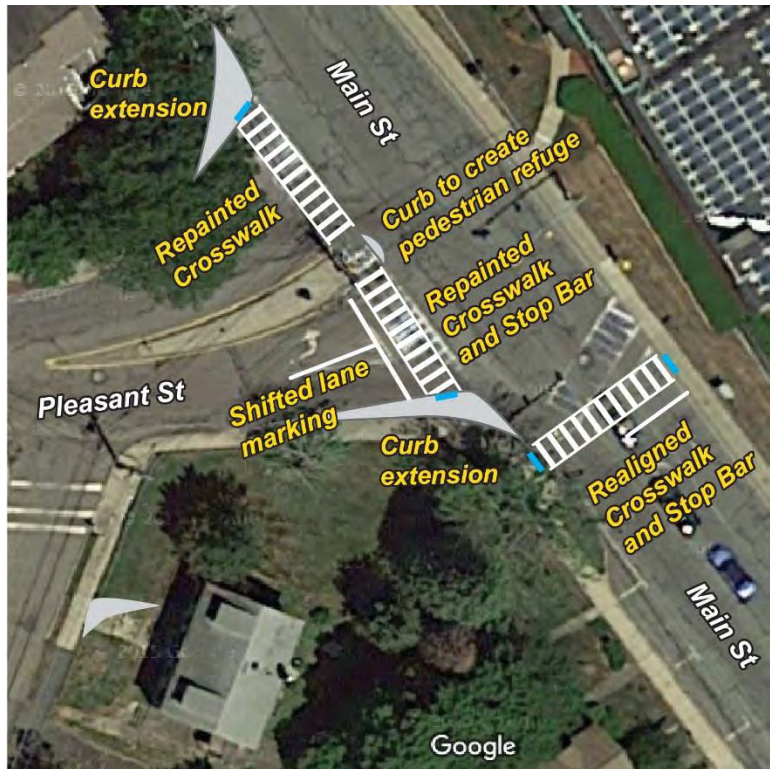
Figure 26: Recommended improvements at the intersection of Main Street and Pleasant Street.

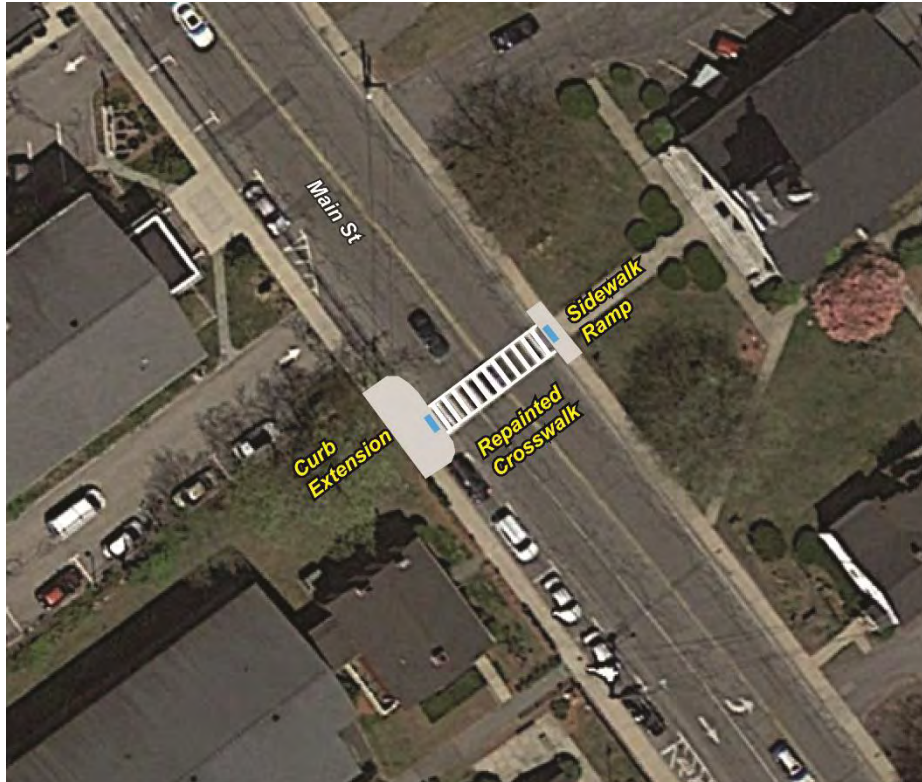
- Long crossing distance
- Lack of visibility
- Potential for multiple threat crash due to the added left turn lane

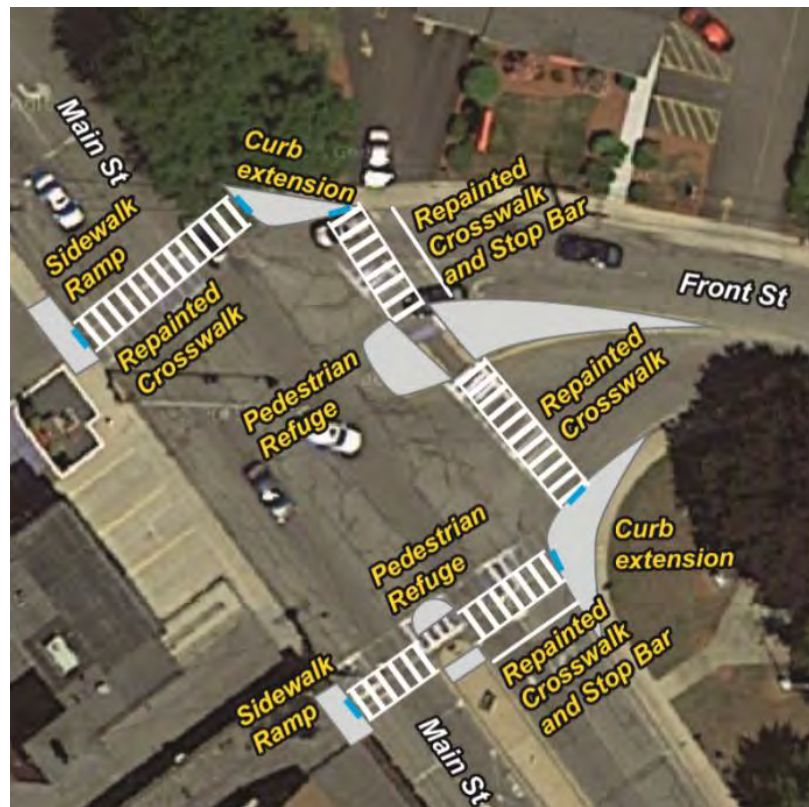
Figure 27: Recommended improvements at the intersection of Main Street and Front Street.
