DAVID MINDESS ELEMENTARY SCHOOL ASSESSMENT REPORT Ashland, MA

January 2017

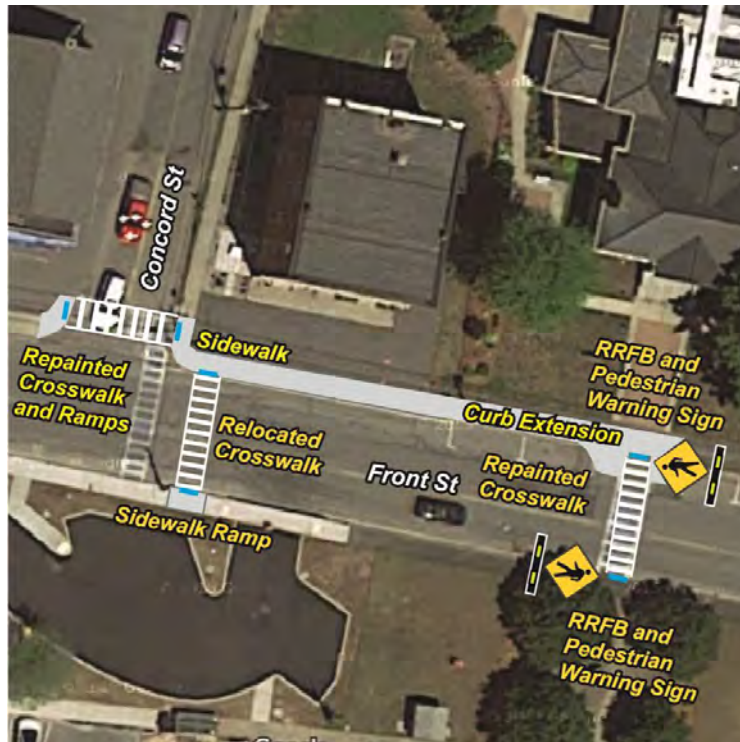
Figure 28: Recommended improvements at the intersection of Front Street and Concord Street.

Potential recommendation: Add two pedestrian warning signs at the uncontrolled crosswalk across Front Street at Concord Street, and two rectangular rapid flashing beacons at the mid-block crosswalk connecting the municipal parking lot to the library at Front Street. Construct concrete sidewalk with granite curbing across the driveway to better define the sidewalk space from parking. Construct a curb extension at the midblock crossing on the north side of

Front Street. Realign the crosswalk across Front Street at Concord Street so the crosswalks do not provide apex style curb ramps. Add ADA compliant ramps with detectable warning pads at both crosswalks, and restripe the crosswalk with high-visibility ladder style markings.

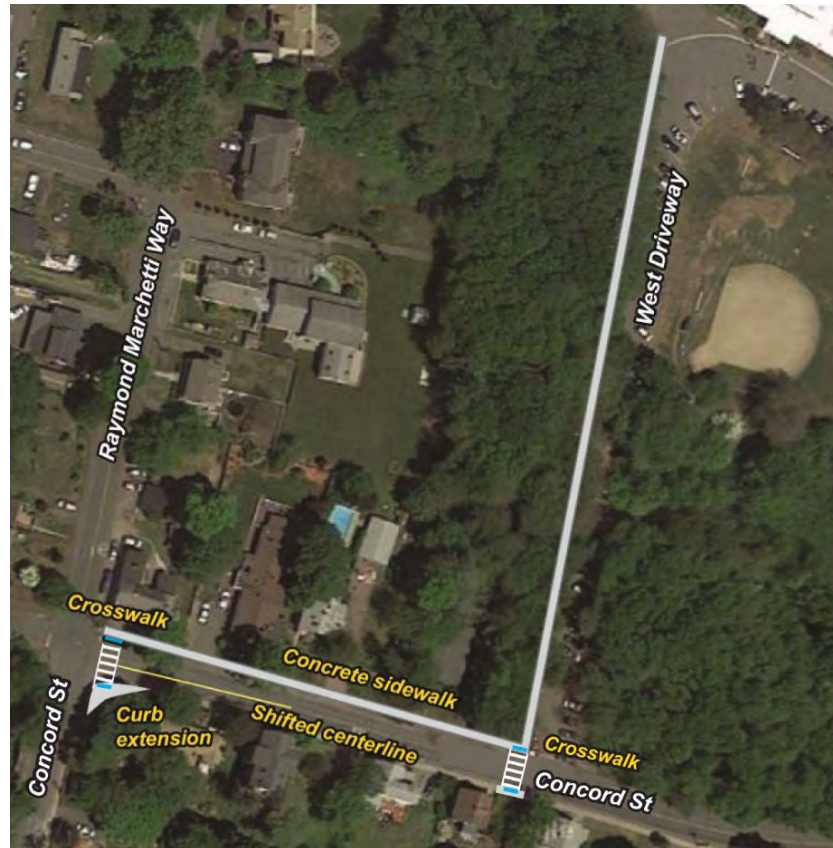
Figure 29: Recommended improvements at the intersection of Concord Street and Raymond Marchetti Way and at the west driveway.

Construct a sidewalk on the north side of Concord Street and on the west side of the Mindess School West Driveway. Reinstall the existing crosswalk with ramps to cross Concord Street at the Mindess School West Driveway. Install a crosswalk and accessible ramps on either side to cross Concord Street at Raymond Marchetti Way. Reduce the wide corner radius on the southeast corner of Concord Street.

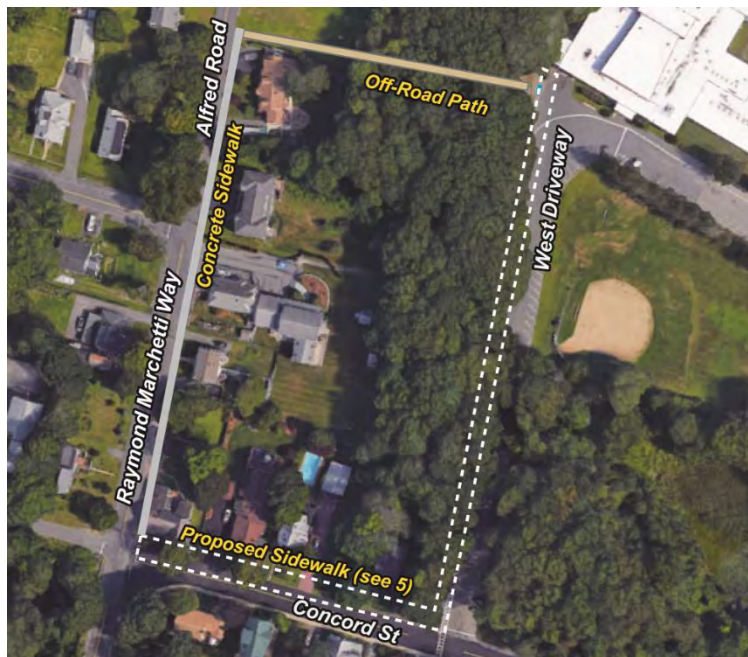
Figure 30: Recommended Improvements to Connect the Mindess School Driveway to Alfred Road.

Potential recommendation: Construct a sidewalk along the east side of Raymond Marchetti Way and an off-road path connecting this new sidewalk to the Mindess School west driveway. Procure an easement from one or more property owners to construct the path. Ideally, this recommendation would be completed in tandem with the recommendation for Site #5, which includes a sidewalk on the northern side of Concord Street and west side of the Mindess School West Driveway.

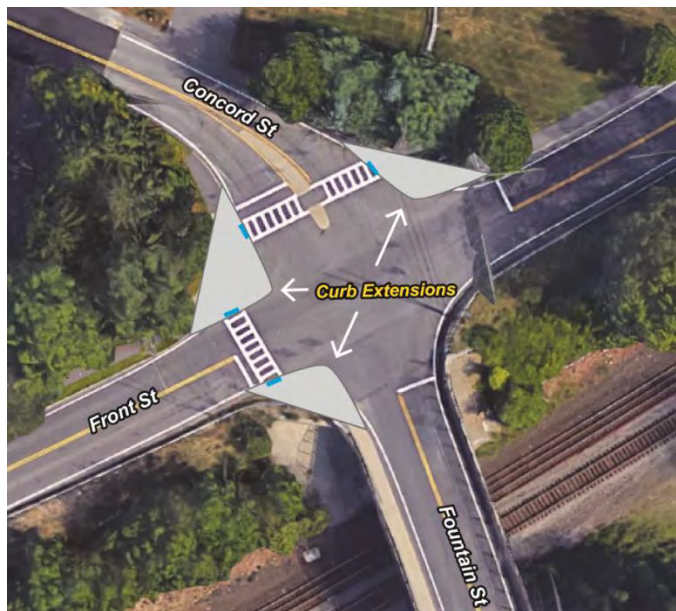
Figure 31: Recommended improvements at the intersection of Concord Street and Front Street (East).

Potential recommendation: Construct curb extensions to shorten the crossing distance across Concord Street and Front Street.

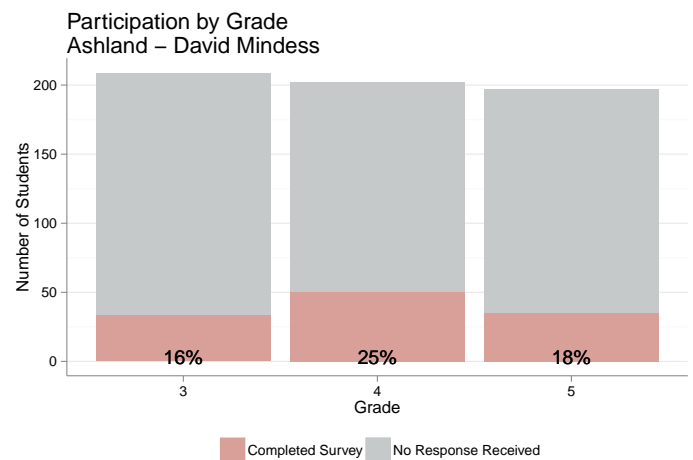
- Survey Dates: 2016-06-02 to 2016-06-16
- Responses Received: 119
- School-wide Participation Rate: 20%

The figure below shows the survey participation rate for each grade. Total enrollment is based on the 2015-2016 school year, per Department of Elementary and Secondary Education. Survey responses from each grade were used to estimate the distance and travel choice for the entire grade. The higher the participation rate, the more reliable the survey results are.

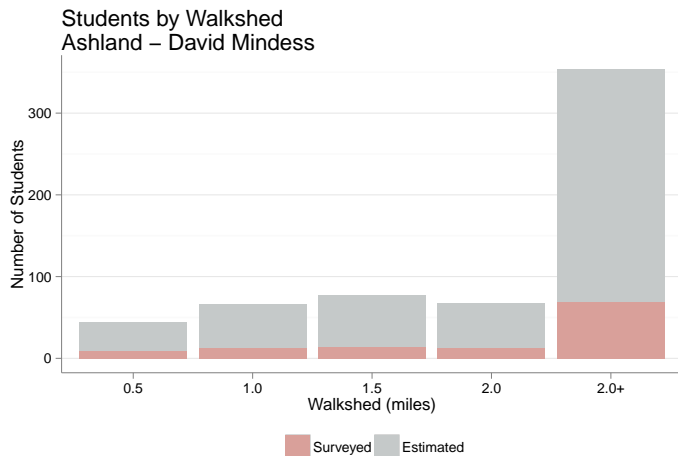
Students By Walkshed

The chart and table below show the number of students surveyed and the total estimated students by walkshed. Student totals by walkshed are estimated assuming that the proportion of surveyed students within each walkshed and grade is proportional to the enrolled students within each walkshed and grade.

Students	0.5	1.0	1.5	2.0	2.0+
Estimated	44	66	77	67	353
Surveyed	9	13	15	13	69
Percent	7%	11%	13%	11%	58%

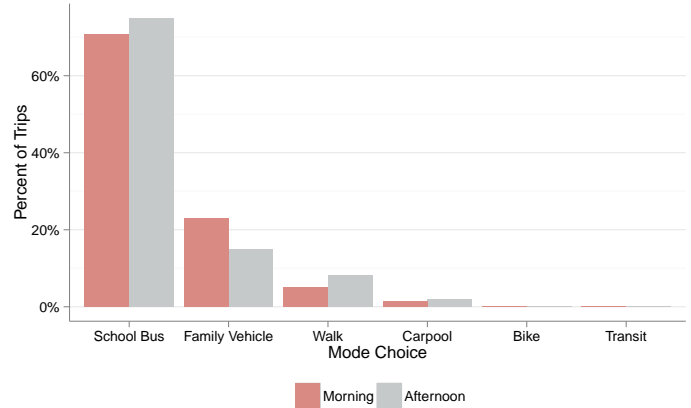
Morning and Afternoon Mode Choices
Ashland – David Mindess

Walk share is 4.9% in the morning and 8.2% in the afternoon. The auto share is lower in the afternoon, indicating that as many as 30.8% of those who are driven to school in the morning get home by other means in the afternoon.

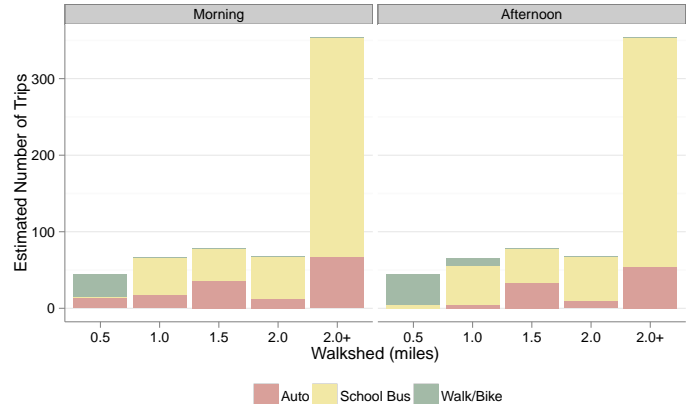
Travel Mode, Morning and Afternoon

0.5	1.0	1.5	2.0	2.0+
Morning					
Auto	14	18	36	12	68
School Bus	0	48	42	55	285
Walk	30	0	0	0	0
Afternoon					
Auto	0	4	34	10	54
School Bus	4	52	43	57	299
Walk	40	10	0	0	0

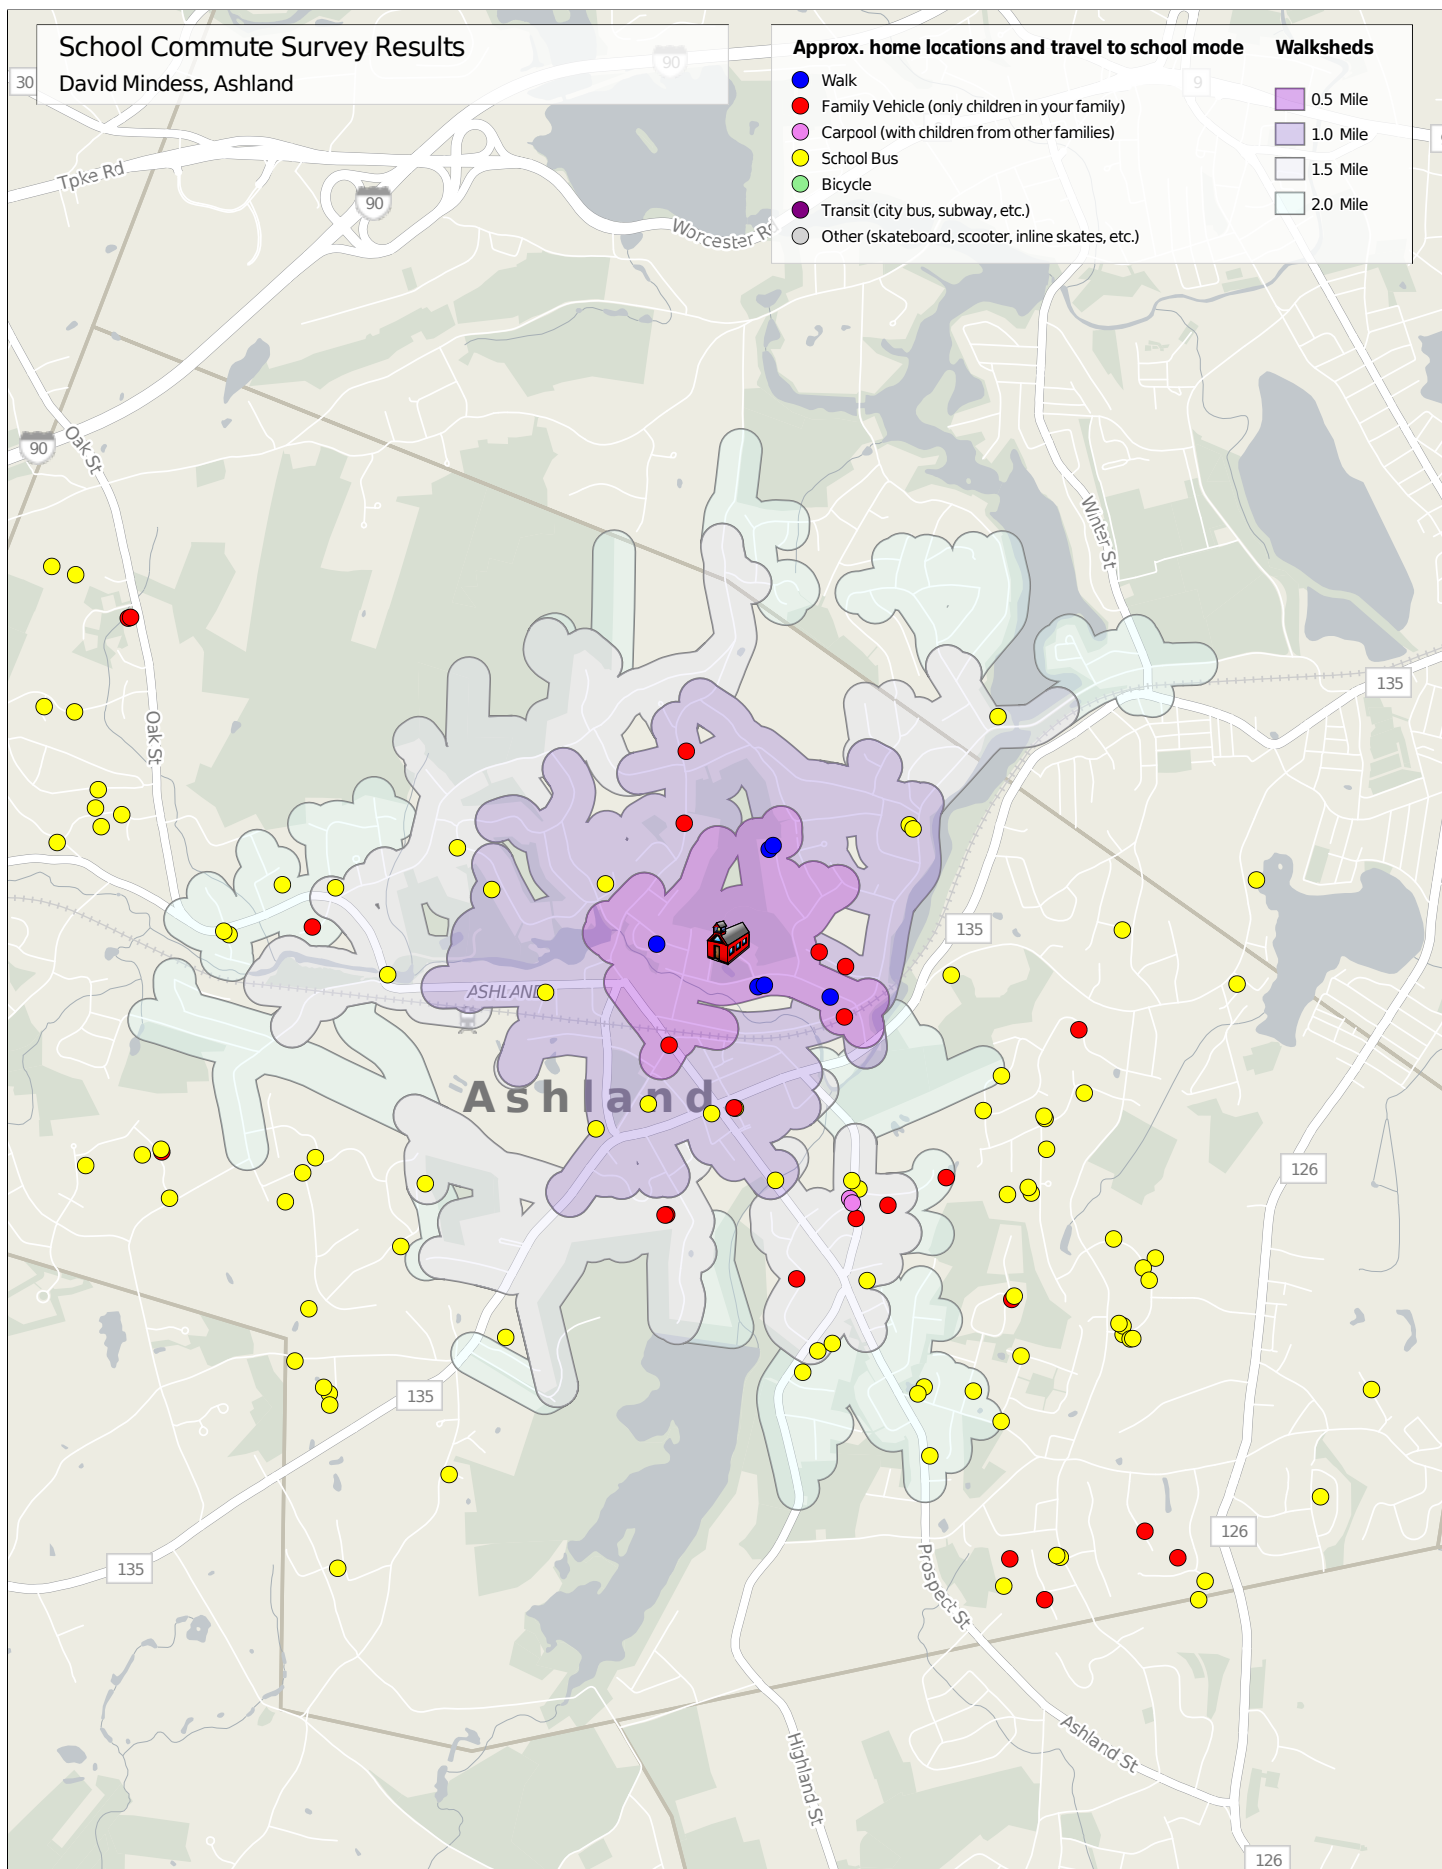
Walksheds

- 0.5 Mile
- 1.0 Mile
- 1.5 Mile
- 2.0 Mile
