WATERSHED-BASED PLAN

Bare Hill Pond

HARVARD, MA

July 25, 2025

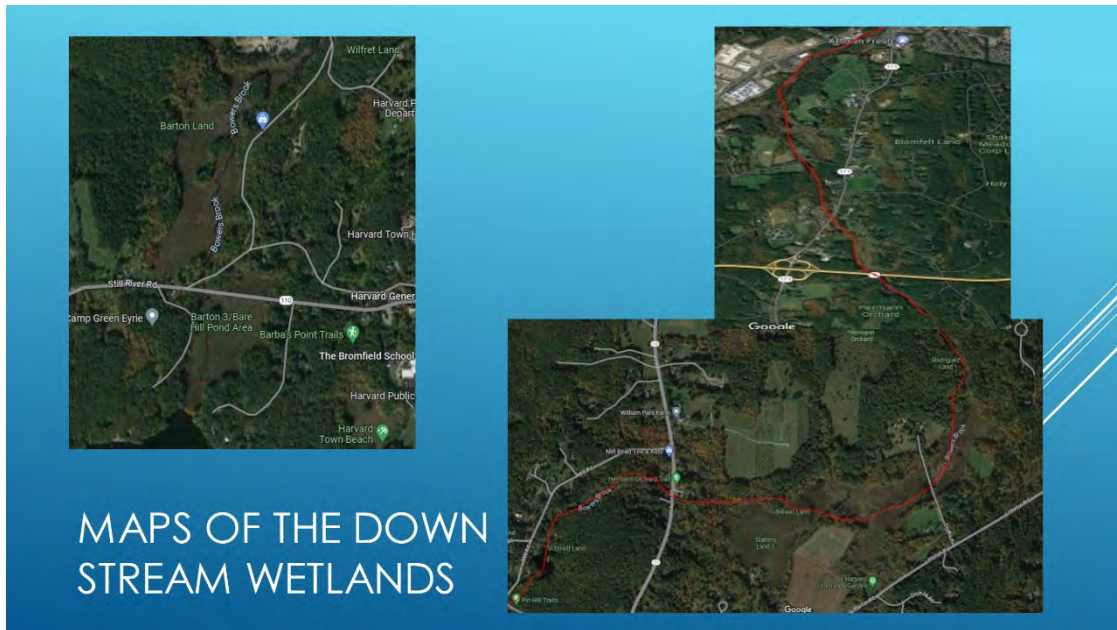
These wetlands provide a nature-based solution for the removal of phosphorus from the water leaving Bare Hill Pond to protect downstream watershed areas. Also, they significantly moderate the flow of water during the drawdown which occurs at approximately 2" per day as required in the QAPP.

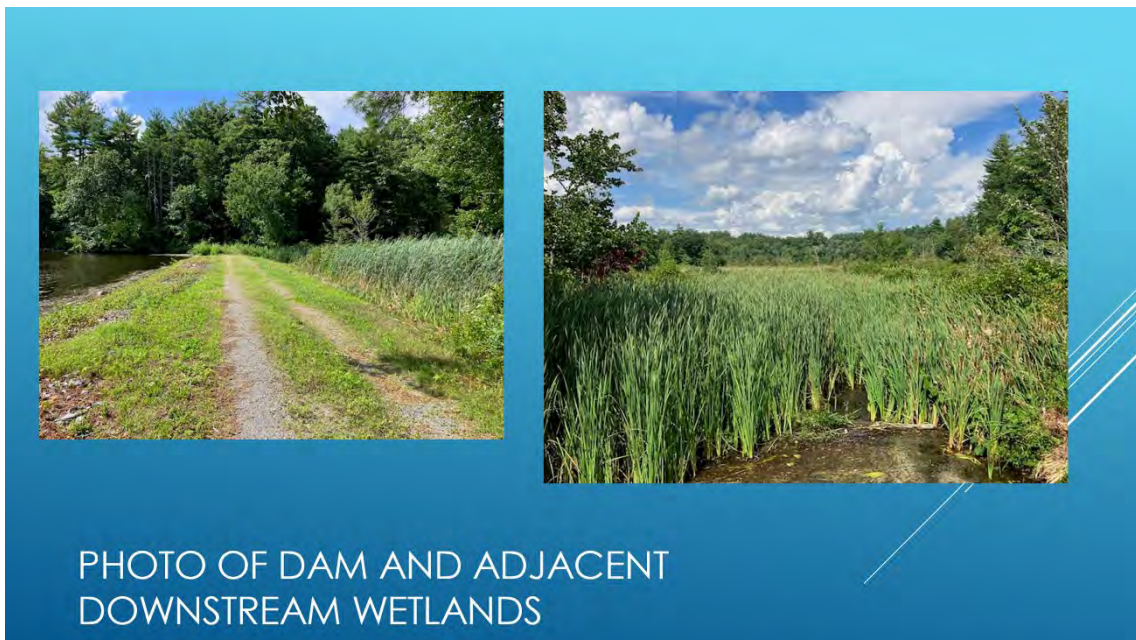
Here are photos showing the dam and adjacent wetlands and their health looking north to Rt 110:

Note that even with the higher flow of water below the dam, there is little evidence of channeling and good evidence of dispersal of the water. There is a large impoundment created by Rt 110 in the distance approximately at tree line where the water is held back by the road during the drawdown and the outflow is regulated by the existing culvert which is well above the height of the floor of the wetland. This allows for a

slower movement of the water. The roads and culverts perform similar function intermittently over the approximately 4 miles of wetlands.

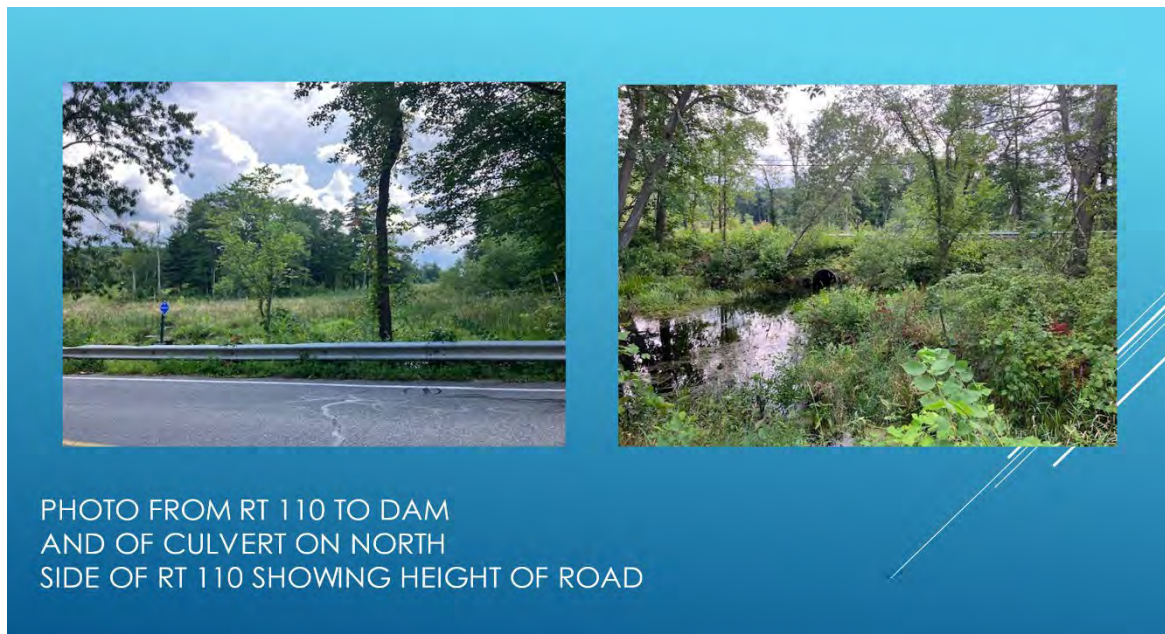
Here are additional photos of the wetlands in the first mile or two below the dam:

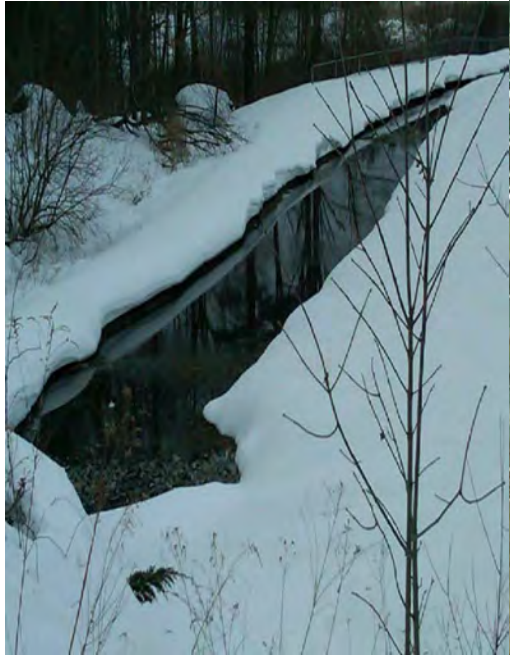
DA4 on Map

Here are photos of the major BMP sites that are in operation:

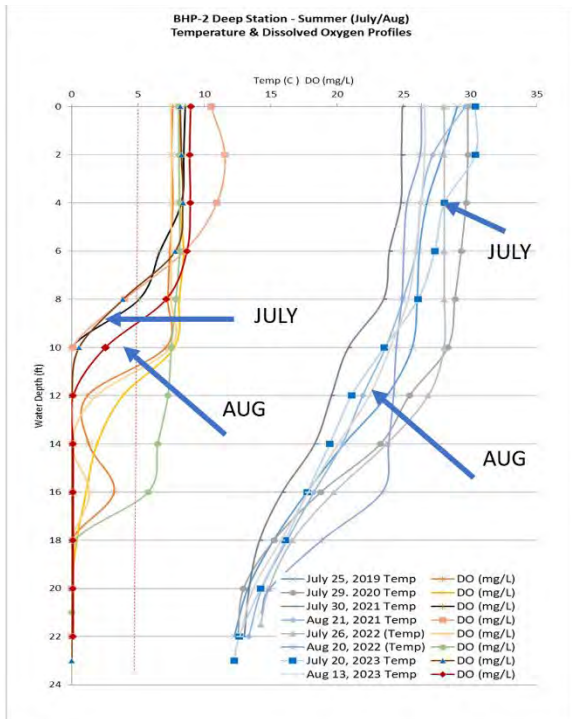
The following data from the [2023 ARC Annual Report](#) and prior annual reports show the impact of increased temperatures and anoxic zone expansion over the last few years. One can also see the impact of phosphorus release in the sample sites in the deeper zones.

Note: Red Line = low visibility indicator of algal bloom and hazardous visibility for swimming per Harvard Board of Health

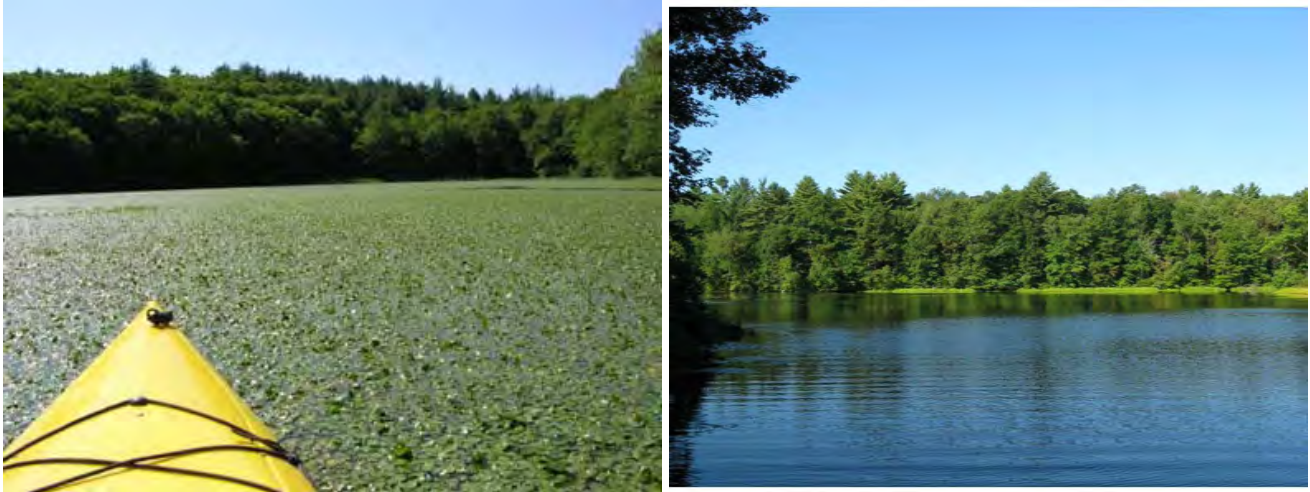
Invasive water chestnut plants were also identified as a goal for removal in the 1999 TMDL. Below is a picture of the Clapps Brook area of Bare Hill Pond as it typically appeared in mid-summer prior to 6 years of harvesting and a picture after the multiple years of harvesting in mid-summer. A video documentary discussing this successful project can be found [here](#).

Today an occasional water chestnut plant is observed and hand pulled from time to time. The area is now largely populated with native species due to the area being in the drawdown zone allowing native plants to out-compete the fanwort and milfoil.

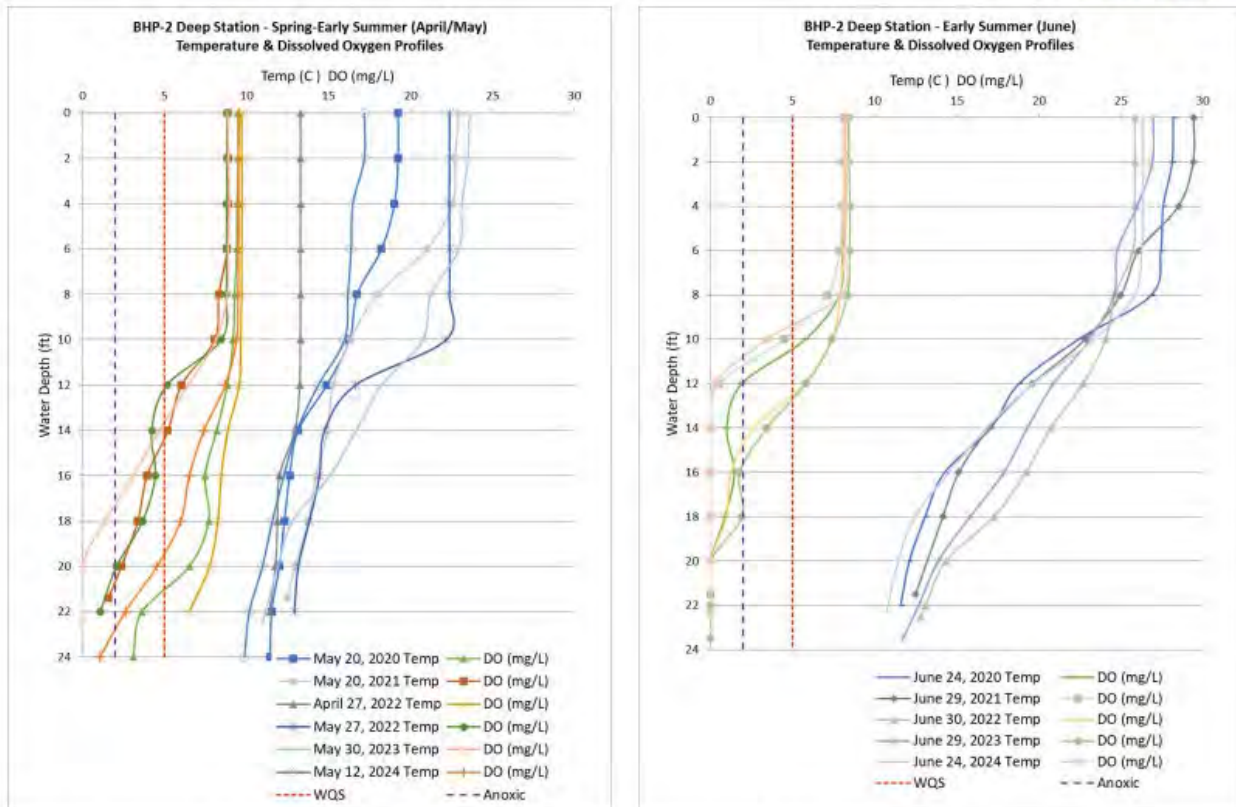
Figure 5. Temperature & Dissolved Oxygen Profiles at BHP-2 during Spring & Early Summer for 2020-2024

As shown in the following graphs, as temperature increases, dissolved oxygen increases, and this in turn leads to anerobic release of phosphorus from the pond sediment. Note the difference between Spring and Summer:

Note also that the crossing of the dotted black line (anoxic condition) occurs at a shallower depth in the summer when the temperature is high in Summer compared to Spring.
