**Barnstable County Superior Court
Barnstable, MA**

**HVAC SYSTEM
EVALUATIONS
COVID-19**

Office of Court Management

January 13, 2021

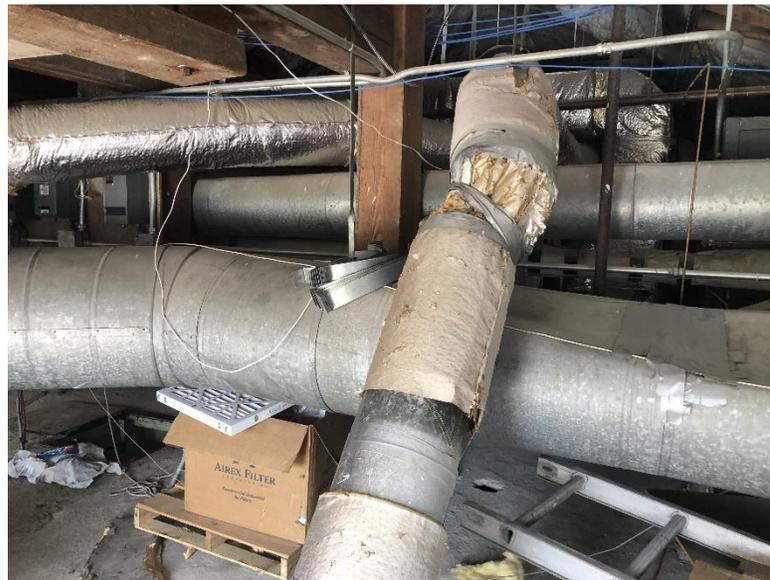
Photo 1 – Representative Attic Conditions

The main courtroom is heated, cooled, and ventilated by a constant volume air handling unit (AHU-1) located in the attic. This AHU has steam heat, an associated external exhaust fan and pneumatic controls. We understand that most of the pneumatic controls for the AHU are no longer operational. The drawings indicate that the unit was installed in 1971, and the unit appears to be original. The unit is in very poor condition but operational. The pneumatic actuator for the linked outside air and return air damper is no longer functional. Facilities staff indicated that they have recently manually shifted the damper to a higher outside air percentage. The fans for this unit only operate during the heating season. During the cooling season, a pair of residential-type air handlers provide cooling through the same ductwork distribution system. No ventilation air is provided during the cooling season.

An air handler in the attic (AHU-2) originally served many first and second floor interior spaces but has been out of service for some time according to staff. Some of the ductwork has been damaged/removed, and some registers have been blocked off. It is unclear if the unit is salvageable.

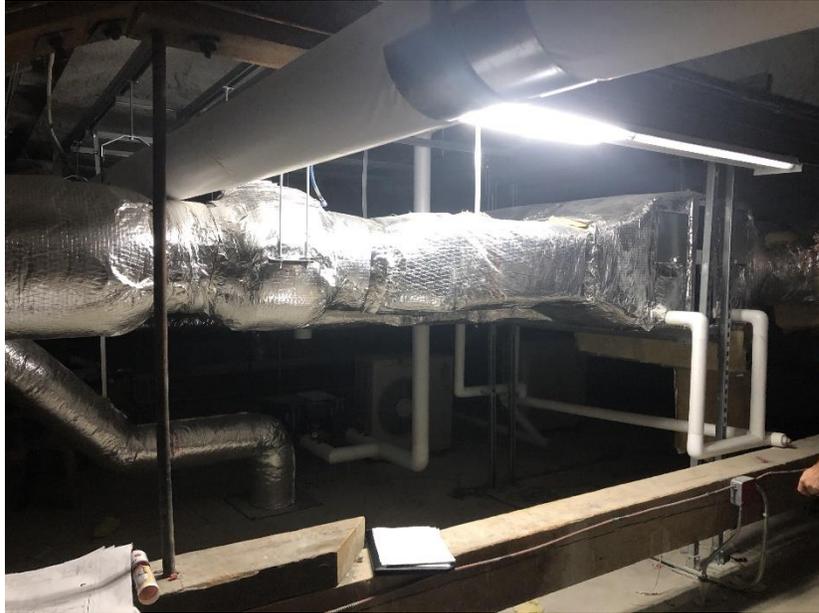
Photo 2 – Lockup ventilation system

The second floor lockup area was renovated in 2019. This area is heated and cooled with ducted heat pump units concealed above a drop ceiling and ventilated with a dedicated Energy Recovery Ventilator (ERV) providing 100% outside air directly to the cells and corridor, and exhausting through the cells.

This measure is recommended for the lockup areas only. The lockup ventilation strategy is based on maintaining a slight airflow deficit in the cells relative to the corridors in the lockup area. To minimize the risk of one prisoner infecting others, it is important that the air balance is correct. If any exhaust grilles have been accidentally closed or if the supply air flow is too high in these areas, the likelihood of cross contamination increases.

The design documents indicate a very small (5 CFM) differential between the supply and exhaust air in each of the cells. This is below the margin of error during balancing and does not provide adequate differential between supply and exhaust. We recommend balancing each cell to 75 CFM of supply air and 100 CFM of exhaust air. Increase the total supply airflow to the circulation corridor by 75 CFM. Refer to the 2019 as-built drawings.
