BARNSTABLE DISTRICT COURT HVAC SYSTEM EVALUATION SUMMARY

**Barnstable District Court
Barnstable, MA**

HVAC SYSTEM EVALUATIONS COVID-19

April 6, 2021

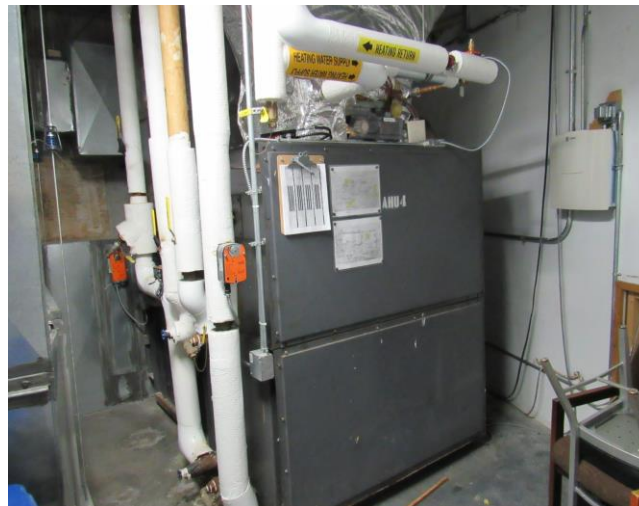
AHU's 1-4 have a hot water coil, chilled water coil, hot water reheat coil, supply fan, as well as return and outside air dampers. Each AHU has an associated external return air fan and exhaust air damper. The air handling units are generally in fair condition. Several of the coils were dirty, and the coils were showing some signs of corrosion. It does not appear that the coils were replaced as part of the 2003 upgrades.

Photo 1 – Representative Air Handler

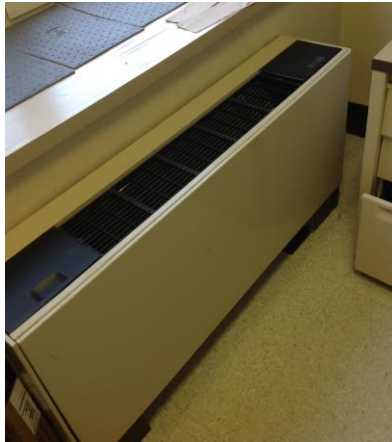
The unit ventilators have separate hot and chilled water coils fed through a four-pipe hot and chilled water distribution system, and are generally in good condition. According to the design drawings, they were mostly replaced in kind in 2003, with very minor changes. Notably, one of three UV's was removed from courtrooms 2 and 3, presumably due to the

addition of AHU-5. According to staff, most units are operational, but there are a few that have failed in areas such as the courtrooms and lobbies where there are more than one unit serving the space.

Photo 2 – Representative Unit Ventilator

Repair unit ventilators that are not operational. Replace actuators in units where the actuators have failed open. Once repairs are made, reestablish the control sequence to allow the fans to operate continuously during occupied periods.
