BARNSTABLE PROBATE & FAMILY COURT HVAC SYSTEM EVALUATION SUMMARY

**Barnstable Probate & Family Court
Barnstable, MA**

**HVAC SYSTEM
EVALUATIONS
COVID-19**

January 13, 2021

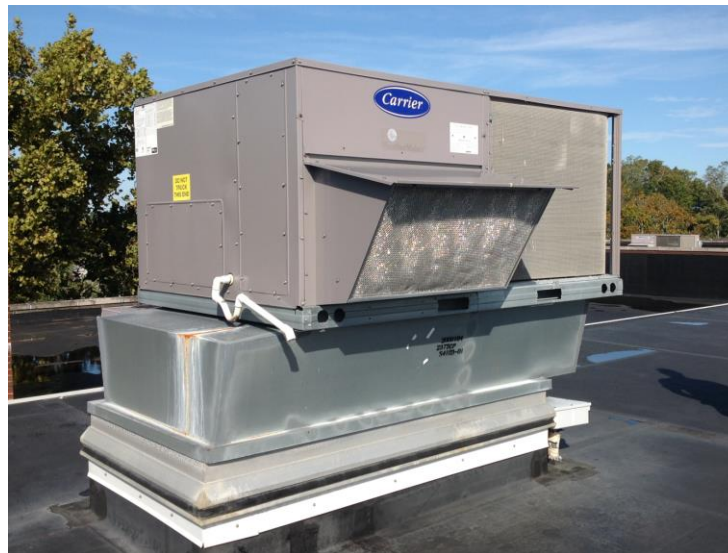
Photo 1 – Representative Rooftop Air Handler

The RTU's have DX cooling, supply fan, as well as return, outside, and relief air dampers. There is no heating within the RTU's. The conditions vary from poor to good condition, as some appear to have been replaced at different times. The RTU fans do not operate continuously, and cycle in response to cooling needs in the spaces served. In heating mode, RTU's 1-3 run continuously to serve the multiple zones with individual hot water heating coils in the ductwork. RTU's 4-6 are single zone systems and only provide cooling, cycling the fan in response to cooling demands. Heat is provided in these areas via hot water baseboard around the perimeter. The newer RTU's (1,3,5, and 6) include economizer controls and have 3 position outdoor air dampers. The oldest RTU's (2 and 4) have fixed outdoor air dampers.

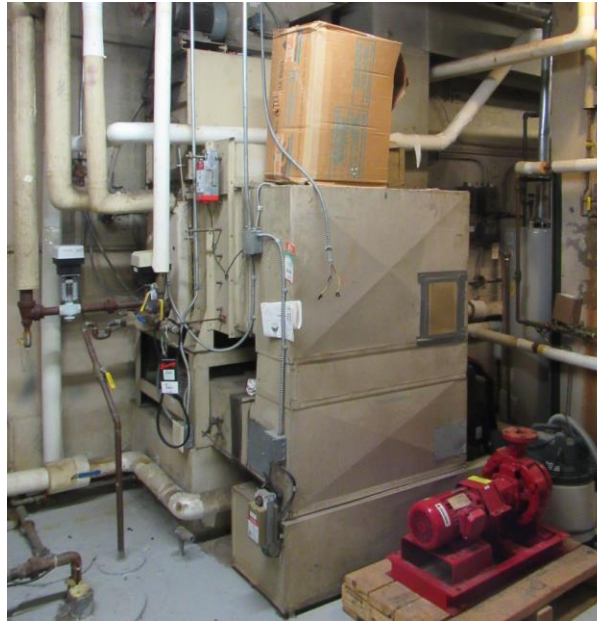
Photo 2 – Air handler AHU-1

AHU-1 is located in the basement boiler room and serves the land court offices in the basement. The unit has a hot water coil, chilled water coil, hot water reheat coil, supply fan, as well as return and outside air dampers. This unit is in poor condition. The hot water coil was dirty, and the unit did not appear to be providing any outdoor air at the time of the visit based on the position of the outdoor air damper.

2.7.5 Replace AHU-1, RTU-2, and RTU-4

AHU-1 appears to be original to the building. RTU's 2 and 4 are the oldest rooftop units. They have fixed outdoor air dampers, which do not allow for economizer function or shutting off outdoor air during unoccupied periods. Consider replacing these units within the next 5 years.
