# Bordering Land Subject to Flooding 2014 FEMA Study for Concord River Watershed and Climate Change

Thomas Maguire, MassDEP Wetlands Program Circuit Rider Network Presentation - May 22, 2014

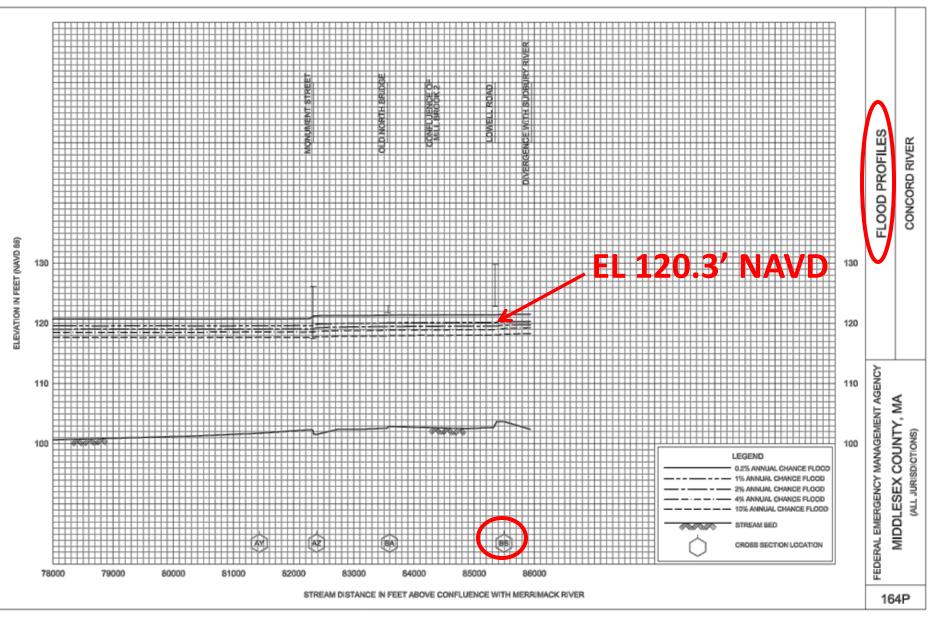
## What Is A FEMA Flood Profile?

FEDERAL EMERGENCY MANAGEMENT AGENCY MIDDLESEX COUNTY, MA (ALL JURISDICTIONS)				FLOODWAY DATA				
				CONCORD RIVER

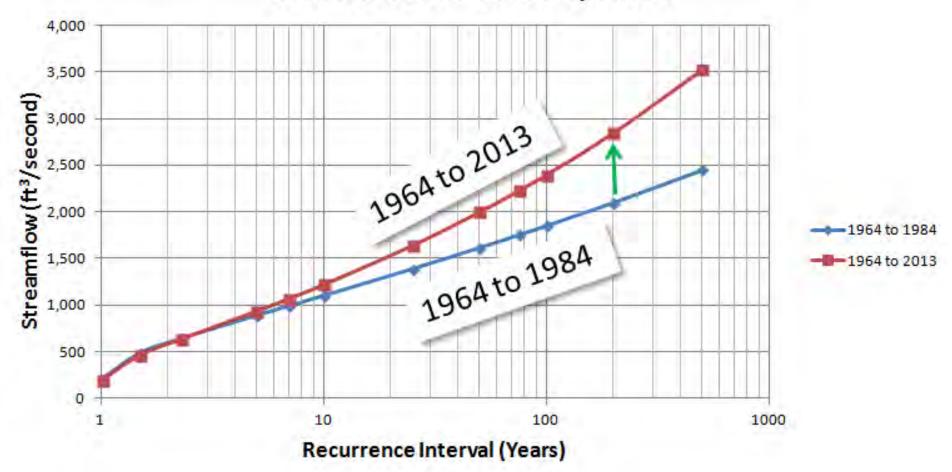
### Shawsheen River at Wilmington, MA USGS Gage, Recurrence Interval Comparison

Log Pearson Type III Analysis of USGS Gage #01100600 Data

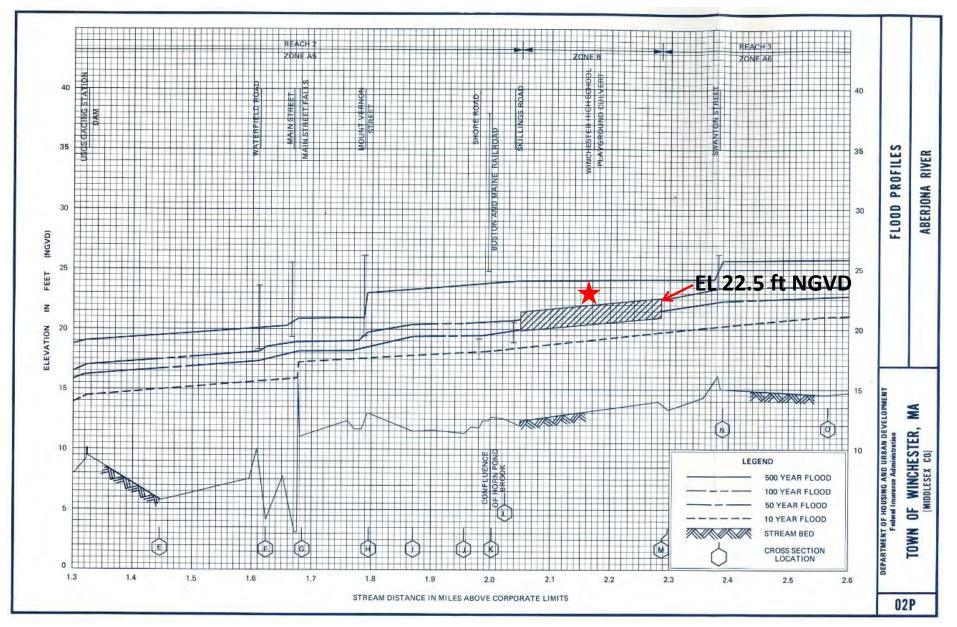
## **1979 FEMA Flood Profile**

S	3.092	100	825	0.9	26.6	26.6	27.0	0.4
Miles above cor	porate limit <b>79 F</b>		A Flo	odv	vay	Data	a Tak	ble
EPARTMENT OF HOUSING AND URBAN DEVELOPMENT Federal Insurance Administration TOWN OF WINCHESTER, MA (MIDDLESEX CO.)				FLOODWAY DATA				
				ABERJONA RIVER

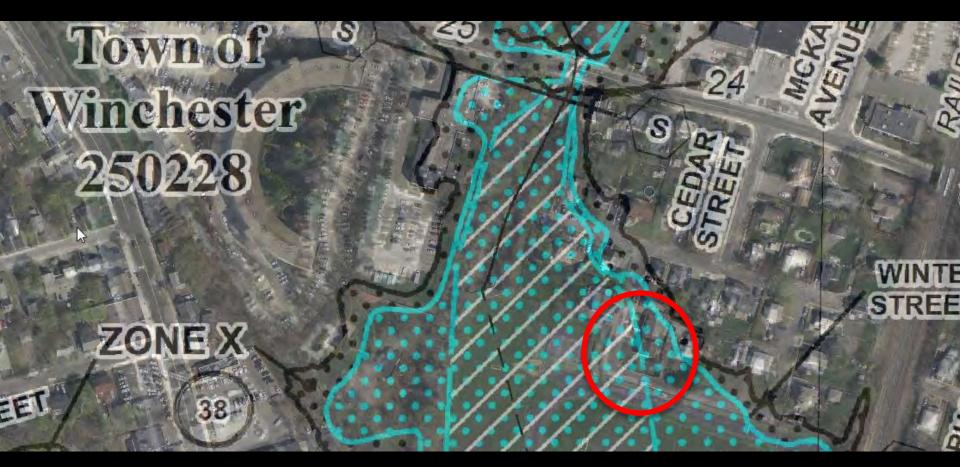
2010 FEMA Update, Flood Map Insurance Rate Map

The building was built in 2006. It was not located in FEMA flood zone at that time according to 1980 FEMA study that was then available . No compensatory flood storage was provided. The preliminary FEMA study was issued in 2007. The building flooded in March 2010. The FEMA study was issued in June 2010.
