**Brighton Division
Boston Municipal Court
Brighton, MA**

HVAC SYSTEM EVALUATIONS COVID-19

Office of Court Management

May 14, 2024

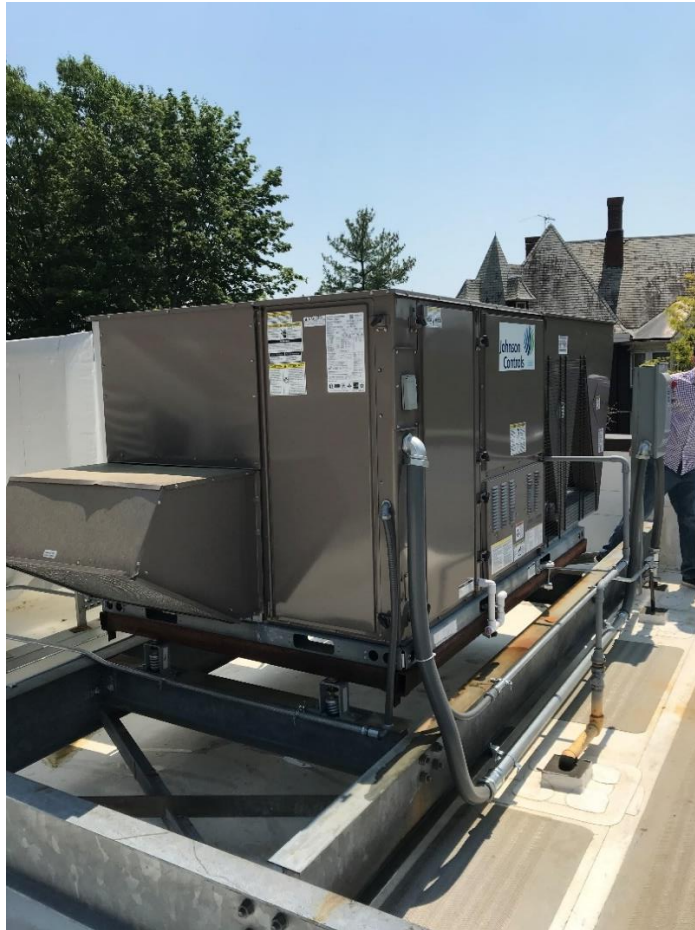
Photo 1 – Representative Roof Top Unit (RTU)

Each RTU contains a supply fan, refrigerant (DX) cooling coils, gas heat, and 2" MERV 13 filters. The supply fan is equipped with a variable speed drive but operates as a constant volume fan. The rooftop units were installed as part of the 2020 renovation and are in very good condition. The outside air and return air dampers and actuators are operational and in very good condition, and the heating and cooling coils are clean.

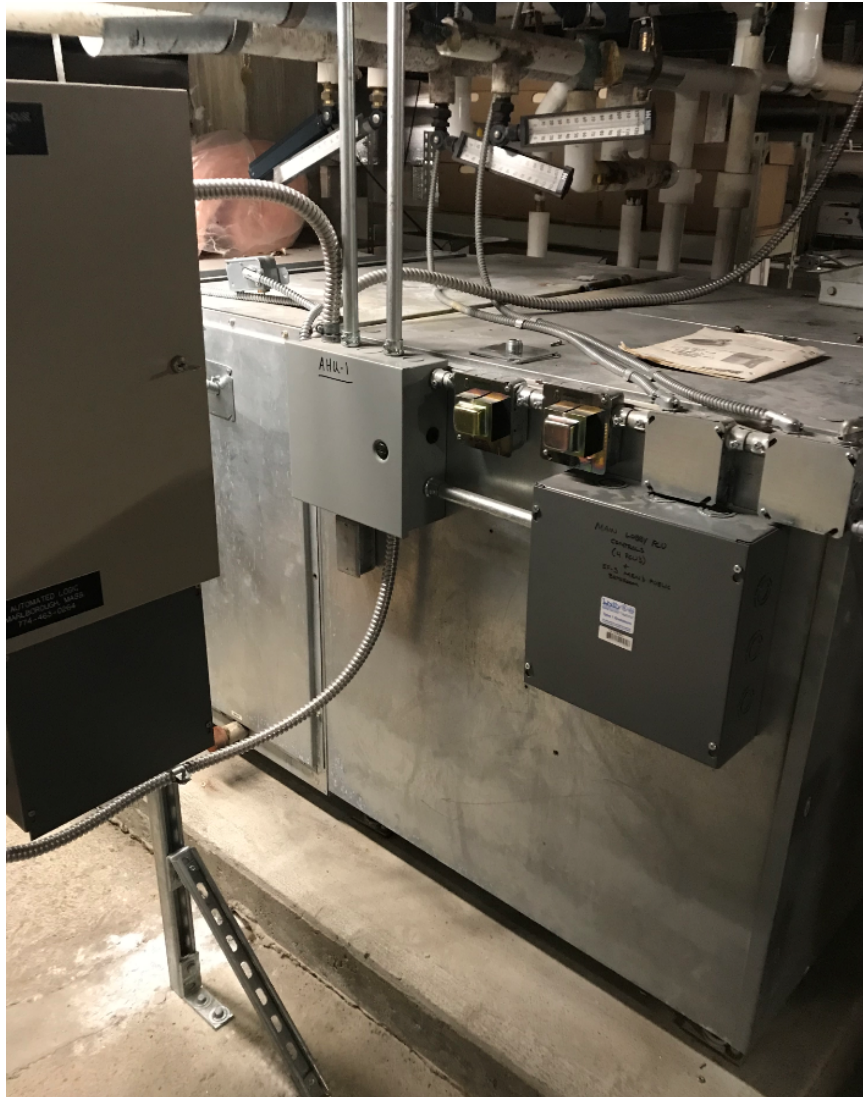
Photo 2 – Representative Air Handling Unit (AHU)

AHU-1 is a constant volume mixed air unit serving the core of the lower level including the courtroom on the lower level and the probation office area. AHU-1 contains mixed air dampers, 2" MERV-13 filters, a glycol hot water heating coil with 3-way control valve, a chilled water coil with 3-way control valve and a supply fan in a draw through configuration. Based on our physical inspection during the site walk through, the unit appears to be in fair working condition with all dampers, damper actuators and valve actuators appearing to be in good condition. This unit was installed in 1994 and is 27 years old.

We recommend the following equipment maintenance and upgrades for the three AHUs in the lower level, AHU-1, AHU-2 & AHU-3:

RE-1: *Test existing air handling system dampers and actuators for proper operation.*

Replace dampers and actuators that are not functioning properly.

RE-2: *Clean air handler coils and drain pans.*

RE-7: *Test the existing air handler control valves and actuators for proper operation.*
