**Brookline District Court
Brookline, MA**

HVAC SYSTEM EVALUATIONS COVID-19

Office of Court Management
November 29, 2021

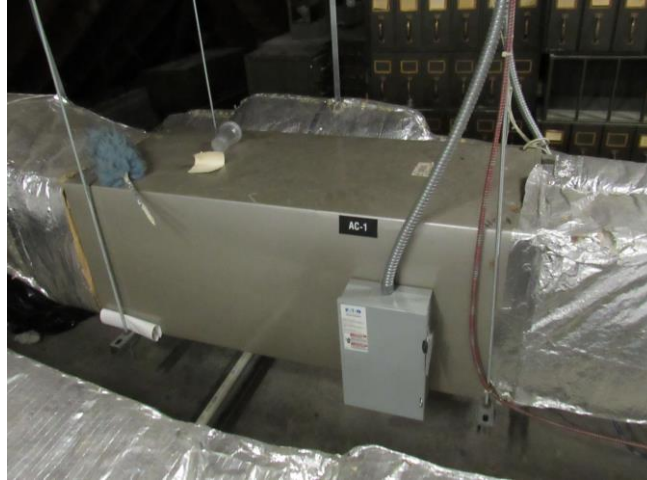
Photo 1 – Representative Air Handler

AC's 1-7 are light commercial / residential style constant volume air handlers. Each unit has a DX cooling coil, supply fan, and an outside air duct with an on/off motorized damper. The AHU's do not provide heat. Heating in the areas served is provided by steam perimeter radiators. The AHU's are currently configured to cycle the fan on/off with calls for cooling, and do not operate in the heating season. The AHU's do not have an economizer function. The AHU's are generally in good condition.

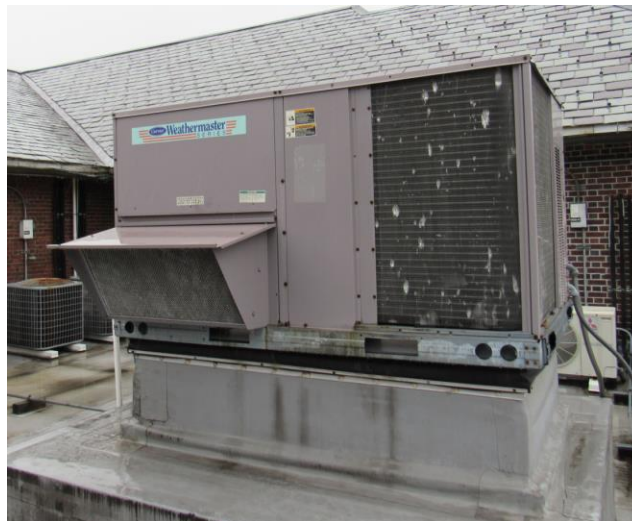
Photo 2 – RTU-1

RTU-1 is a constant volume unit in good condition. The RTU has a DX cooling coil, supply fan, as well as return, outside, and relief air dampers. There is no heating within the RTU. The unit has onboard economizer controls and a power exhaust. Heating in the area served is provided by steam perimeter radiators. The RTU is also configured to cycle the fan on/off with calls for cooling, and does not operate in the heating season.

We believe the outdoor air for RTU-1 can safely be increased to 680 CFM with the current operation. This will likely reduce comfort on extremely cold days.

7. The outdoor airflow of RTU-1 appears to have been balanced to the original design airflow (480 CFM). The outdoor airflow should be rebalanced to match the recommended outdoor airflow in Table 2 (680 CFM).
