**Cambridge/Malden District Courts
Medford, MA**

**HVAC SYSTEM
EVALUATIONS
COVID-19**

Office of Court Management
November 29, 2021

Existing Conditions & Site Observations

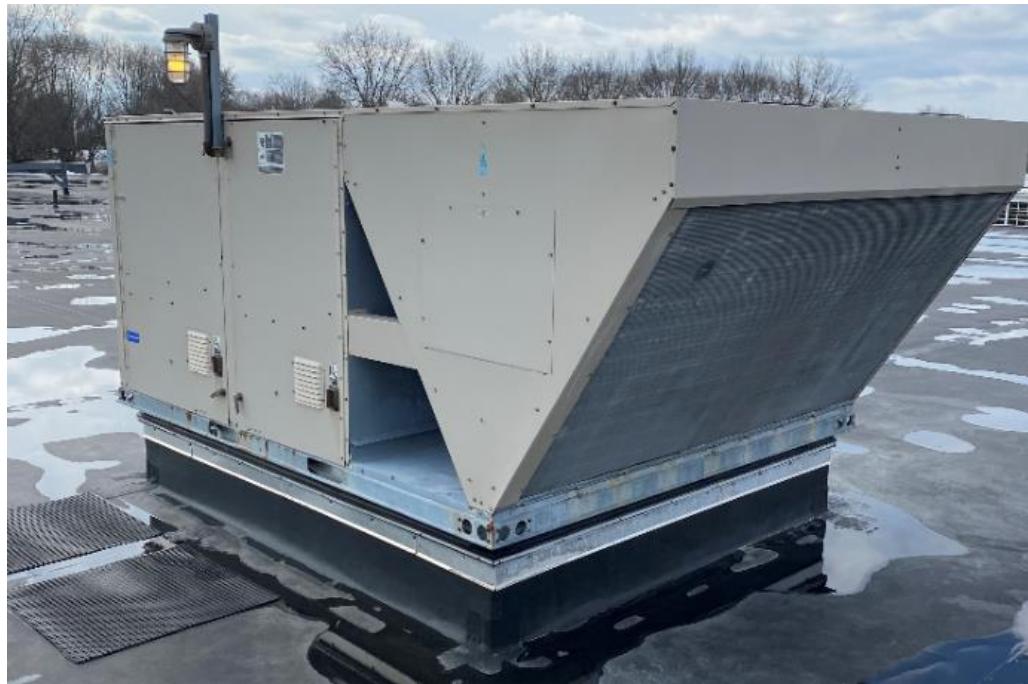
Photo 1 – Representative Air Handler

The two larger units and the ERU were installed as part of a renovation to the building in 2008 and are in good condition, however, the fans in RTU-6 makes a loud noise and the PVC cooling coil condensate drain piping has broken off. The four smaller units serving the Courtrooms and corridor were existing and relocated during the 2008 renovation. Tighe & Bond is unsure of their exact age, but we estimate that they were manufactured ~2005 based on information found on unit nameplates. ASHRAE data indicates that the median useful life expectancy for Rooftop Units like these are 15 Years, however, these unit appear to be in good condition and with proper maintenance, likely have several years of useful life remaining.

As mentioned above, the supply fan for RTU-6 makes a loud noise. We recommend inspecting the fan belts, sheaves and bearings to determine the source of the noise and repair / replace parts as necessary. This recommendation is a maintenance item and does not increase the indoor air quality of the building.

As mentioned above, the PCV condensate trap piping has broken off the unit and air is being sucked into the unit downstream of the filters, through the condensate drainpipe. We recommend replacing it to prevent further unfiltered air from entering the unit.
