# Chapter 3—Existing Conditions: Bowker Overpass

## 3.1 INTRODUCTION

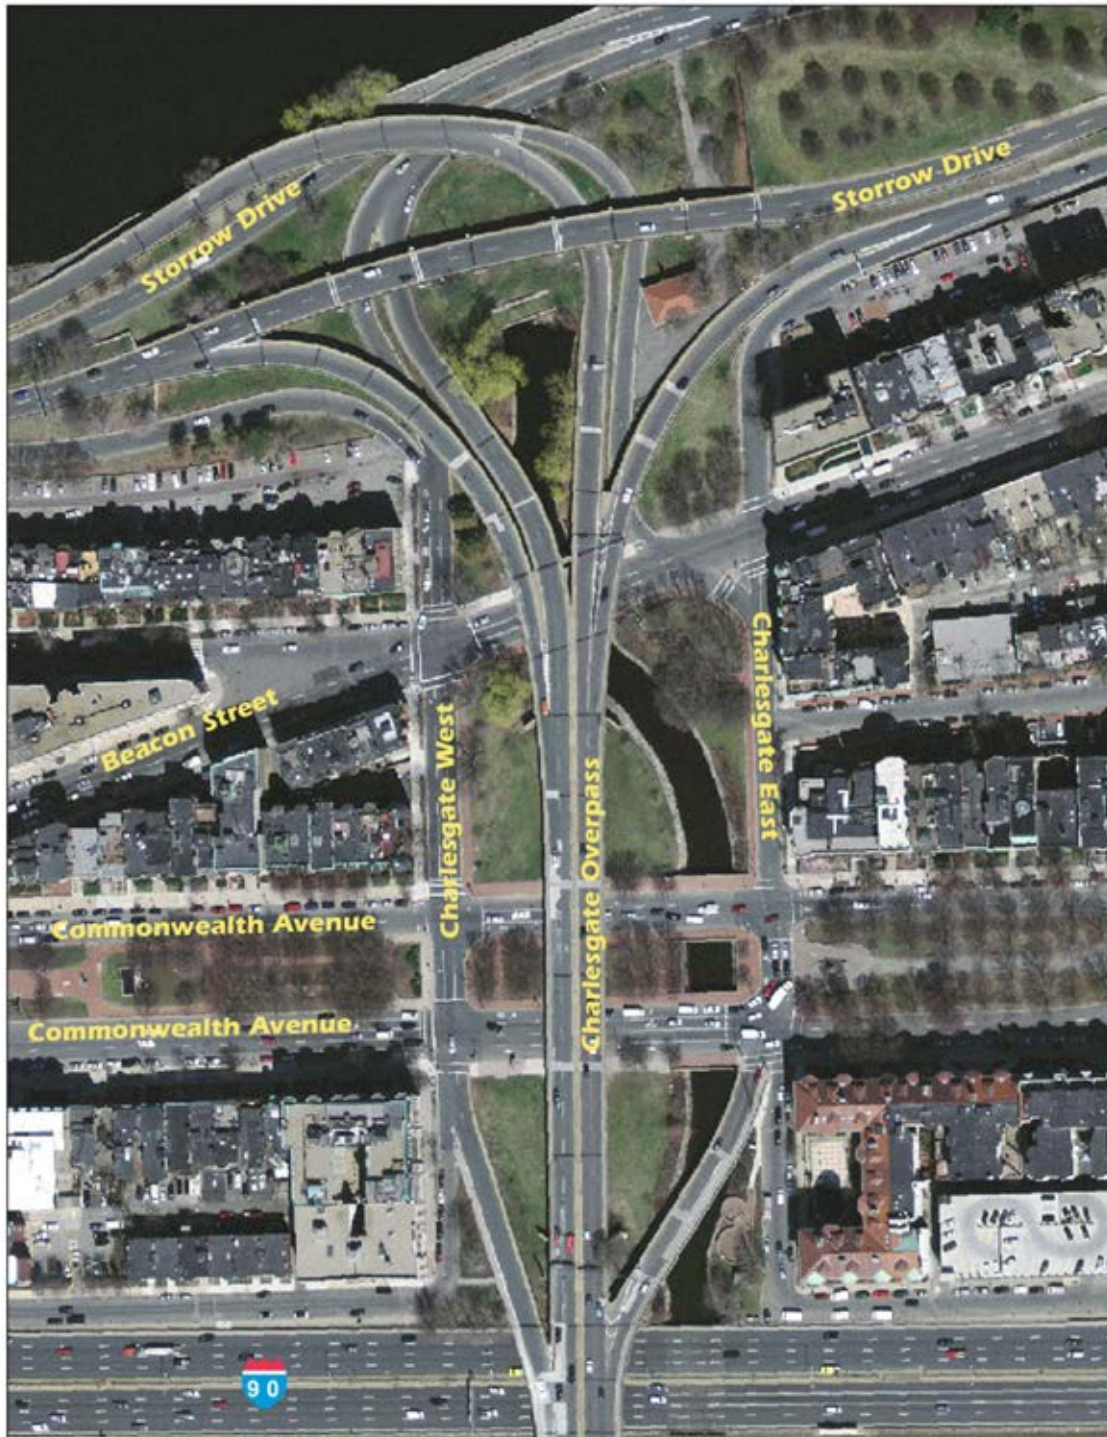
**Figure 3-1**  
**Bowker Overpass Area**

The overpass is roughly 1,600 feet long with two travel lanes in each direction. It is a limited-access roadway divided by a six-foot wide curbed median with a guardrail. There are off- and on-ramps for access to/from eastbound Commonwealth Avenue and both directions of Storrow Drive. As the Bowker descends at the north end, the roadway passes under eastbound Storrow Drive.

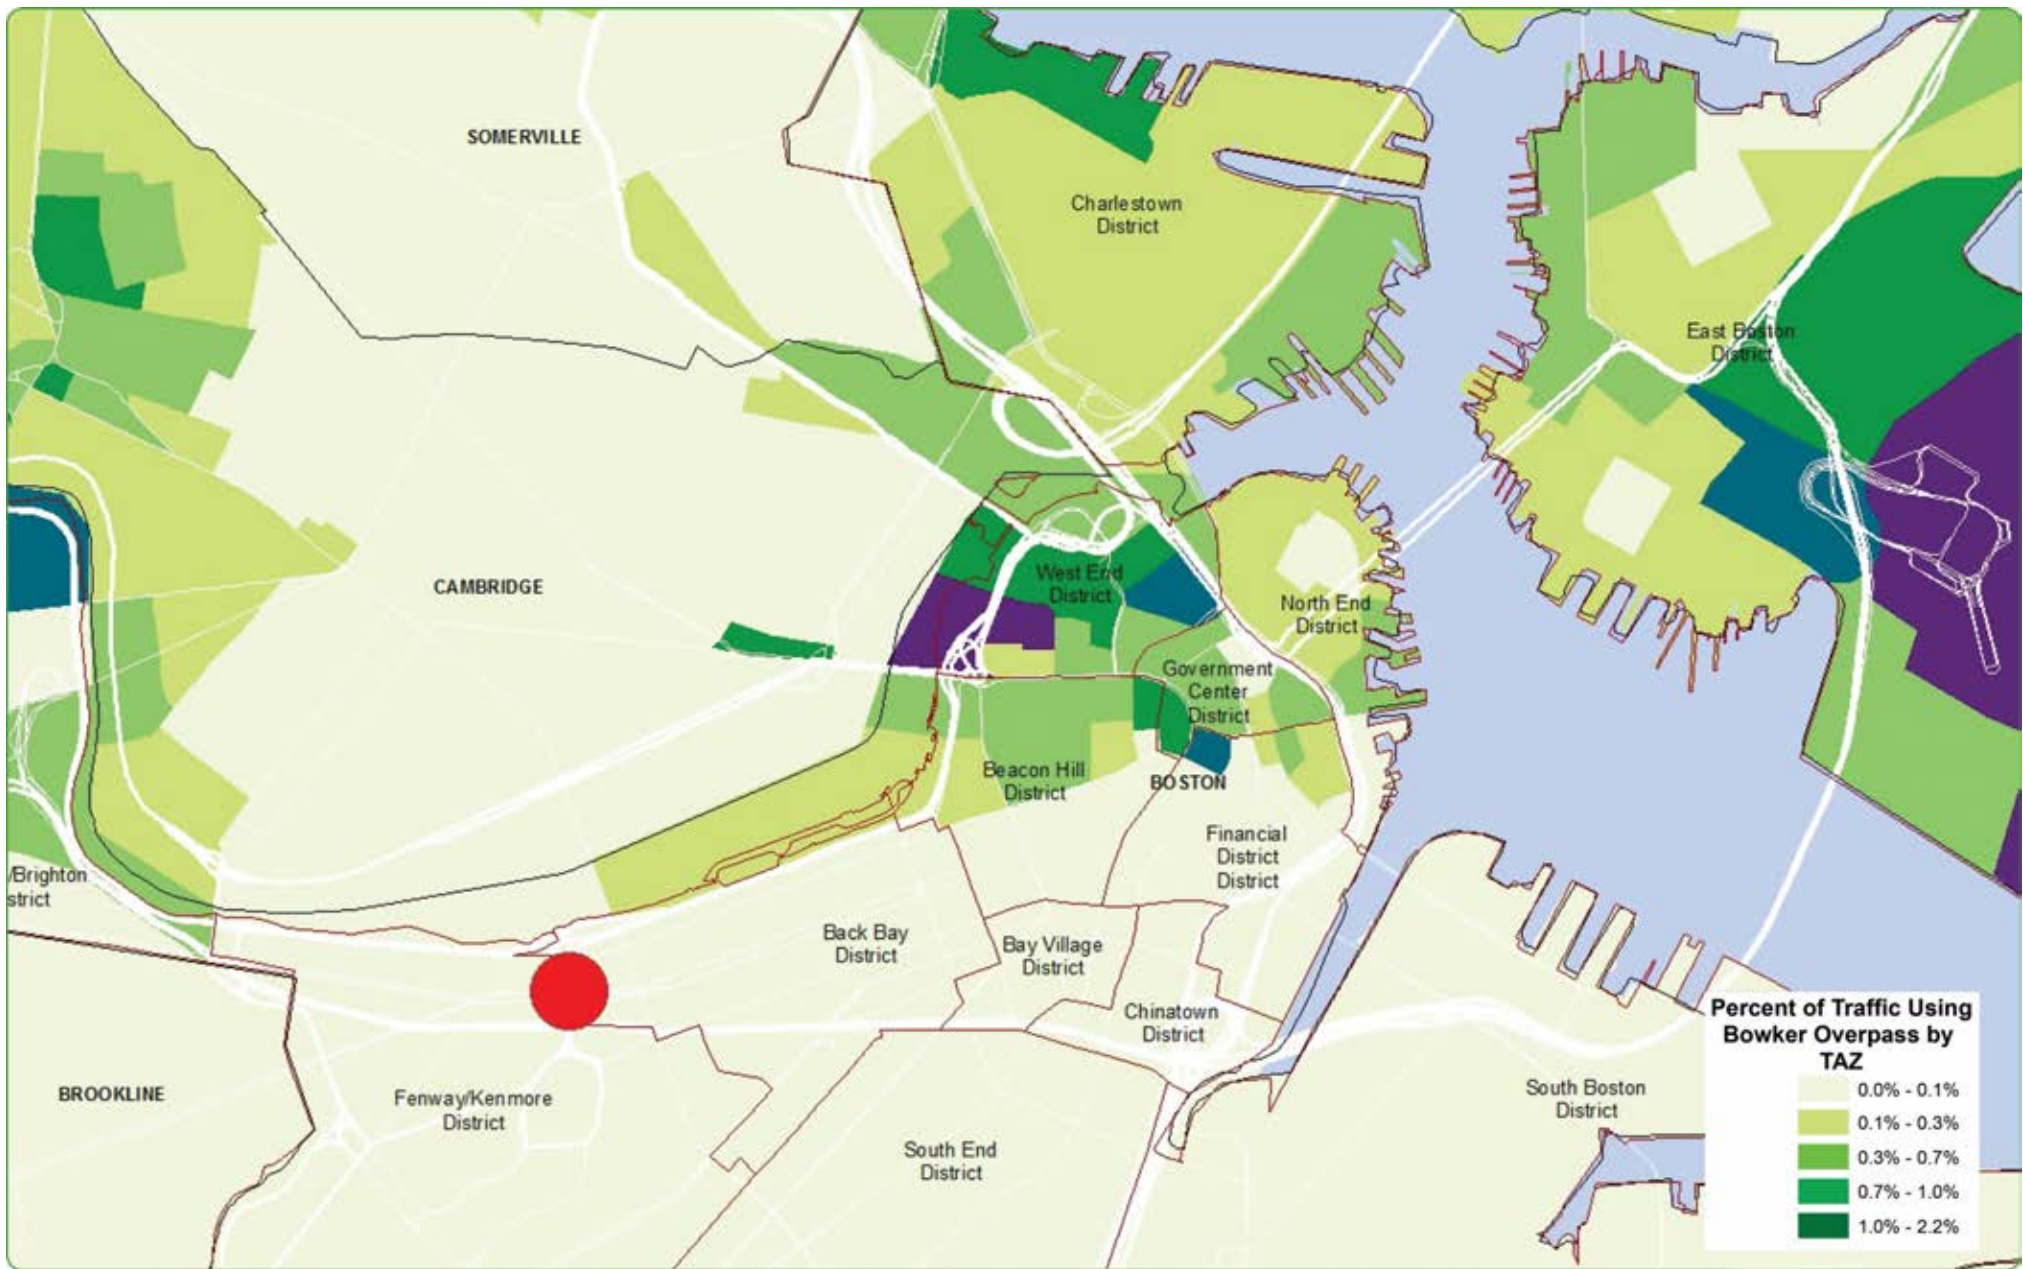
The primary destinations for northbound Bowker Overpass vehicle trips are Cambridge and other Boston districts, as shown in Figures 3-18 and 3-19. Figure 3-19 displays a detailed map indicating that the primary Boston destinations are Beacon Hill, the West End, Charlestown, and East Boston.

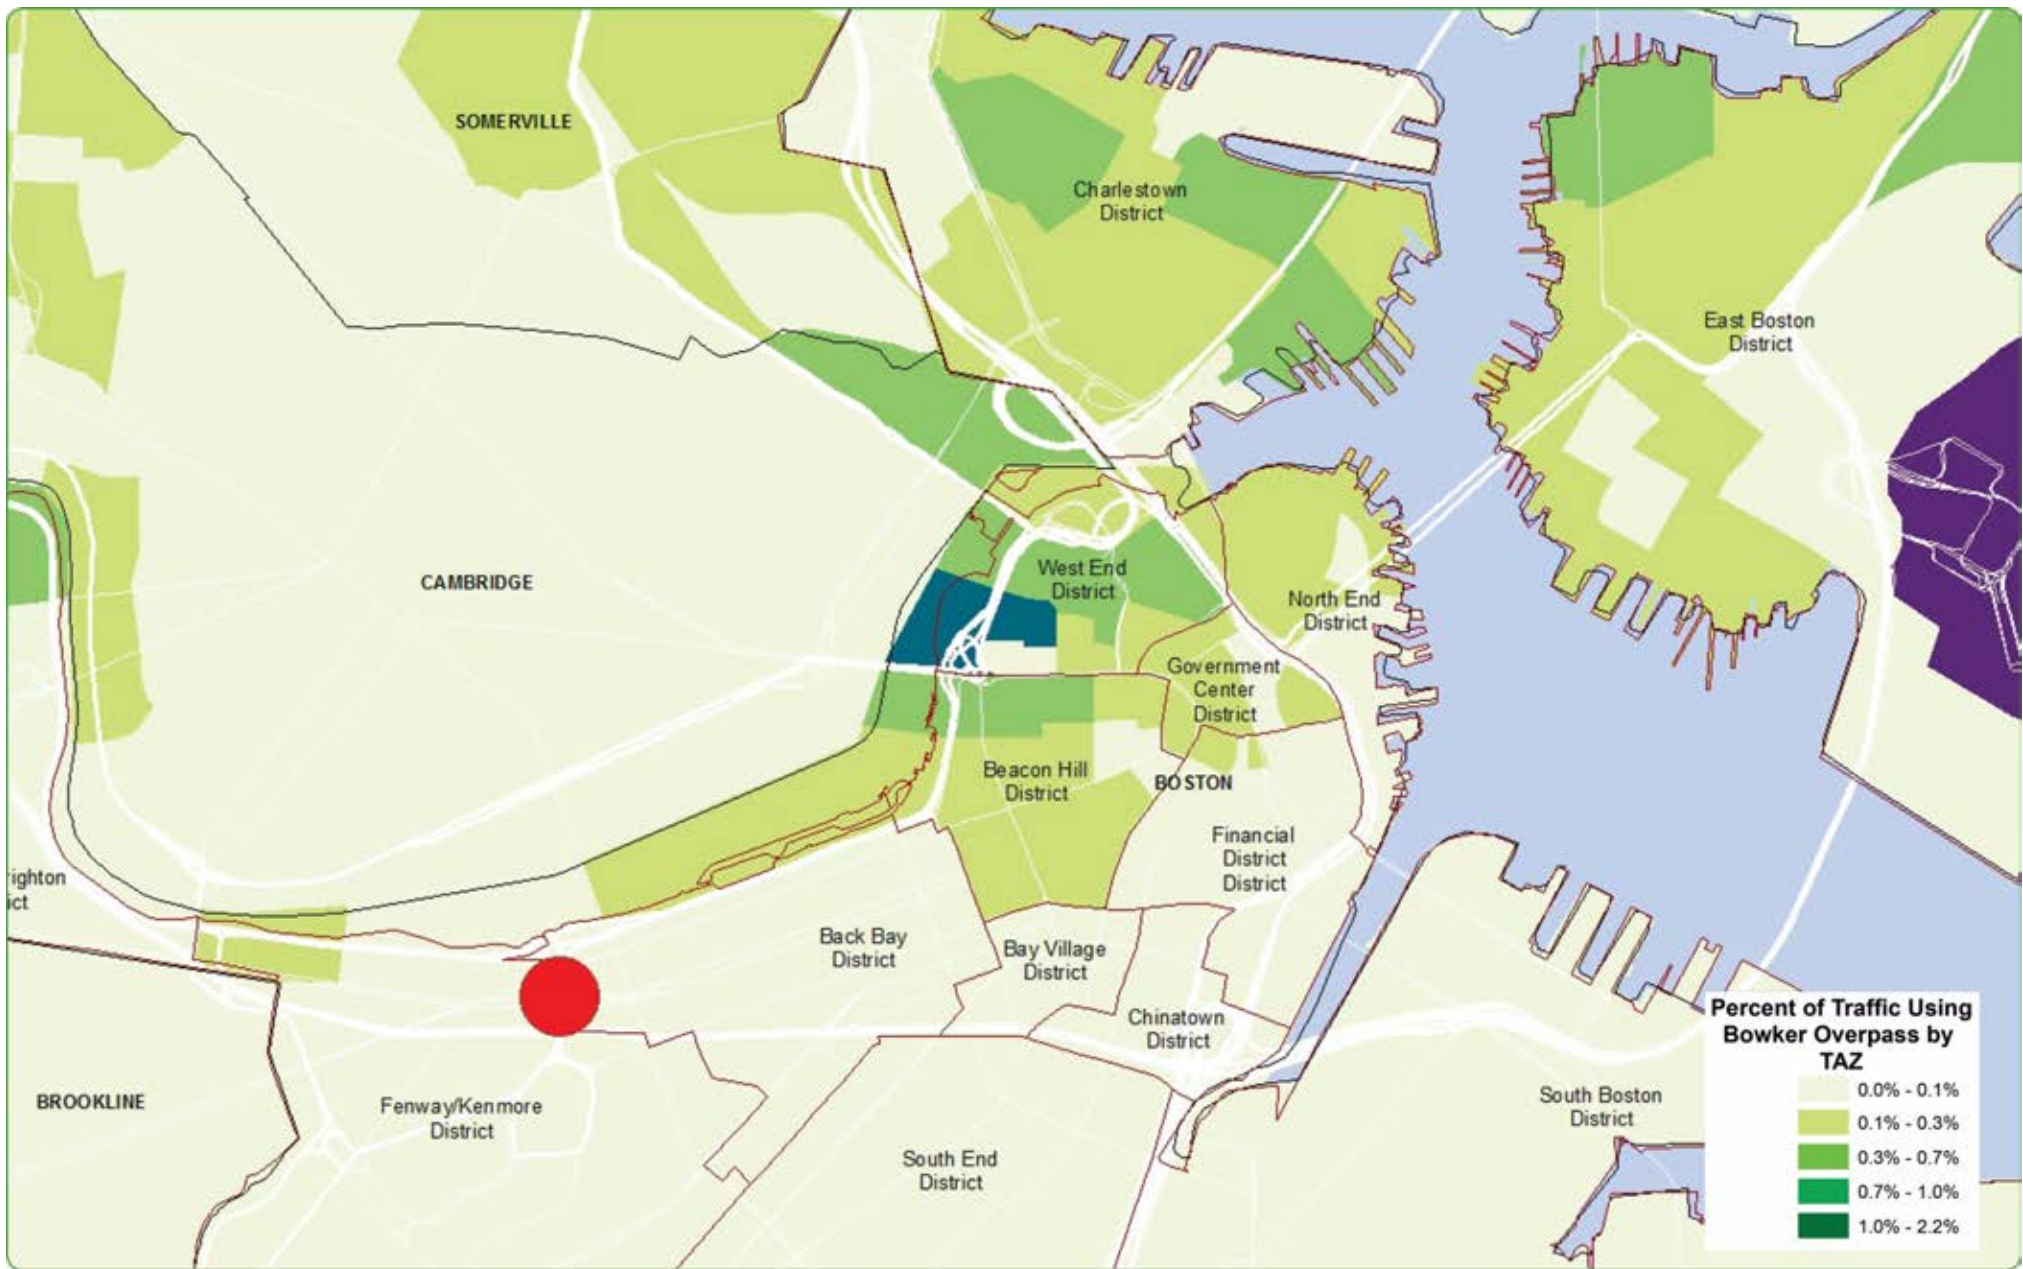
Vehicle trips using the southbound Bowker Overpass originate from a number of places, as shown in Figure 3-20. Figure 3-21 shows that many trips originate in Beacon Hill, the West End, Charlestown, and East Boston.

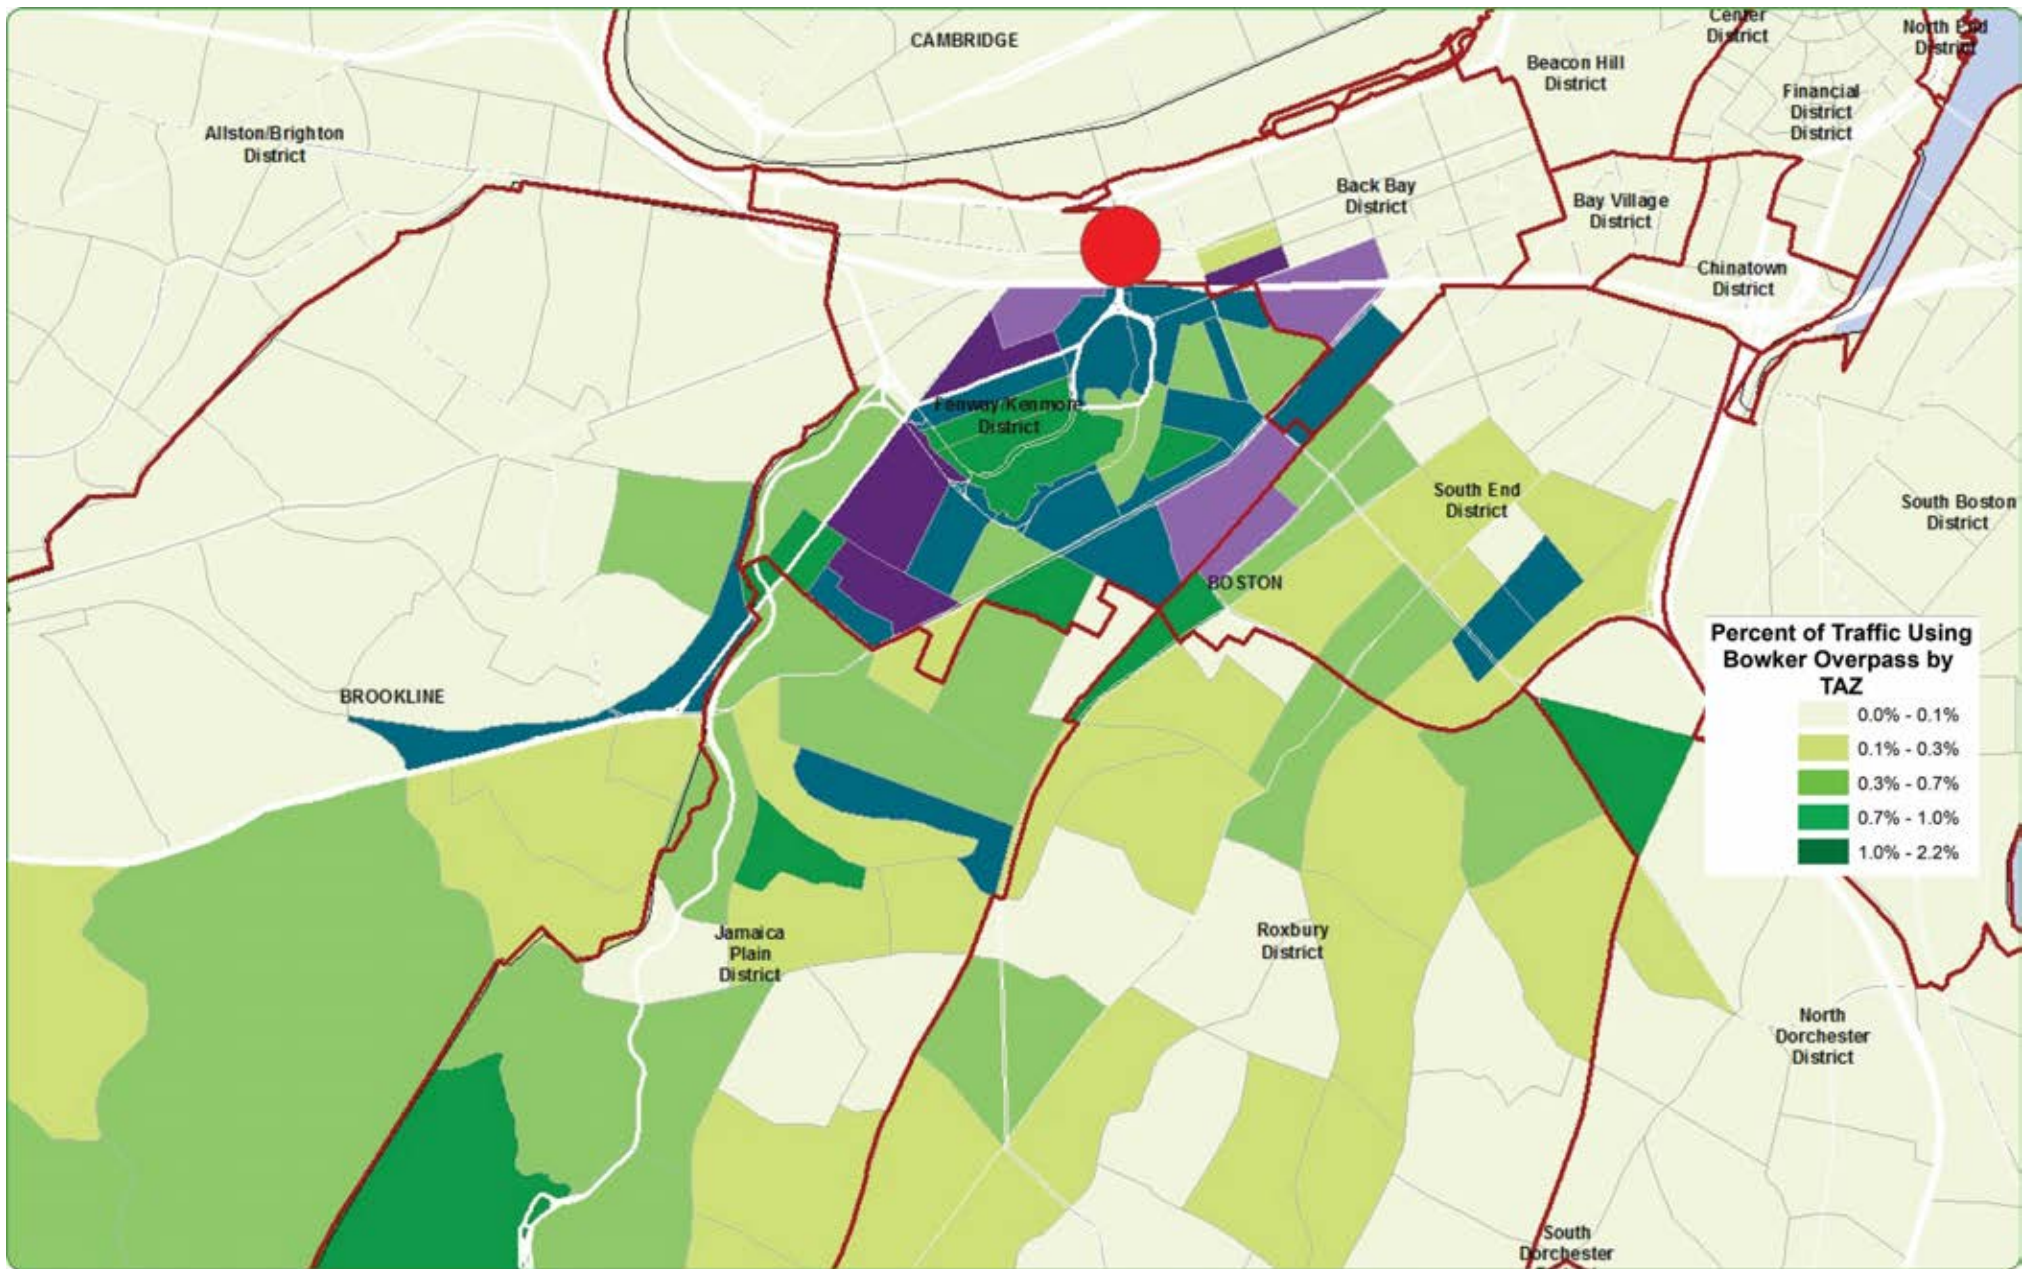
The primary destinations for southbound Bowker Overpass vehicle trips are shown in Figures 3-22 and 3-23. The primary destination is immediately south of the Bowker Overpass, in the Fenway and Kenmore neighborhoods, and the LMA area.

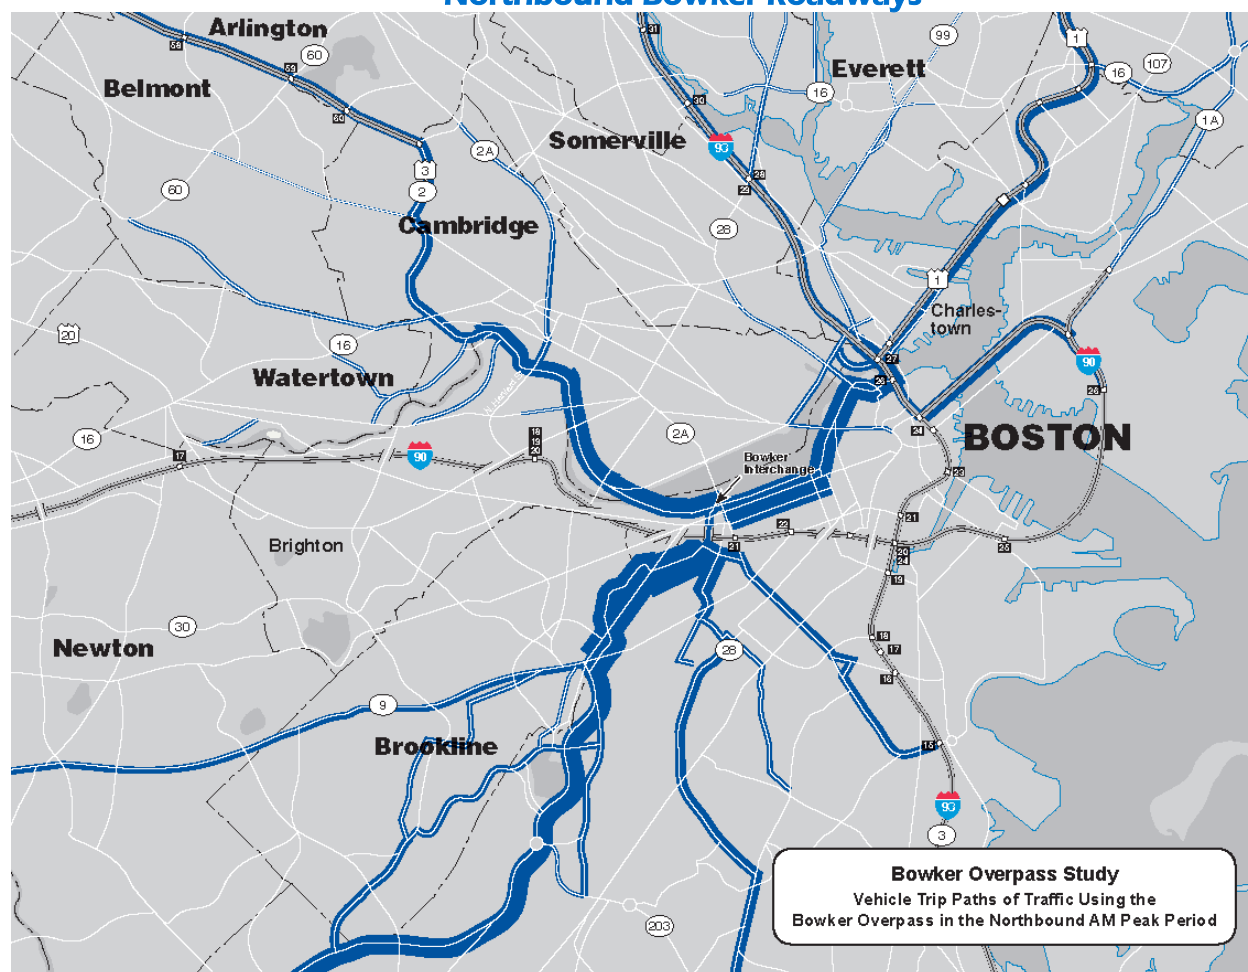
**Figure 3-24**  
**Northbound Bowker Roadways**

The following figures provide information related to the various paths Bowker Overpass vehicle trips use. Figure 3-24 shows the paths that northbound Bowker Overpass vehicle trips use. As shown, many trips use the Jamaicaway and Brookline Avenue south of the Bowker Overpass, represented by the heavy blue lines. North of the overpass, Storrow Drive in both directions is the primary roadway used by northbound trips.
