**Chicopee District Court  
Chicopee, MA**

# **HVAC SYSTEM EVALUATIONS COVID-19**

Office of Court Management  
January 21, 2022

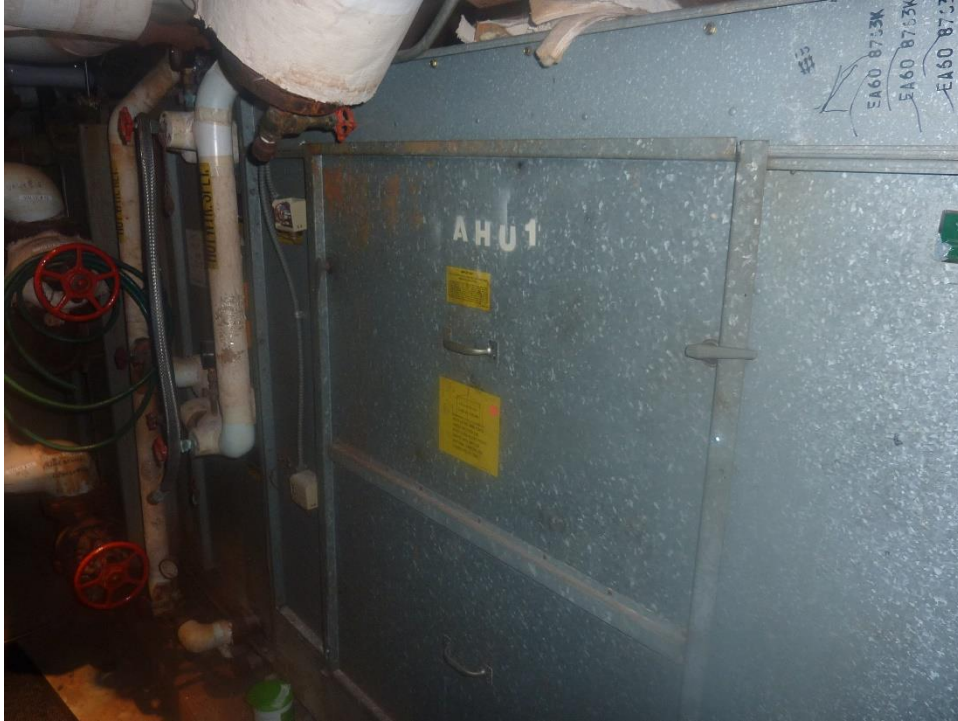
Photo 1 – Representative Air Handler

The air handler and return fan are from the original construction. The air handler appears to be in poor condition, and the return fan, manufactured by Buffalo Forge, is of very solid construction and appears to be in good condition for its age.

Indoor air handling units have a life expectancy of 35-45 years. The air handler is approximately 37 years old and in poor condition. Consider replacing this units in the next 2-5 years. Replacing the return fan controls should also occur in conjunction with the replacement of the air handling unit to provide an overall positive building pressure to reduce infiltration. This recommendation is an energy saving measure and does not increase the indoor air quality of the building.
