WATERSHED-BASED PLAN

Clesson Brook (MA33-15)
Within the Towns of Buckland,
Ashfield, and Hawley

December 2024

Franklin Regional Council of Governments
12 Olive Street
Greenfield, MA

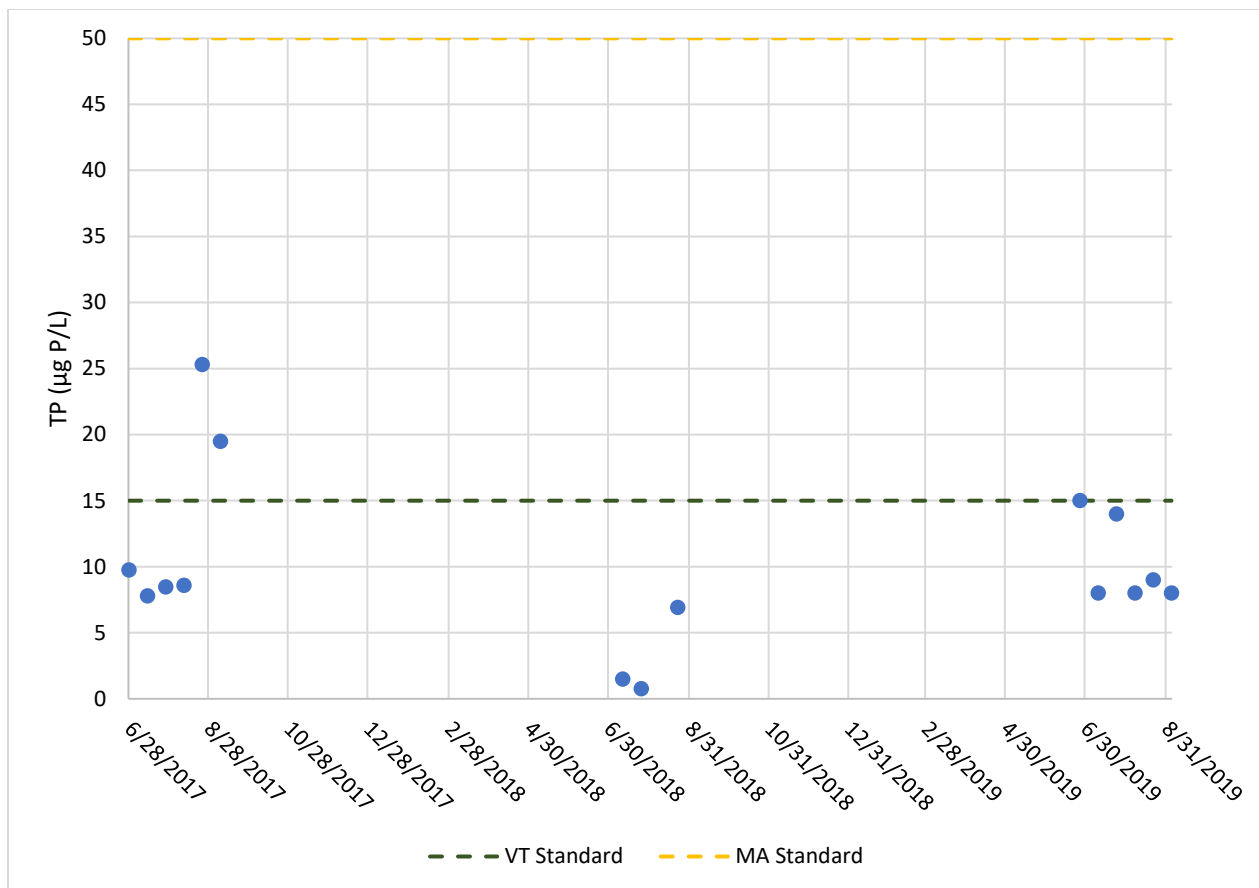
Figure A-3: Total Phosphorus levels in the Clesson Brook 2017-2019

Average total phosphorus levels in Clesson Brook remained well under the Massachusetts standard of 50 µg P/L, and were typically below the Vermont standard of 15 µg P/L. Similar to nitrogen, elevated levels of phosphorus can occur from agricultural soil erosion and runoff, wastewater, and failing septic systems.

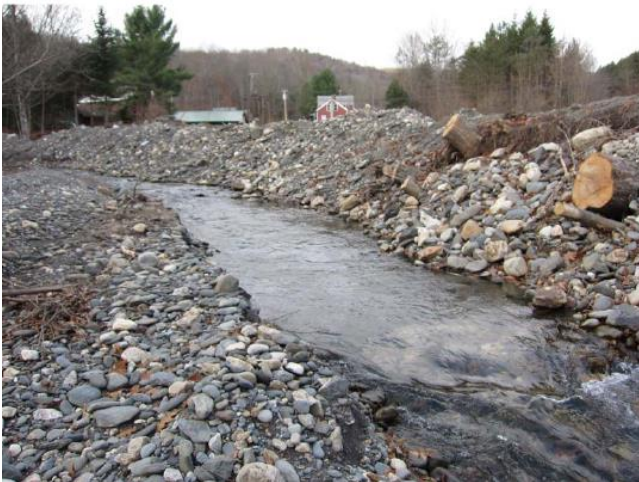
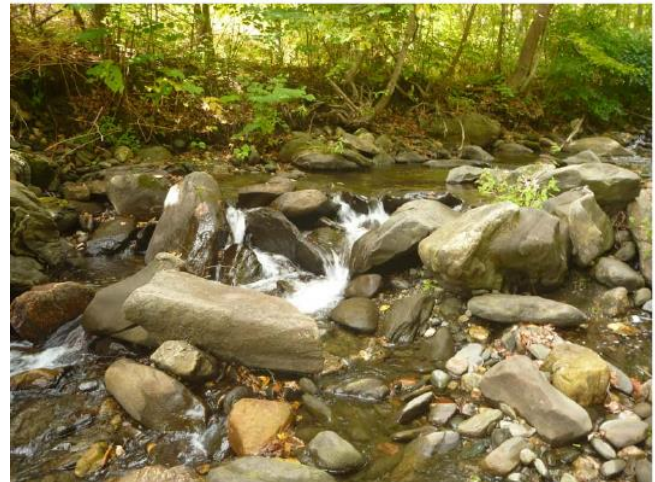
Left: Emergency work completed in the months following Tropical Storm Irene included extensive windrowing, as gravel and cobbles were excavated from the channel and piled as berms along Clesson Brook. Photo by Andrea Donlon. Right: Headcuts, or knickpoints, migrating upstream during high flow events represents vertical instabilities in the streambed initiated in the aftermath of Tropical Storm Irene. Photo by Nic Miller.

Rebuilding efforts following the flood from Tropical Storm Irene included extensive windrowing, as gravel and cobbles were excavated from the channel and piled as berms along Clesson Brook and its tributaries. Long sections of Clesson Brook Road were rebuilt after Tropical Storm Irene, as in some areas the entire road grade had been eroded. The sections of the road that were reconstructed are armored extensively with boulder riprap, gabion baskets, stacked boulder, and concrete retaining walls. In some areas, this armor constricts the stream channel, potentially increasing the risk of future fluvial erosion. In other areas, the riprap has started to be undermined by migrating headcuts.

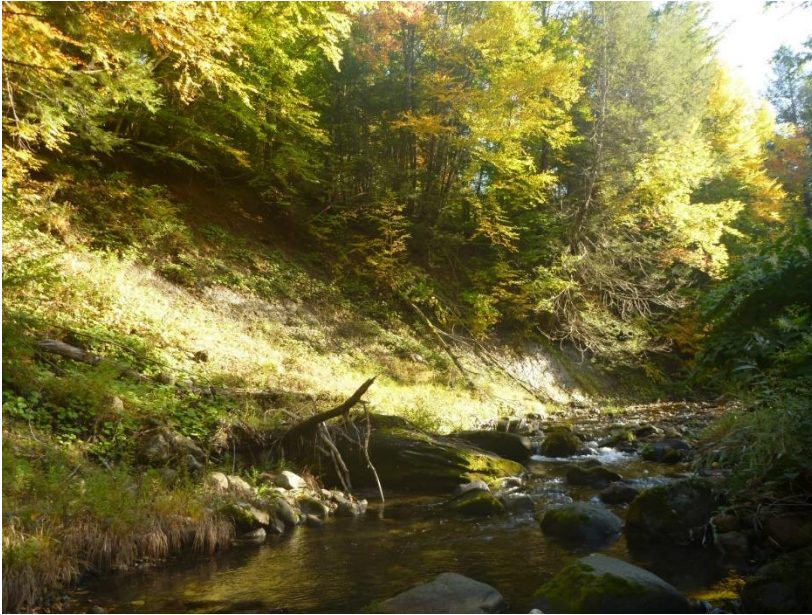
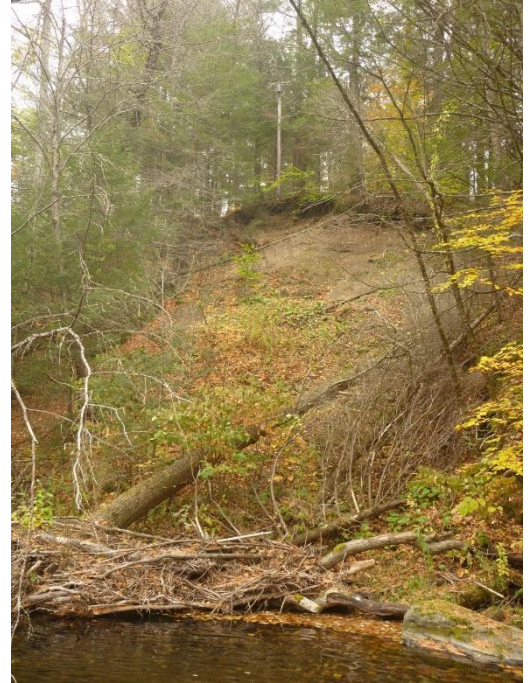
Mass failures along the Clesson Brook. Photos by Nic Miller of Field Geology Services.

Streambank mapping completed for the Fluvial Geomorphic Assessment identified mass failures as a major source of sediment loading in the Clesson Brook Watershed. Twenty-eight landslides were mapped along the length of Clesson Brook; the largest mass failure was 180 feet long and 40 feet high. Mass failures represent

significant sources of coarse sediment adding to enlarged channel bars, and fine sediments contributing to suspended sediment loads and water quality impacts.

A significant mass failure is located near the Route 112 Bridge, and coupled with the undersized crossing, represents a fluvial erosion hazard.

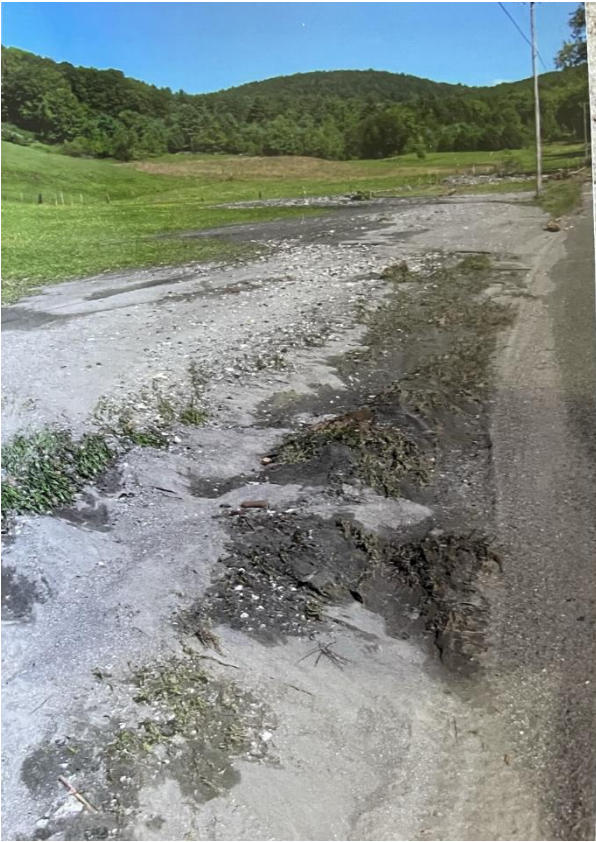
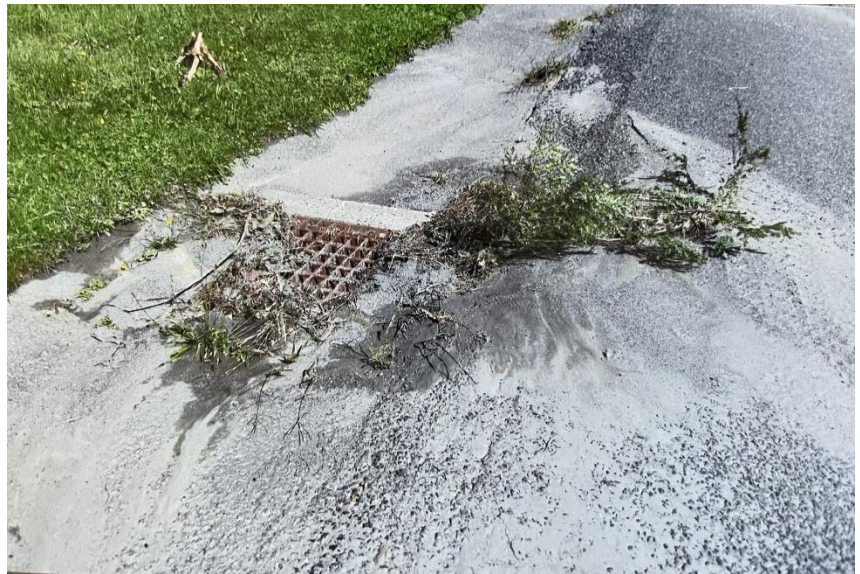
Left: Shepard Brook carried a significant amount of sediment down Shepard Brook Road to Clesson Brook during Tropical Storm Irene in 2011. **Right:** A clogged storm drain on Clesson Brook Road due to Tropical Storm Irene. Photos by Sandra Brown.

As noted in the fluvial geomorphic assessment, the majority of the sedimentation in the Clesson Brook is due to in-stream fluvial erosion. However, during site visits with landowners in the watershed, some areas were noted to be other likely sources. The Clesson Brook Watershed is hilly, with many steep slopes, and current stormwater infrastructure may not accommodate heavier stream flows. During Tropical Storm Irene in 2011, Shepard Brook carried sediment down towards Clesson Brook and overwhelmed the available storm drains.
