Clinton District Court Clinton, MA

HVAC SYSTEM EVALUATIONS COVID-19

Office of Court Management April 26, 2022

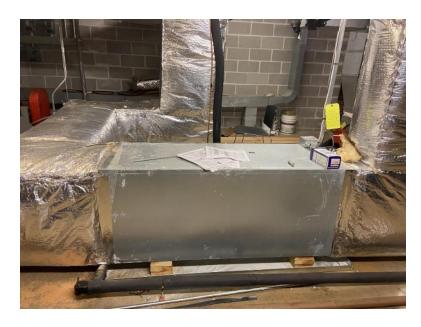
Photo 1 – Air Handler AHU-1

While on site, we could not confirm the age of the units, however the Office of Court Management provided us with invoices of the air handlers. The invoices had a date of 2013. The units appear to be in fair condition. The outdoor air, return, and exhaust dampers were not accessible. The electric damper actuators are in good to fair condition. The cooling coil in AHU-2 was dirty and the coil in AHU-1 appeared to be clean. The duct mounted electric heating coils were not accessible.

RF-1: Replace filters with MERV-13 filters.

RF-3: Install a differential pressure sensor with a display across the filter bank.

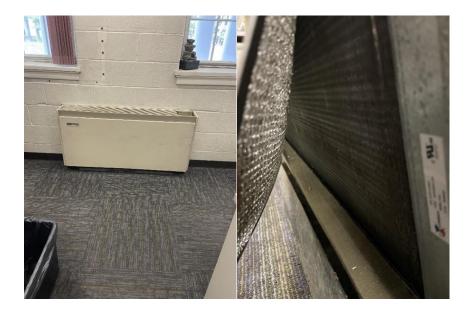
Photo 3 – Typical PTAC Unit

There are also packaged air terminal air conditioners (PTAC) located in the perimeter spaces that provide refrigerant based cooling and, according to the 1970 design drawings, were designed to provide ventilation air. The 1970 drawings also indicate each PTAC unit was designed to provide heating, however the label on the unit in Room 211, Adult Probation Officer, indicated the unit does not provide heat. Further field investigation is required to determine which units provide heating. The units contain mesh filters with no MERV rating. While all units were not inspected, the coils of the units that we did inspect were fairly clean. The outdoor air damper was not accessible, therefore it was unclear if the PTAC units provide outdoor air. The units are connected to a louver on the outside

wall. The louvers may be used to reject heat from the refrigeration cycle only, may be used to bring in outdoor air, or both. The units appear to be in fair condition. According to facilities staff, the PTAC units only operate when there is a call for space heating or cooling, and typically fail within seven to ten years. If some units do not provide heat, it's likely these units do not run during the winter and therefore do not provide ventilation air to the space during the heating season. Electric baseboard heaters provide additional heating to the perimeter spaces.

It is likely that the PTAC units cannot be fitted with MERV 13 filters. Further investigation will be required to determine if this is possible.

- 4. The PTAC units are not providing any ventilation air. We recommend investigating if these units can be connected to the outdoors and if they units can accommodate the added load of conditioning the outdoor air.
