Concord River Diadromous Fish Restoration

FEASIBILITY STUDY

Concord River, Massachusetts

DECEMBER 2016

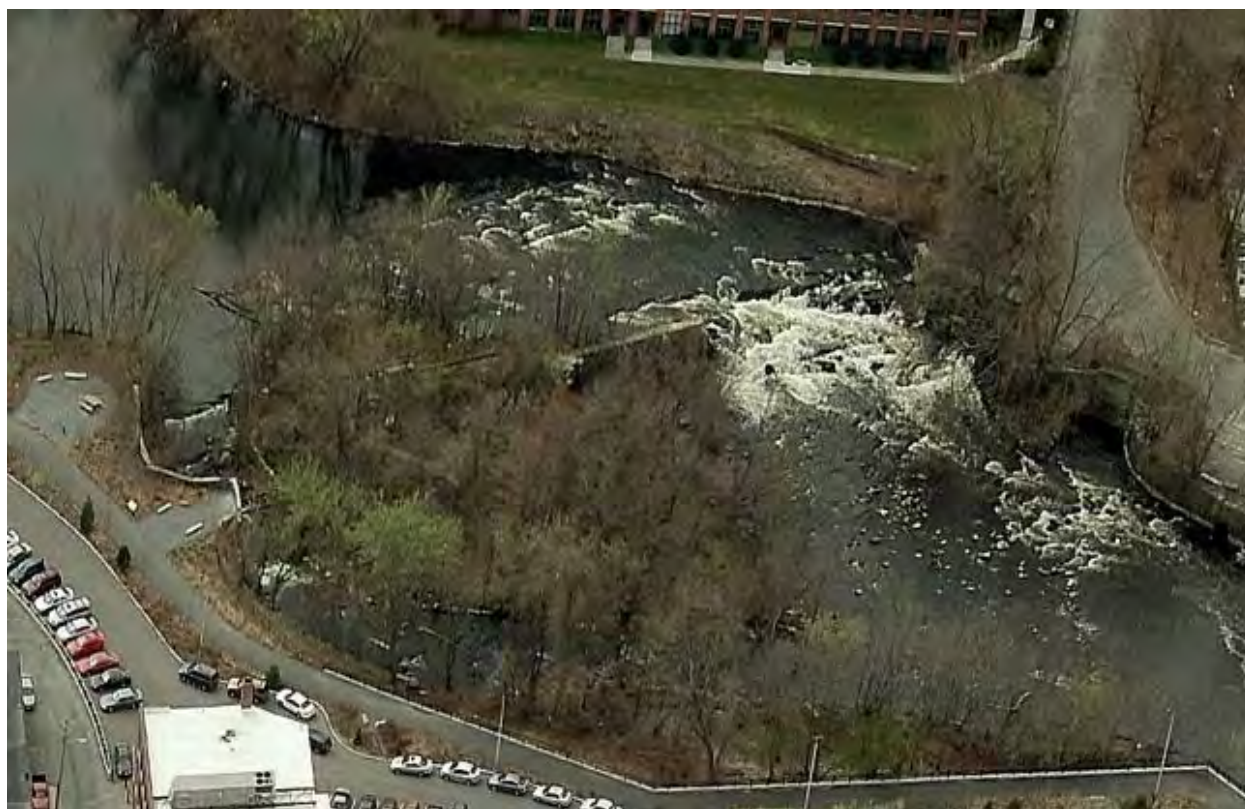
*Middlesex Falls (looking upstream), showing major (river left) and minor (river right) channels. See **Figure 2.2.1-1** for a labeled version of this aerial image (Bing, 2015).*

The first potential obstacle to fish passage in the Concord River is Middlesex Falls at river mile 0.44 in Lowell. The drainage area at this location is approximately 400 square miles¹⁹. This is the site of the former Middlesex Dam, which was breached in the early 1980s. The site now consists of a large island flanked by a main channel on river left²⁰, defined by the remains of the concrete dam abutments, and a minor channel on river right, defined by the remains of the former mill race/power canal. **Figure 2.2.1-1** shows an aerial image of the site with key features labeled. Photographs of the site can be found in **Appendix B**.

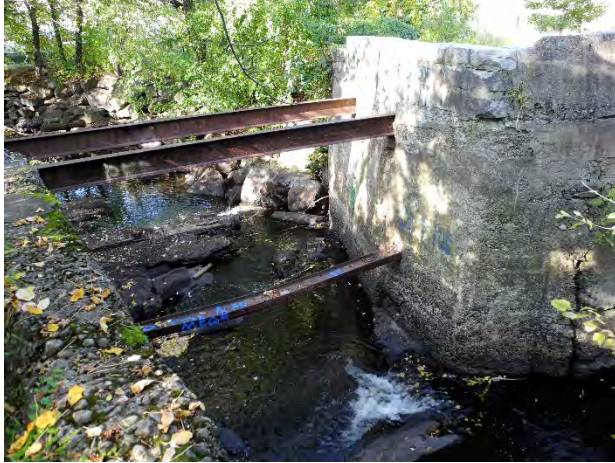
Former mill race/power canal in minor channel on river right (looking downstream).

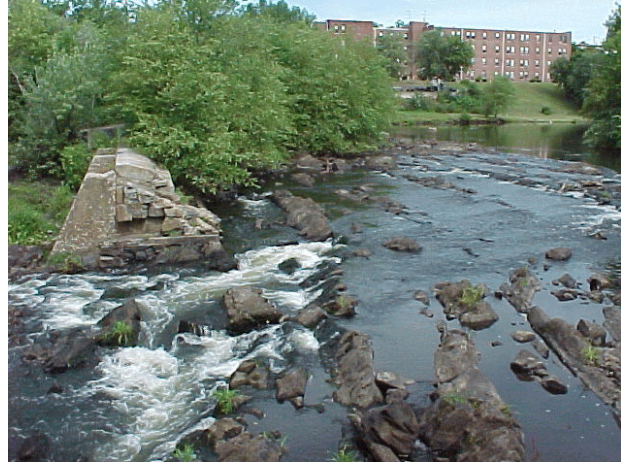
Main channel on river left showing proposed passage route along remaining abutment (looking toward island) (McKeon, 2002).

In 2000, the NRCS worked with the USFWS to conduct a survey of the main channel at Middlesex Falls. Existing plan and profile drawings of the site developed from this survey are provided in **Figures 2.2.1-2** and **2.2.1-3**. The survey found no remnants of timber crib or stone/concrete footings in the channel. However, the natural bedrock ledge of the falls creates turbulence, making it hard for fish to pass upstream. A preliminary hydraulic assessment indicated that during low flow (approximately 650 cfs) conditions in spring, fish passage could be impeded, particularly for river herring and American shad (McKeon, 2002).

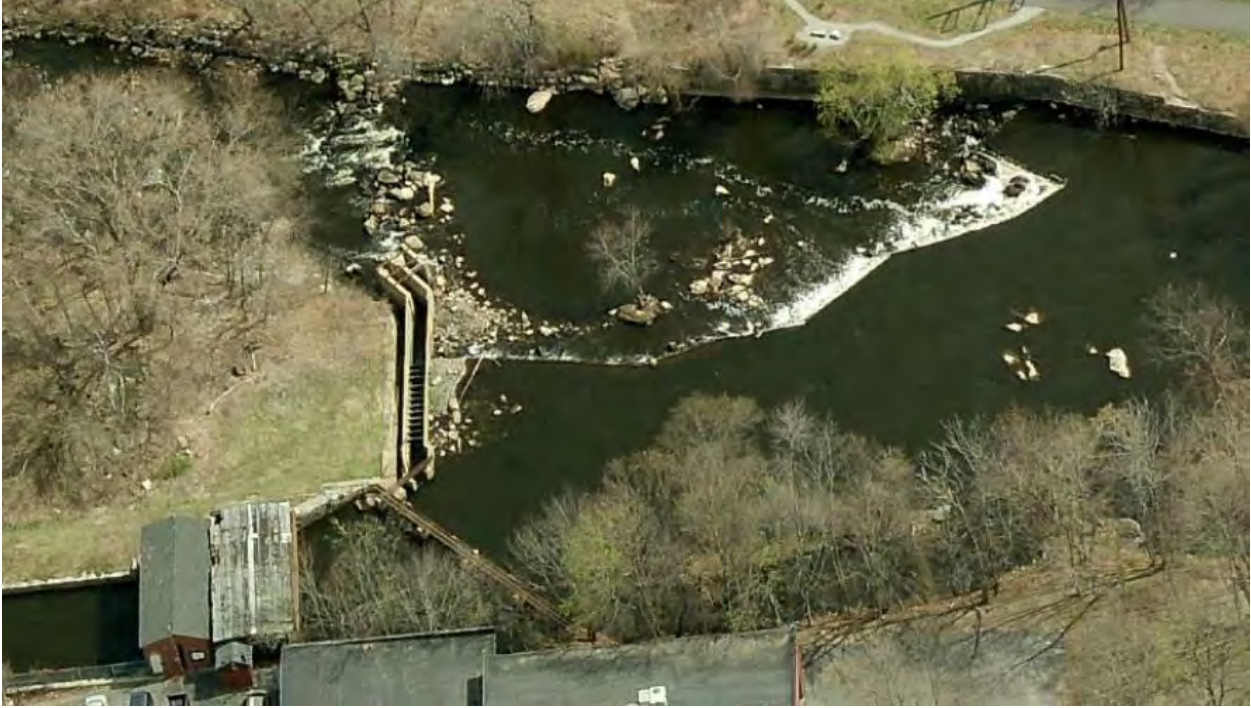
*Centennial Falls Dam (looking downstream), showing the power canal and gatehouse on the left, spillway and bypass reach below on the right, and fish passage structures adjacent to the river left side of the dam. See **Figure 2.2.2-1** for a labeled version of this aerial image (Bing, 2015).*

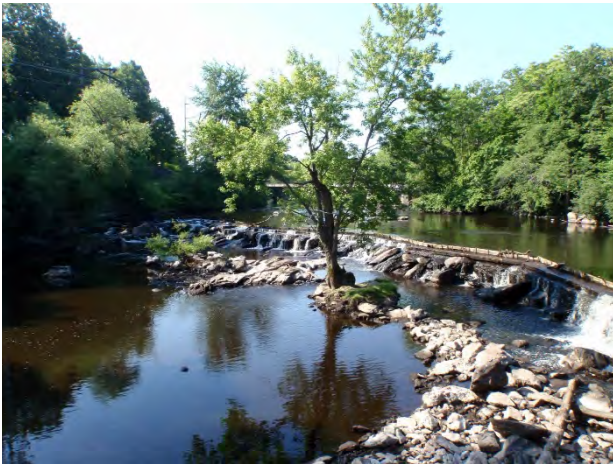
Centennial Falls Dam (looking upstream). Fishway is out of view to the right side of picture (Smithwood, 2013).

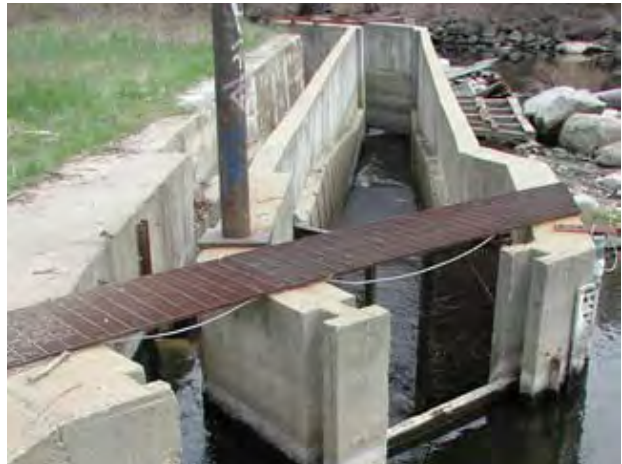
Centennial Island fish passage structures, showing downstream bypass entrance on the left and Denil fish ladder exit on the right (Brady et al., 2005).

The LPCT, whose volunteers have performed fish counts in the past, has reported that fish are utilizing the fishway. However, the NMFS and the DFW report that fish may be attracted to the base of the dam rather than to the entrance of the fishway due to differences in attraction flows (Stratus Consulting, 2012).

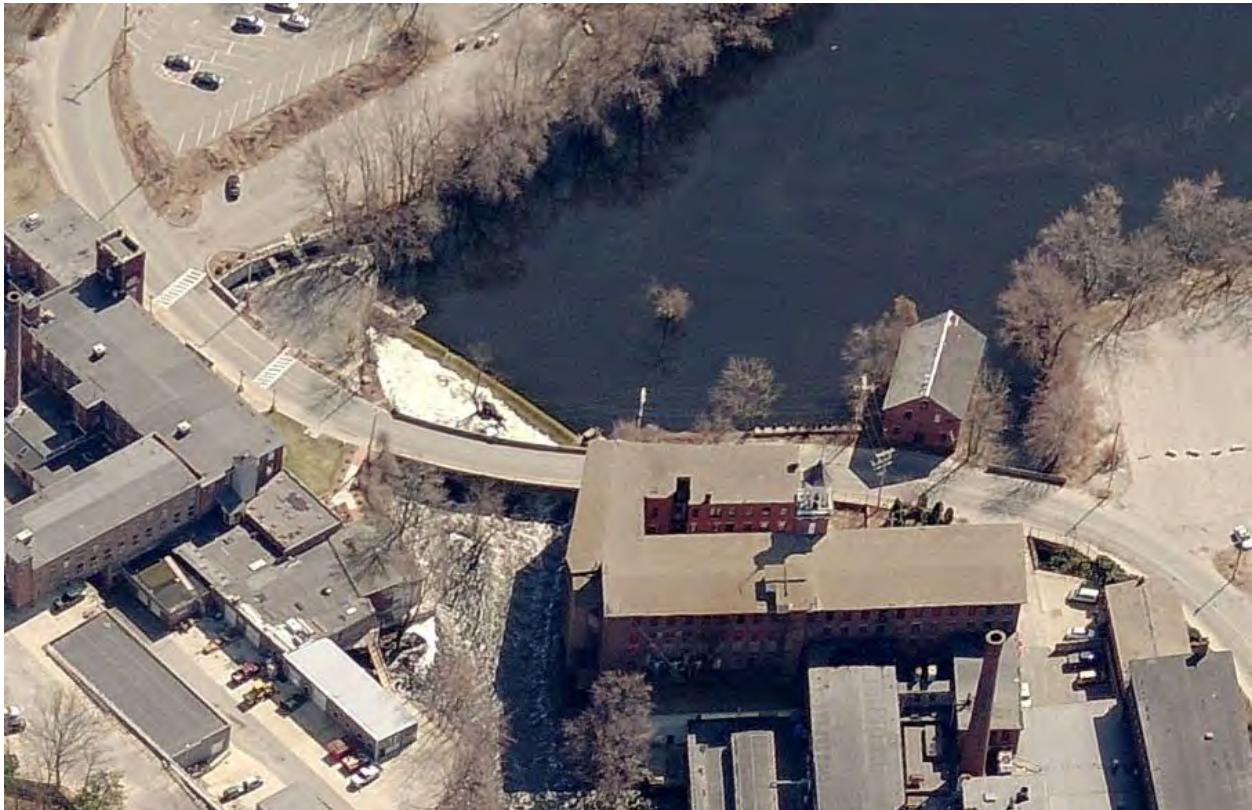
*Talbot Mills Dam (looking upstream), showing the Faulkner Mills complex on the left and the Talbot Mills complex on the right. See **Figure 2.2.3-1** for a labeled version of this aerial image (Bing, 2015).*

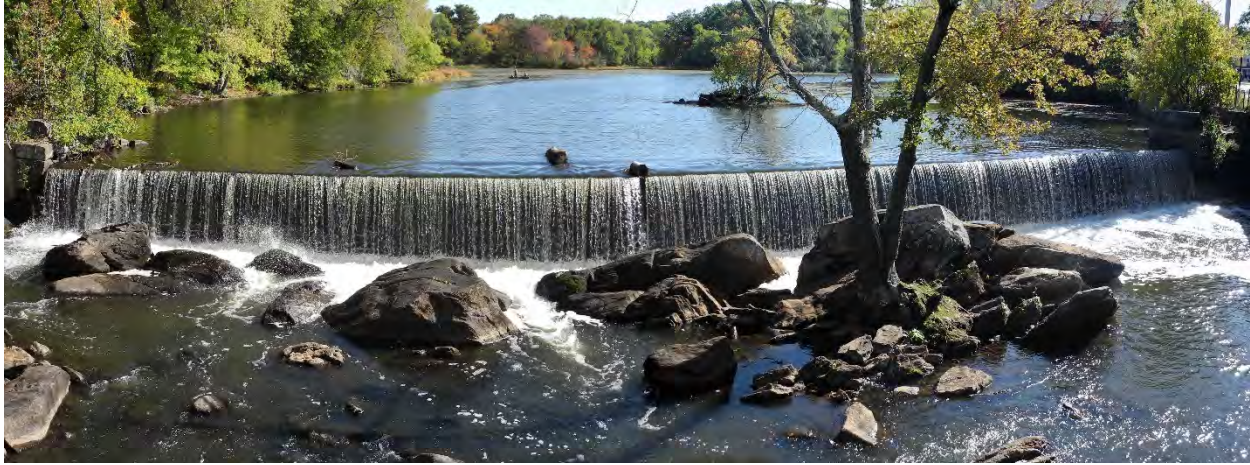
Talbot Mills Dam (looking upstream), showing the bedrock channel downstream of the dam.

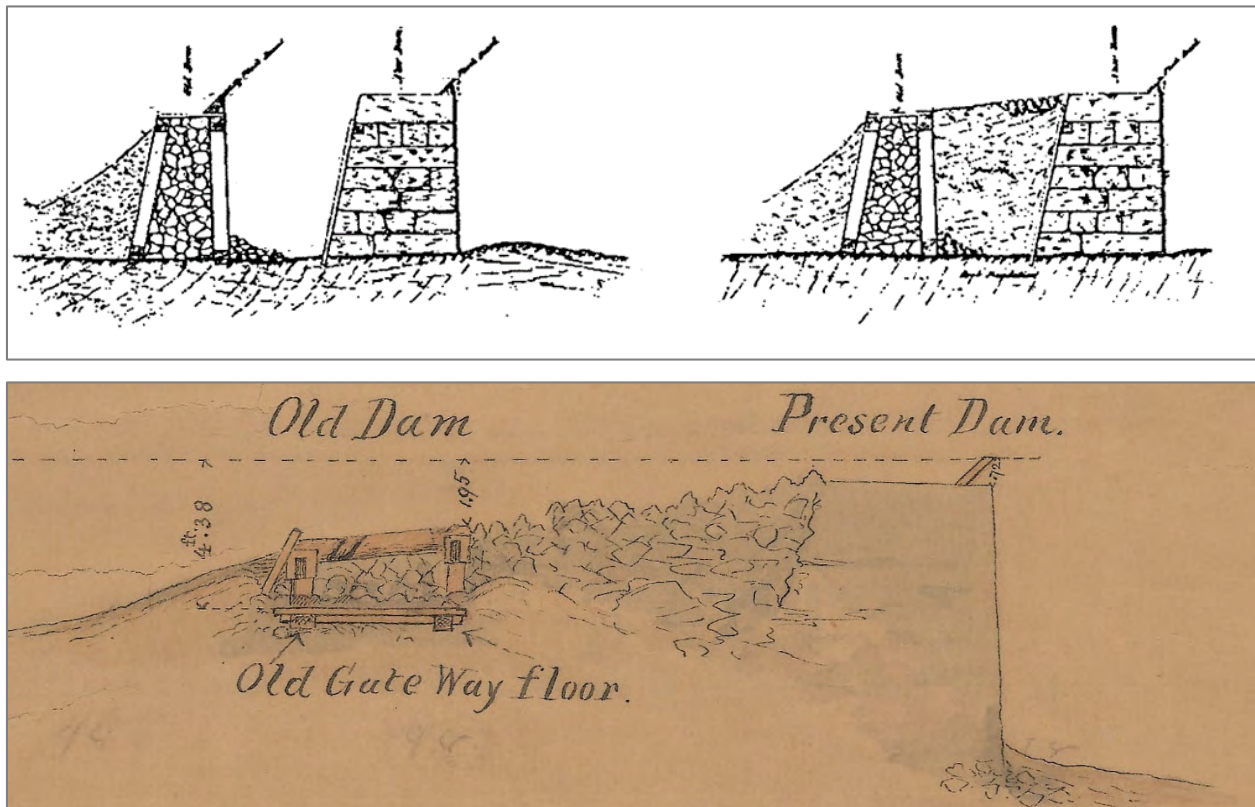
Historical details showing the relative positions of the current Talbot Mills Dam (on the right/downstream in each detail) and the legacy dam that was submerged when the current dam was built (on the left/upstream in each detail). The legacy and current dams were the fourth and fifth dams built at the Talbot Mills site, respectively (Source: Top – Ingraham, 2009, bottom – Alvord et al., 1862 (excerpted from **Figure 2.2.3-5**)).

In 1828-29, the canal proprietors built the current (fifth) masonry dam to replace the deteriorating and insufficient 1798 structure. Rather than removing the earlier dam, the new dam was built just downstream (approximately 8 to 12 feet) and the space between them was filled with rock and gravel, as shown in the figures below. During this era, antiquated dams were commonly left in place to be submerged by the new, usually taller dams that replaced them, in part to save on demolition costs and provide water control during construction. The submerged dam is often referred to as a “legacy dam.” The new dam crest was set about 12 to 14 inches higher than the cap sill of the old dam, but its flashboards were lower than those of the old dam (with reported flashboard heights ranging from 9 to 11 inches for the 1828 dam and 20 to 33 inches for the 1798 dam) (MA House of Representatives, 1860).

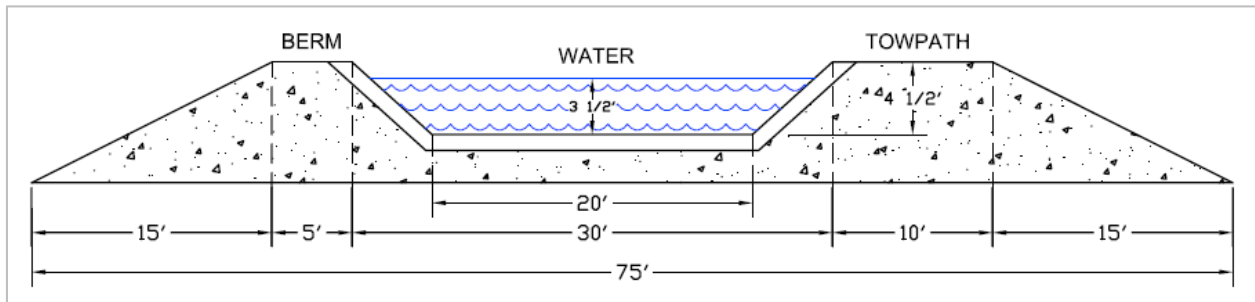
Typical Middlesex Canal prism and buffer cross-section (Waterfield Design Group, 2008a).

Construction of the canal began in 1794 in North Billerica and was completed in 1803. The typical canal prism was 30 feet wide at the top and 20 feet wide at the bottom with an average water depth of 3 ½ feet, as shown in the figure below (Waterfield Design Group, 2008a). Assuming a canal water surface elevation of approximately 108.81 feet NAVD 88, the canal bottom elevation can be estimated to be approximately 105.31 feet NAVD 88 (108.81-foot water surface minus 3.5-foot water depth) (Breen, 2015).

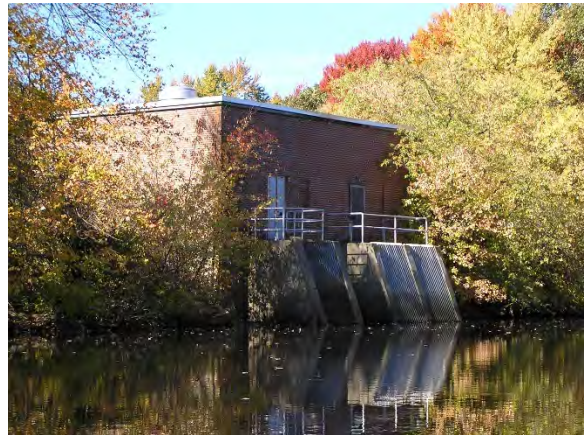
The water supply intake (pictured at right) is located approximately 6,700 feet (about 1 ¼ miles) upstream of the Talbot Mills Dam (about 1,200 feet downstream of the Route 3A/Boston Road bridge), which is within the dam's impoundment⁴³. The intake structure was built in 1955 and consists of a screened wet well and three pumps used to withdraw water from the river (J. McGovern, personal communication, 2014). **Figure 2.3.2-1** provides an excerpt from the 1954 engineering plans for the intake structure showing the following key elevations:⁴⁴

- Maximum flood elevation = 117.2 feet NAVD 88
- Normal high water elevation = 113.2 feet NAVD 88
- Minimum low water elevation = 107.2 feet NAVD 88
- Structure invert elevation = 102.2 feet NAVD 88

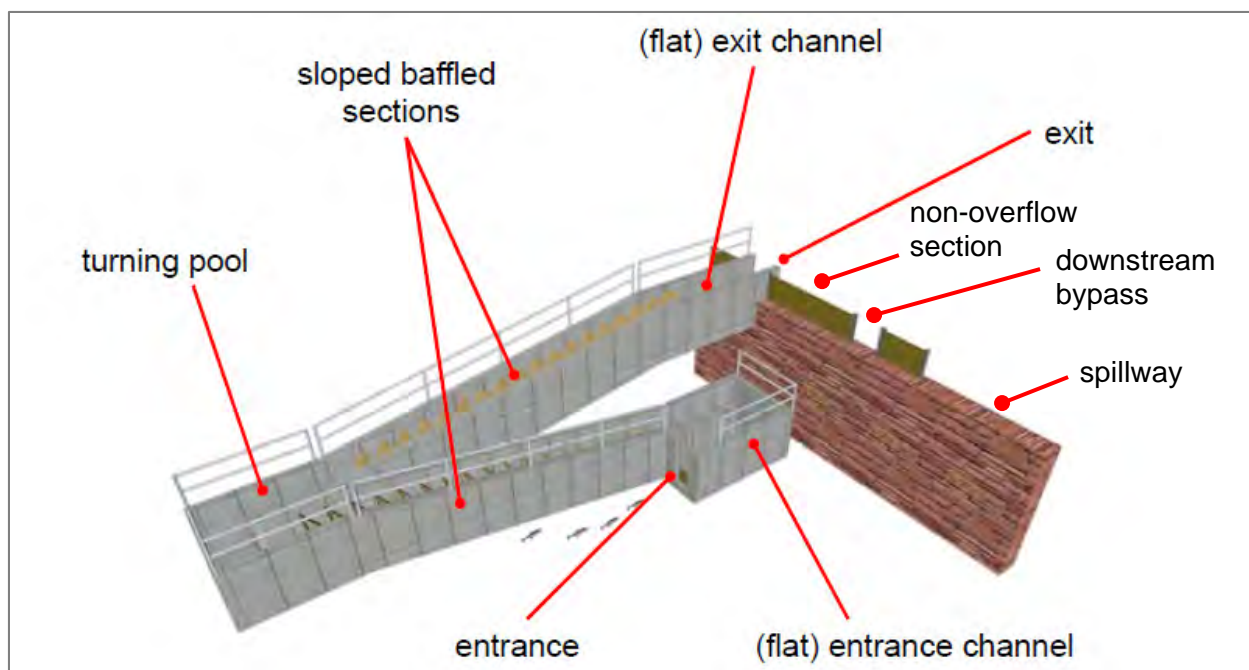
Typical components of a standard Denil fishway (Towler, 2014).

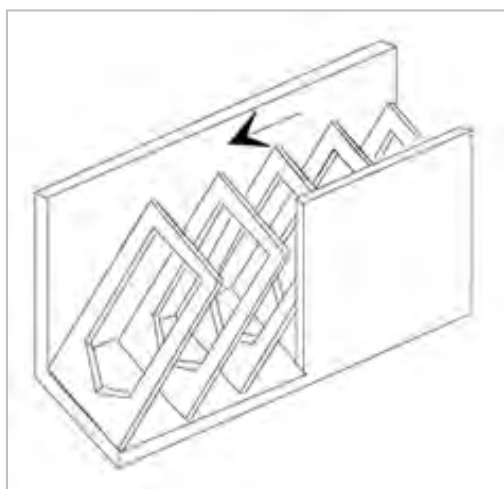
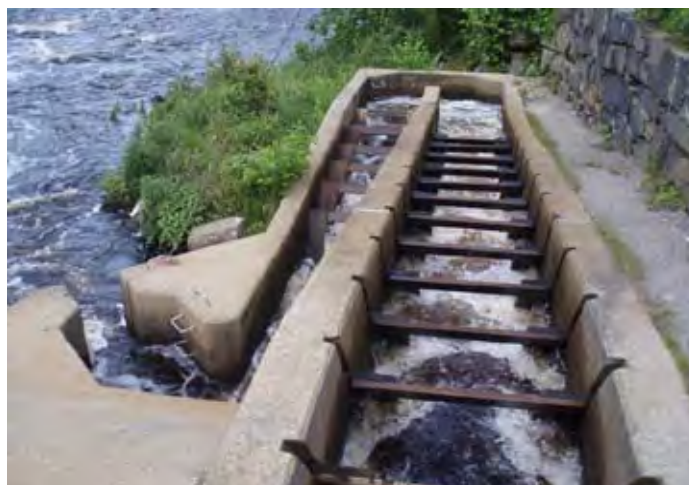
Standard Denil fishway schematic (left) and example (right) at Potter Hill Dam, Pawcatuck River, Westerly, RI.

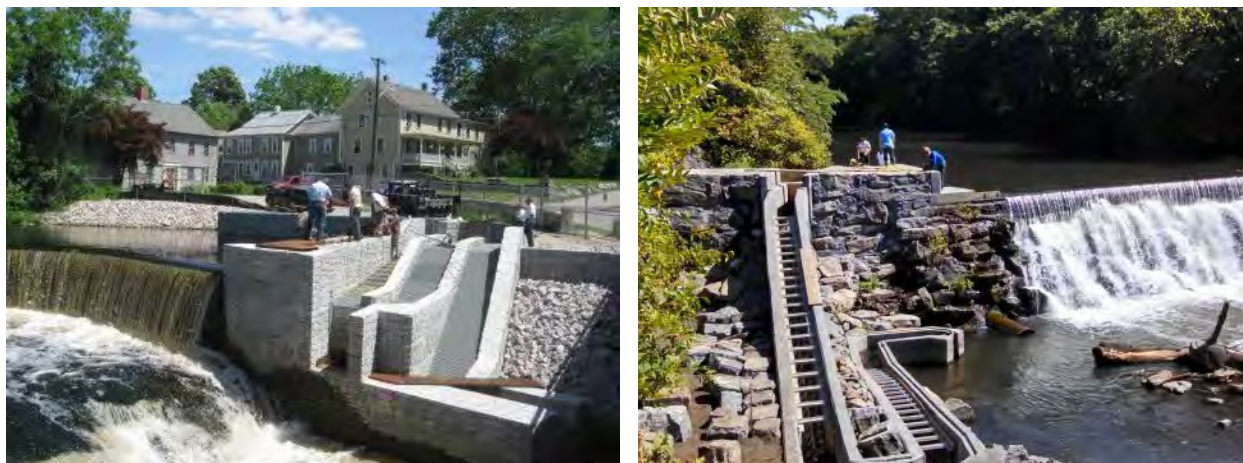
Examples of fish ladders installed at historic dams: A Denil ladder with integrated eelway at Horseshoe Falls Dam on the Pawcatuck River in Shannock Village, Rhode Island (left) and a steep pass (with eel ramp later added) at East 182nd Street Dam on the Bronx River in Bronx, NY (right).

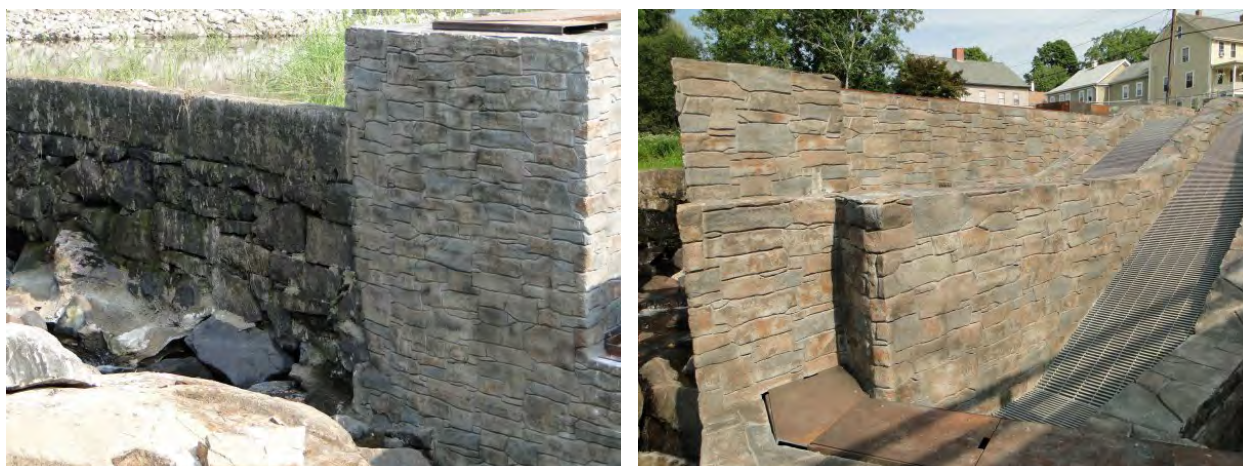
Example of a concrete Denil fish ladder stamped and hand-stained to match existing stone masonry of a historic dam spillway as a requirement of the Section 106 consultation process for the Horseshoe Falls Dam on the Pawcatuck River in Shannock Village, Rhode Island.

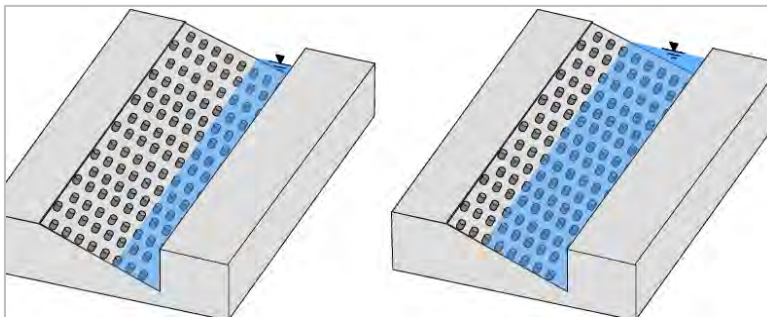
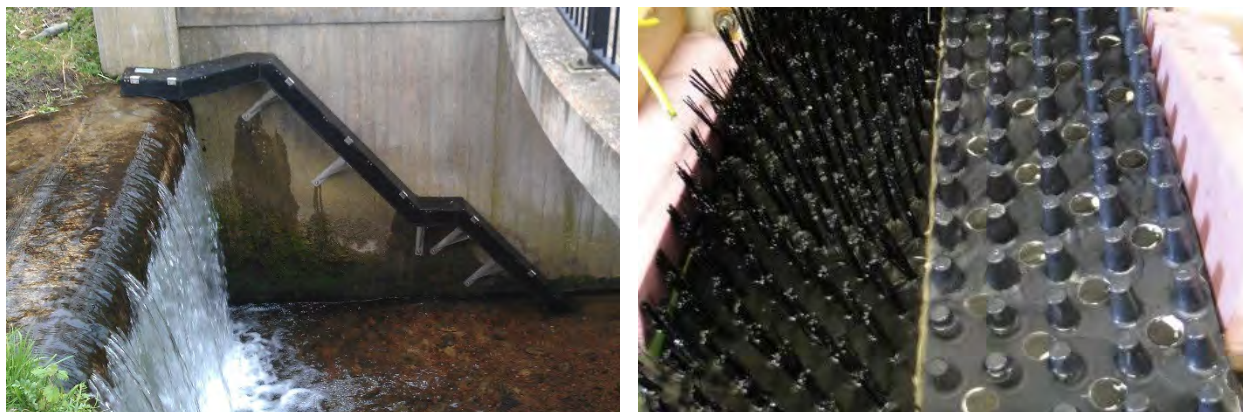
Example of a simple full-height eel ramp exiting to the headpond (left) and close-up of dual substrate types (right).

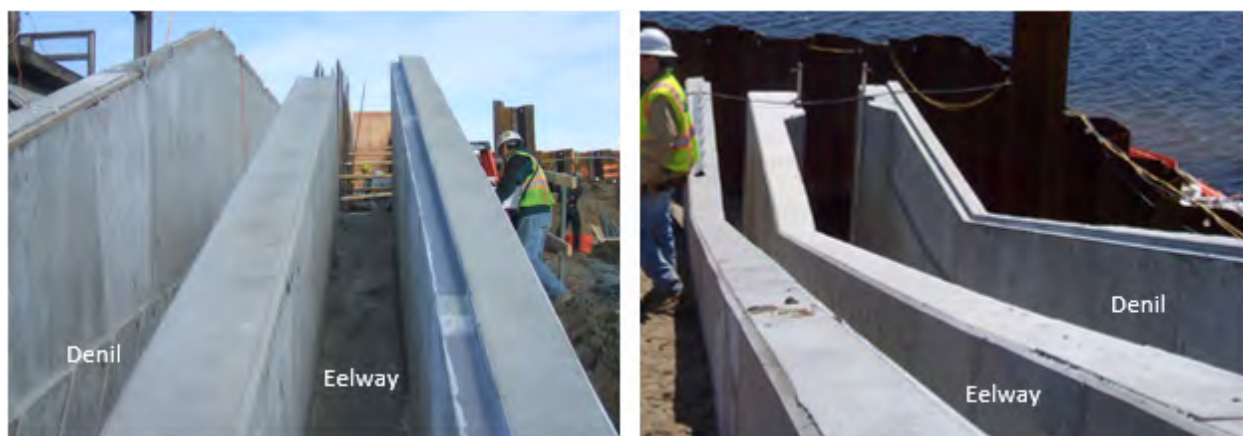
Example of an eel ramp incorporated into a concrete Denil fishway at Upper Mystic Lake Dam in Massachusetts.

An eelway can also be incorporated into the design of a traditional fish ladder, such as a Denil, as shown in the images below and in the Horseshoe Falls Dam fish ladder example shown above.

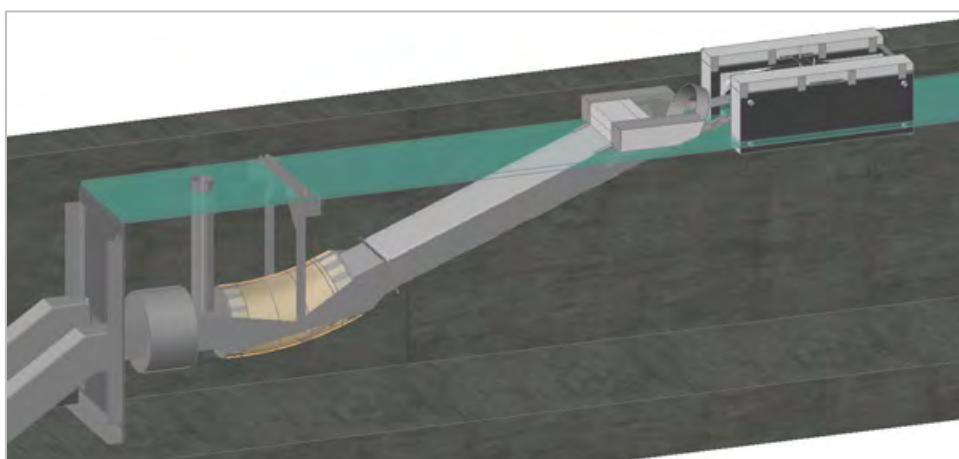
Innovative eel ramp water control assembly that employs a self-regulating floating baffle at the exit installed at the historic Horseshoe Falls Dam on the Pawcatuck River in Shannock Village, Rhode Island in 2012.

A solar-powered pump can be used to provide the constant flow rate needed for an eel ladder, but presents additional operation and maintenance concerns. Recently, an innovative alternate water control assembly that employs a self-regulating floating baffle at the ramp exit was fabricated, piloted, lab tested, and integrated into a fish ladder at a historic dam to address aesthetic, maintenance, and layout constraints, as shown below.

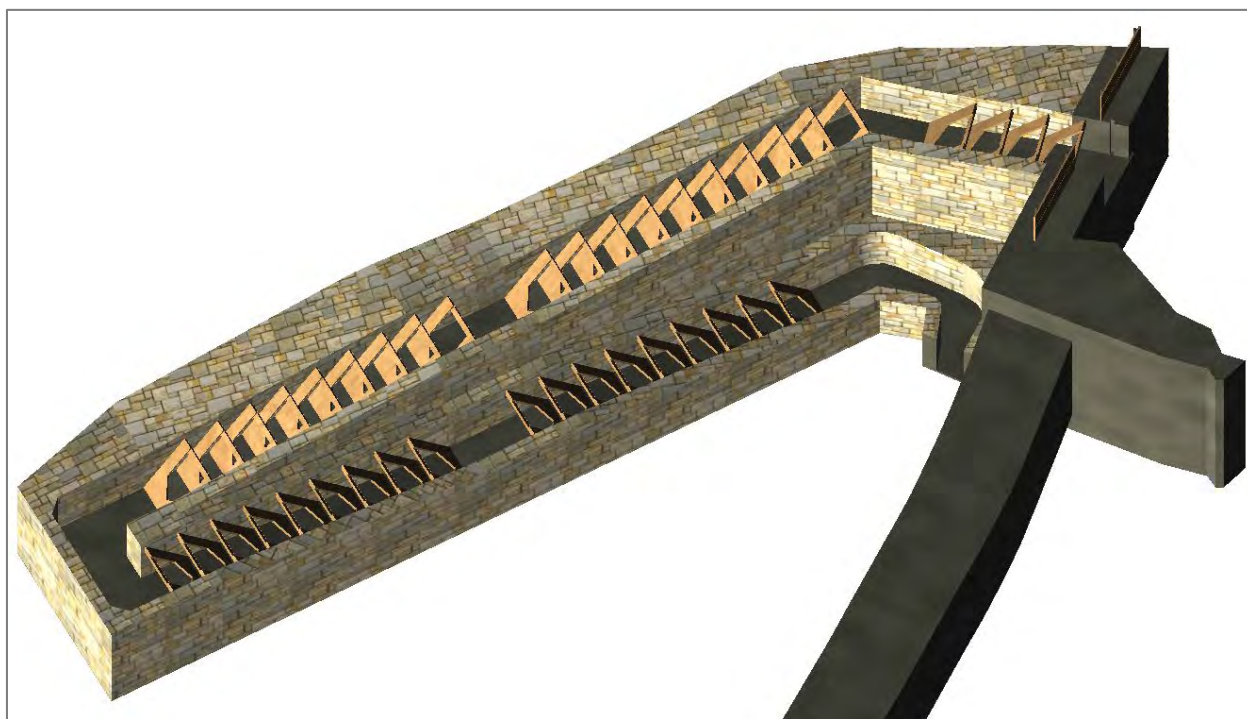
Conceptual rendering of a Denil fish ladder installed at the right abutment of the Talbot Mills Dam

Considering these design guidelines, a slope of 1H:9V was used with a resting pool for every 22.5 feet of horizontal distance (corresponding to 2.5 feet of vertical distance along the slope). One switchback turning pool was needed to allow the ladder to fit within the site constraints (i.e., upstream of the bridge) and also to place the fishway entrance adjacent to the spillway where it will receive the most attraction flow. The fishway could optionally be fitted with metal screens along the top and a trash rack at the exit to prevent debris from entering, but if public viewing is desired, the metal screens could be omitted and the fishway could be checked more frequently for debris. Alternately, a smaller upstream exit section could remain uncovered to facilitate viewing.

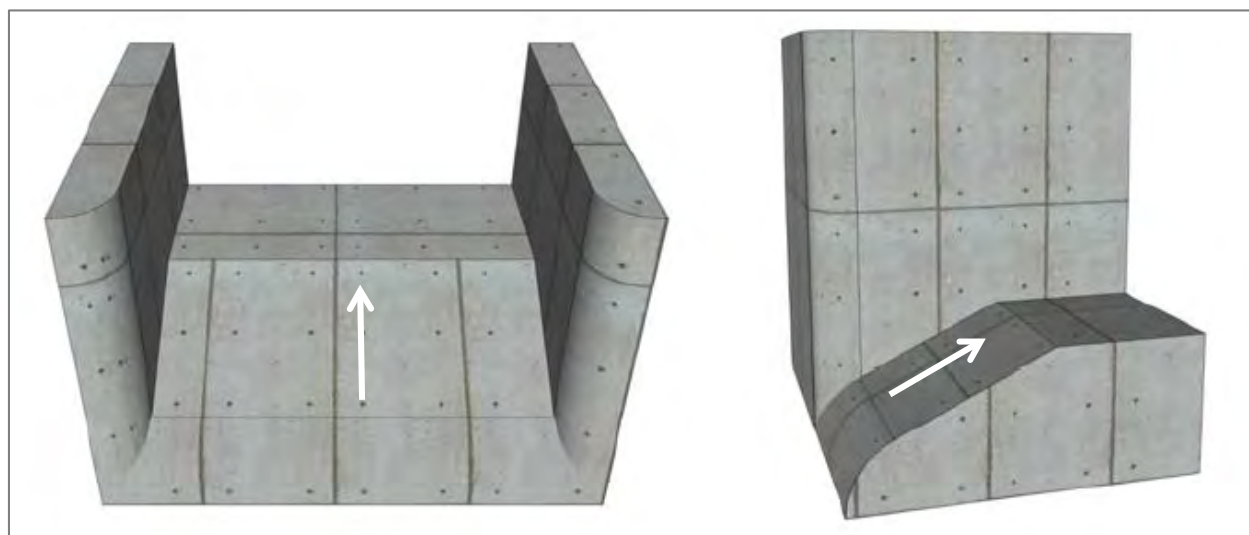
Schematic of a uniform acceleration weir downstream bypass from the upstream (left) and side (right) views (Towler, 2014).

A notch is proposed to be cut into the dam spillway create a “downstream bypass” that will direct fish passing over the spillway to a deeper plunge pool. The dimensions of the notch would be approximately 3 feet wide by 2 feet deep. The bypass location was selected as the river left (southwesterly) end of the spillway adjacent to the abutment to avoid interference with the Denil entrance and take advantage of what appears to be a deeper existing plunge pool in that area. The exact channel elevations below the proposed bypass are unknown, but existing pool depths about 10 feet downstream at a surveyed cross-section along the upstream face of the Faulkner Street bridge (shown in **Figure 4.3.2-1**) appear to be 1.2 to 5.5 feet under the low and high design flows, respectively. Therefore, some removal of channel bed substrate (i.e., bedrock) may be needed to meet the USFWS 4-foot depth recommendation. Ideally, the bypass would have a sloping upstream face—a design known as a “uniform acceleration weir,” as shown in the figure below—to minimize regions of high acceleration.
