DECONSTRUCTING 22 DRYDOCK AVENUE

For our case study today, we will examine a recent project at 22 Drydock Ave in the Boston seaport area.

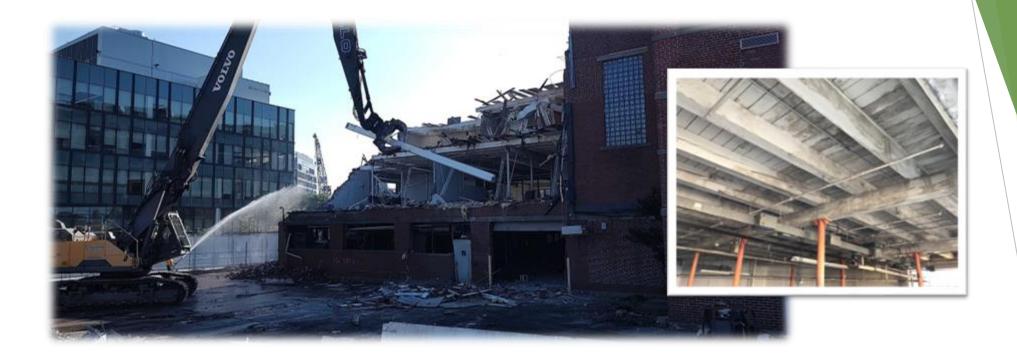
We recognized the potential for good salvage from the 22 Drydock building early in our introduction to the project.

The structural make up of the building was heavy timber framing. We know from similar building types, that we have well honed mechanical capabilities to dismantle this structure safely, with minimal labor exposure and high recovery of delicate timbers, by using one of our high reach excavators equipped with a rotating grapple.

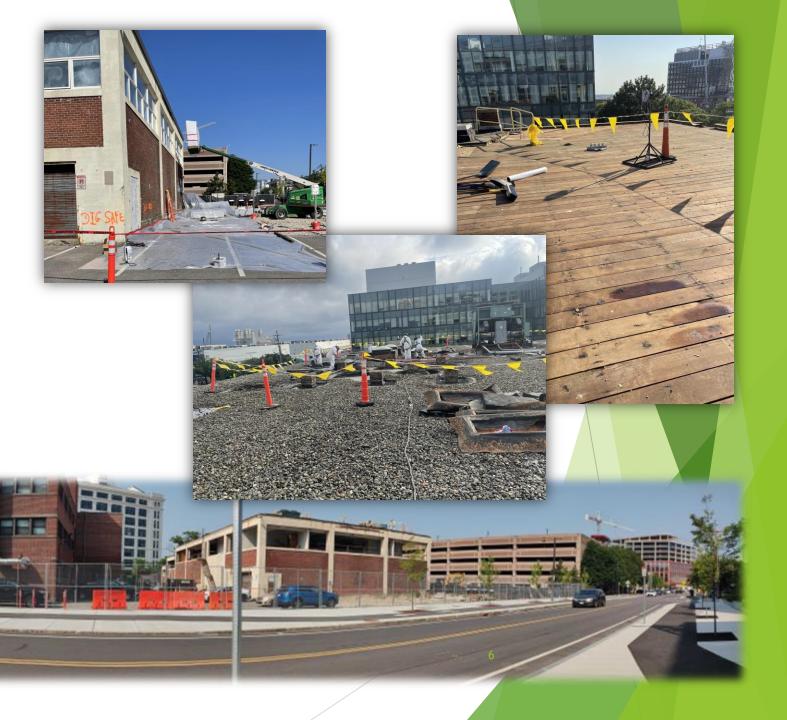
We had sequenced our work so that all asbestos abatement and an adjacent concrete structure had been demolished, leaving a clean slab for processing and stockpiling the 22 Drydock building material components. In a very systematic manner, we separate and remove building components to reveal the timbers to be harvested.

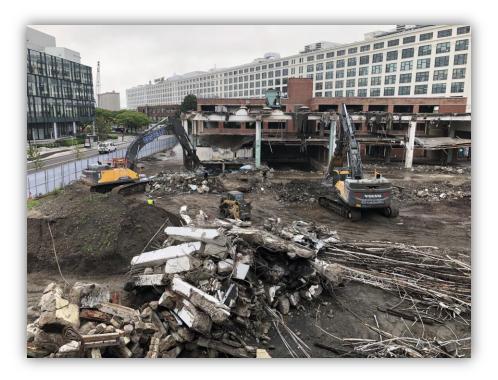
This results in a deliberate, careful source separation of:

- painted and unpainted bricks
- painted and unpainted concrete
- high wood content C&D debris
- mixed unsorted debris
- mixed grades of ferrous scrap metal
- mixed grades of nonferrous scrap metal

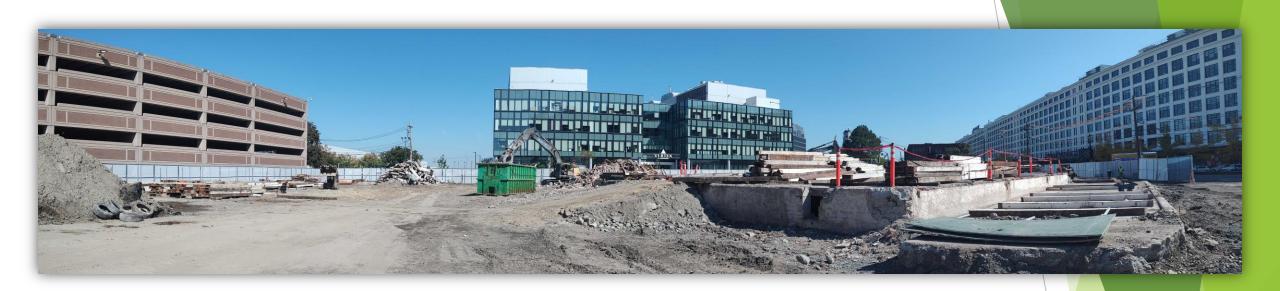
We utilize a variation of the source separation theme on every project which we undertake.

Not only is disposal pricing controlled, but we maintain the site in a neat and organized manner which greatly improves site safety and appearance during a demolition project. In a continuous effort of sorting and packaging all salvaged materials, as demolition proceeds, timbers were bundled and loaded for delivery to a local sawmill with whom we have a long-standing relationship.
