Occupational Fatality Report

Municipal Crossing Guard Fatally Injured When Struck by a Motor Vehicle – Massachusetts

Release Date: January 8, 2013
Investigation: # 12-MA-010-01

Massachusetts Department of Public Health
Occupational Health Surveillance Program

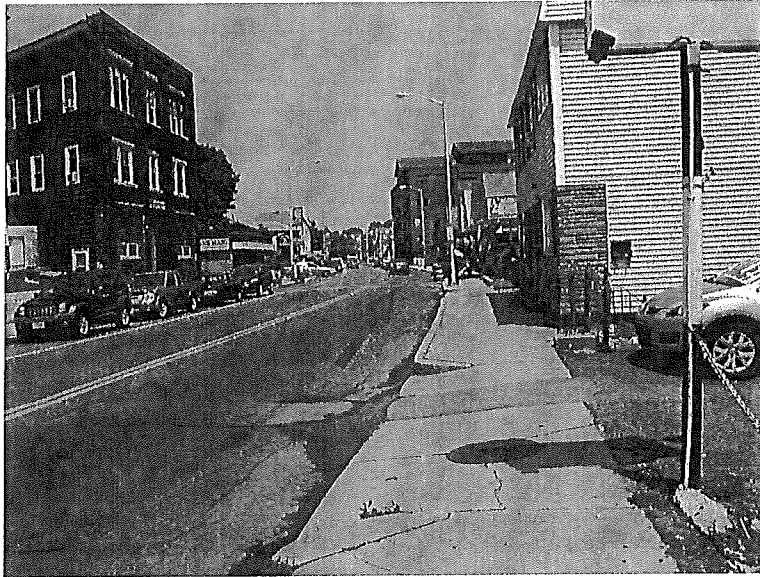
Figure 2 – View of the main roadway heading north towards the intersection

The school closest to the crosswalk that the victim was assigned to was an elementary school for students in kindergarten through eighth grade. This school is located in an urban setting and the school property spans one city block (Figure 1). The roadway in front of the school is a side street that runs east and west and has two travel lanes with one lane for each direction. There is a parallel roadway that is located directly behind the school. This roadway is also a two lane side street that runs east and west with one lane for each direction of traffic. The main roadway, where the incident occurred, is located to the west of the school. This main roadway has two lanes that run north and south with one lane for each travel direction. Parking is allowed along the west side of the southbound travel lane (Figure 2).

Arrow points to the crosswalk where the victim was struck and direction of travel and approximate location of the truck involved.

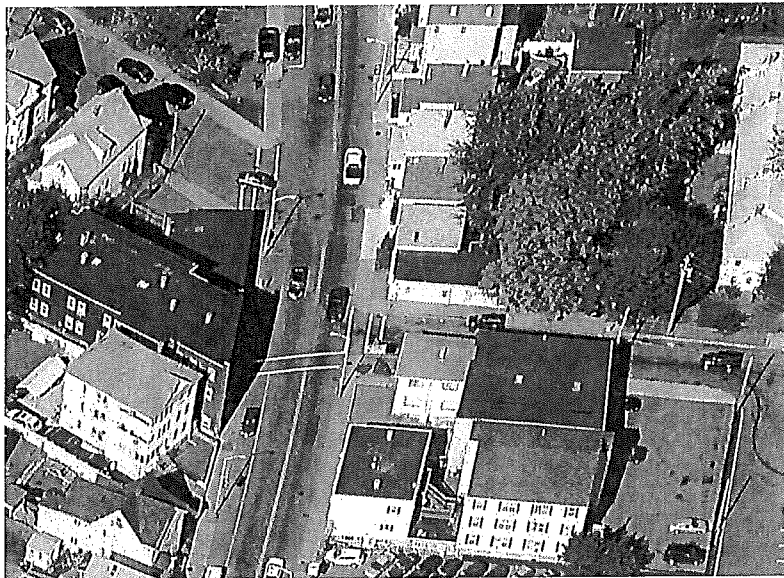
Figure 3 – Aerial view of the intersection where the incident occurred.

The incident occurred at the unsignalized T-shaped intersection of the main roadway and the side street located at the rear of the school. The intersection has two painted crosswalks. One crosswalk is located across the beginning of the side street and the other is located across the main roadway at the southern side of the intersection. Each crosswalk is made up of two painted parallel lines with no center painted markings (Figure 3). The crosswalks were in poor condition at the time of the incident, the paint was faded and cracked. In contrast, the crosswalks directly in front of the school were made up of two painted parallel lines with painted diagonal center lines. These crosswalks in front of the school were not faded and in good condition (Figure 4).

Red arrow points to the crosswalk where the victim was struck and the direction and approximate location of the truck involved.

- Ensure painted crosswalks are highly visible and in good condition. The crosswalk where the victim was struck consisted of two white parallel lines that were faded and in overall poor condition. There are other common markings that can be used for increased crosswalk visibility. These markings include ladder type pattern, with multiple longitudinal lines parallel to traffic flow, or diagonal striping. Crosswalks and other roadway marking should be routinely evaluated to ensure they are not faded and are in good condition.

- Install permanent pedestrian signs, flashing lights, and/or additional street markings at all crosswalk locations. At the incident location there were no signs warning motorists that there was a pedestrian crosswalk. Signs and/or flashing lights should be added, both for the southbound and northbound travel lanes, to give motorists advanced warning of the crosswalk location.

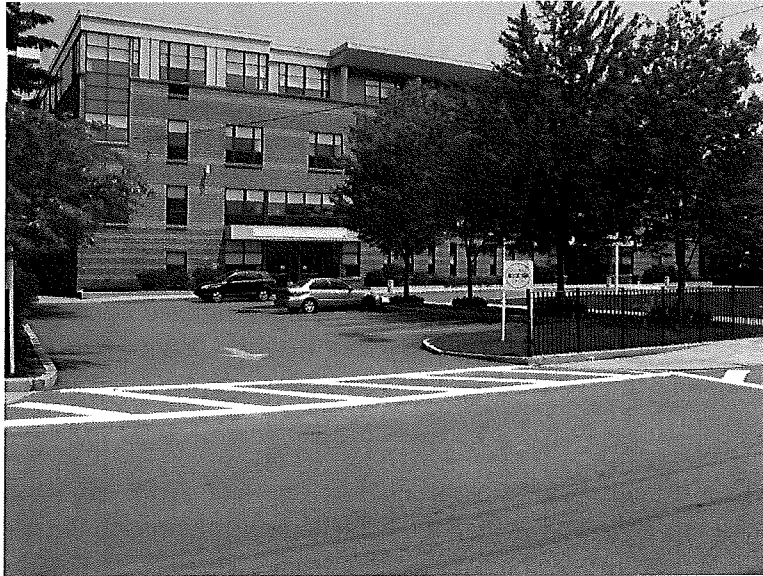
The speed limit for the main roadway is 30 miles per hour (MPH). The roadway's markings consisted of a white painted fog line along the western edge of the southbound travel lane. This white painted line was approximately eight feet out from the edge of the sidewalk's granite curbing and designates the location for on street parking. The northbound travel lane does not have a white painted fog line and there is no on street parking along this travel lane. The southbound and northbound travel lanes are separated by double yellow parallel divider lines that are painted in the center of the roadway (Figure 4).

Figure 4 – Crosswalk markings located in front of the school

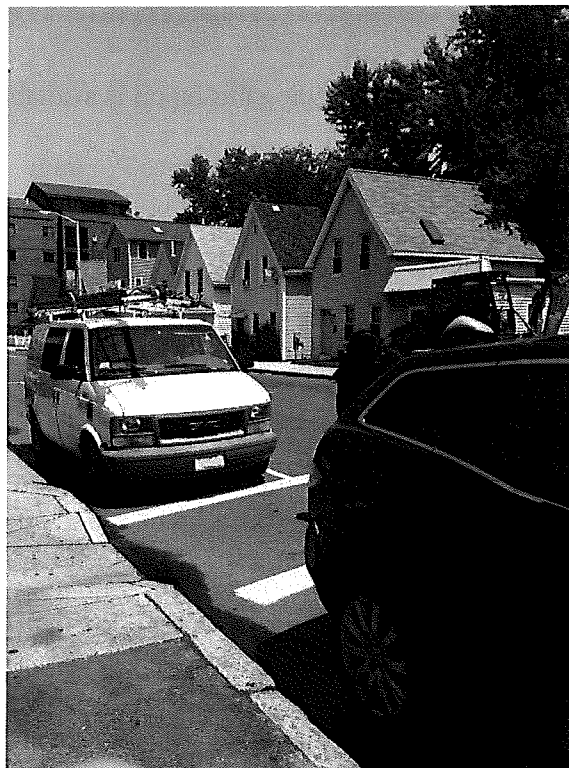
Two bus stops are located at the intersection where the incident occurred, one bus stop on either side of the main roadway. The bus stop on the northbound travel lane is located immediately before the intersection and the crosswalk. The bus stop on the southbound travel lane is located across the T-shaped intersection, north of the perpendicular side street (Figure 3). There is a convenience store located in front of this bus stop. The bus stops are designated no parking areas, but during the site visit more than one vehicle had parked in the bus stop to go into the convenience store (Figure 5).

Figure 5 – Incident location with vehicles parked on both sides of the crosswalk

- Prohibit parking and stopping of any motor vehicles within 20 feet of both sides of crosswalks. When vehicles are allowed to park or stop on either side of a crosswalk these vehicles block both the pedestrian's view of oncoming traffic and the motorist's view of the pedestrian trying to enter the crosswalk. "No parking" and "no stopping" signs and roadway markings should be used. Bus stops should also be excluded from this 20 foot zone.
