# Quabbin Park Cemetery Restoration Project

## Final Report

June 2012

Final report prepared by – Ta Mara Conde

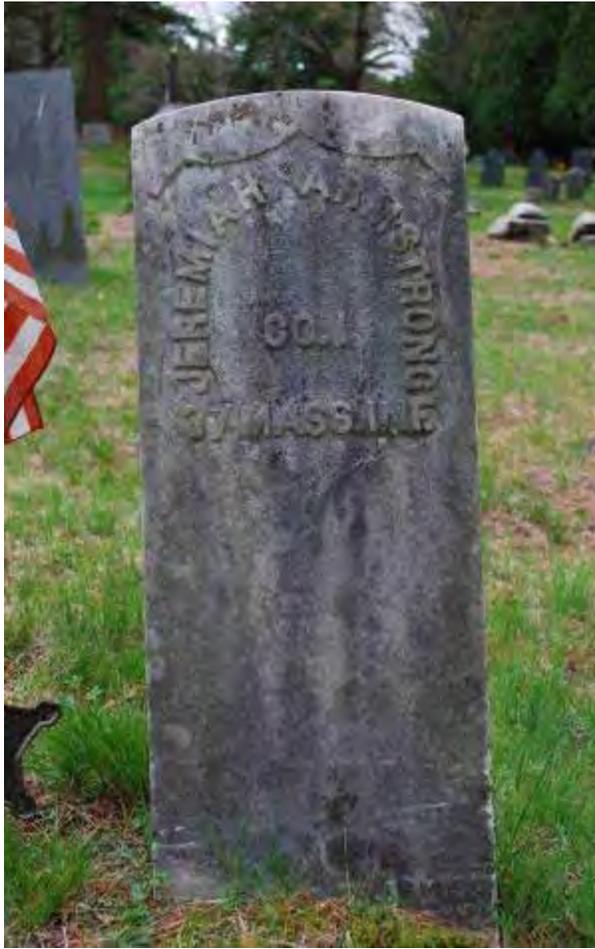
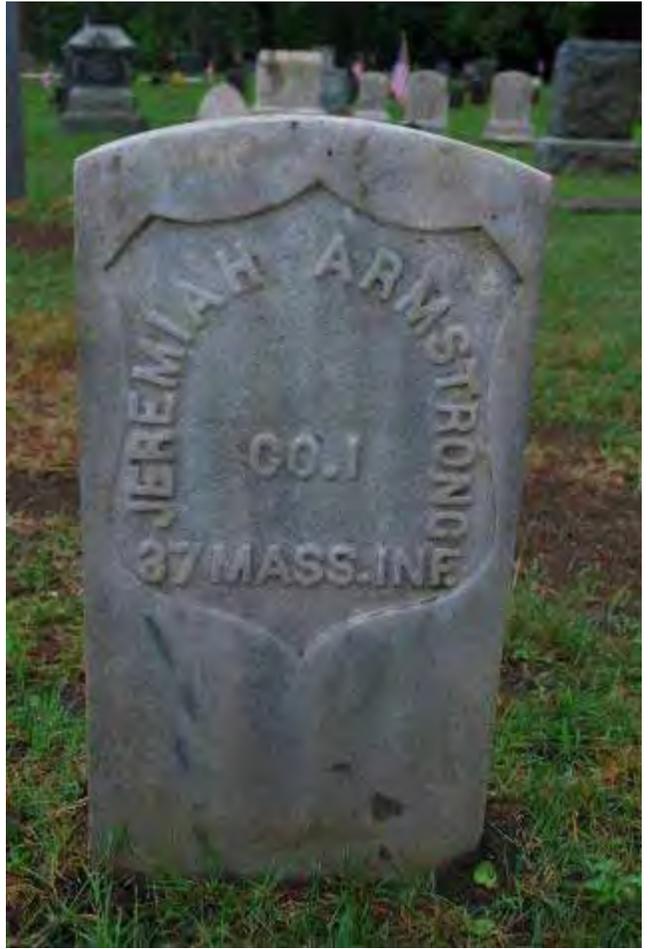
**Cemetery** Quabbin Park  
**Location** Ware, MA  
**Record Date** May 2012  
**Name** Armstrong, Jeremiah  
**Date of Death**

**Previous Work** Concrete foundation stuck on base

**Stone Condition** Leaning, biological growth

**Treatment** Clean and reset level

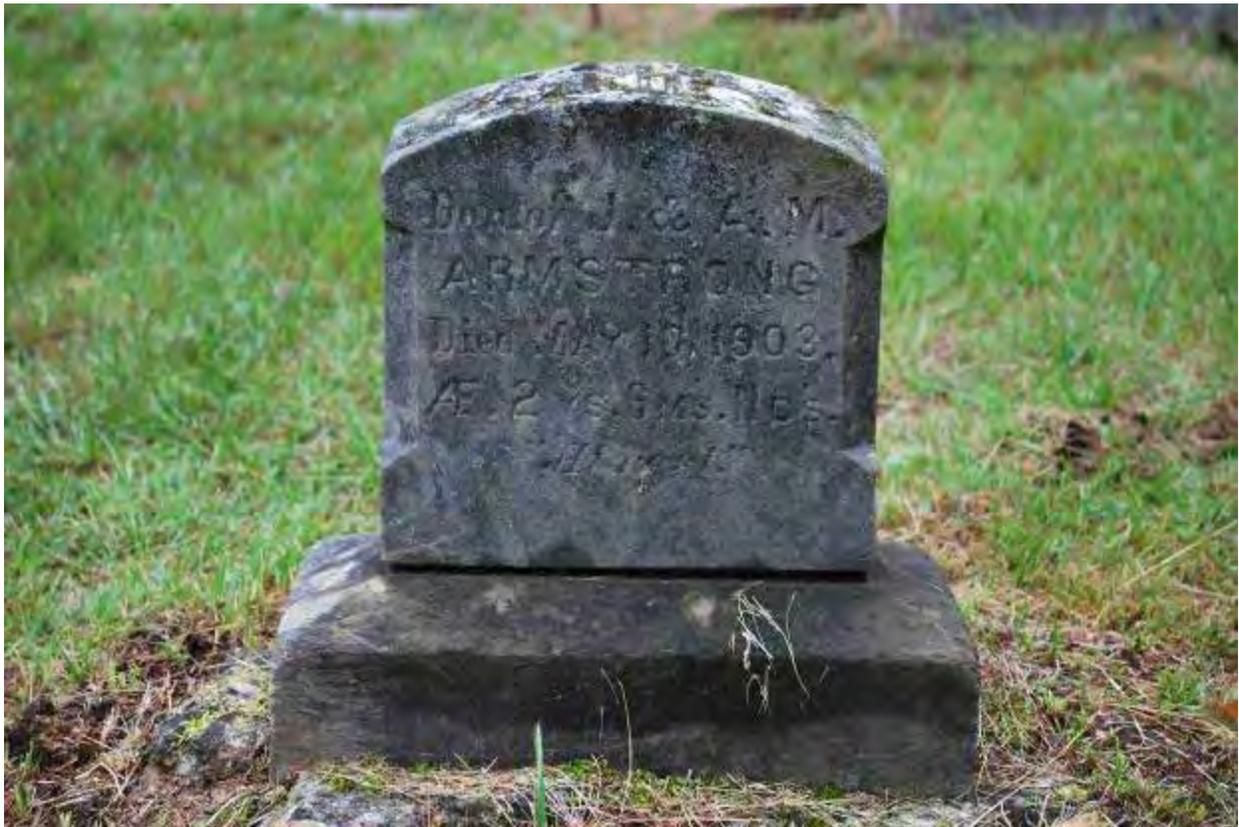
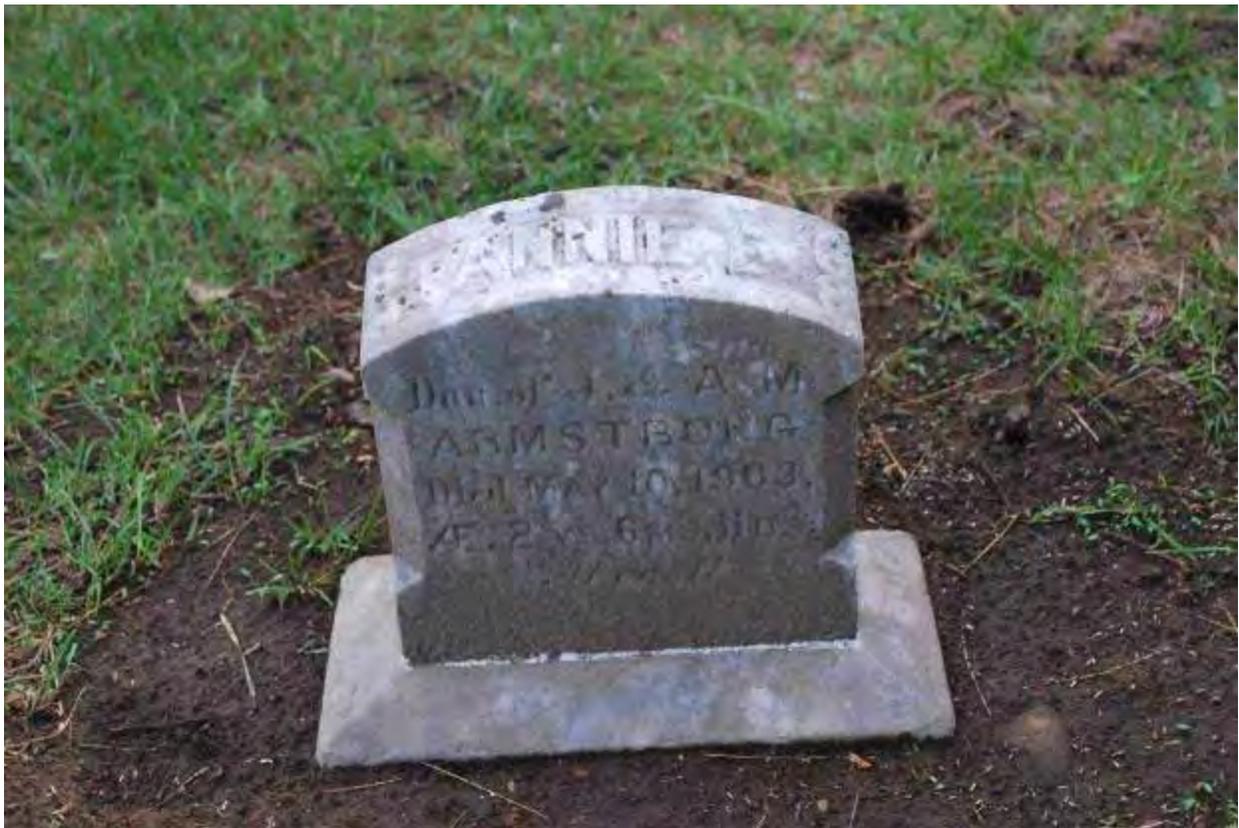
**Cemetery** Quabbin Park  
**Location** Ware, MA  
**Record Date** May 2012  
**Name** Armstrong, Fannie E.  
**Date of Death** May 10, 1903

**Previous Work** Concrete foundation stuck on base

**Stone Condition** Leaning, biological growth

**Treatment** Clean, excavate and reset level

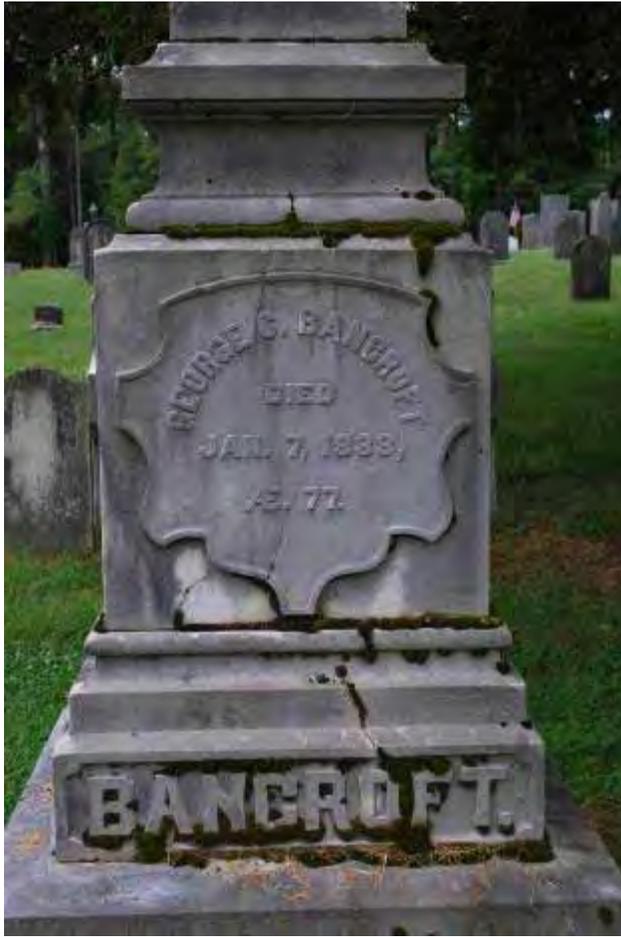
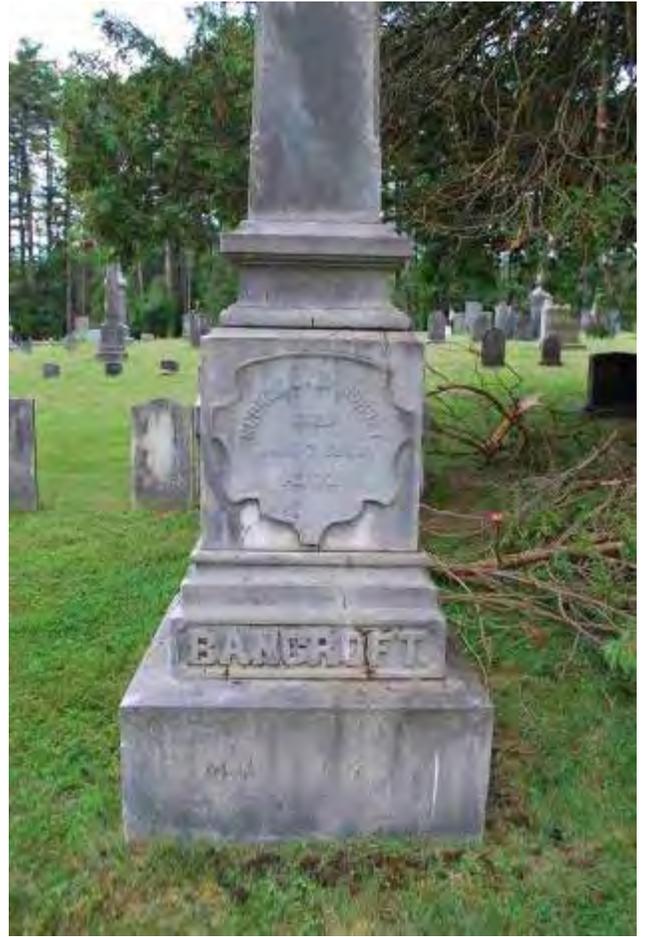
**Cemetery** Quabbin Park  
**Location** Ware, MA  
**Record Date** May 2012  
**Name** Bancroft, George Elizabeth J.  
**Date of Death** Jan. 7, 1933 February 5<sup>th</sup>, 1926

**Previous Work** Concrete foundation stuck on base

**Stone Condition** Moss growth, Cracks in the center a lower sections.  
Cracks may penetrate through the stone.

**Treatment** Bottom section of the monument was cleaned for further inspection. Cracks should be monitored for signs of expansion.

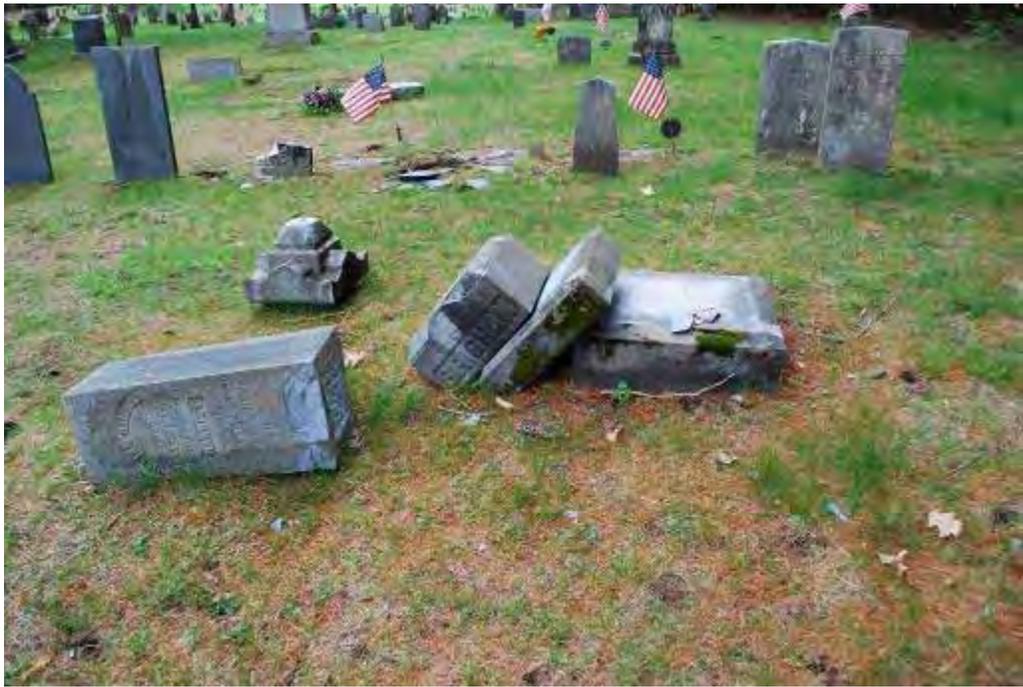
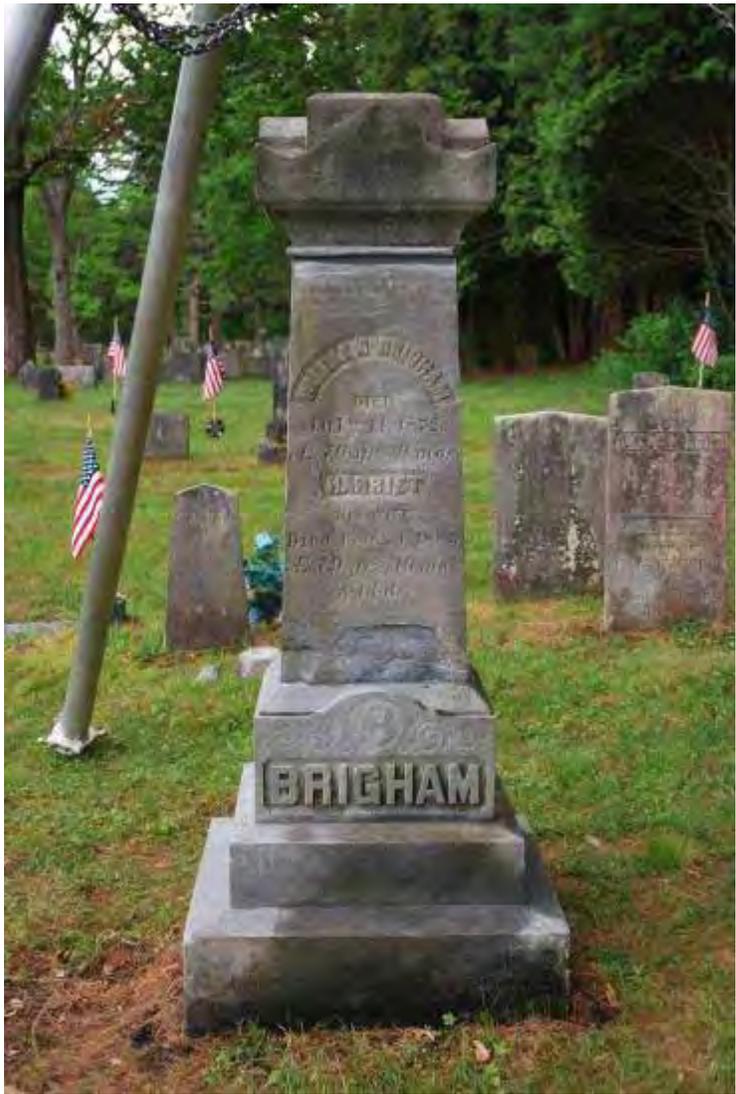
**Cemetery** Quabbin Park  
**Location** Ware, MA  
**Record Date** May 2012  
**Name** William Brigham  
**Date of Death** July 11, 1872

**Previous Work** Concrete foundation stuck on base

**Stone Condition** Broken, Bio growth

**Treatment** Clean, Excavate and reassemble level with mortar

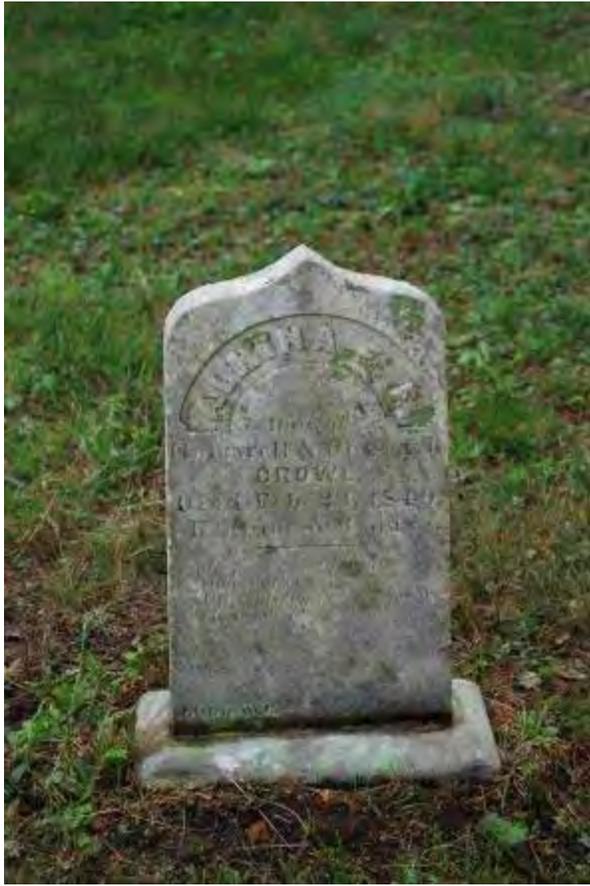
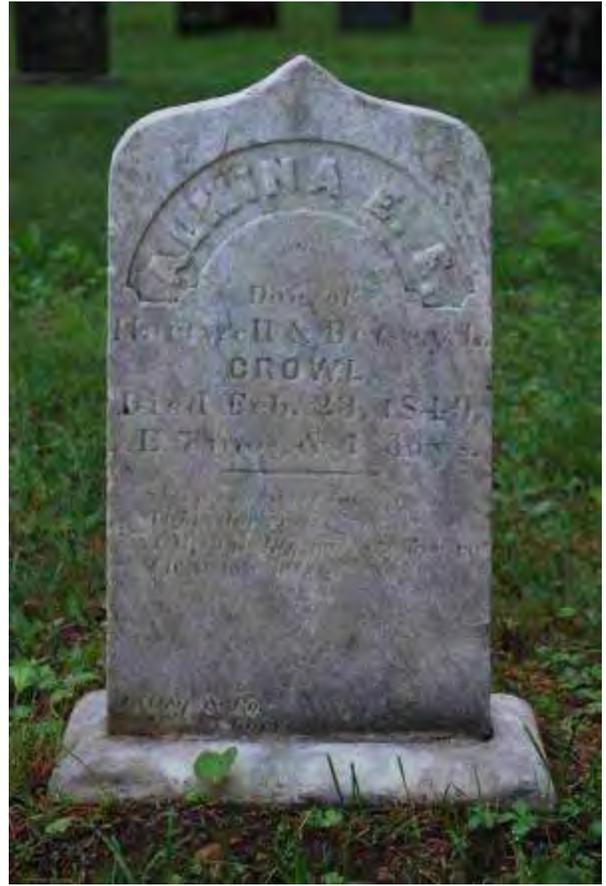
**Cemetery** Quabbin Park  
**Location** Ware, MA  
**Record Date** May 2012  
**Name** Crowl, Almira E. E.  
**Date of Death** Feb 23, 1849

**Previous Work** Concrete foundation stuck on base

**Stone Condition** Biological growth

**Treatment** Clean

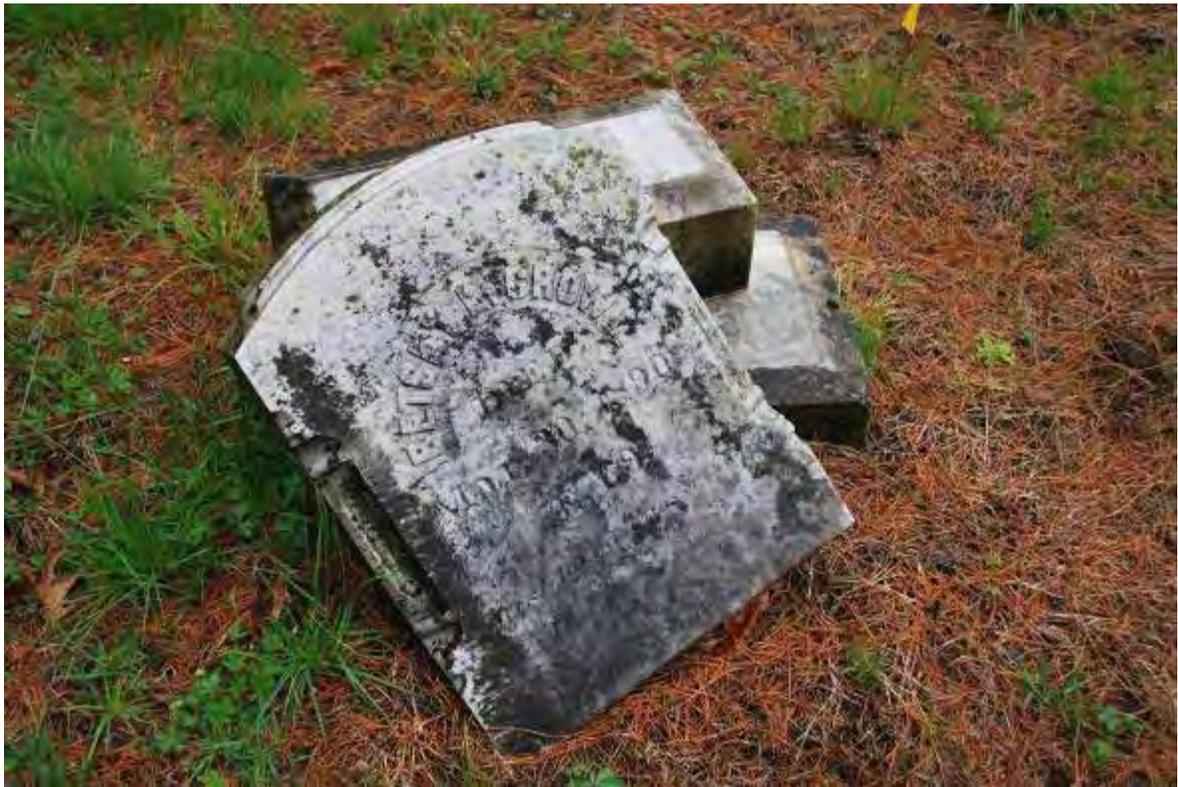
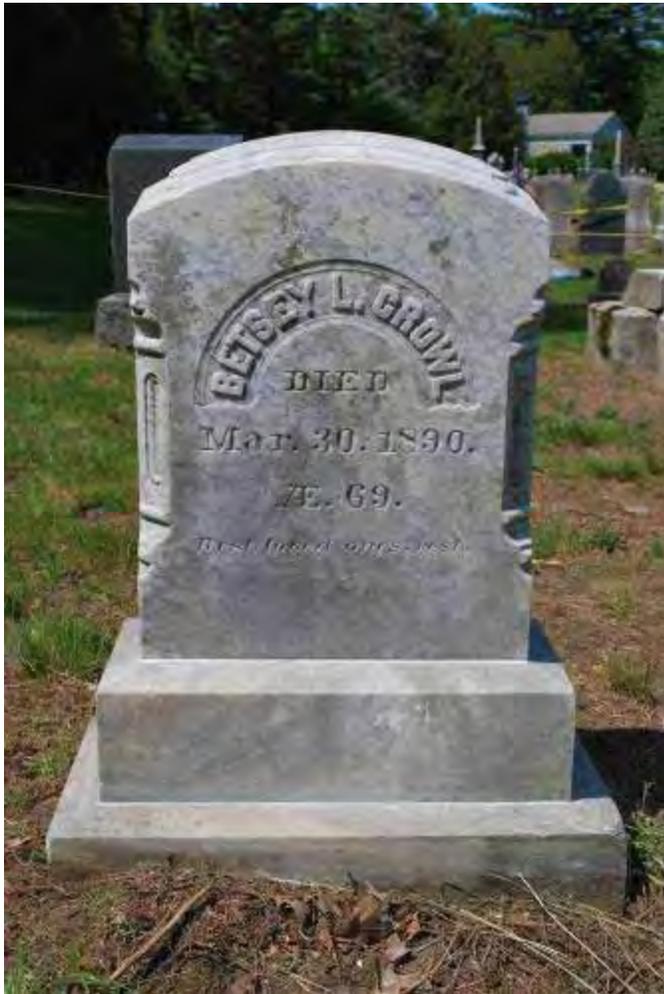
**Cemetery** Quabbin Park  
**Location** Ware, MA  
**Record Date** May 2012  
**Name** Crowl, Betsey L.  
**Date of Death** March 30, 1890

**Previous Work** Concrete foundation stuck on base

**Stone Condition** Fallen, Biological growth

**Treatment** Clean, Excavate and reset level with mortar

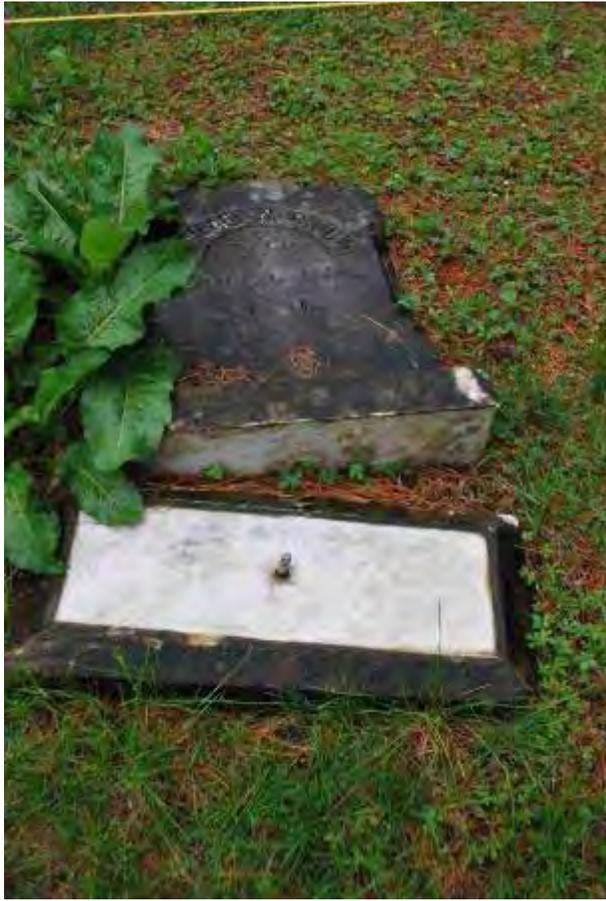
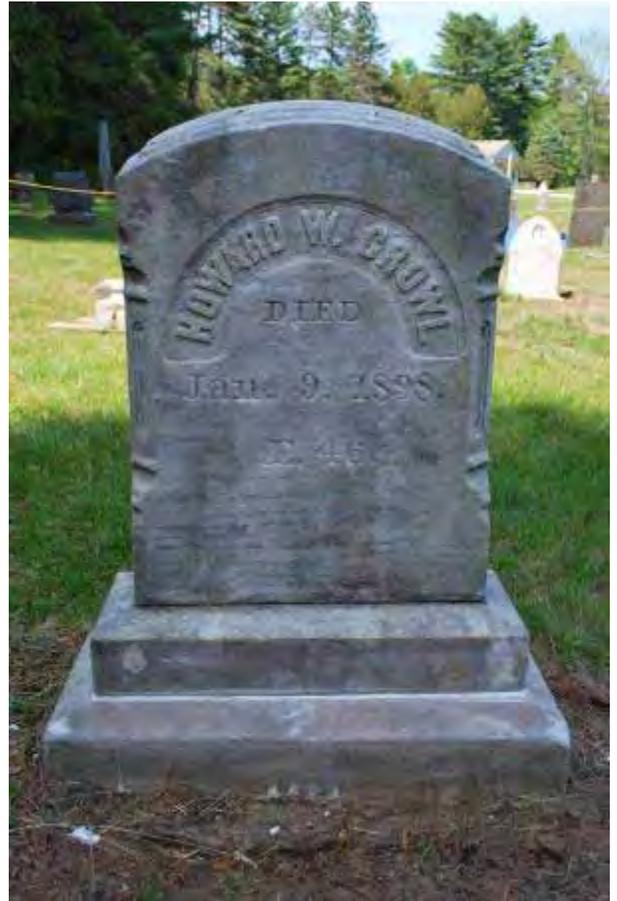
**Cemetery** Quabbin Park  
**Location** Ware, MA  
**Record Date** May 2012  
**Name** Crowl, Howard W.  
**Date of Death** Jan 9, 1898

**Previous Work** Concrete foundation stuck on base

**Stone Condition** Fallen over, Biological growth

**Treatment** Clean, excavate and reset die and base level

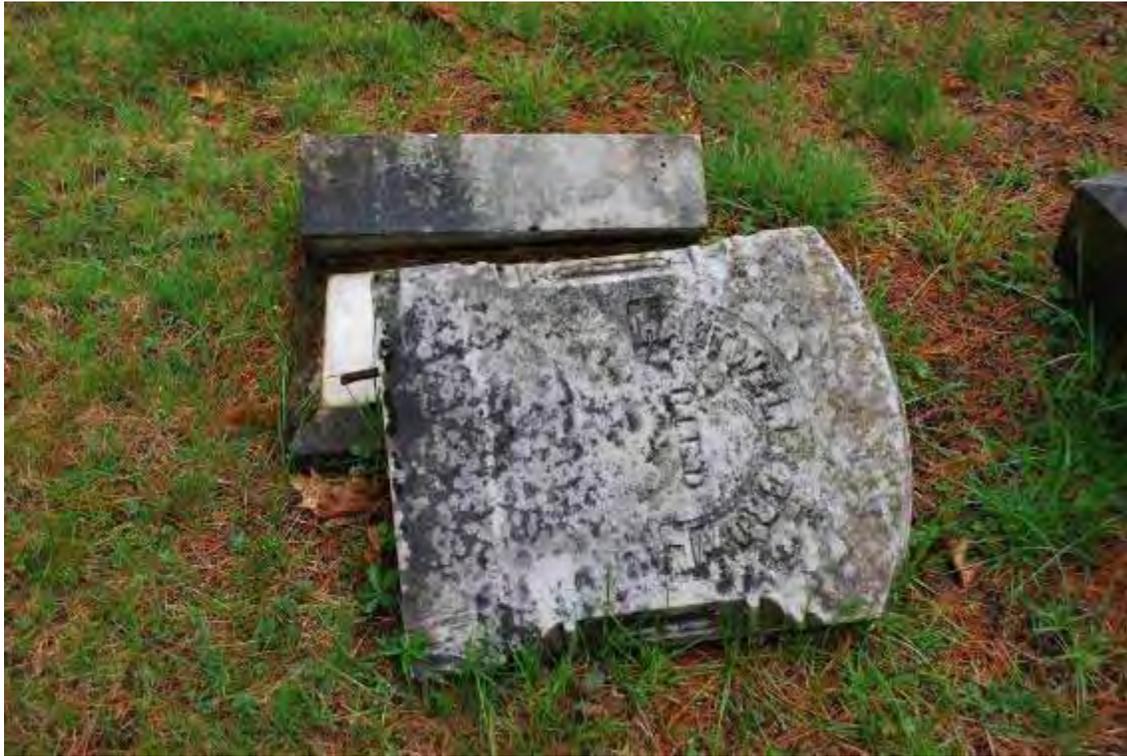
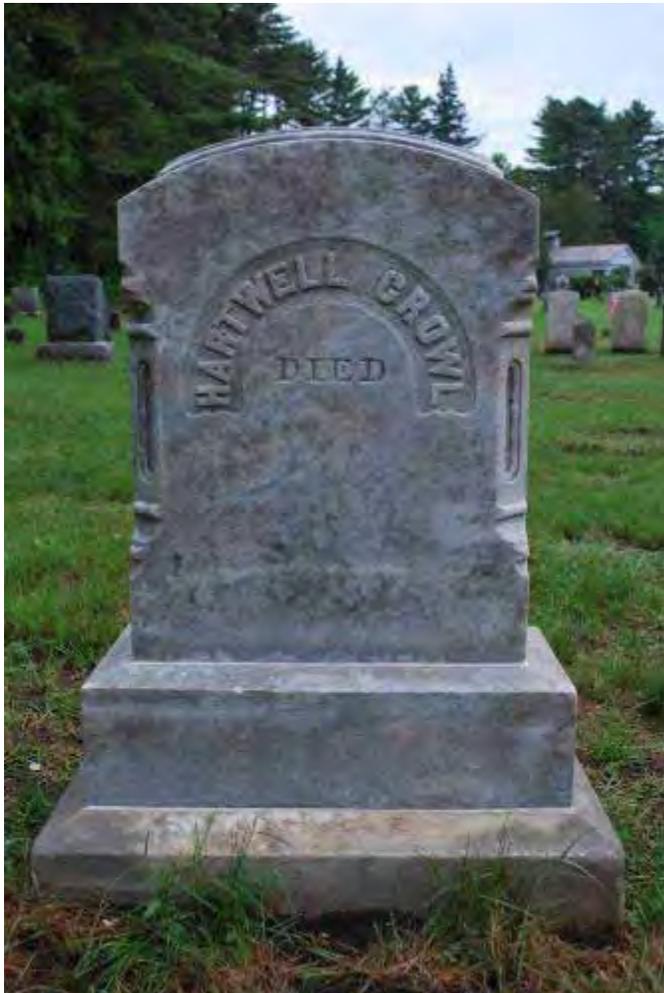
**Cemetery** Quabbin Park  
**Location** Ware, MA  
**Record Date** May 2012  
**Name** Crowl, Hartwell L.  
**Date of Death**

**Previous Work** Concrete foundation stuck on base

**Stone Condition** Fallen, Biological growth

**Treatment** Clean, excavate and reset die and base level

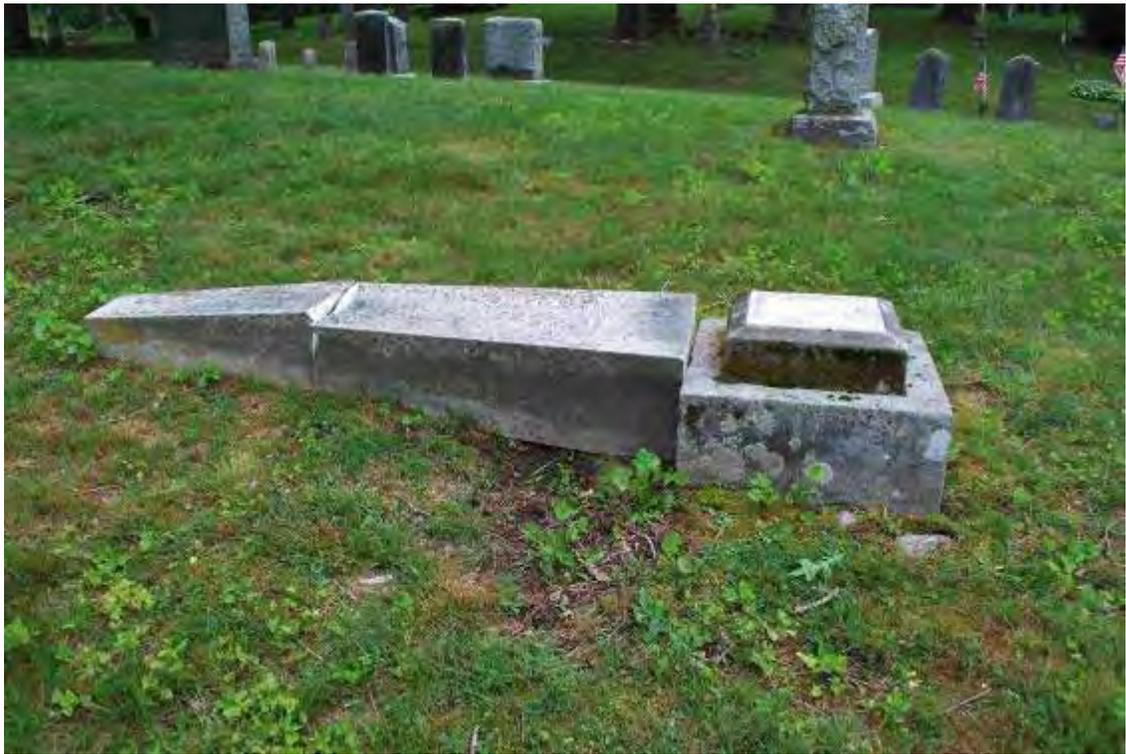
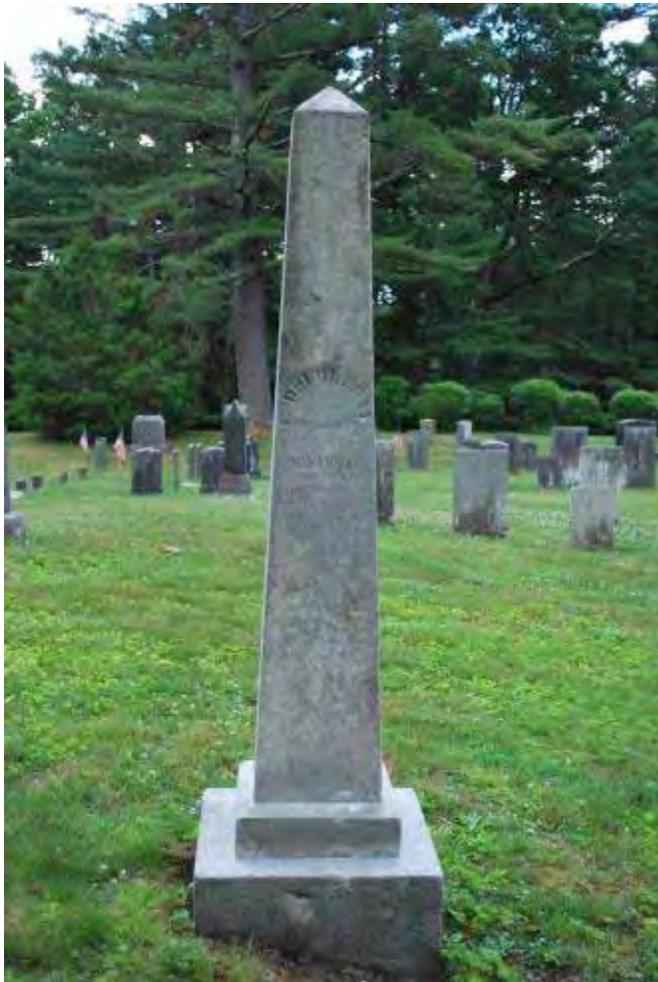
**Cemetery** Quabbin Park  
**Location** Ware, MA  
**Record Date** May 2012  
**Name** Doubleday, Susannah  
**Date of Death** Nov. 11, 1880

**Previous Work** Concrete foundation stuck on base

**Stone Condition** Biological growth, Fallen, broken 2 pieces

**Treatment** Clean, Reset level and reattach broken piece with Jahn mortar

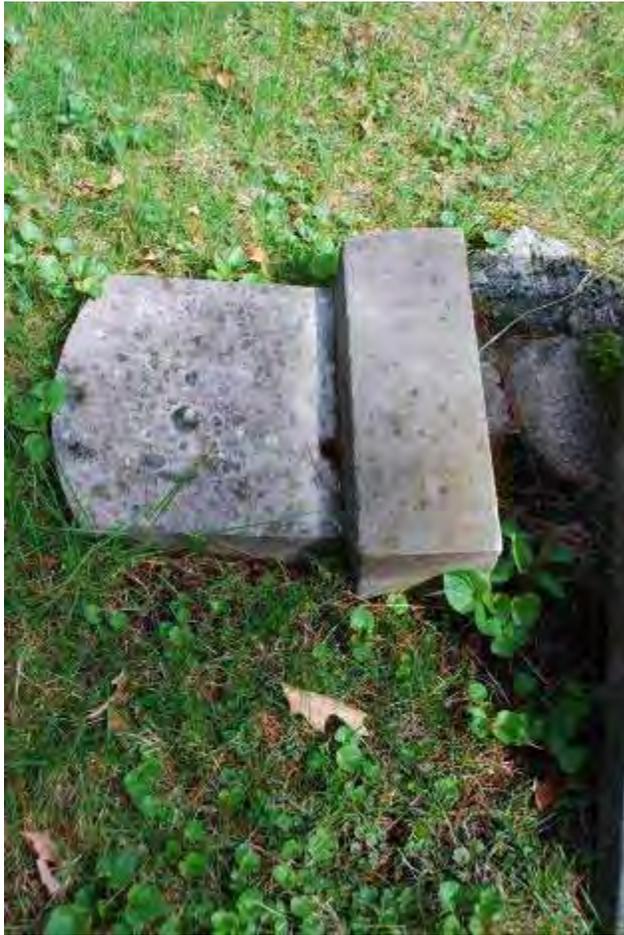
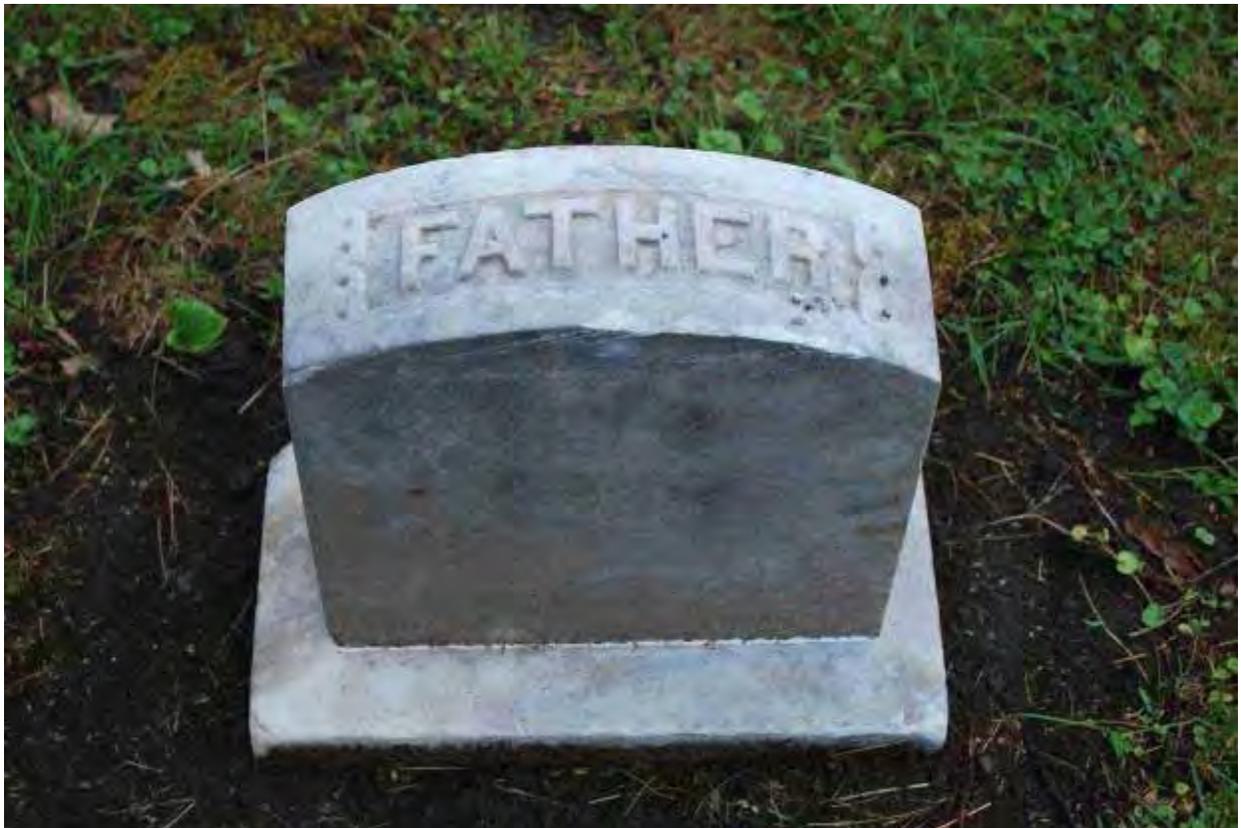
**Cemetery** Quabbin Park  
**Location** Ware, MA  
**Record Date** May 2012  
**Name** Father  
**Date of Death**

**Previous Work** Concrete foundation stuck on base

**Stone Condition** Biological growth, Fallen

**Treatment** Clean, excavate and reset level with mortar

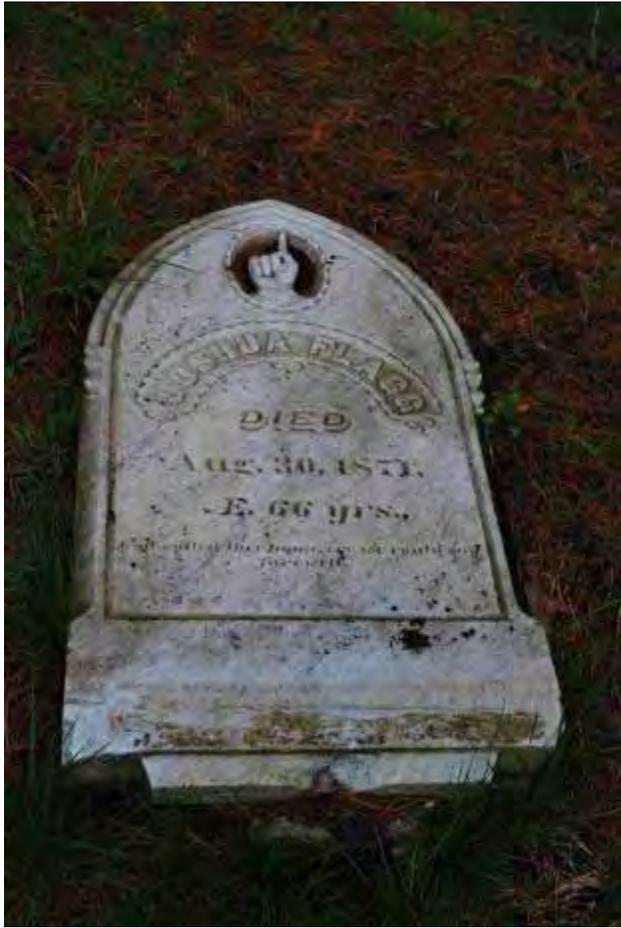
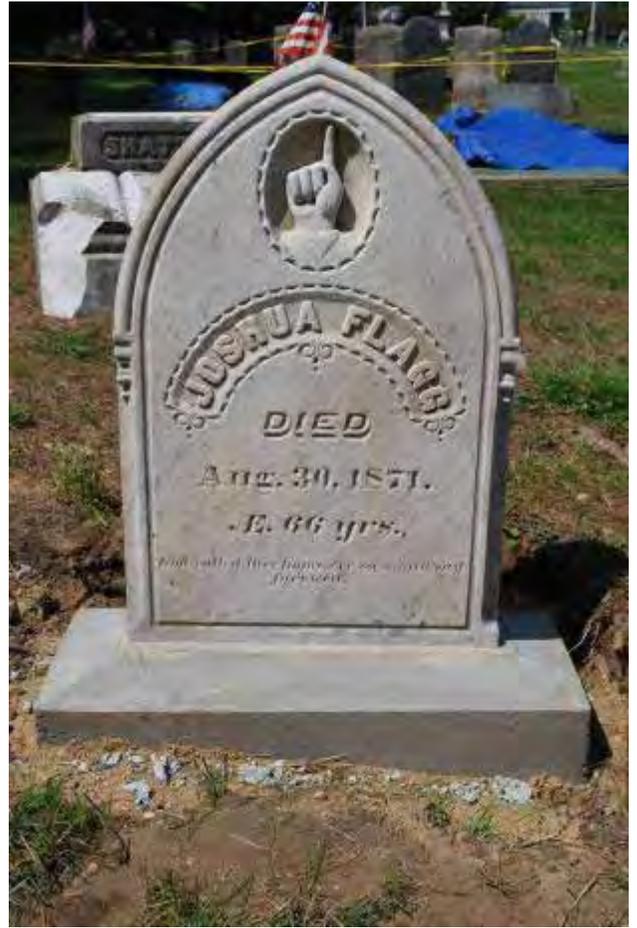
**Cemetery** Quabbin Park  
**Location** Ware, MA  
**Record Date** May 2012  
**Name** Flagg, Joshua  
**Date of Death** August 30, 1871

**Previous Work** Concrete foundation stuck on base

**Stone Condition** Fallen, Biological Growth, missing base

**Treatment** Excavate, clean and reset level in a new base

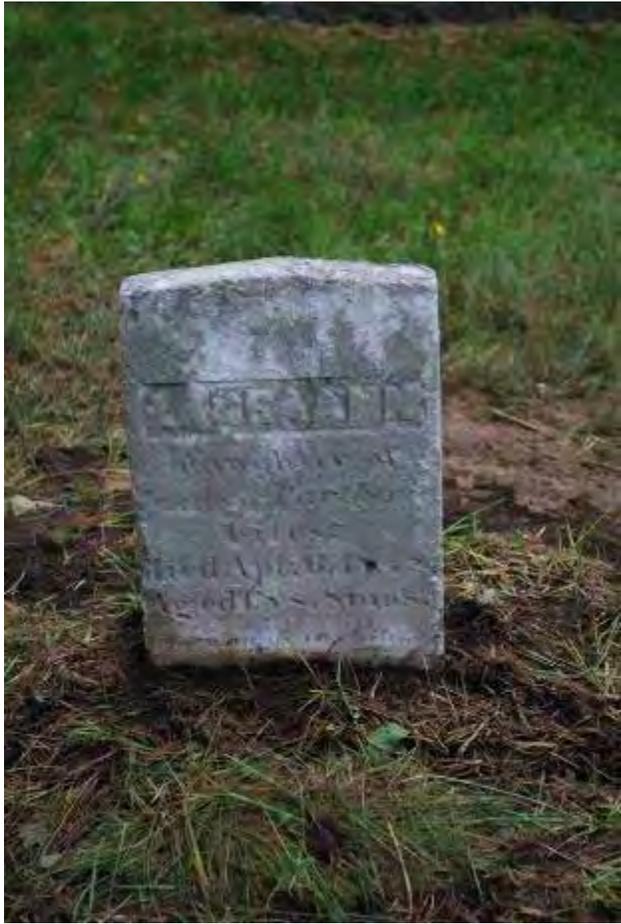
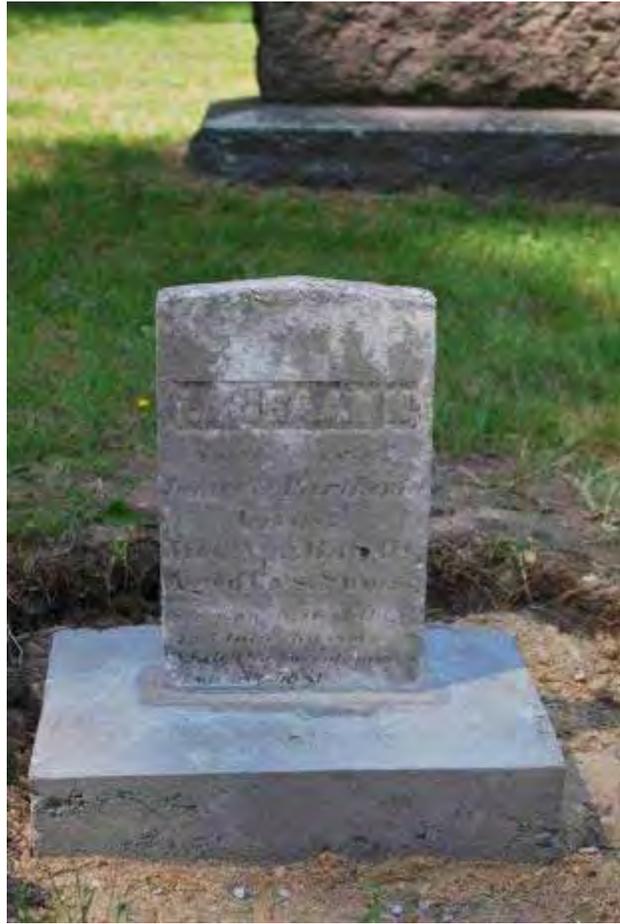
**Cemetery** Quabbin Park  
**Location** Ware, MA  
**Record Date** May 2012  
**Name** Giles, Laura Ann  
**Date of Death** April 6, 1848

**Previous Work** Concrete foundation stuck on base

**Stone Condition** Biological growth, leaning

**Treatment** Clean, excavate and reset level with new base

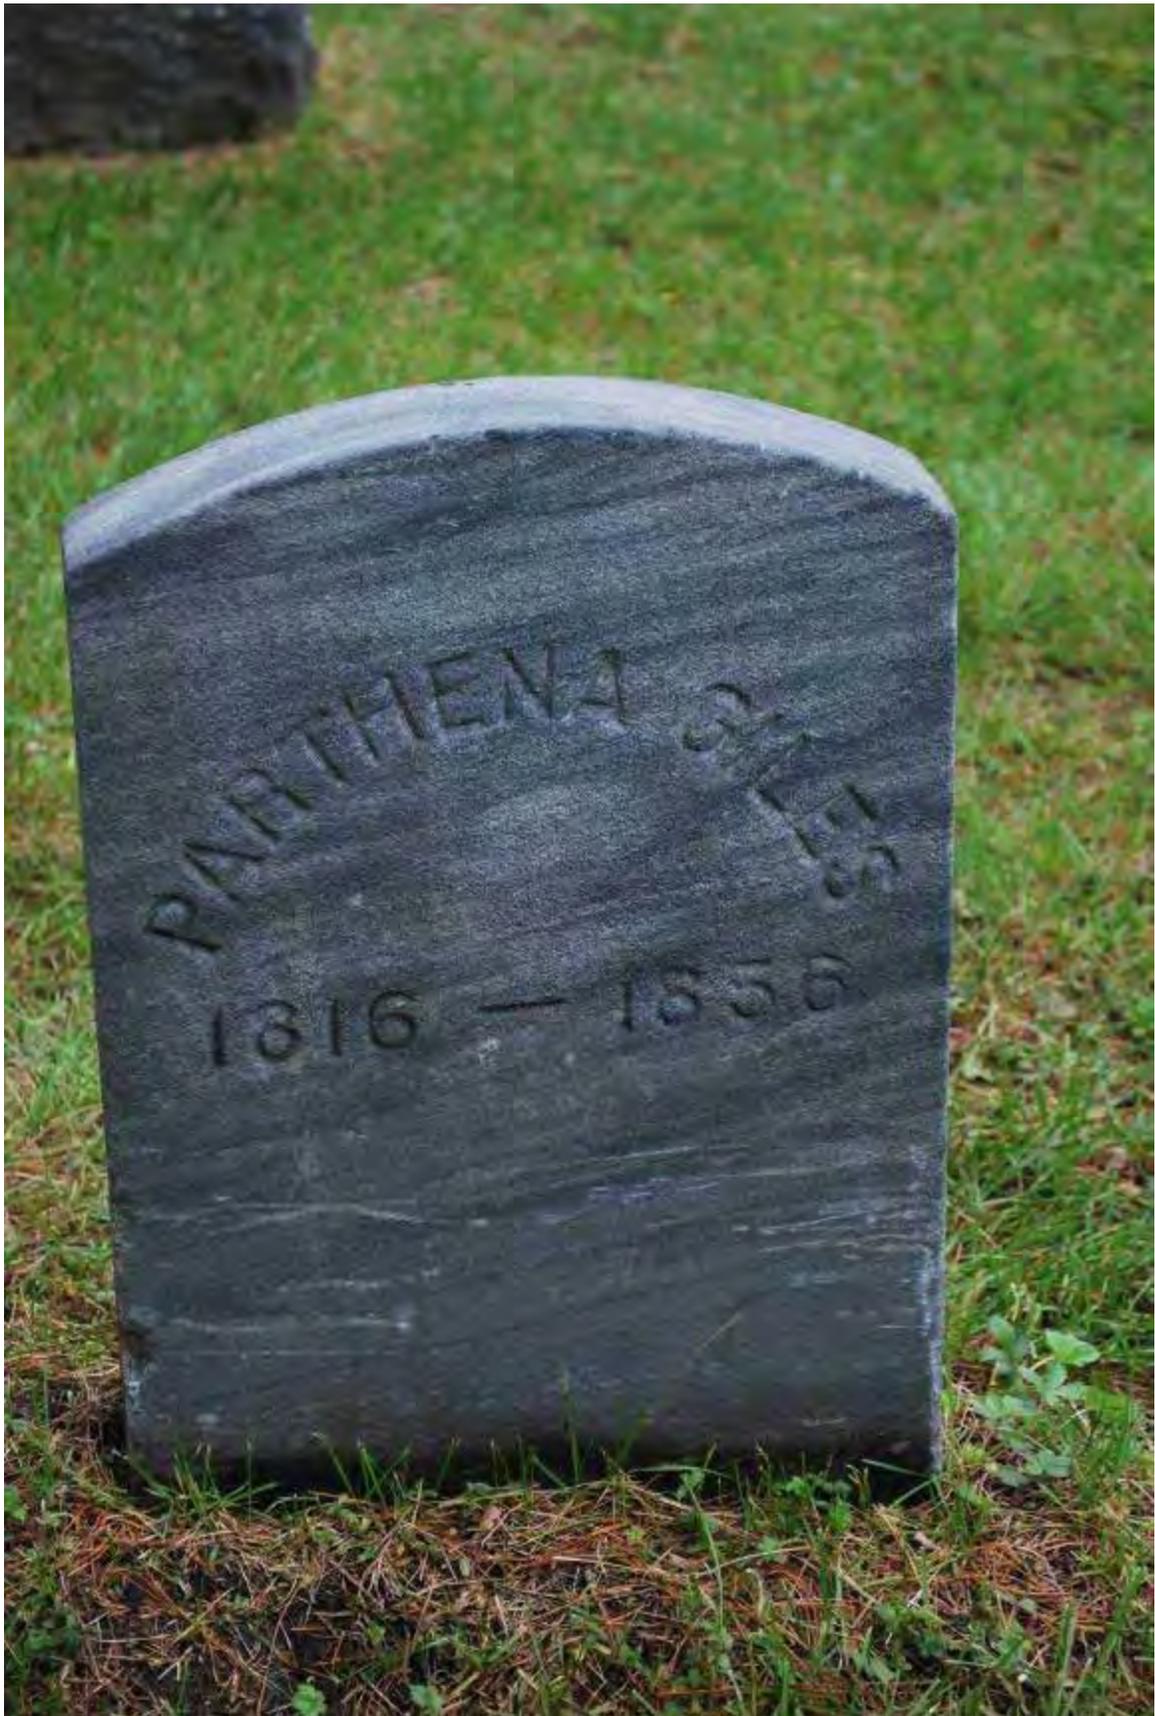
**Cemetery** Quabbin Park  
**Location** Ware, MA  
**Record Date** May 2012  
**Name** Giles, Parthena  
**Date of Death** 1856

**Previous Work** Concrete foundation stuck on base

**Stone Condition** Biological growth

**Treatment** Clean

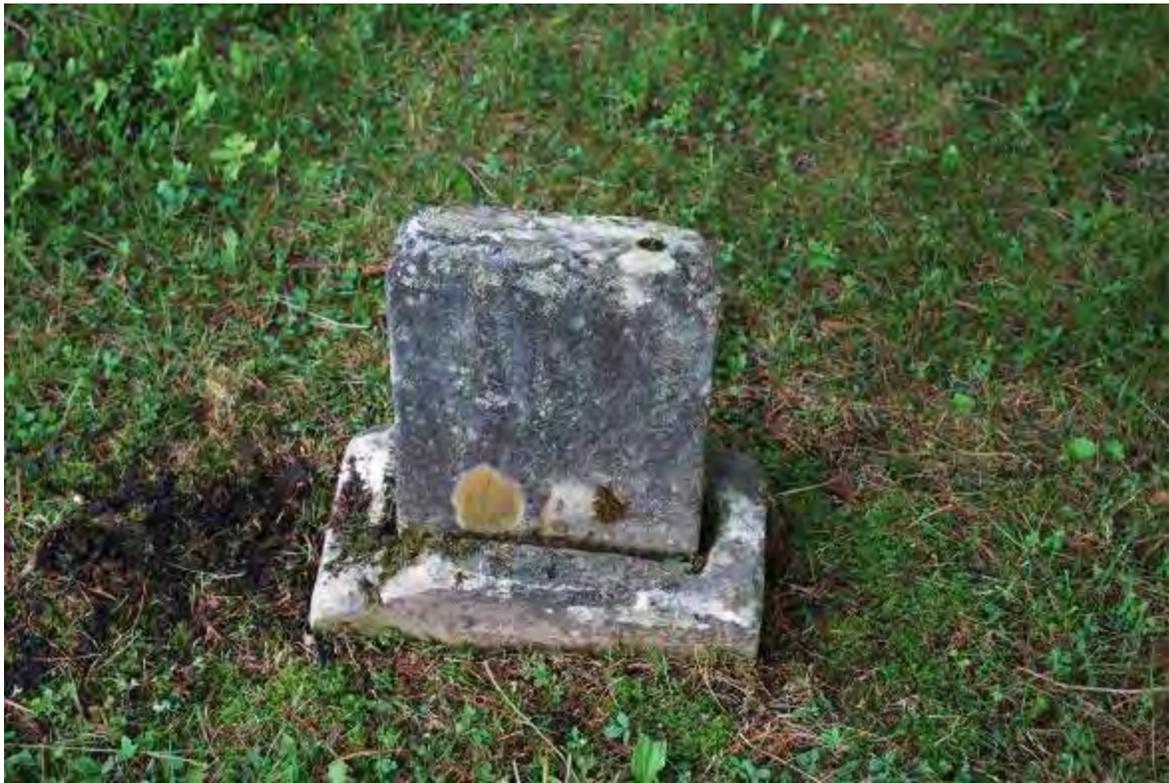
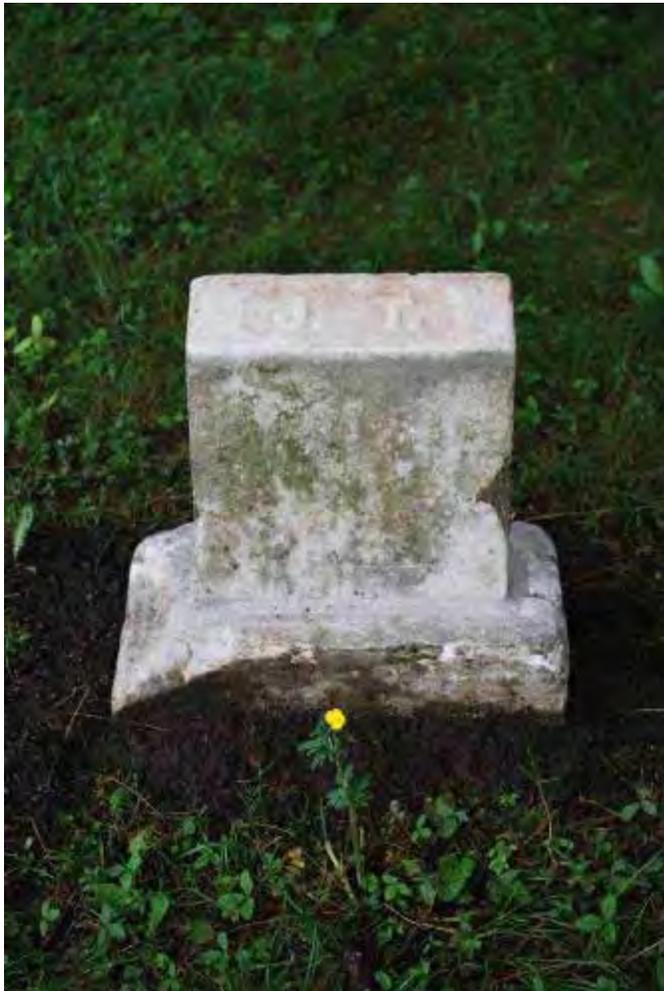
**Cemetery** Quabbin Park  
**Location** Ware, MA  
**Record Date** May 2012  
**Name** J.T.  
**Date of Death**

**Previous Work** Concrete foundation stuck on base

**Stone Condition** Biological growth, Loose in base

**Treatment** Clean, Excavate, reset level in base with mortar

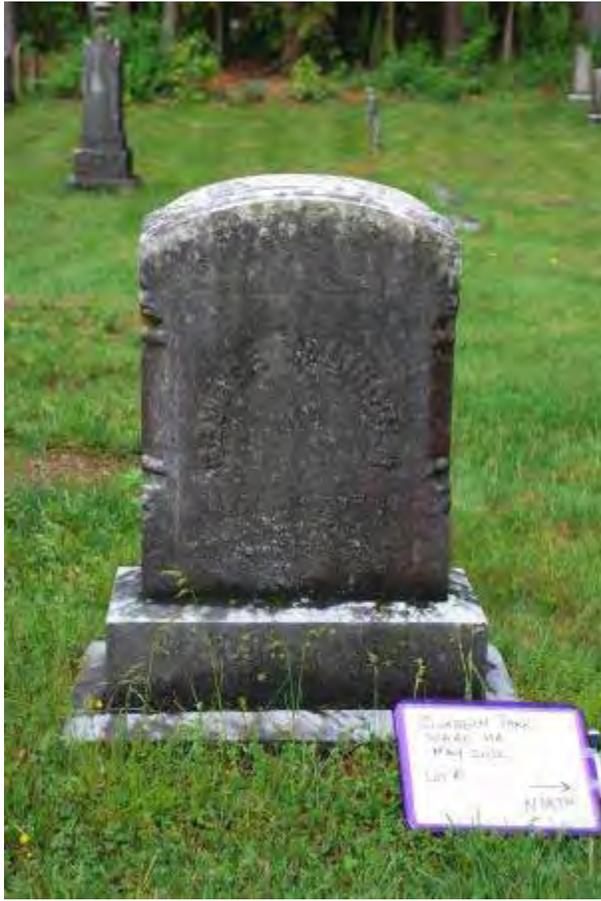
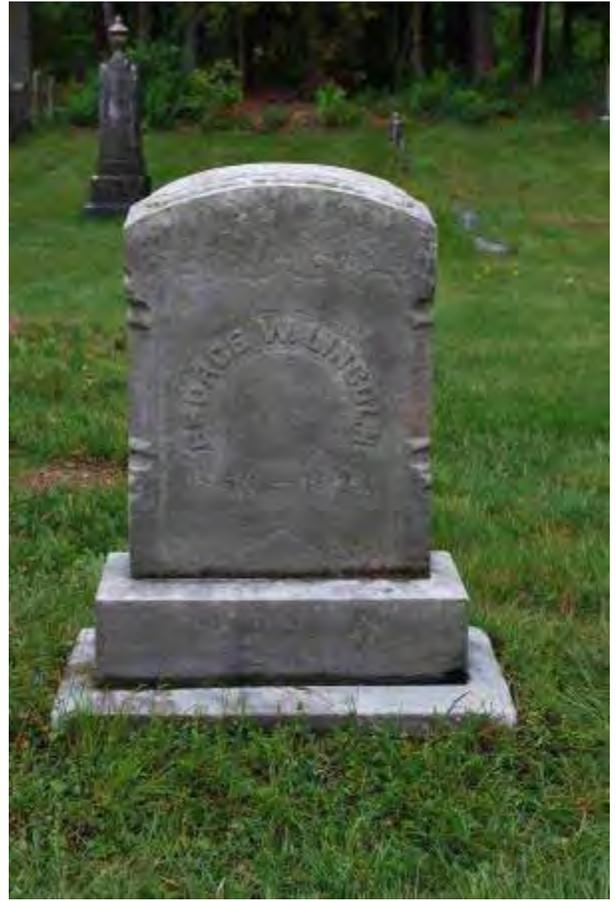
**Cemetery** Quabbin Park  
**Location** Ware, MA  
**Record Date** May 2012  
**Name** Lincoln, George W.  
**Date of Death** 1923

**Previous Work** Concrete foundation stuck on base

**Stone Condition** Biological growth, Leaning

**Treatment** Clean, Excavate, reset level on base
