# Quabbin Park Cemetery Restoration Project

## Final Report

June 2012

Final report prepared by – Ta Mara Conde

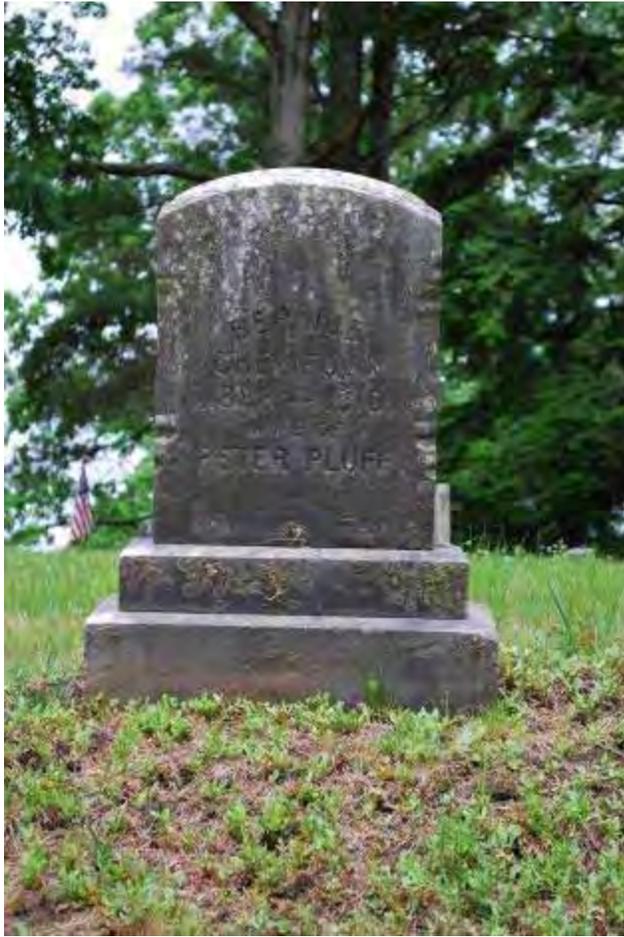
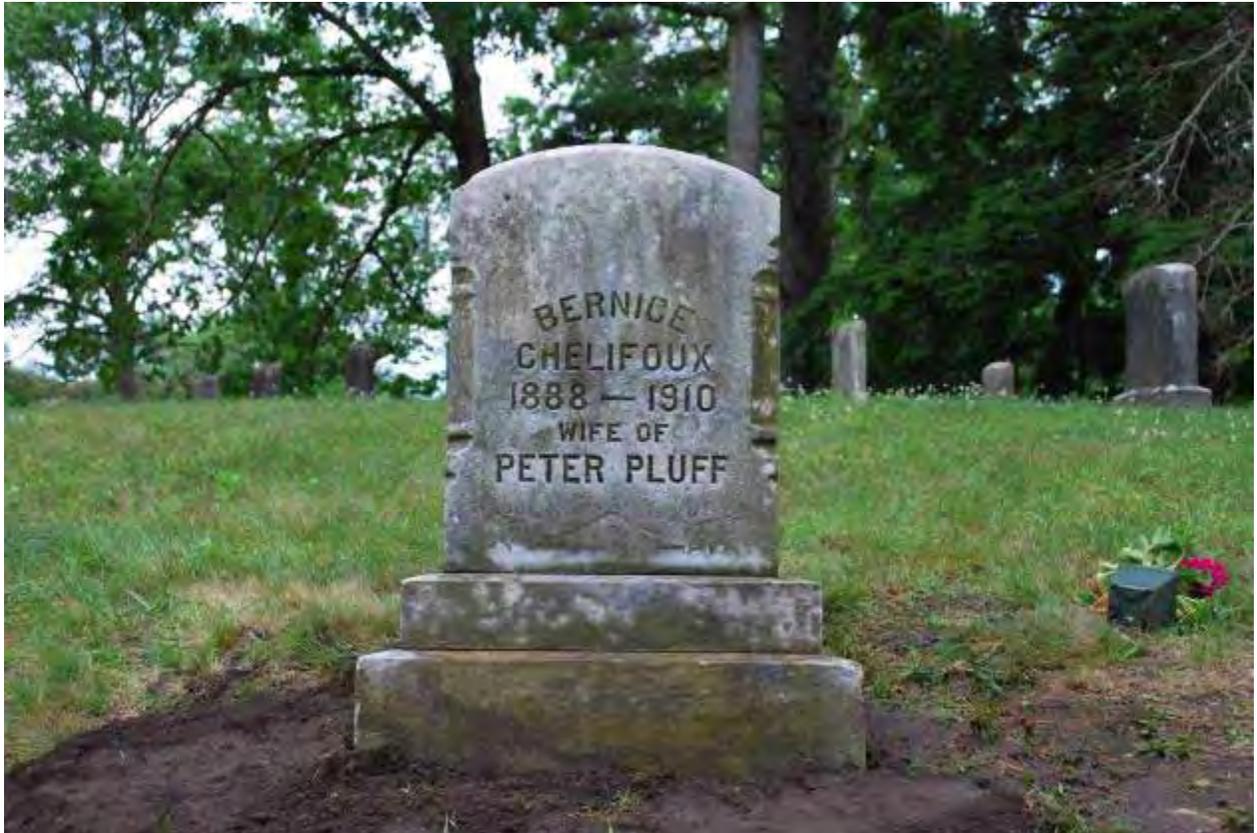
**Cemetery** Quabbin Park  
**Location** Ware, MA  
**Record Date** May 2012  
**Name** Chelifoux, Bernice  
**Date of Death** 1910

**Previous Work** Concrete foundation stuck on base

**Stone Condition** Biological growth, Leaning

**Treatment** Clean, Excavate, reset level on base

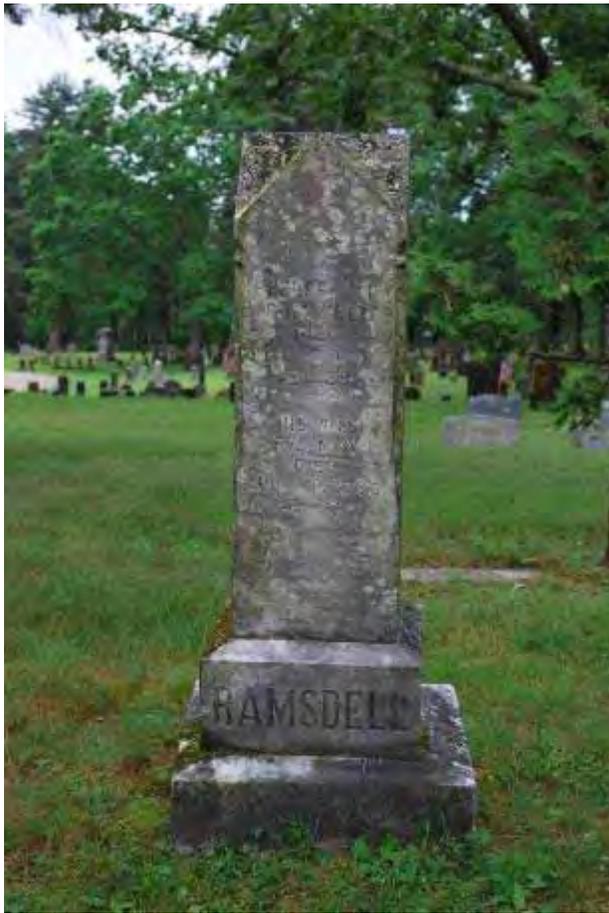
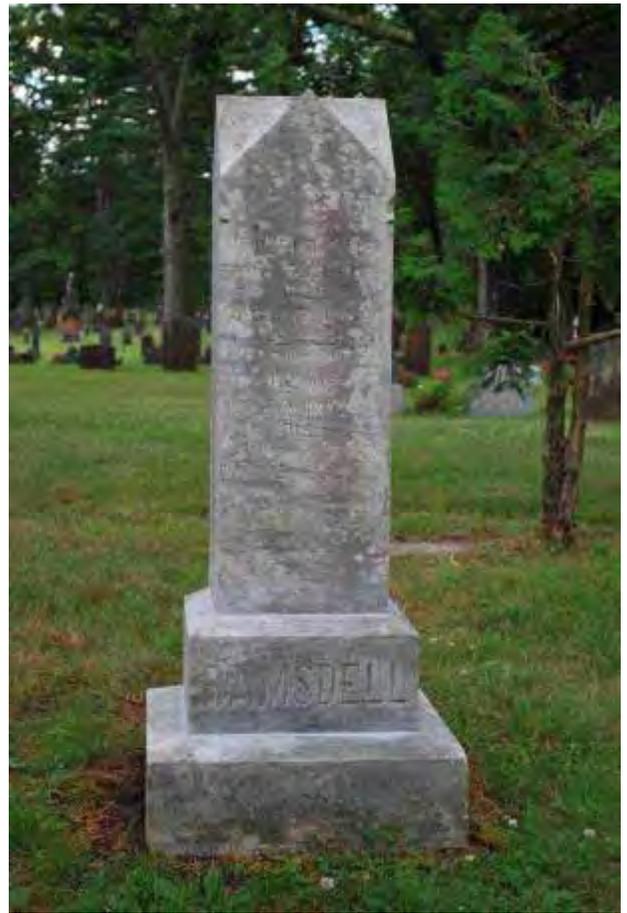
**Cemetery** Quabbin Park  
**Location** Ware, MA  
**Record Date** May 2012  
**Name** Ramsdell, Frederic H.  
**Date of Death** Dec. 7, 1904

**Previous Work** Concrete foundation stuck on base

**Stone Condition** Biological growth, Leaning

**Treatment** Clean, Excavate, reset pieces level with mortar

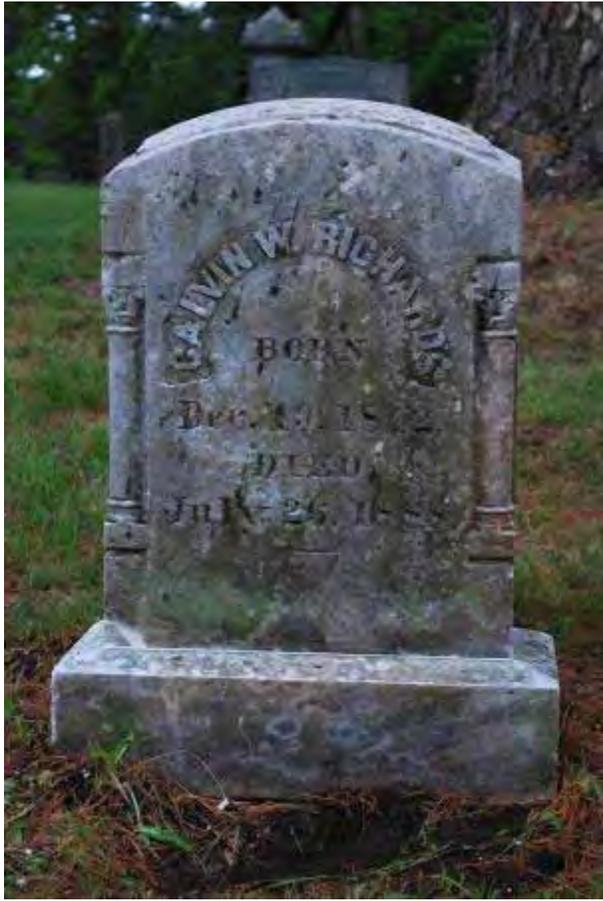
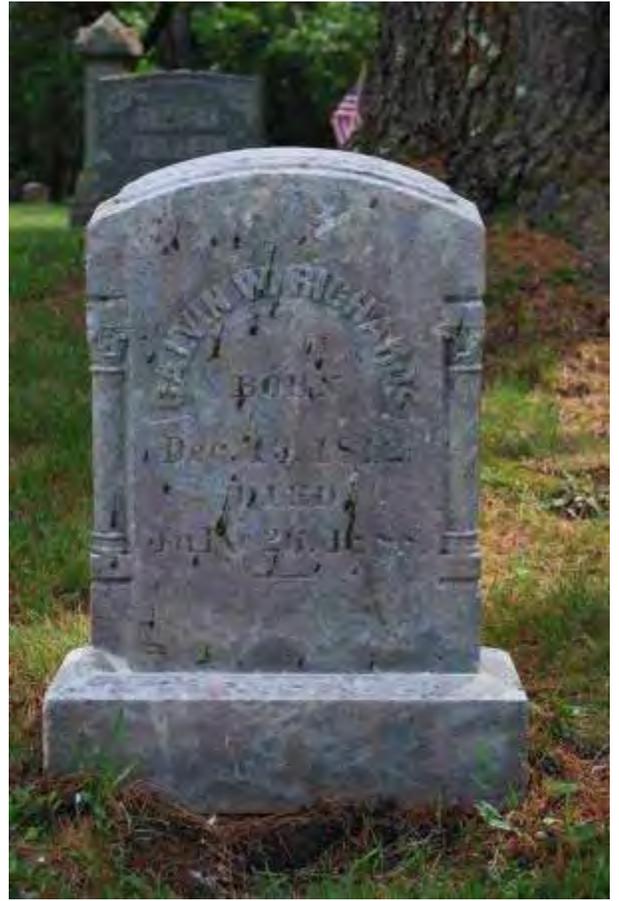
**Cemetery** Quabbin Park  
**Location** Ware, MA  
**Record Date** May 2012  
**Name** Richards, Calvin W.  
**Date of Death** July 26,1888

**Previous Work** Concrete foundation stuck on base

**Stone Condition** Biological growth

**Treatment** Clean

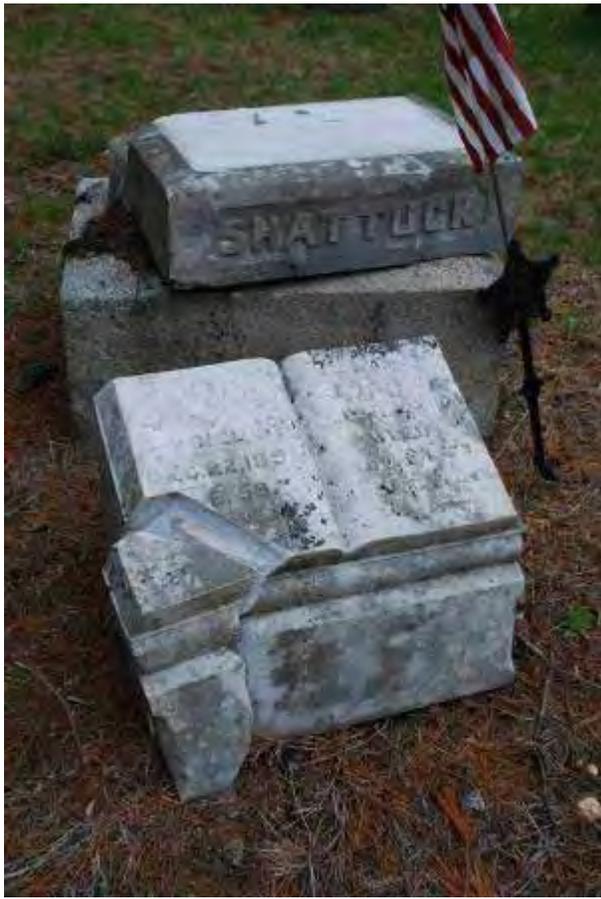
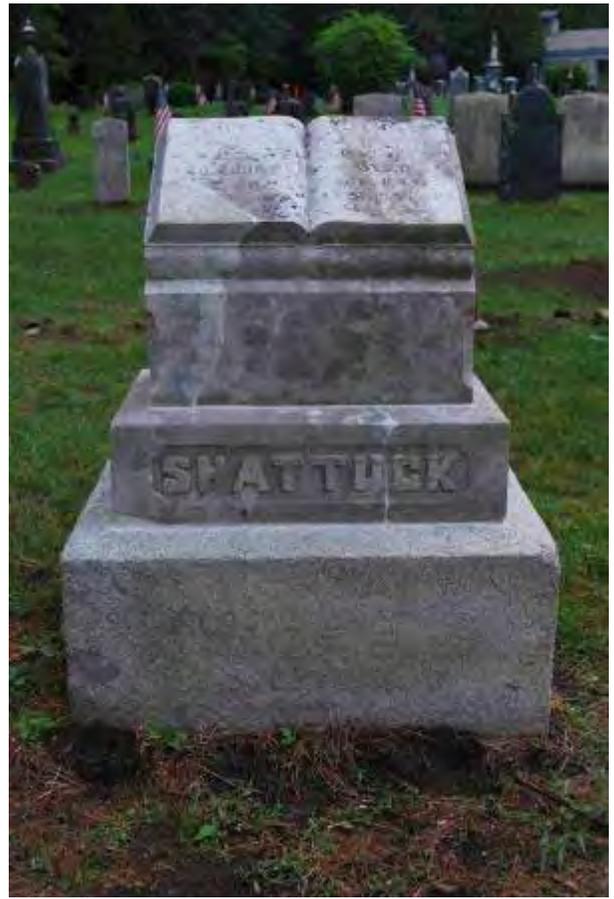
**Cemetery** Quabbin Park  
**Location** Ware, MA  
**Record Date** May 2012  
**Name** Shattuck, A.L.  
**Date of Death** December 22, 1982

**Previous Work** Concrete foundation stuck on base

**Stone Condition** Broken pieces, biological growth

**Treatment** Clean, Reattach pieces with Jahn mortar

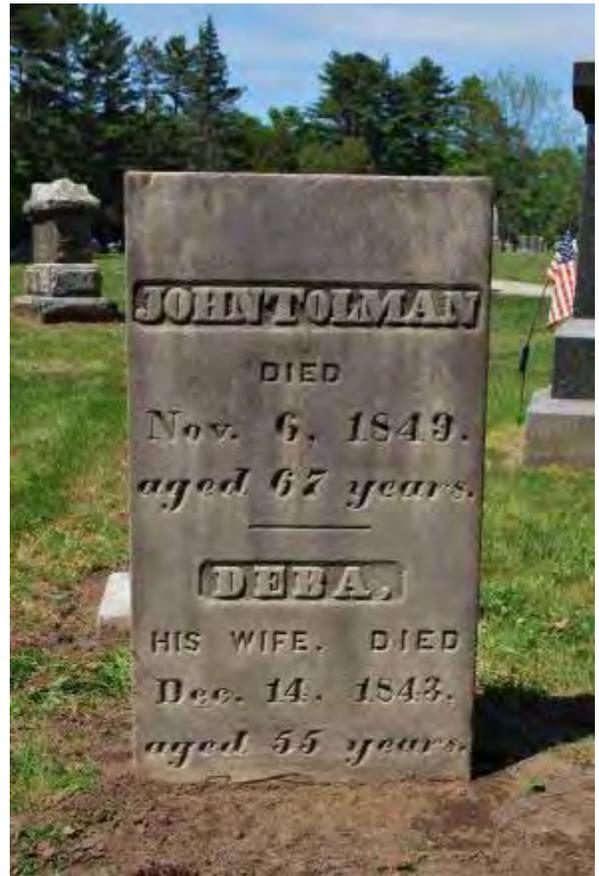
**Previous Work** Concrete foundation stuck on base

**Stone Condition** Leaning

**Treatment** Clean, excavate and reset level as a tablet

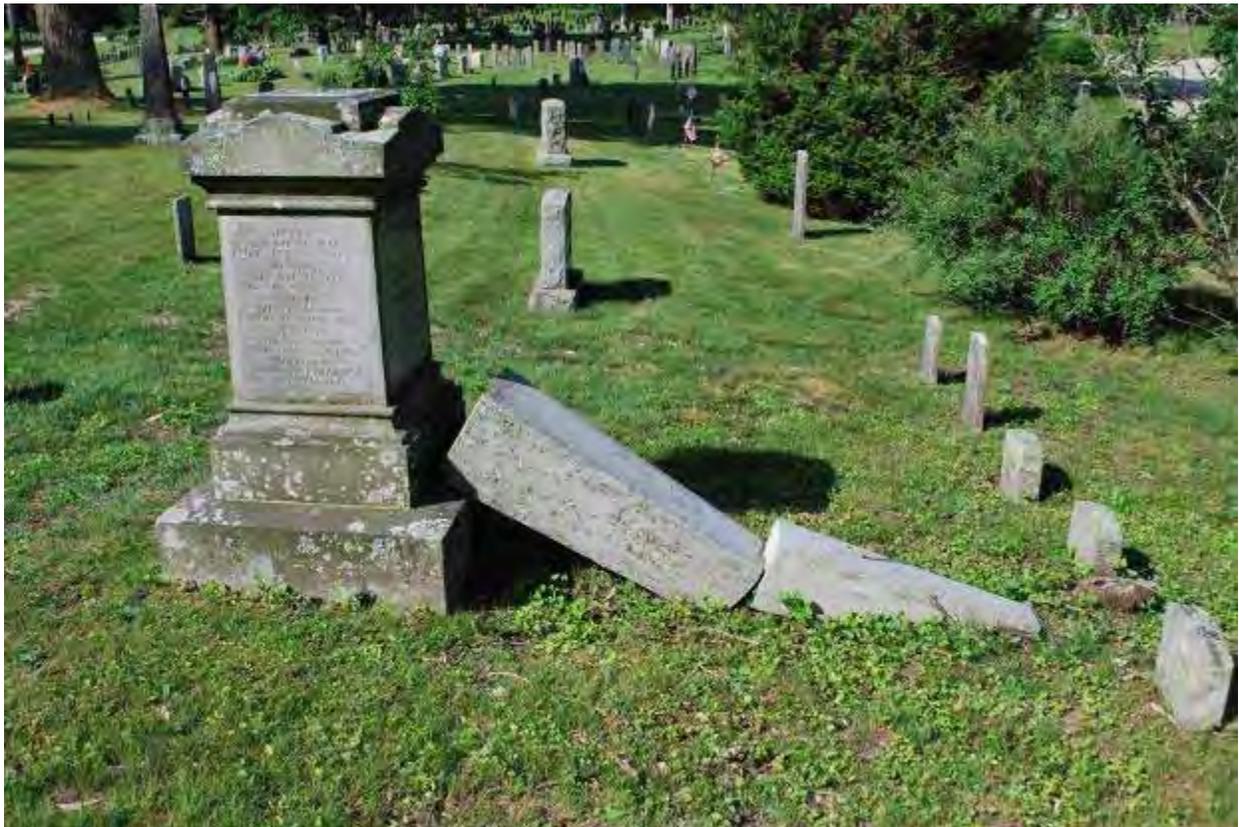
**Previous Work** Concrete foundation stuck on base

**Stone Condition** Biological growth, Obelisk fallen and broken into two pieces

**Treatment** Clean, Reattach broken pieces with Jahn mortar

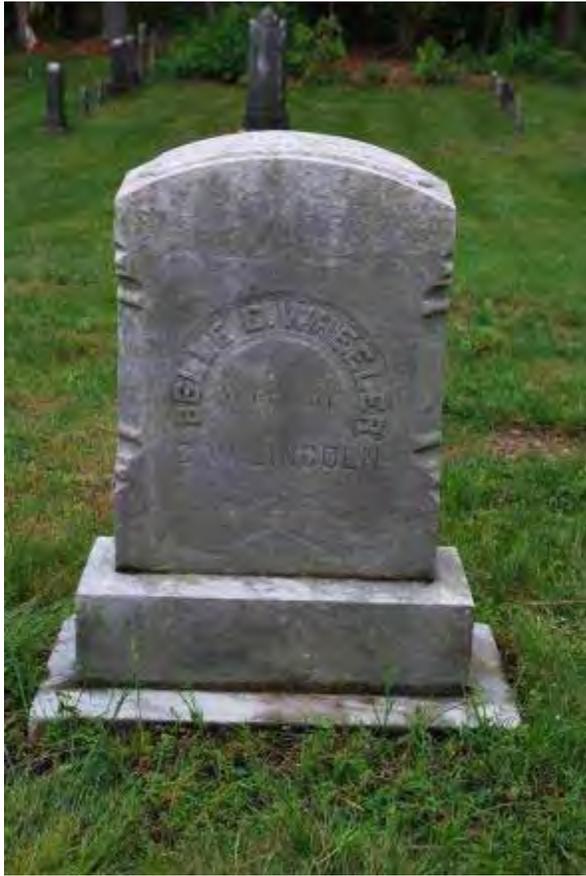
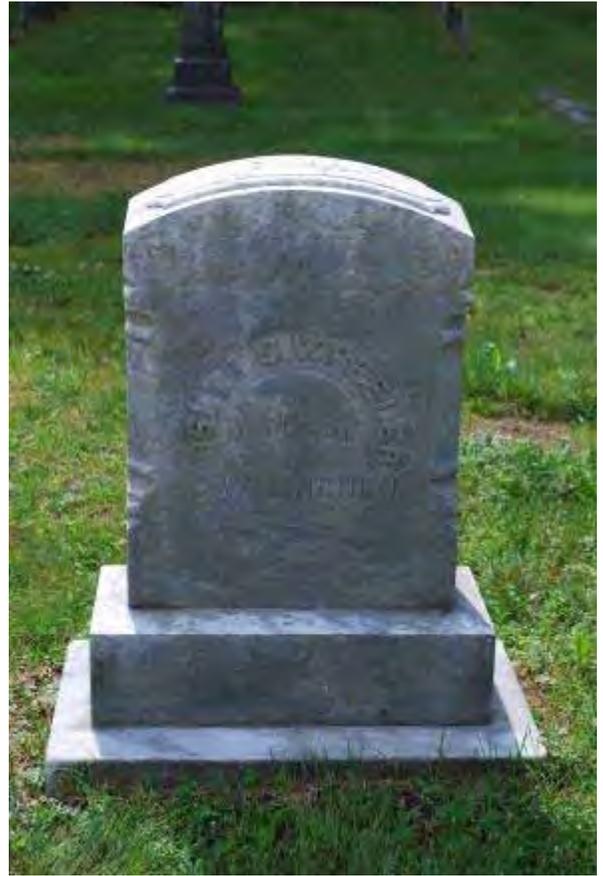
**Previous Work** Concrete foundation stuck on base

**Stone Condition** Biological growth

**Treatment** Clean

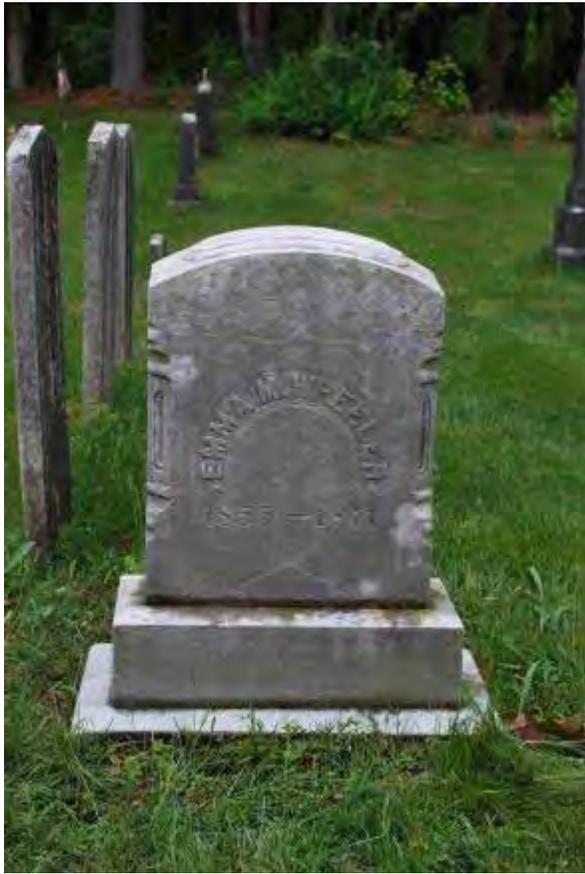
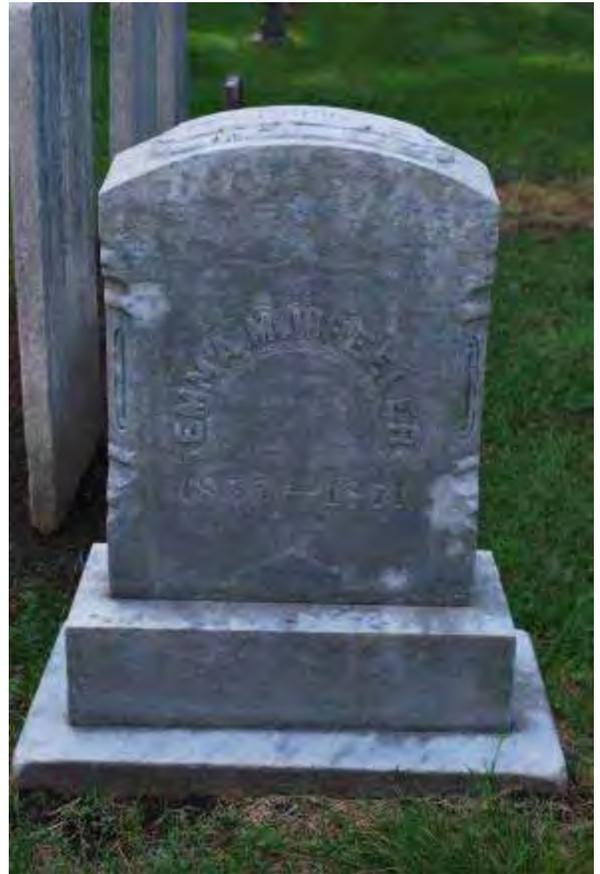
**Previous Work** Concrete foundation stuck on base

**Stone Condition** Biological growth

**Treatment** Clean

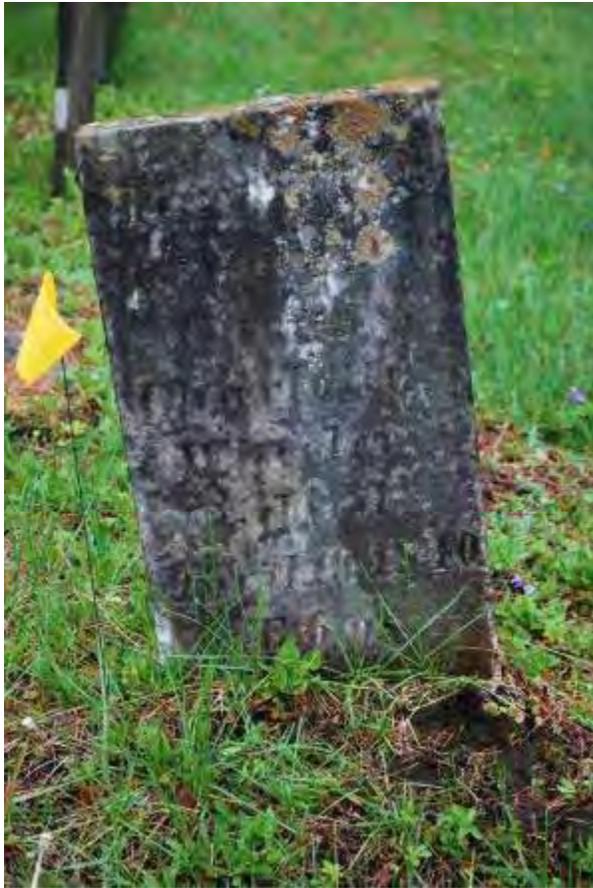
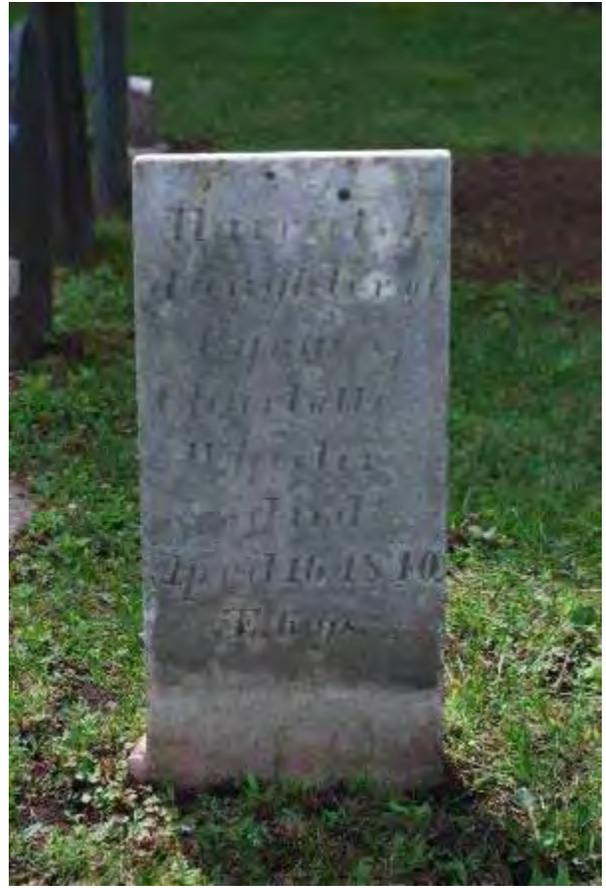
**Previous Work** Concrete foundation stuck on base

**Stone Condition** Fallen, Biological growth, broken in two pieces

**Treatment** Clean, reattach pieces with Jahn mortar, new base

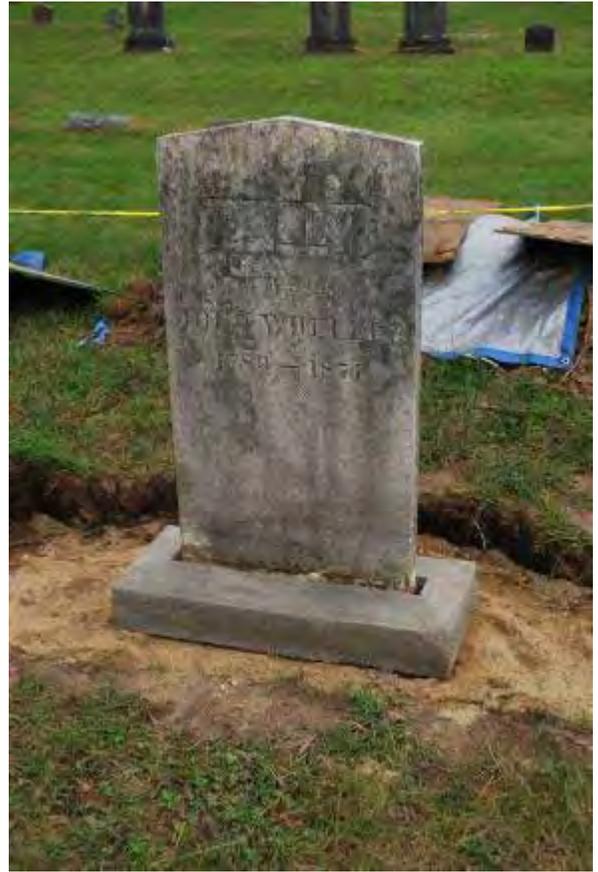
**Previous Work** Concrete foundation stuck on base

**Stone Condition** Leaning, Biological growth, weak bottom section

**Treatment** Clean, provide new base collar

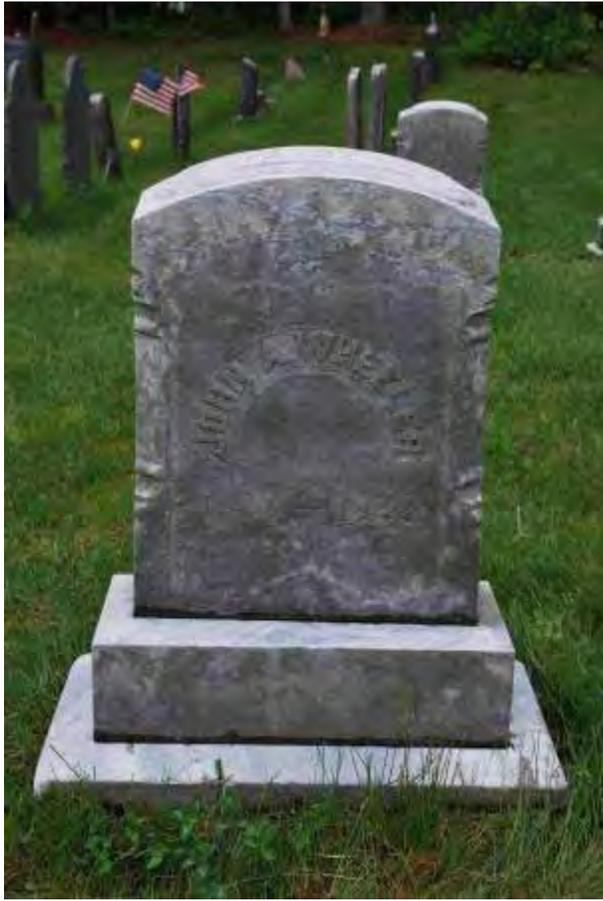
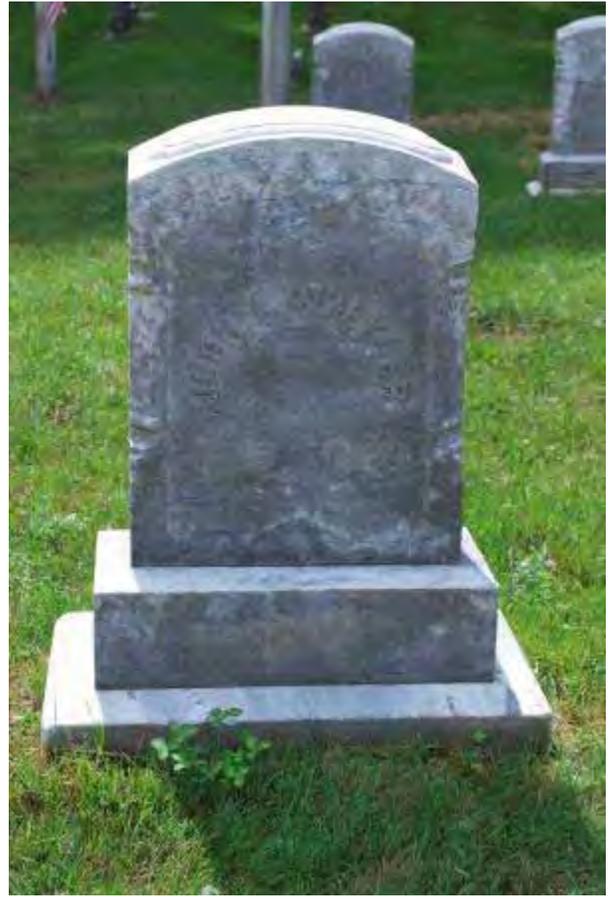
**Previous Work** Concrete foundation stuck on base

**Stone Condition** Biological growth

**Treatment** Clean

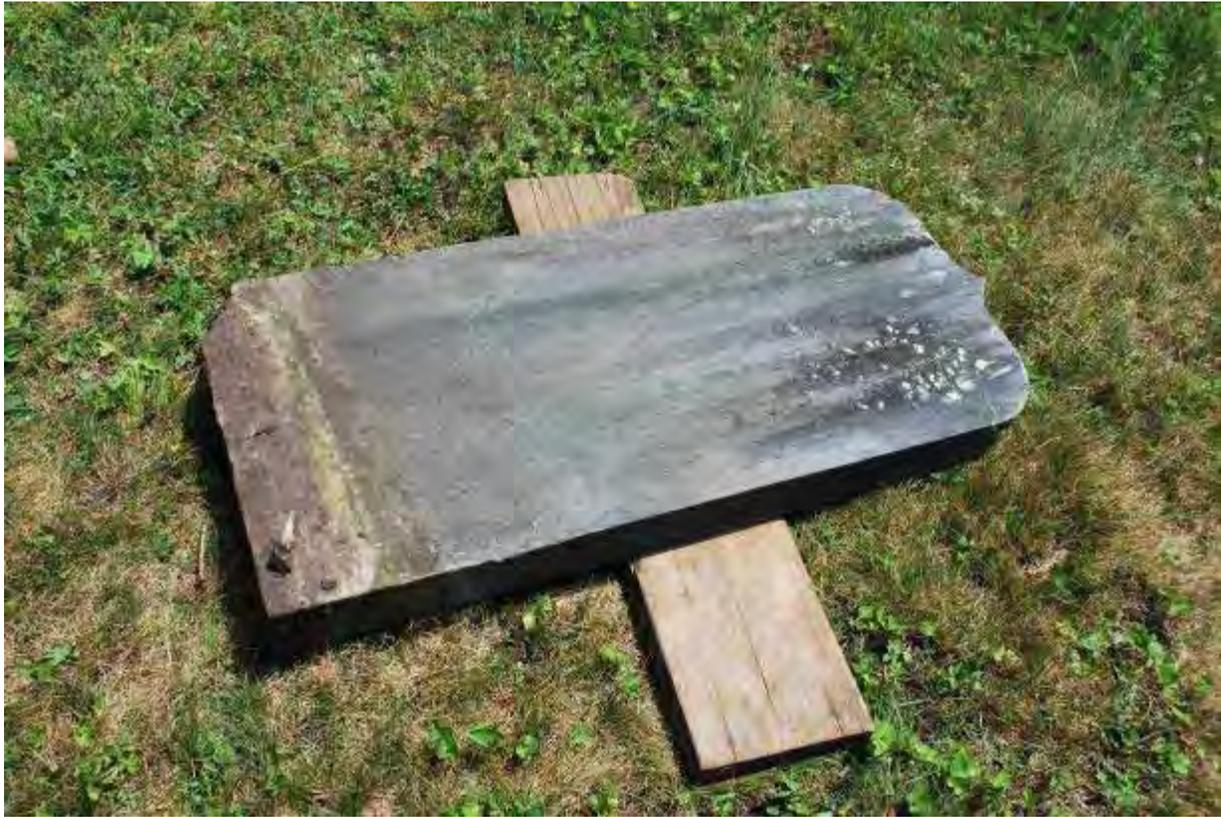
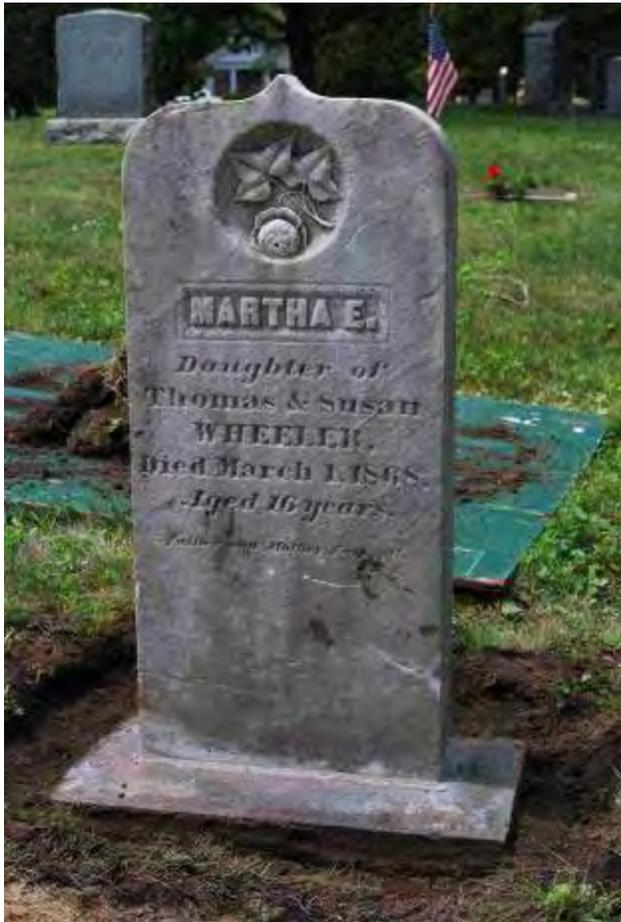
**Previous Work** Concrete foundation stuck on base

**Stone Condition** Biological growth, weak bottom section

**Treatment** Clean, reset level in existing base and provide new base collar

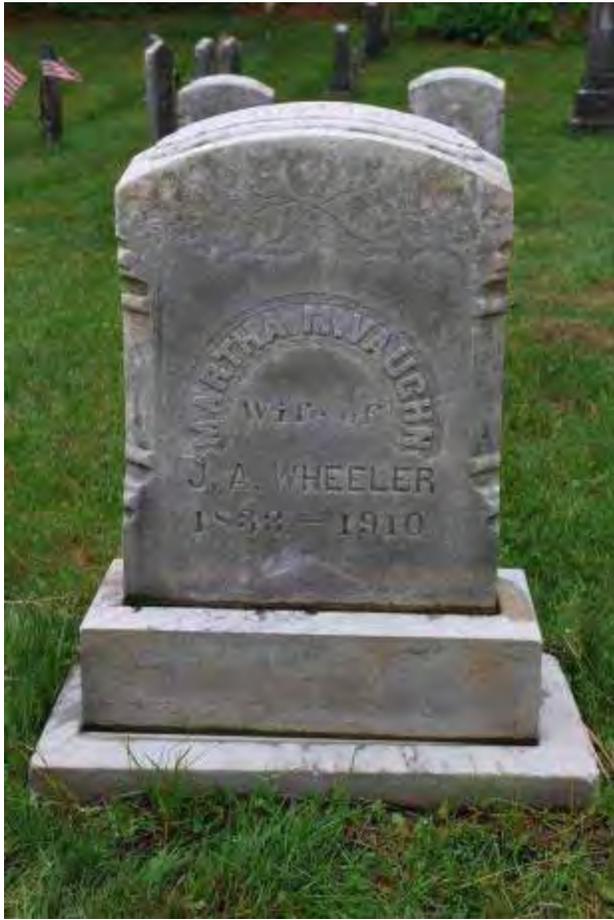
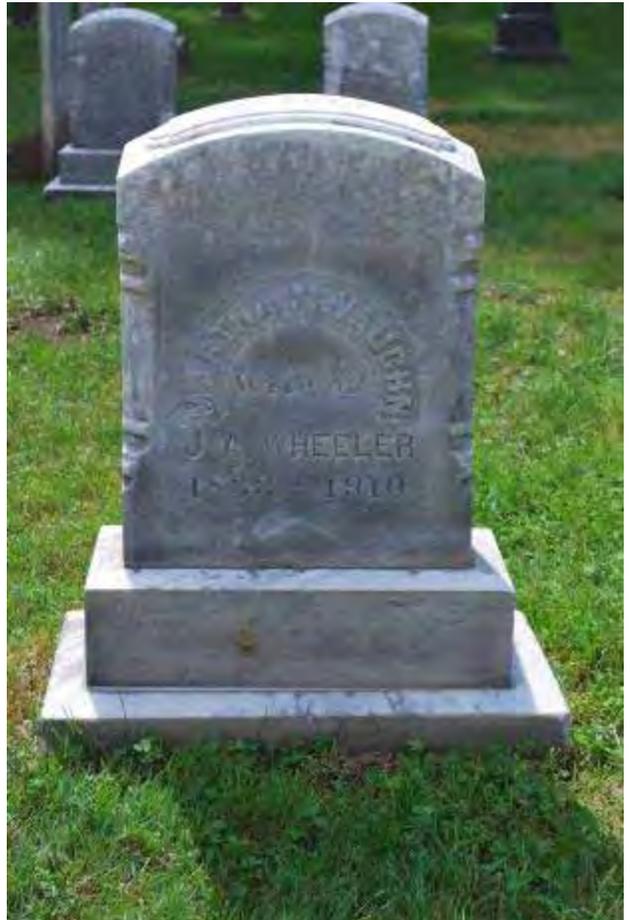
**Previous Work** Concrete foundation stuck on base

**Stone Condition** Biological growth, Loose in base

**Treatment** Clean, reset level in existing base with mortar

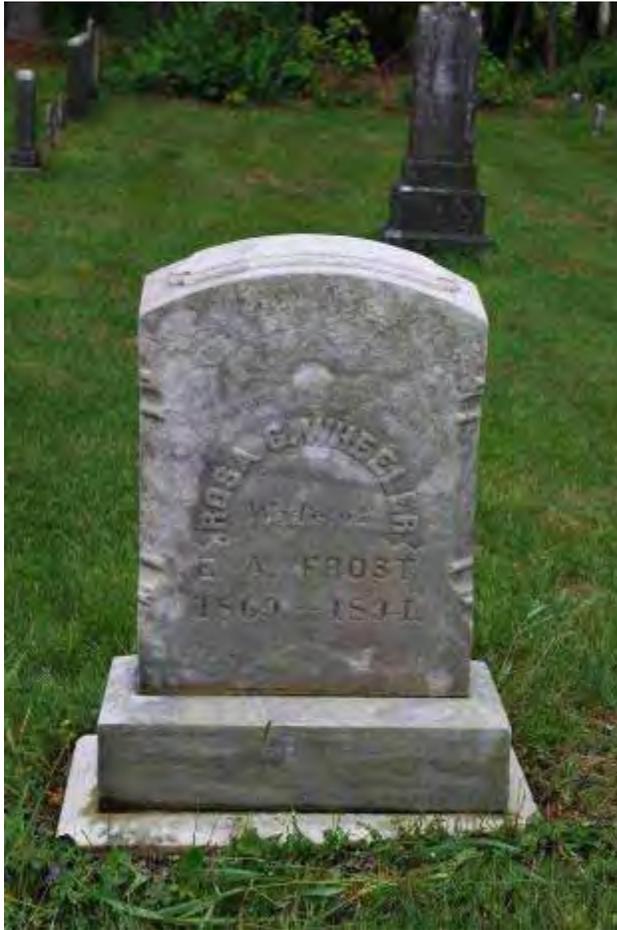
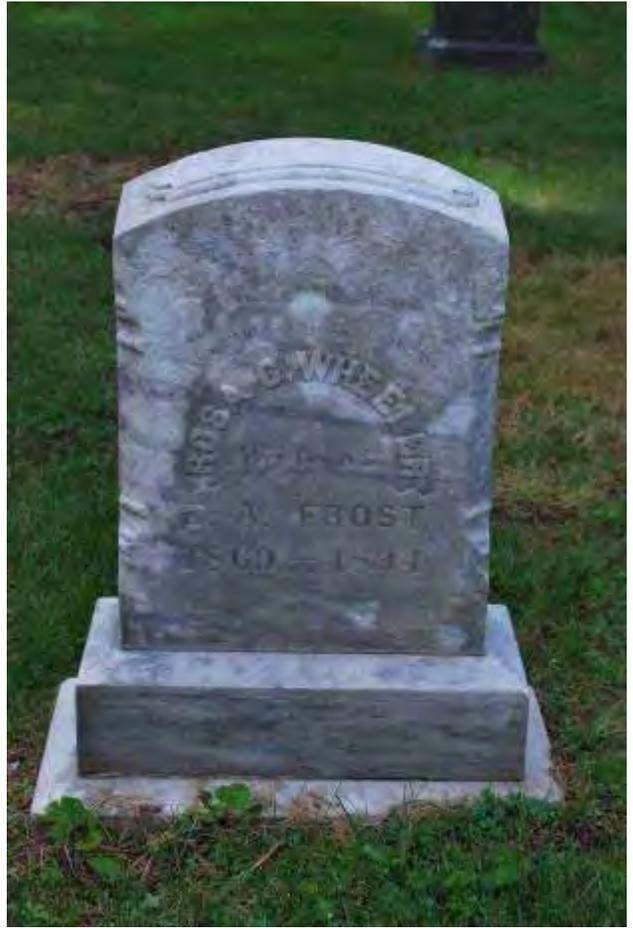
**Previous Work** Concrete foundation stuck on base

**Stone Condition** Biological growth

**Treatment** Clean

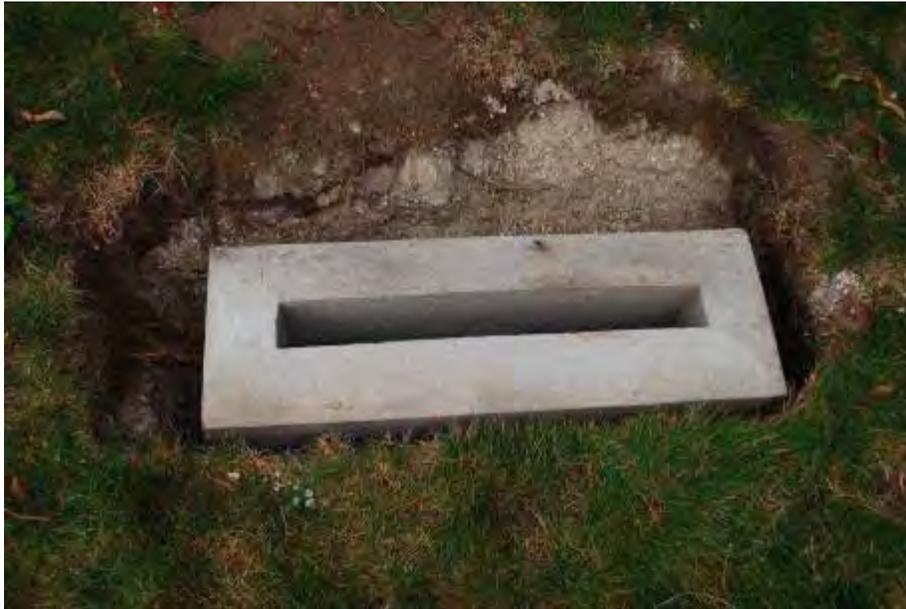
Cast concrete bases are typically made with a slot that is 1/2" wider and thicker than the stone and is recessed 3"-4". Depending on the size of the stone the base is usually 8"-12" deep, 8"-12" greater thickness and 6"-8" wider than the stone. This method is fine when resetting stones with a square bottom.
