# QUABBIN SPILLWAY FENCE PROJECT

## Introduction

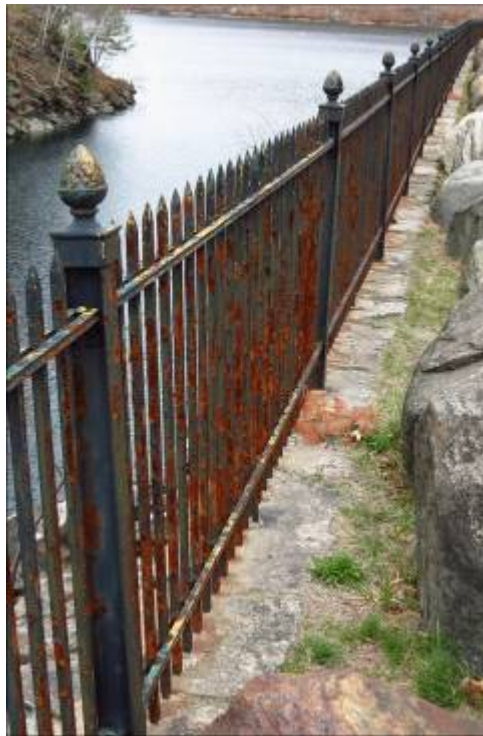
A section of fence showing the extensive rust and flaking of the protective paint covering.

The project includes removal of the fence to an off-site where there will be lead paint abatement, repairs, galvanizing, color coating and attaching new anchor posts to the fence sections. After completing this work, the fence will then be returned to the Spillway where the sections will be reinstalled in their original location. The original fence was installed with acorn finials, 10 of which are missing. The contract work includes fabrication and installation of these missing finials. In addition, 20 linear feet of bent steel fence damaged by vehicle collisions will also be repaired.

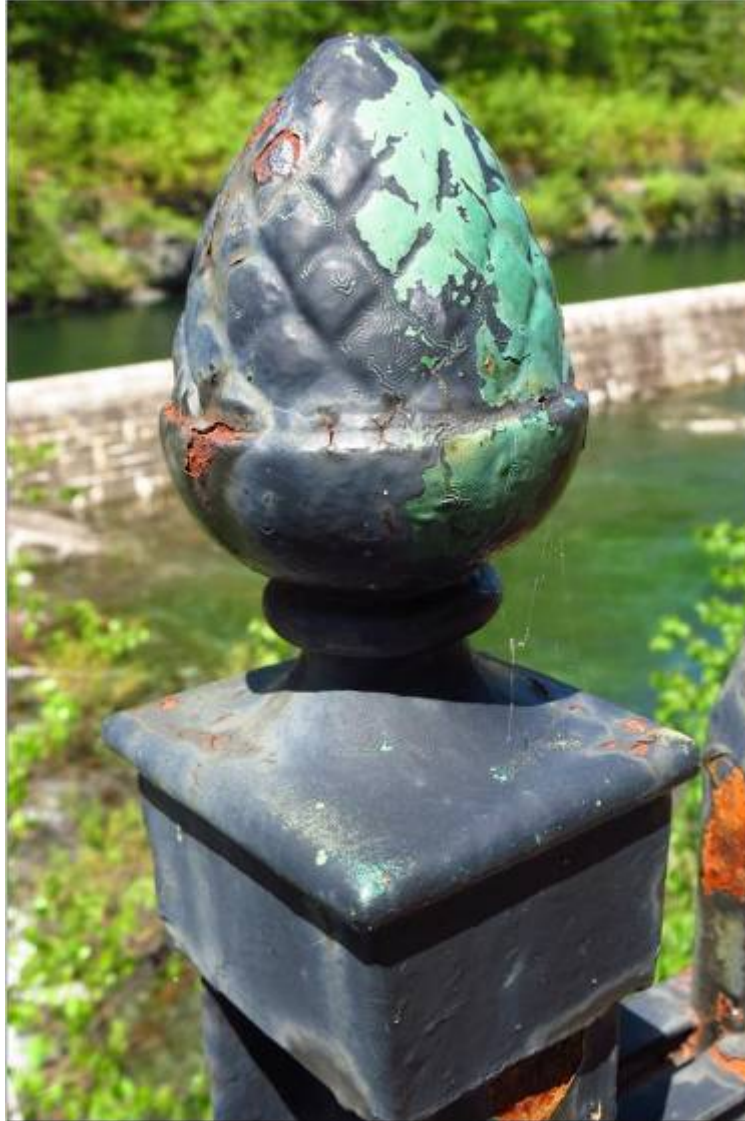
One of the stately Acorn Finials which adorn the top of the fence at each of the anchor posts.

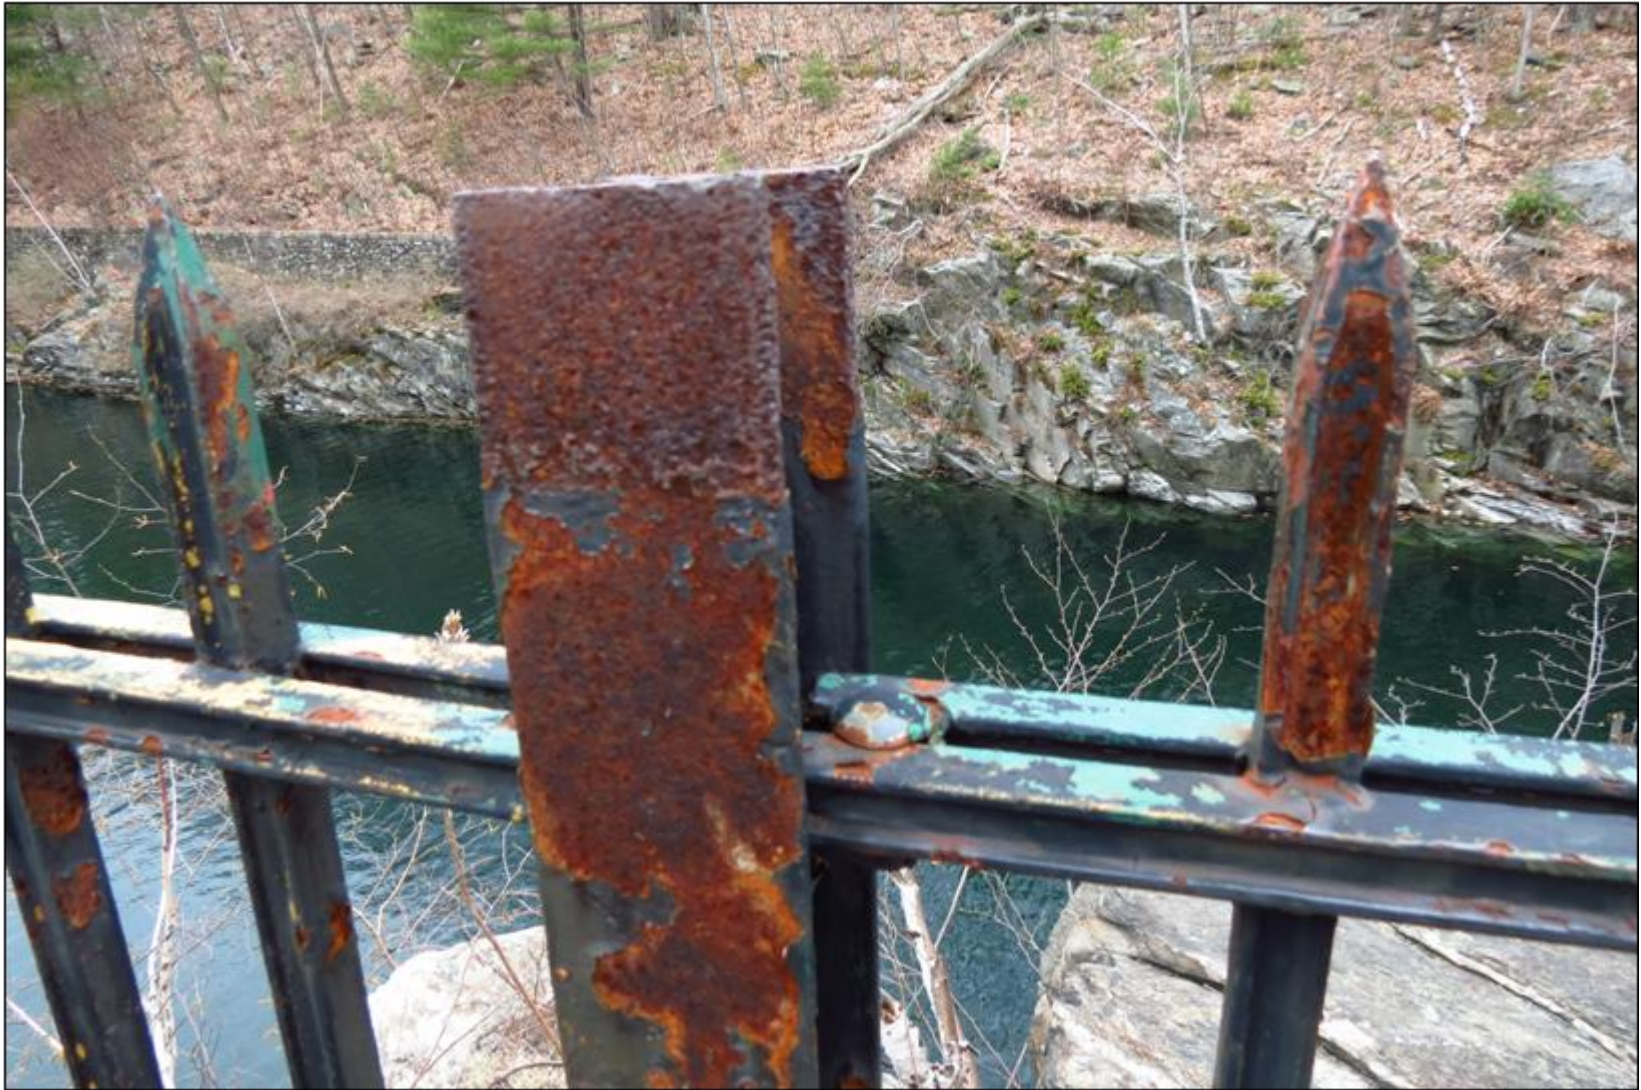
The top of the anchor post which is attached to fence sections on either side and sunk into the stone base below.

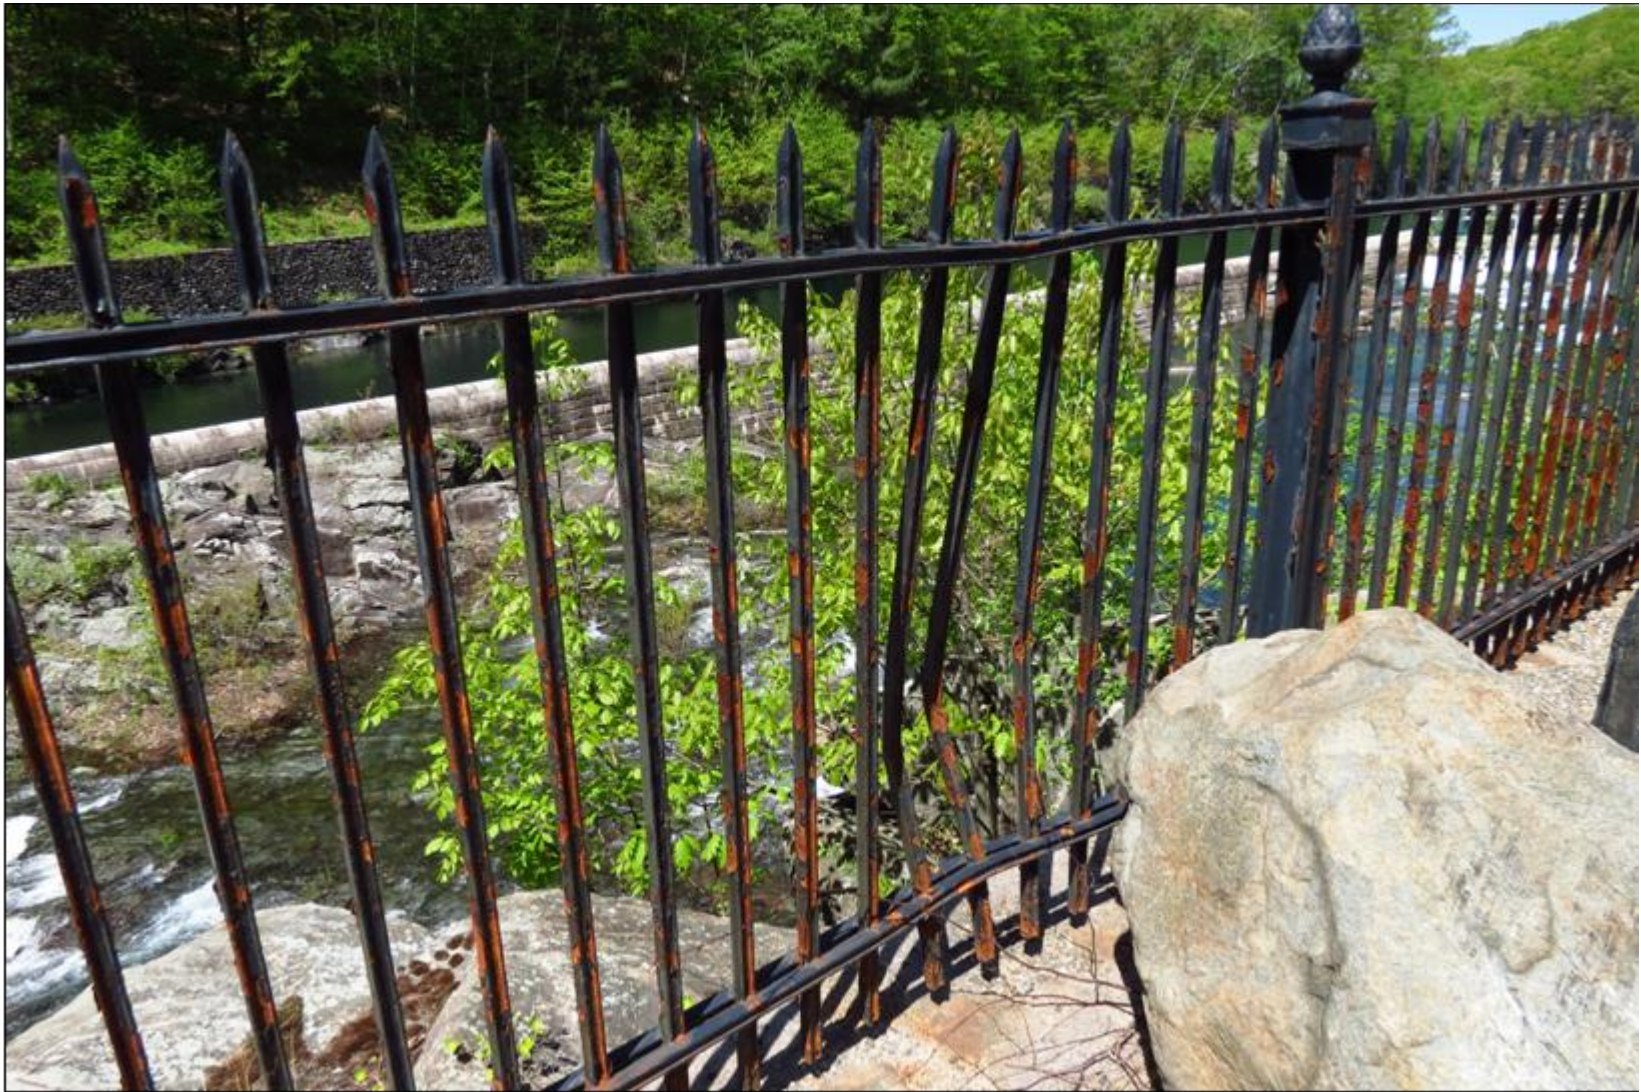
The fence has sustained damage in a number of places due to motor vehicle collisions.
