Report No. 22-025

Detecting Subsurface Voids in Roadways Using UAS with Infrared Thermal Imaging

Principal Investigator(s)
Dr. Alessandro
Dr. Tzuyang Yu
University of Massachusetts Lowell

Final Report

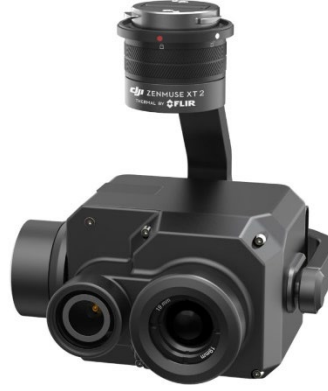
Figure 2.7: FLIR Zenmuse XT2 IR camera

For all the tests described in this section, the IR system used consists of the Zenmuse XT2 IR camera manufactured by FLIR with a noise equivalent temperature difference (NETD) $< 50\text{mK}$ and a thermal resolution of 640×512 pixels shown in Figure 2.7 (80). The camera was fitted with a 13 mm focal length lens and positioned to have a working distance of 1.10 m (~ 43 in.) when in nadir position (i.e., perpendicular to the road surface). The setup resulted in the camera's field of view (FOV) equal to $0.85 \times 0.67 \text{ m}$ ($\sim 2.80 \times 2.20 \text{ ft}$) and ground sampling distance (GSD) resolution of $1.6 \times 10^{-3} \text{ m/pixel}$ ($6.3 \times 10^{-2} \text{ in./pixel}$). These values can be scaled linearly with the working distance for larger FOVs.
