**Dorchester District Court
Dorchester, MA**

**HVAC SYSTEM
EVALUATIONS
COVID-19**

Office of Court Management

July 26, 2021

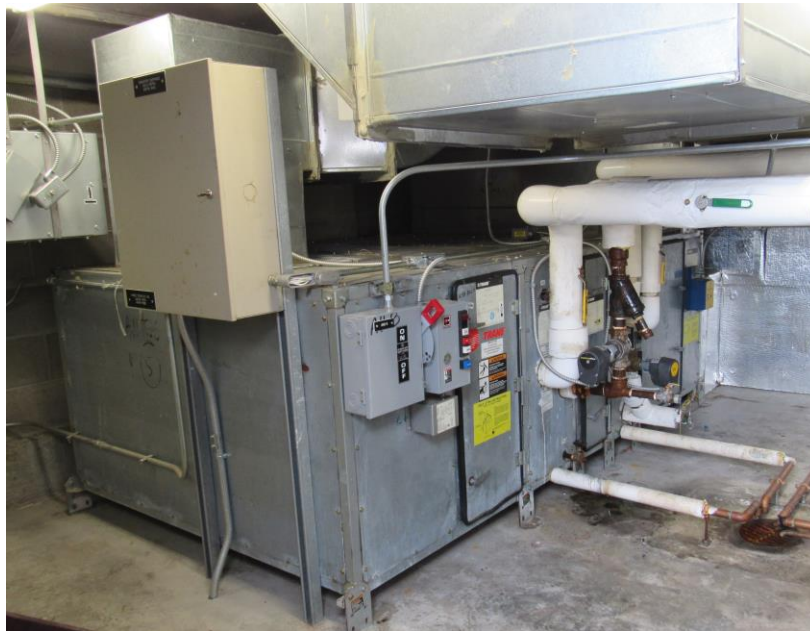
Photo 1 – Representative Air Handler

The air handling units are generally in fair condition. They appear to have been installed as part of the 1994 renovation. Motors, actuators, bearings, and other wear items appear to have been replaced as they failed. Most outdoor air dampers are in poor condition and are rusty but appear to be operational. Also, several filters were poorly fitted, and coils had dirty areas around the edges indicating possible bypass air around the filters.
