**Dudley District Court
Dudley, MA**

HVAC SYSTEM EVALUATIONS COVID-19

Office of Court Management

April 26, 2022

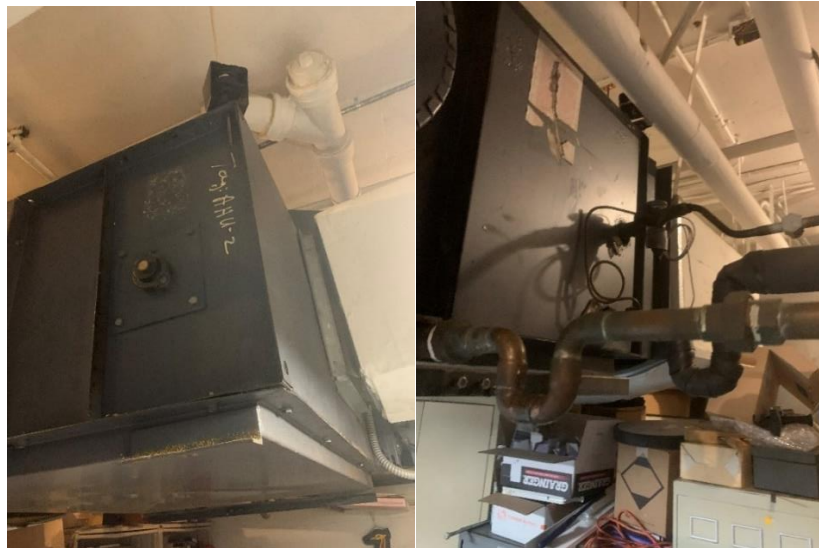
Photo 1 – Typical Air Handler

AHU-1, AHU-2, and AHU-3 appear to be from the original 1972 construction and are in poor condition. According to the original drawings, AHU-1 serves the main lobby, AHU-2 serves the main courtroom, and AHU-3 serves the holding cells. The dampers were not accessible while on site and the units were not accessible to open the access doors. The units contained 2", MERV 8 filters, which were accessible through a separate door. The rooftop condensing units serving the refrigerant cooling coils in AHU-1 and AHU-2 were replaced as part of a project completed in 2004.

Indoor air handling units have a life expectancy of 35-45 years. Air handlers AHU-1, 2, and 3 are approximately 50 years old and are in poor condition. Consider replacing these units in the next 2-5 years. Adding unventilated spaces to the new air handling equipment should be considered. Other than adding unventilated spaces to the air handling equipment, this recommendation is an equipment maintenance measure and does not increase the indoor air quality of the building.

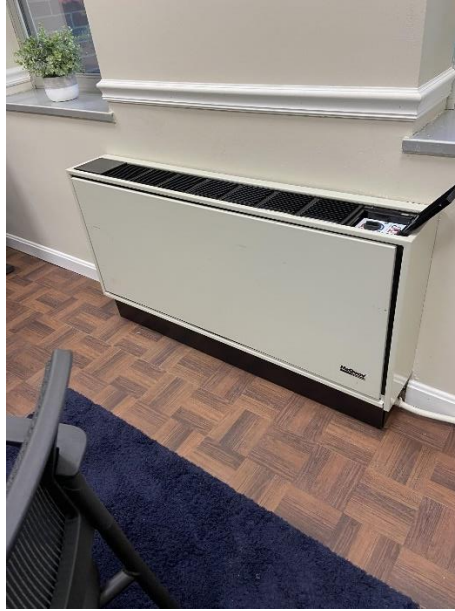
Photo 2 – Typical PTAC Unit

The PTAC units were replaced in approximately 2004 and appear to be in good to fair condition. Some units contain ¼" metal screen filter, which possesses no MERV rating while others contain 1" filters, also without a MERV rating. The filters that were examined were very dirty, as well as the coils. There are outdoor air louvers on the perimeter walls, however the outdoor air dampers were not accessible. The 2004 design drawings do not list the quantity of outdoor air these units were designed for. According to facilities staff, the PTAC units only operate when there is a call for space heating or cooling. Ventilation air is only provided when the units are running. Facility personnel indicated some units have been replaced since 2004. There is a mix of McQuay, Islandaire, and Carrier PTAC units installed in the courthouse. We sent Islandaire one of the unit model numbers and they confirmed that the unit was equipped with a motorized outdoor air damper.

The PTAC units with 1" filters may be able to accommodate a 1" MERV 13 filter. We recommend having a TAB Contractor determine if there is a significant drop in airflow using MERV 13 filters.
