WATERSHED-BASED PLAN

East Branch of the Housatonic River

September 2024

Berkshire Regional Planning Commission

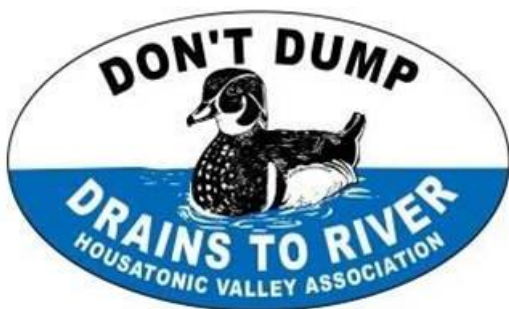
Figure 1: HVA's Storm Drain Decal

HVA has worked with Pittsfield and Dalton to glue decals adjacent to storm drains to inform people not to dump anything down the storm drain. In both municipalities, the focus was to decal neighborhoods where they are most visible. These decals need to be replaced every 1 – 3 years. In Pittsfield, many need replacing. Boy Scout groups and students from elementary and high schools assisted with decaling.

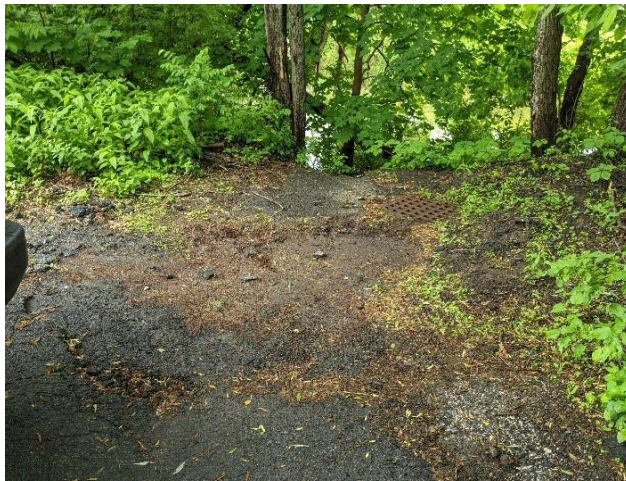
Photo C-1: End of the road runoff avoids the high catch basin and drains to the paved swale left of the basin.

Proposed Improvements: To capture stormwater before reaching the East Branch, a modified leaching catchbasin design is proposed. It will include an expanded stone envelope and a small internal storage reservoir or saturated zone that will mimic the function of a subsurface gravel wetland. The inlet will be a grated inlet and the outlet will occur over a stabilized internal clay berm. There is no secondary outlet as excess flow will level spread through the stone over the internal berm.

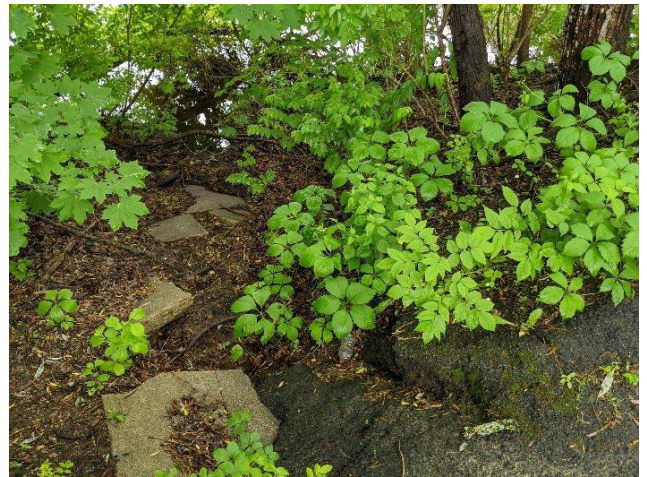
Photo C-2: Surface runoff is conveyed in the paved swale directly to the East Branch of the Housatonic River.

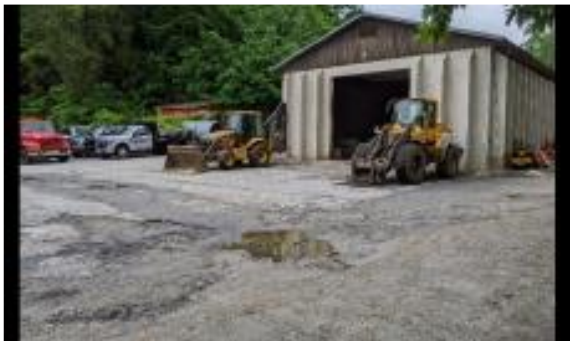
Photo C-3: The main catch basin for the DPW drains half the garage, the lot, and the salt shed. It tends to back up during storms.

Proposed Improvements: Install a bioretention system with a precast pretreatment system for the collection of sediment/solids from the high-use DPW yard. The bioretention basin would be located at the existing drain outfall. The drainage pipe would be replaced in the grassed area up to the access road. This is a combined SCM design consisting of a leaching catch basin to intercept the upland drainage area to a lower bioretention system/infiltration in the adjacent town-owned property. The inlet into the leaching catchbasin will be a grated inlet that discharges to the bioretention system. The overflow will be through an armored spillway over the existing grade. The Town of Dalton has been approved for a Community Compact Best Practices Grant to implement this project. Construction will be completed by the DPW staff.

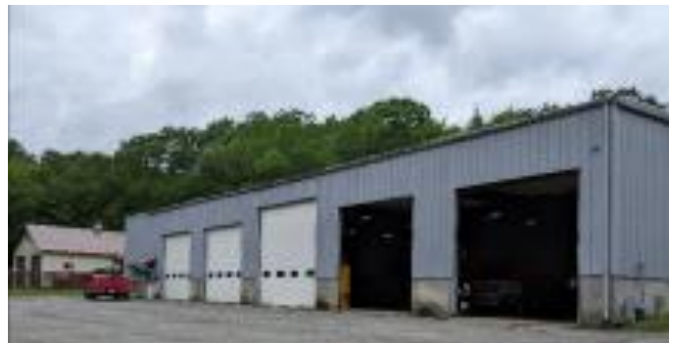
Photo C-4: Front of parking lot and half of the garage are all impervious surface with no stormwater treatment. Infiltration near street may be an option.

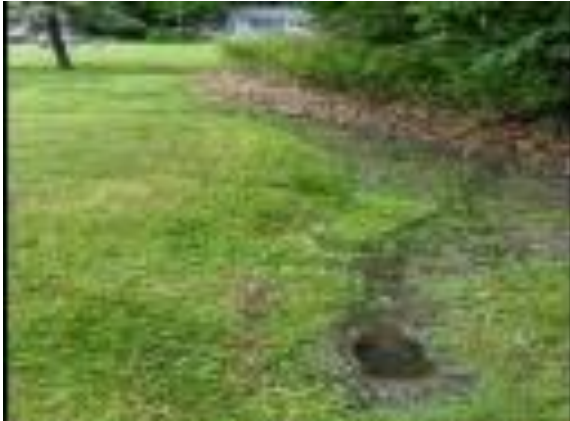
Photo C-5: The outlet of the DPW stormwater pipe is submerged and drains to a yard with no outlet. The outlet should be daylighted and treated with a BMP such as a bioretention basin (Site B).

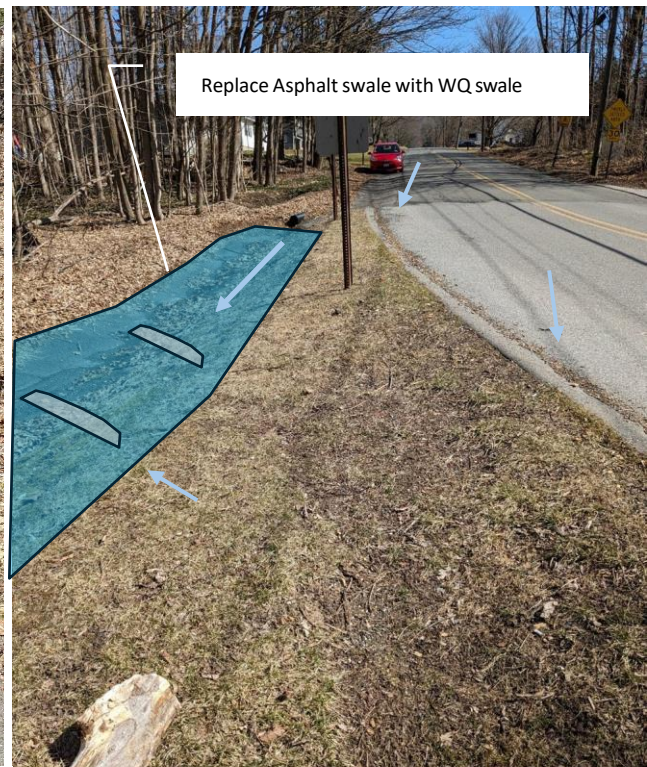
Photo C-7: Asphalt swale along Grange Hall looking towards pipe outlet.

1. Remove asphalt swale and stabilize the area around the pipe outlet.
2. Install water quality swale with check dams (approx. 1500 SF).

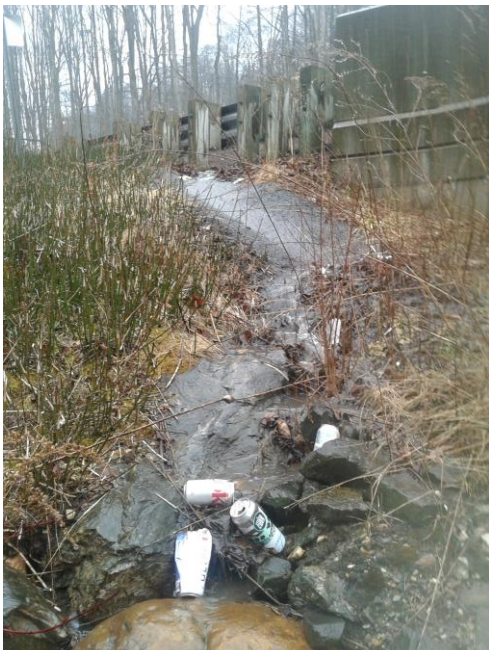
Photo C-8: (above) Curb cut and outfall pipe on Route 8 ROW which leads to an informal stormwater

This potential BMP project provides an opportunity to infiltrate stormwater from Route 8 in Dalton and reduce the volume of stormwater directly discharged to the East Branch of the Housatonic River. The project site is adjacent to the East Branch of the Housatonic River in Dalton and is located near the Old Mill Trail Route 8 crossing. The Old Mill Trail is managed by the Berkshire Natural Resources Council. Route 8 and the stormwater infrastructure is managed by MassDOT. There is an asphalt swale that directs stormwater from Route 8 to the East Branch. Further south on Route 8 is a curb cut that allows stormwater to enter an informal infiltration basin. The goal would be to remove the existing asphalt swale and instead direct the stormwater to an infiltration basin. The existing informal basin could be formalized and increased in size with multiple inlets created. These inlets may be asphalted or grassed. The basin could be planted with willow adding to the already existing willow shrubs.

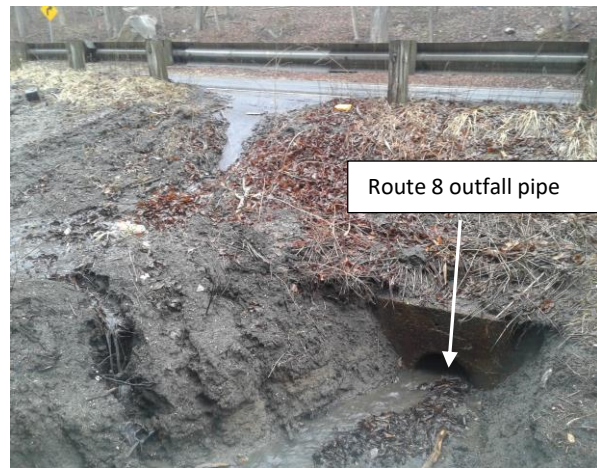
Photo C-9: (left) Asphalt swale from Route 8 which leads to the East Branch of the Housatonic River.

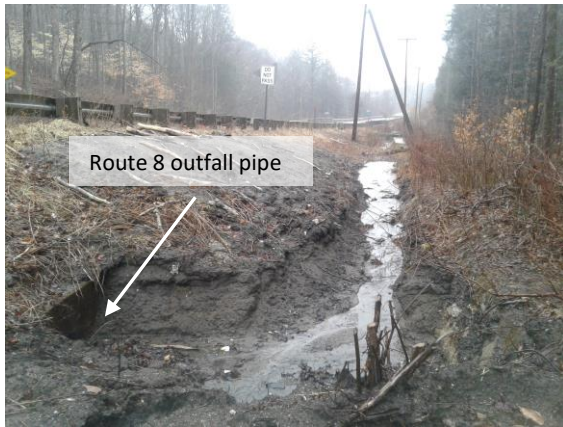
Photo C-10: View of informal infiltration basin

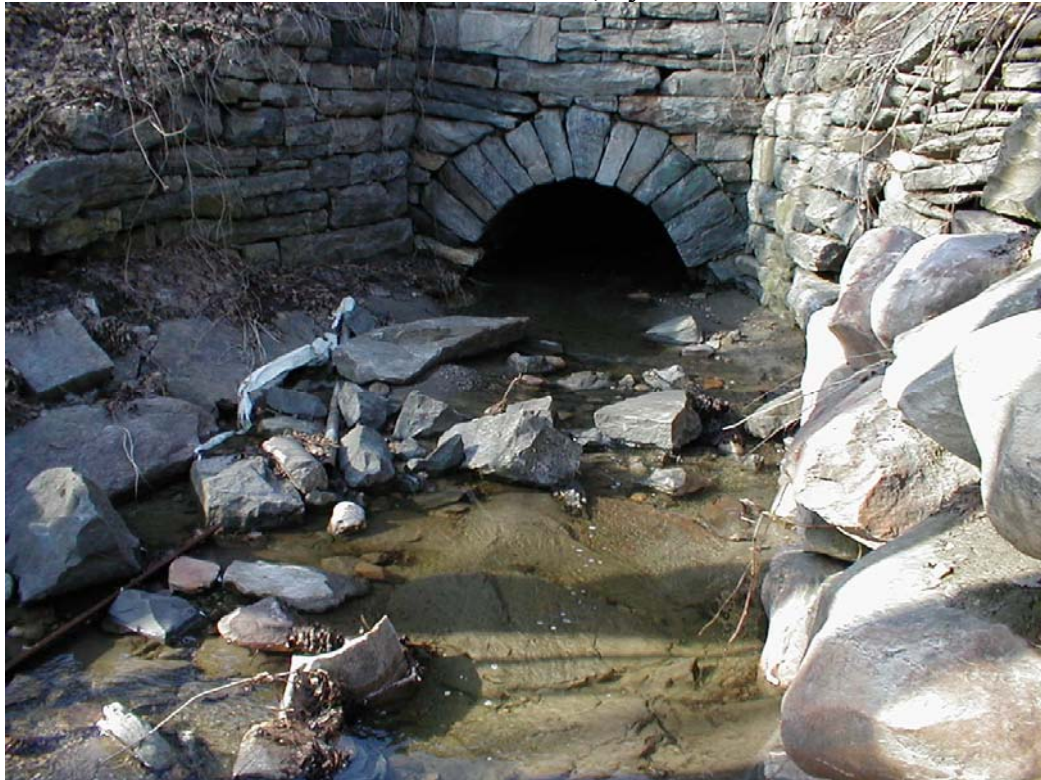
Walker Brook as it exits the “culvert”, by the Dalton Post Office
