**Eastern Hampshire District Court  
Belchertown, MA**

# **HVAC SYSTEM EVALUATIONS COVID-19**

Office of Court Management  
December 28, 2021

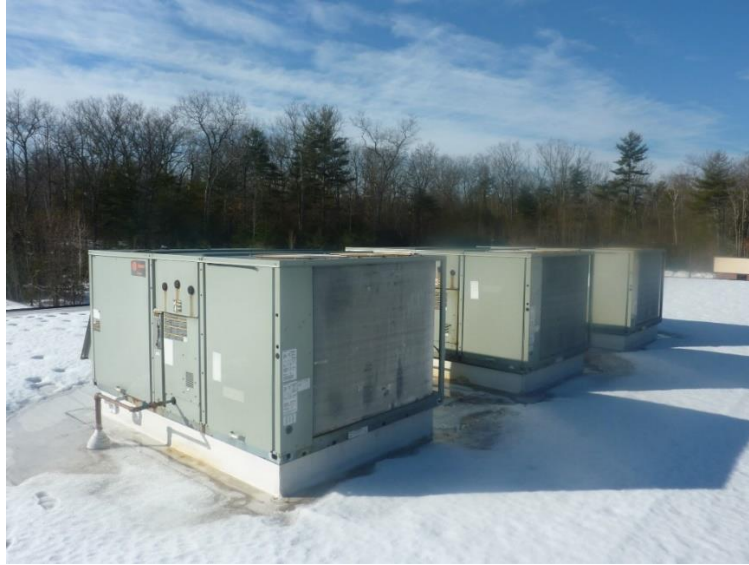
Photo 1 – Representative Rooftop Air Handlers

Ventilation air is provided by eight constant-volume, single-zone packaged rooftop units. Each unit consists of a mixing box with 100% outdoor air economizer, 2" MERV-13 filters, constant-speed supply fan, direct-expansion (DX) cooling coil, gas-fired furnace, refrigeration compressor(s) and condenser. There are no return or exhaust fans in the air handlers, just barometric relief dampers for when the units are in economizer mode. Supply air is distributed through metal ductwork with ceiling-mounted diffusers and return grilles.

All HVAC units are from the original construction and appear to be in fair condition, although at or near the end of their expected service lives. There are comfort issues throughout the building that were noted by staff, which we feel may be due to the limited zoning of the rooftop units, and the coarse staging of cooling and heating (which is largely just on or off).

Outdoor rooftop air handling units have a life expectancy of approximately 20 years. The rooftop units are 14 years old and are in fair condition. They use R-22 refrigerant, an ozone-depleting chemical that has been phased out of production, making it expensive to replace or replenish when a failure occurs. Consider replacing these units in the next 5 years. Replacement units will not only use a more environmentally friendly refrigerant, they will be more energy efficient, and can use heat pump technology to minimize the use of natural gas.

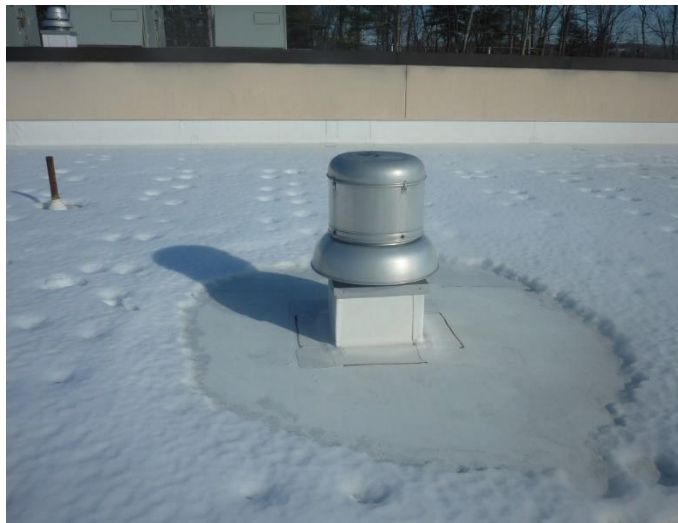
Photo 2 – Representative Exhaust Fans

The mechanical plans we reviewed do not show a separate exhaust fan serving the holding cells, they show return air ducted back to the rooftop unit. However, there is a rooftop exhaust fan located above the area, which most likely serves the holding cells. It was not operating at the time of our visit, and the exhaust grilles in the holding cells were not active, although dust on the grill faces indicates they are or may have been active. The snow melt pattern around this fan also indicates that it runs, see Photo 2 and the explanation that follows.

The exhaust fan in the background, upper left corner of Photo 2, serves the toilet rooms in the Jury Deliberation area, and was running at the time of our site visit. We suspect that the unit in the foreground serves the holding cells. We observed that it was not running, but the snow melt pattern indicates that it has run recently.

We recommend repairing or replacing the controls for exhaust fans that were not working at the time of our visit. Exhaust fans can be interlocked the rooftop units that serve the surrounding space. Small toilet rooms with individual fans can continue using controls interlocked to the lights, but we recommend using a time delay relay that runs the fans for a period after the lights are switched off, such as the Panasonic SmartExhaust AirCycler combination fan/light timer control.
