Massachusetts Department of Fish and Game

Division of Ecological Restoration

Ebb&Flow

November 2016
<http://www.mass.gov/der>

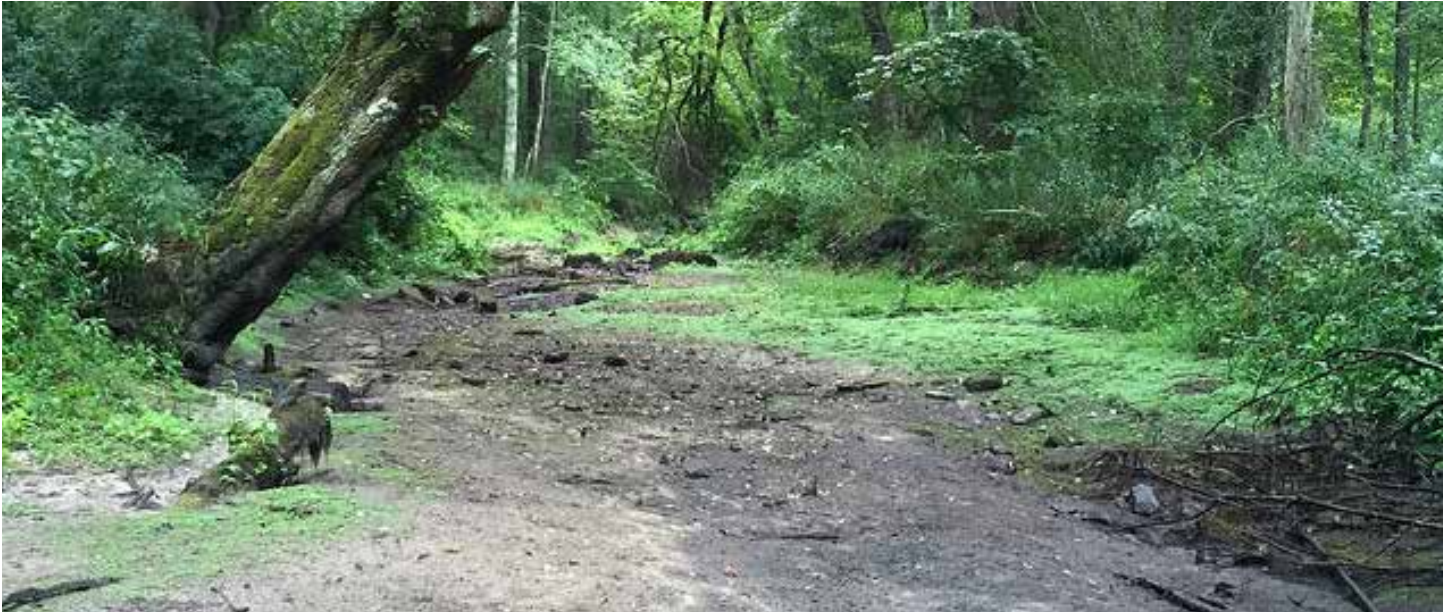
Mattapoissett River Mattapoissett Sept 1 2016

This summer and fall we observed many streams that were completely dry for months at a time and others that were just a series of disconnected pools. In these impacted streams, the baseflow (groundwater that feeds streams during periods when there is no precipitation) had disappeared as groundwater levels dropped below the streambed due to the impacts of water withdrawals, lack of precipitation and impervious surfaces. In other streams water levels behind dams dropped below spillways, resulting in no flow below the dam. The lack of water and flow in these streams directly impacts habitat quantity and quality which may have lasting impacts on aquatic organisms.

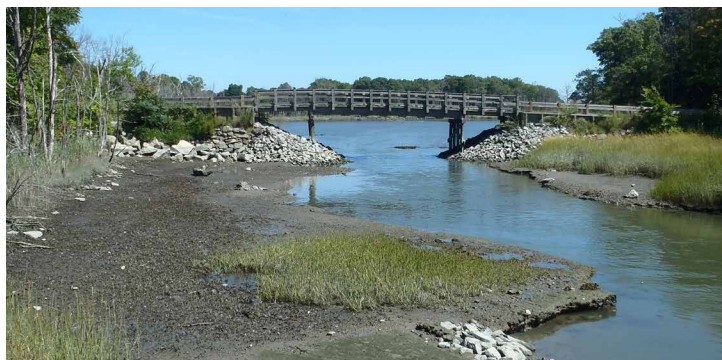
Blue Carbon Calculator: A Simple Methodology for Determining the Greenhouse Gas (GHG) Impact of Aquatic Ecological Restoration Projects

Coastal wetlands capture and bury carbon at high rates. This carbon is called blue carbon. Restored salt marshes are especially capable of sequestering blue carbon and reducing harmful methane emissions. The Blue Carbon Calculator is a first-generation tool to assess GHG impacts of aquatic ecological restoration projects, with a focus on coastal wetlands.

1. Enter Expected Land Cover Changes

The user enters the land area for each type of land cover change resulting from a project.

2. See the Green House Gas Budget

Annual emissions resulting from each change in land cover are calculated based on internationally accepted data. Results appear on the “Calculator” worksheet.

How Does it Work?

As tides are restored, methane (CH_4) emissions decline as a site converts from a freshwater to a saltwater environment. Carbon is stored in the soils more readily under a healthy marsh condition.

With financial support from our parent agency, The Executive Office of Energy and Environmental Affairs (EEA), and in tandem with Abt Associates, we have developed a simple spreadsheet tool that can help us incorporate GHG considerations into the process of selecting and prioritizing aquatic ecosystem restoration projects. We call this new tool the Blue Carbon Calculator. Users simply plug in the anticipated changes in wetland cover types from a coastal, wetland, or riverine project and the Calculator estimates the associated change in GHG emissions.

Healthy wetlands are a critical part of our planet’s ability to regulate carbon. The Blue Carbon Calculator can help us better understand this important ecosystem service of wetlands. Outputs from the calculator underscore the potentially huge reductions in methane emissions when we convert a freshwater wetland site back to a salt marsh with the reintroduction of salt water. On the flip side, creation of new freshwater wetlands, if converted from uplands, can result in an increase in methane production. The restoration of all types of wetlands is important for many reasons, not just GHG accounting. Some of the co-benefits include

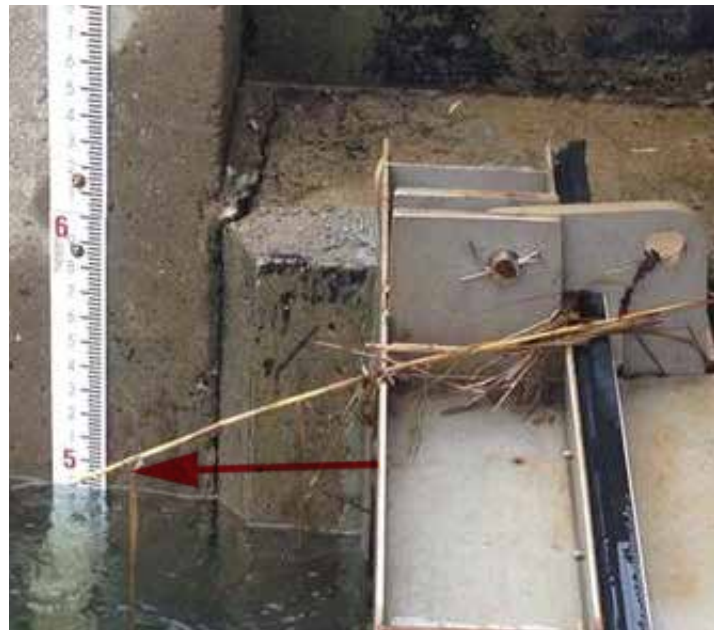
Left: Mill River Gloucester, Tide Gate. Right: Mill River Gloucester Tide Gate at King Tide Photo courtesy of Eric Hutchins, NOAA Restoration Center, October 18th, 2016 ~1:45PM

In August 2011, DER worked with the City of Gloucester and numerous project partners to install a new, specially-designed tidegate at the entrance to the Mill River Estuary. The new tidegate allows all but the highest tides to enter

the estuary. This allows for almost full tidal restoration while simultaneously protecting upstream infrastructure (buildings, roads, etc.) from tidal flooding. DER staff, City of Gloucester officials, and partners had the opportunity to observe the performance of the tidegate during a recent King Tide courtesy of this photograph provided by our partner at the NOAA Restoration Center.

King Tides (a non- scientific term) are the naturally occurring, exceptionally high tides generated when the Earth, sun and moon align during new and full moons. These tides are excellent test cases for what we might expect with sea level rise. The project partners were excited, but not surprised, to see that the tidegate performed as expected during these higher tidal events. While this event illustrates the effective existing functioning of this tidegate, it also highlights the importance of proper tide gate management, particularly given that these extreme tides may be more common in the future.

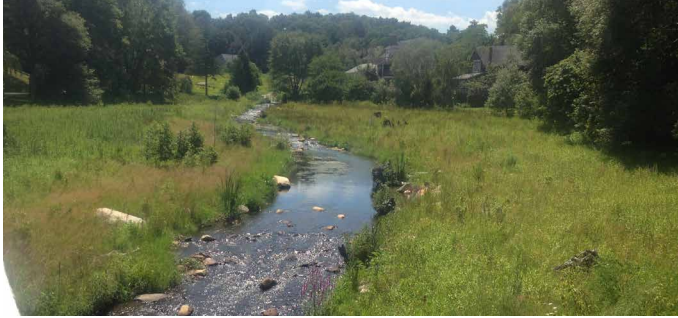
Former Site of Off Billington Street dam impoundment

It has been nearly three years since the Off Billington Street Dam was removed from Town Brook in Plymouth. It was a long, cold winter reshaping the channel and removing tons of contaminated sediment. In spring of 2014, the former impoundment a dozen plant species sprang up. In the years since then, DER and partners have continued to monitor the evolution of the plant community and to hand-pull invasive purple loosestrife. Having just completed Year 3 of that monitoring, the change is striking. Gone are the annuals and common early successional weeds. The plant community is now dominated by native wetland species from the seed mix that was planted in 2014, as well as recruits from elsewhere in the stream corridor.

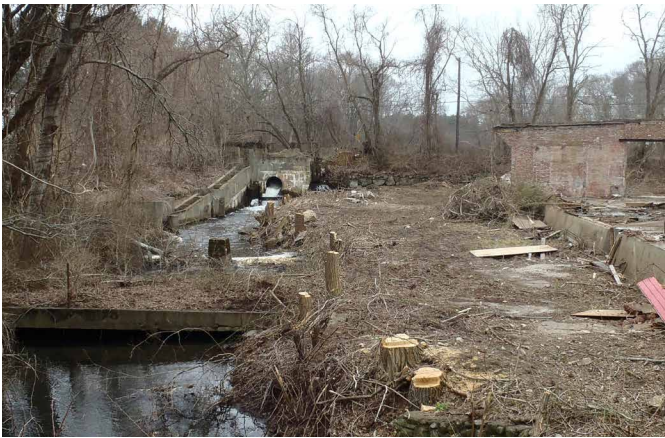
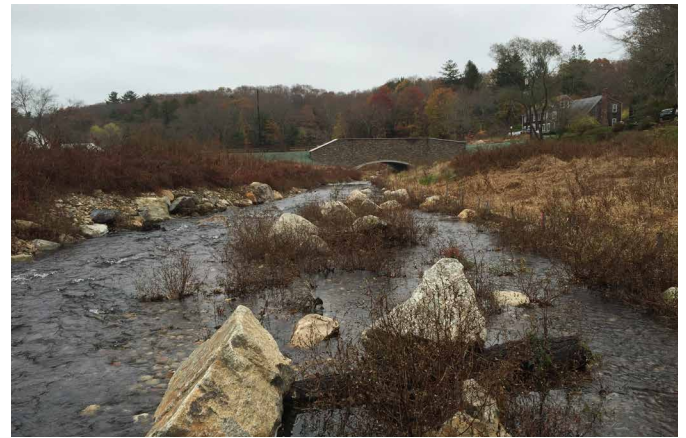
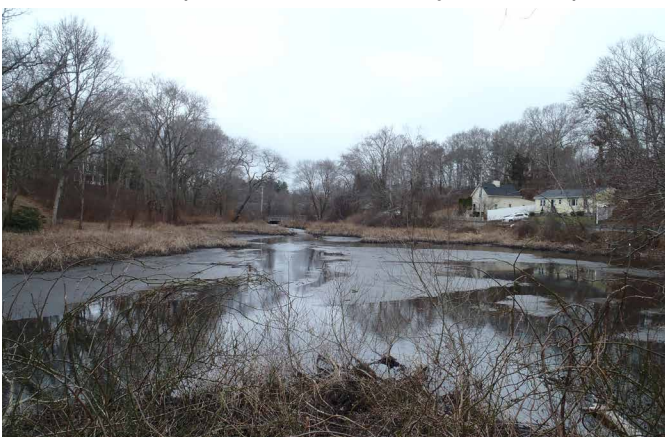
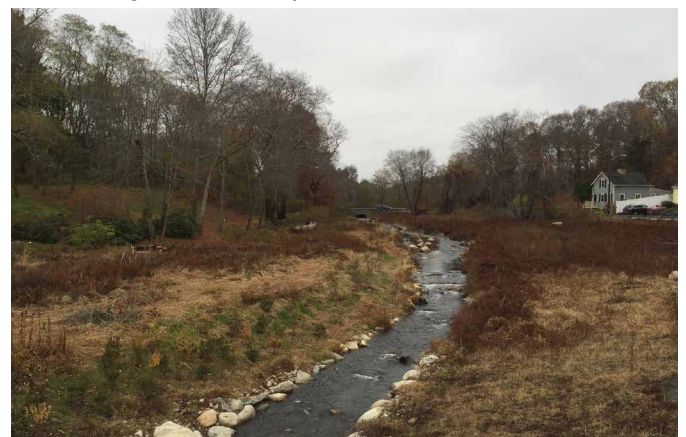
Top Left Plymco Dam prior to removal. Top Right After the Plymco Dam removal.

Bottom Left: Impoundment behind Plymco Dam prior to removal. Bottom Right: Site of Impoundment after dam removal

of the former Plymco Dam. This dam was removed in winter of 2014-2015. As record snow blanketed much of Massachusetts, crews pushed forward restoring the channel and constructing a brand new bridge similar to the one that replaced the Off Billington Street Dam. Now, after the second growing season following dam removal, the project site is really coming into its own as a natural habitat. DER and partners will continue to monitor both sites for another two years to document the establishment and succession of the plant community.

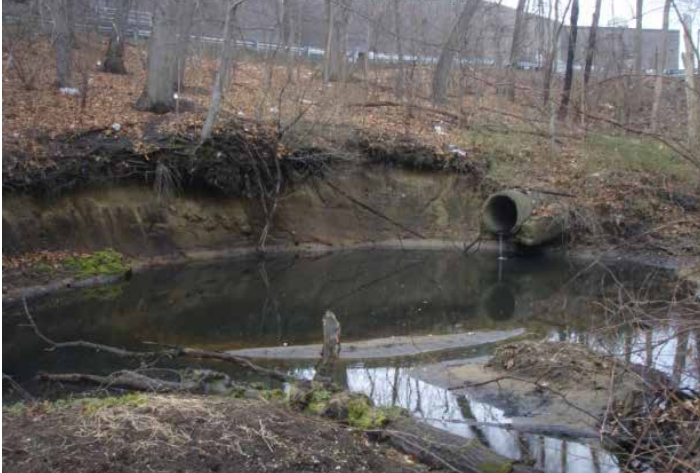
Top left: Abbey Brook 'headwaters' at the top of the ravine.

Abbey Brook is a small headwater stream on the western edge of Springfield that flows into the Chicopee River. The brook's source is buried, with the first glimpse of the brook visible when it flows from a pipe at the top of a steep ravine. The narrowness and steepness of the brook's valley precluded development resulting in 30 acres of open space and conservation land in the midst of a densely developed urban landscape. The Abbey Brook Conservation Area is now the focus of a vibrant partnership of local, city, academic, state and federal entities known as Sustainable Springfield.

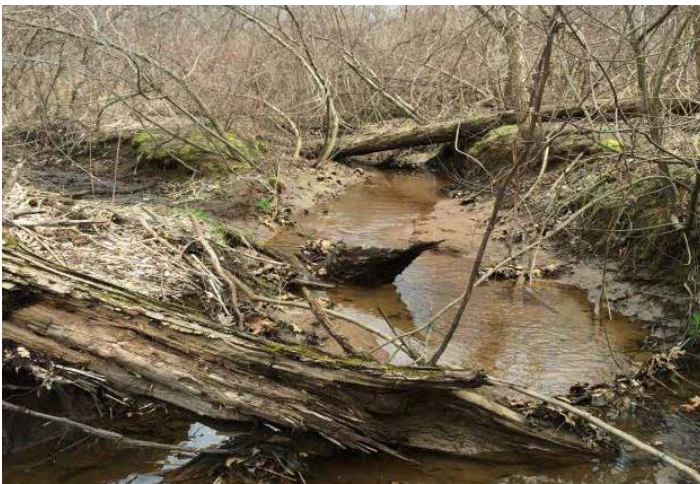
Left: Example of the significant erosion and instability visible along the banks of Abbey Brook.

The quick take away of the report is that stormwater can be a dominating influence in an urban waterway. The most arresting indicator of this at the Abbey Brook Conservation Area is the ubiquitous signs of instability and changing topography as embodied in the several 'newish' shopping carts so embedded in the river bank only a few inches of plastic handle is visible. The surrounding uplands shunts stormwater into the Abbey Brook ravine with the large stormwater outfalls, several feet in diameter, testament to the significant quantities of runoff flowing into the brook. Many of the outfalls were found to be in poor and even collapsed condition.

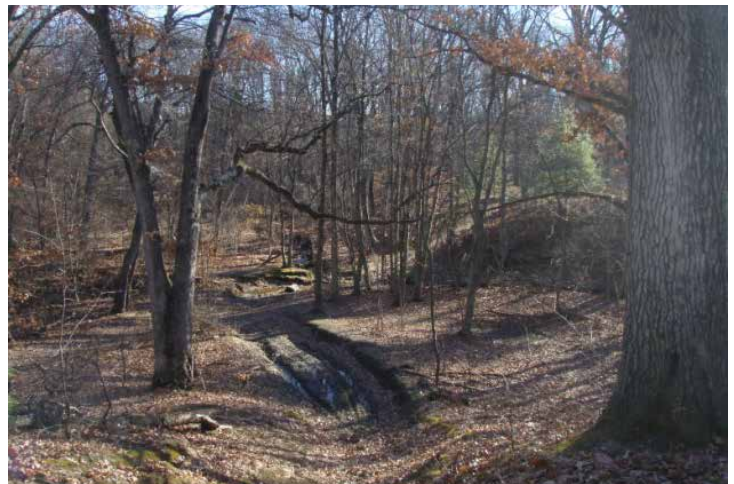
Right: Rutting and erosion caused by off road vehicles are visible throughout the area.

As anticipated in a landscape with a long history of change and manipulation, the assessment report identified the prevalence of invasive species throughout the site. Off road vehicle use was also documented with many images highlighting the negative impact just a few vehicles can cause. Rutted trails and mucky stream crossings caused degraded habitat and increased erosion.

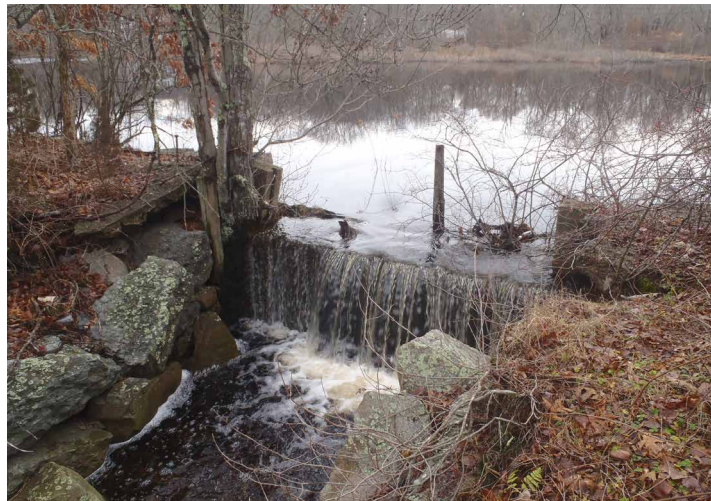
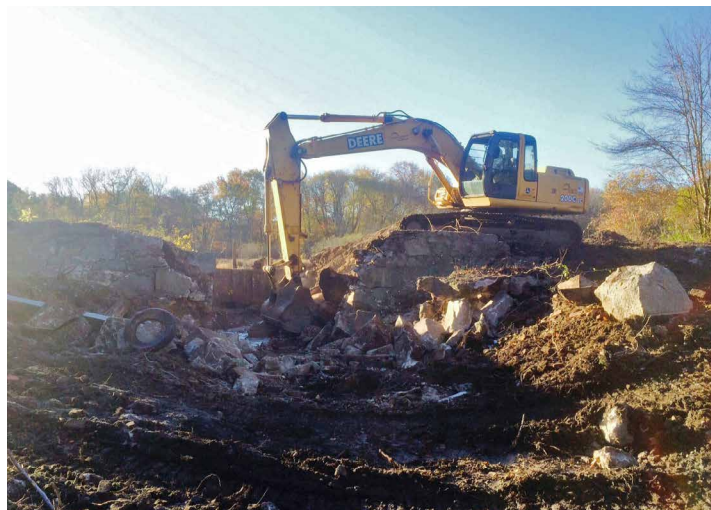
*Above: Rattlesnake Brook Dam
Below: The removal of the Rattlesnake Dam in process.*

The removal of the obsolete Rattlesnake Brook Dam (a.k.a. Crystal Springs Dam) located in Freetown begin in late October.

Removal of this barrier will naturalize stream processes and open the brook to migration to trout from Assonet Bay for miles upstream to the coldwater habitat in the upper watershed.

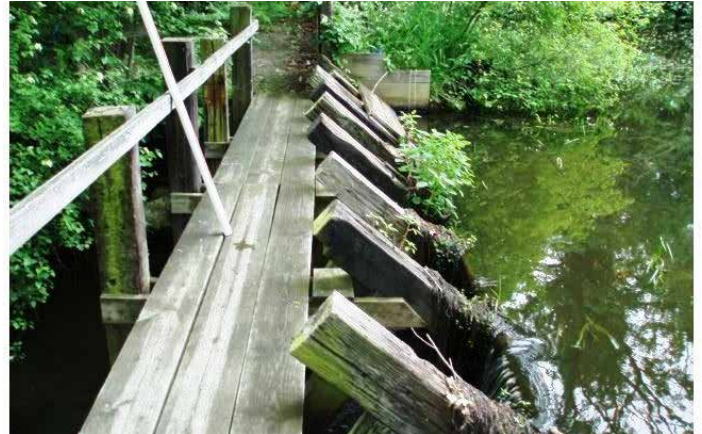
Barstowe's Pond Dam left spillway

It's not unusual that the smallest dams sometimes prove to be the biggest challenges for removal. As in the case of the Barstowe's Pond Dam in Taunton, the challenge comes from a railroad bridge about a quarter mile upstream of the dam. After engineering analysis of the dam removal hydraulics indicated a change at the bridge, DER and partners began the long process working with the railroad owner to find a solution that would protect the bridge and allow the dam removal to go forward. Finally, this summer, DER began working closely with engineers from the MA Department of Transportation to design a solution that will achieve both goals with an aim to remove the dam in late summer 2017.
